# **Southland Museum & Art Gallery**

**Detailed Engineering Evaluation  
Quantitative Assessment Report  
Invercargill City Council**

## Detailed Engineering Evaluation Quantitative Assessment Report

Date: 29 November 2013  
Reference: 6-VI030.00 / 005gv  
Status: Final

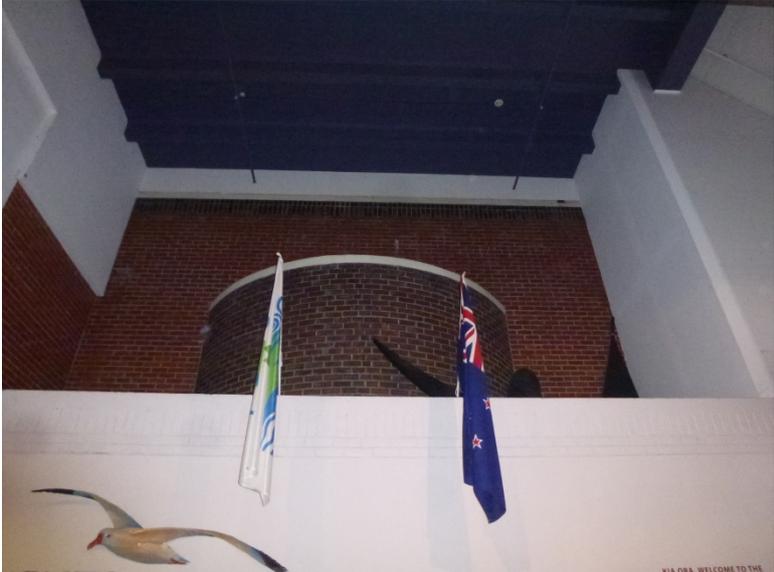
<p>Southwest corner of interior of 1988 addition</p>	<p>West brick veneer of original museum</p>

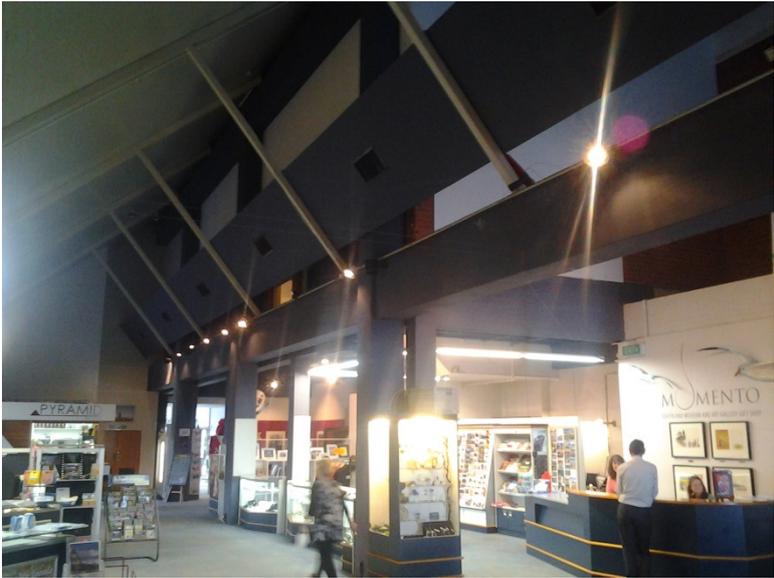
<p>Interior View from Southwest</p>	<p>1988 concrete frame on the exterior of the 1960 concrete frame and original museum. Diagonal bracing for pyramid roof structure also shown.</p>

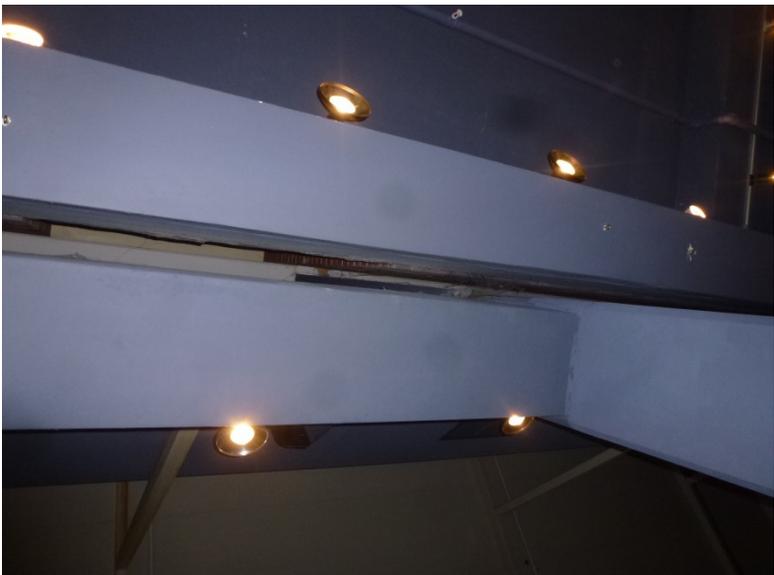
A photograph showing the interior of a museum gallery. The ceiling features a complex concrete structure with diagonal bracing. The space is lit with recessed ceiling lights. In the background, there are display cases and a counter area with a sign that says "MOMENTO".
<p>West of grid 2.</p>	<p>Gap between 1988 structure and 1960 structure along grid 2.</p>

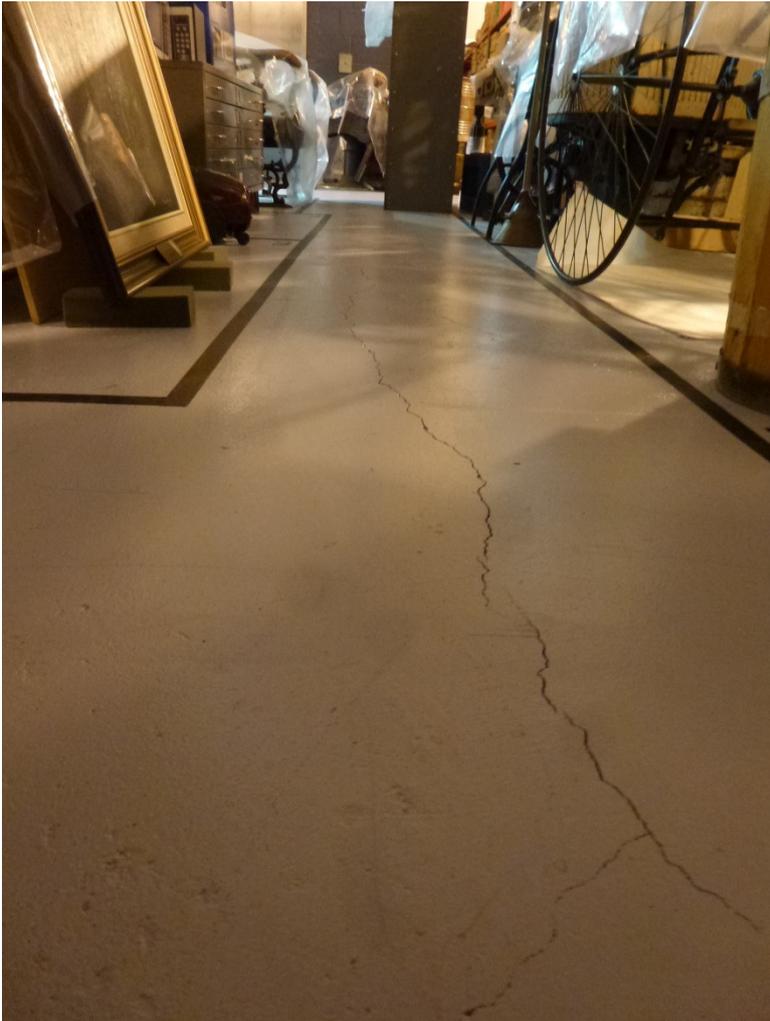
The building appears to be in reasonably good condition. However, many cracks were observed at the topping slab at the 2<sup>nd</sup> floor of the 1988 addition (see photograph in Appendix A). In addition, various elements were partially removed during the various additions and alterations.

<p>1988 Addition</p>	<p>Cracking in Level 3 topping slab</p>

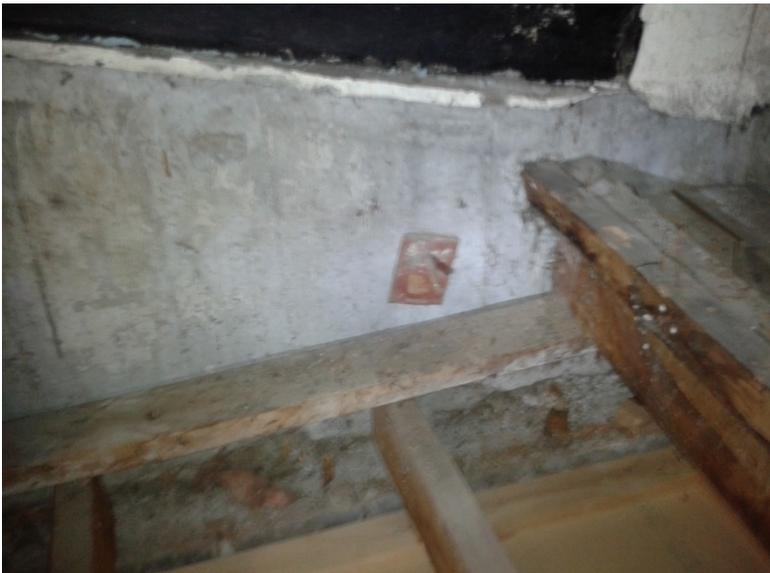
<p>Original Museum</p>	<p>Upper level ceiling joists bearing on concrete wall beam</p>

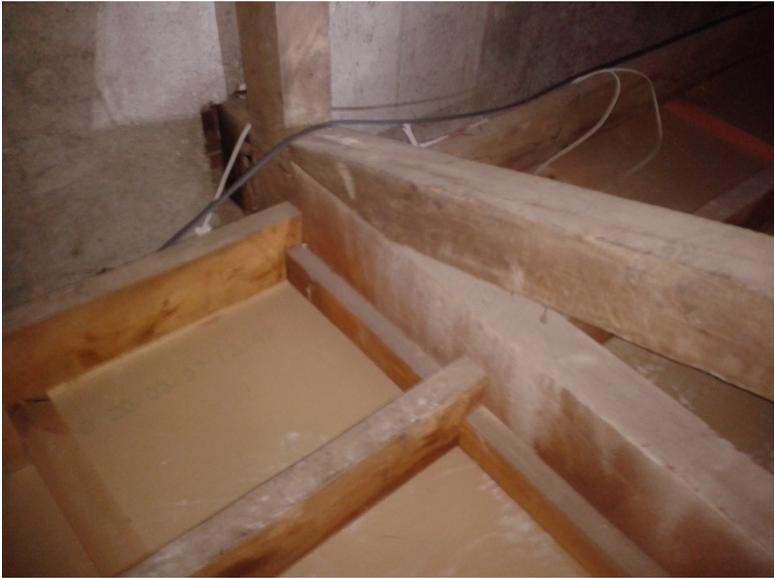
<p>Original Museum</p>	<p>Roof truss bottom chord supported in pocket in concrete wall</p>

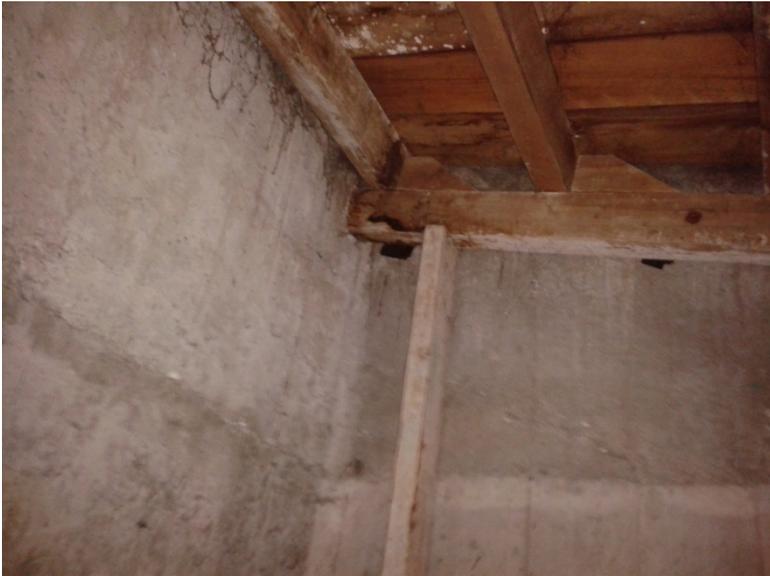
<p>Original Museum</p>	<p>Roof connection to concrete wall.</p>

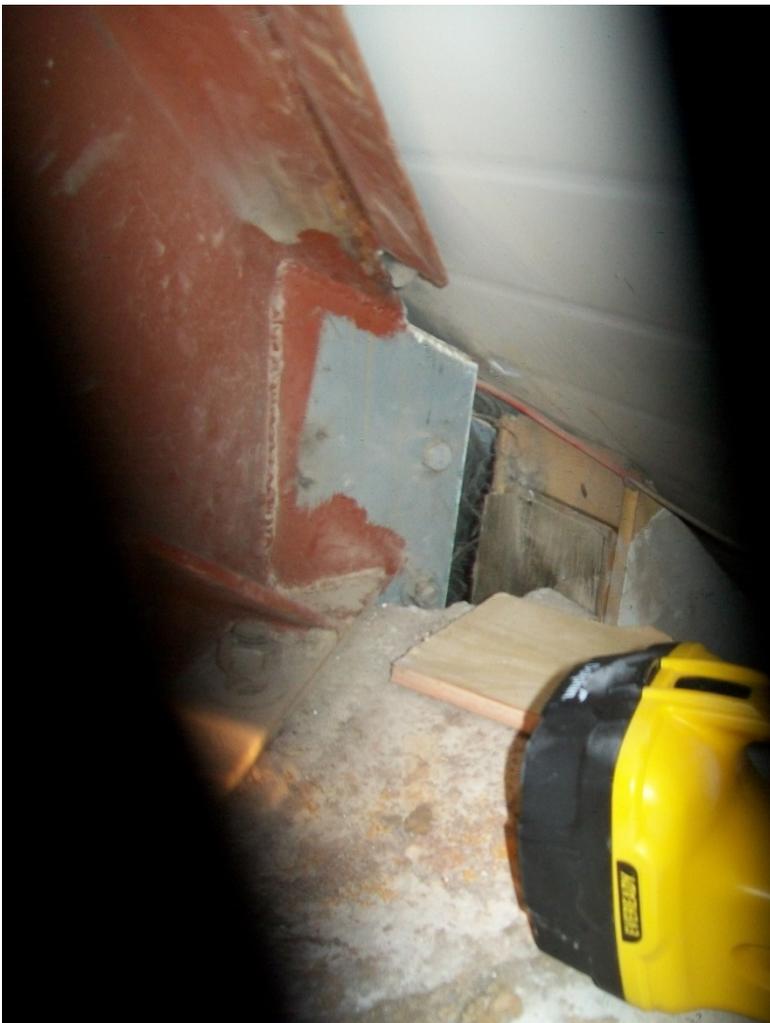
A photograph showing the interior of a structure. On the left is a rough, grey concrete wall. On the right, there are wooden roof trusses and rafters. A vertical wooden post is visible, supporting the roof structure. The lighting is somewhat dim, highlighting the textures of the concrete and wood.
<p>Pyramid Roof Structure</p>	<p>Main corner diagonal (member "B") connection to third floor concrete structure at B-8.</p>

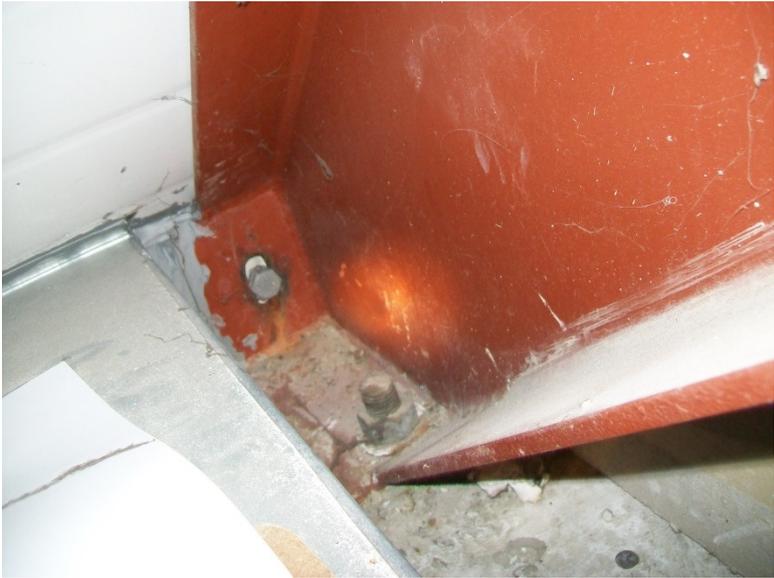
<p>Pyramid Roof Structure</p>	<p>Member “A” pyramid connection at GL 9 to third floor concrete structure</p>

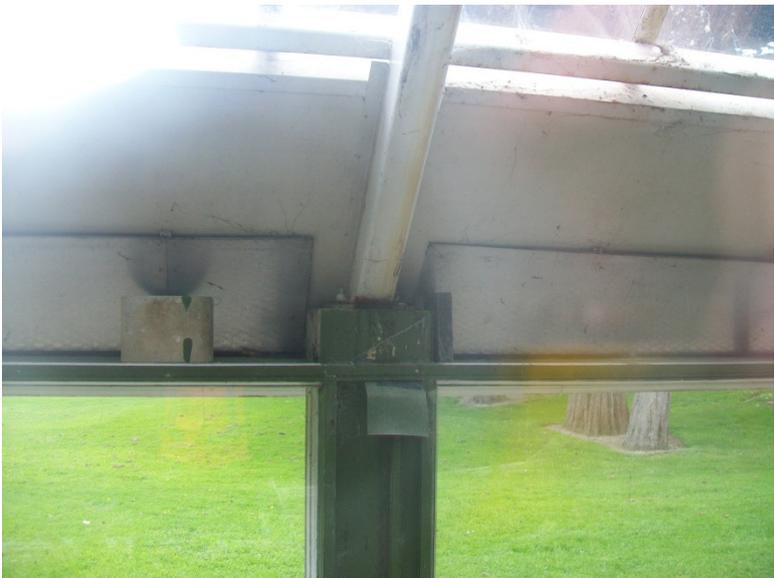
<p>Pyramid Roof Structure</p>	<p>Connection of member “G” to concrete column at A-5.</p>

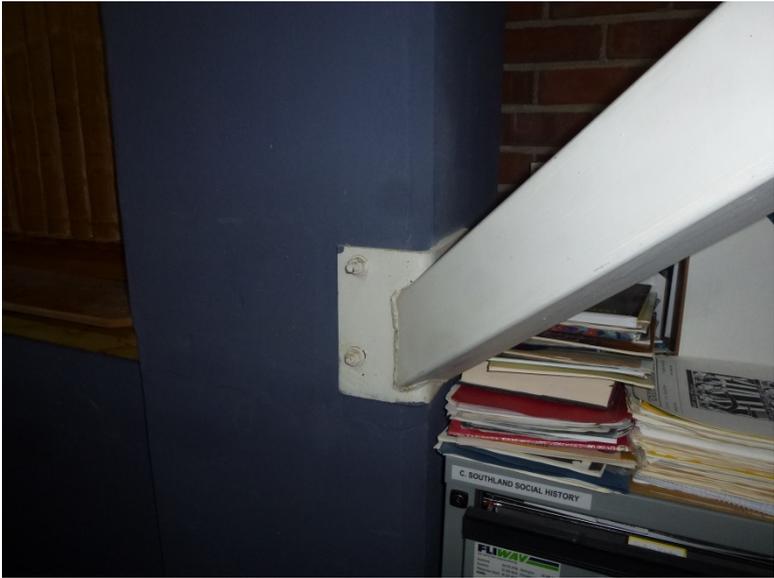
<p>1988 addition and pyramid</p>	<p>Connection of SHS pyramid strut to concrete column</p>

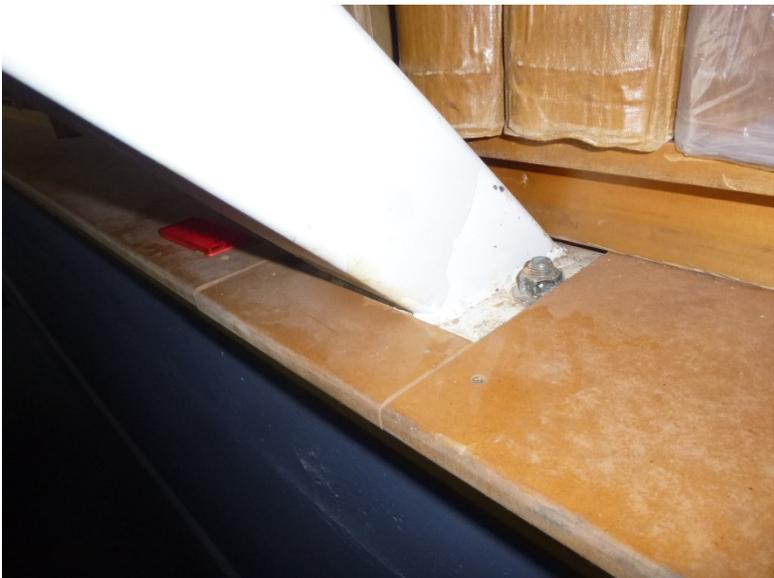
<p>1988 addition and pyramid</p>	<p>Connection of SHS pyramid strut to concrete beam</p>
