Southland Times Building, 67 Esk St, Invercargill, 9810

## DETAILED SEISMIC ASSESSMENT REPORT

Revision	Date	Description/Reason for Issue		
A	23/02/2018	Formal DSA Issue		
		Prepared by	Reviewed by	Approved by
		Name	Warren Holt	Andrew Marriott
		Signature

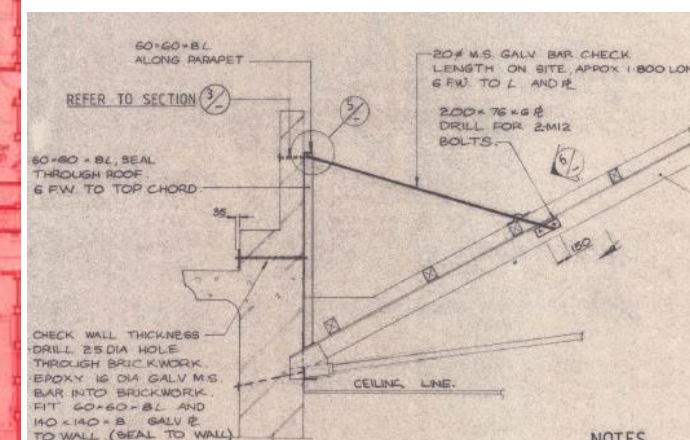
Figure 15: Façade parapet current restraint system

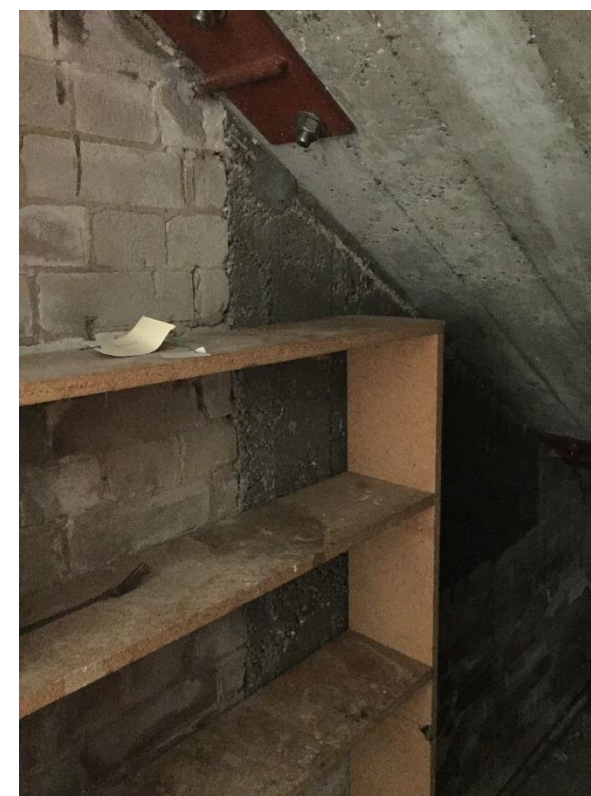
Figure 19 – Concrete Masonry Brickwork with RC window infill and RC stairs tied into West side wall.

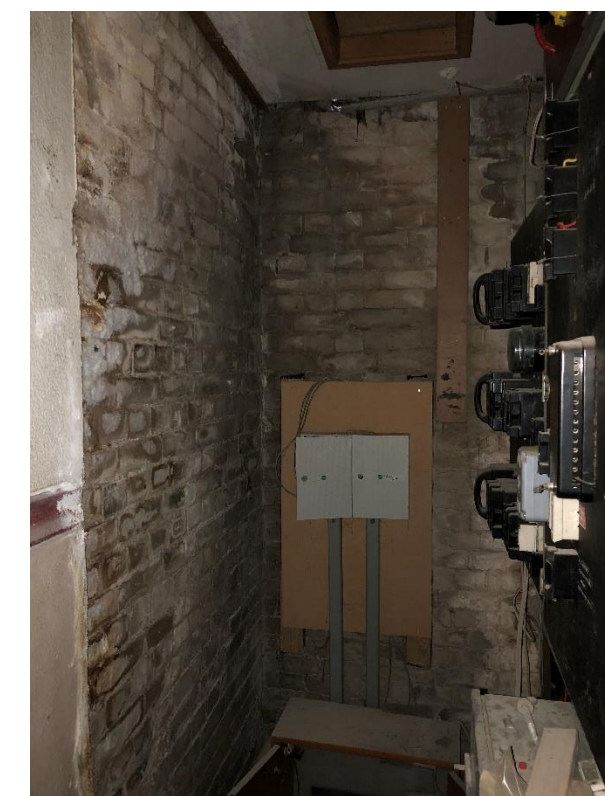
Figure 20 – Ground Floor North West corner evidence of efflorescence to the brickwork internal leaf.

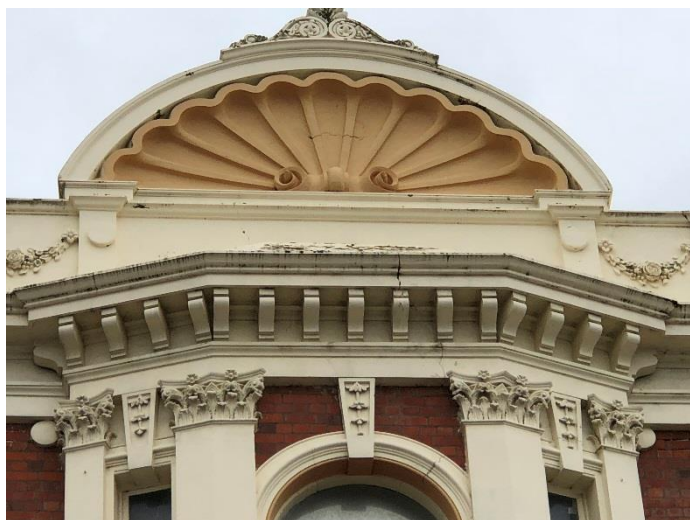
Figure 21 – North Elevation Façade exhibit cracks to the cornice and parapet cladding.

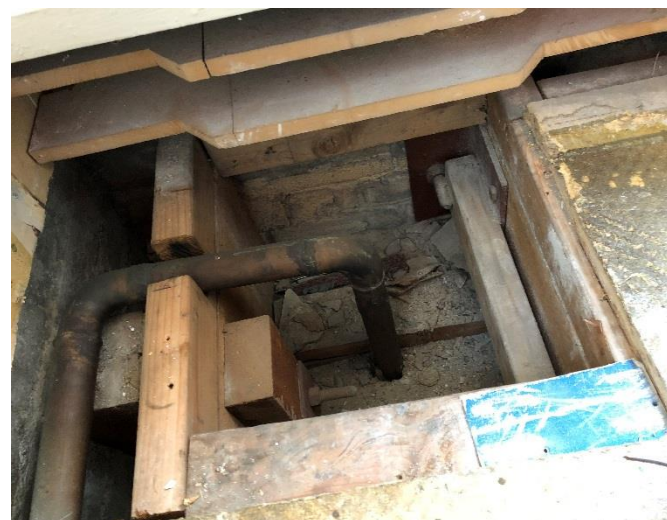
Figure 22 – North and East Elevation ties into floor diaphragm at first floor. Façade tie local to trimming joist only, minimal transfer path. East elevation fixings every second joist

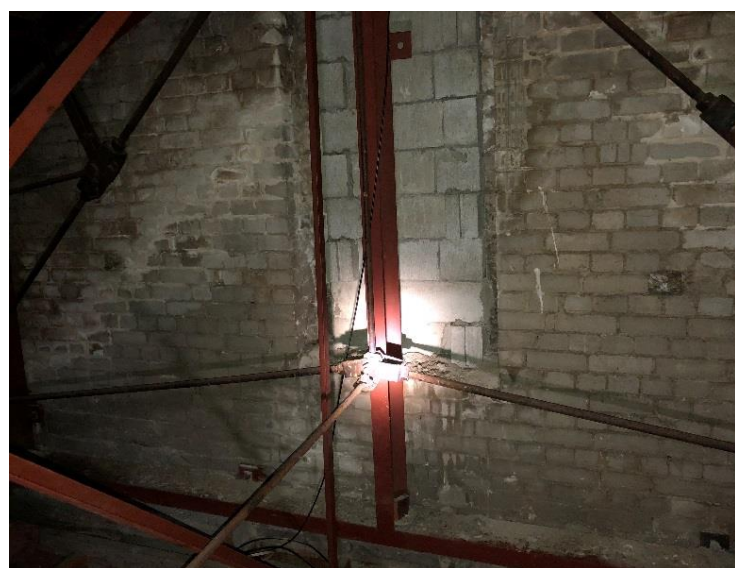
Figure 23 – East Gable front element strengthening girt has no effect on outwards movement as no fixing to wall and only at one location.

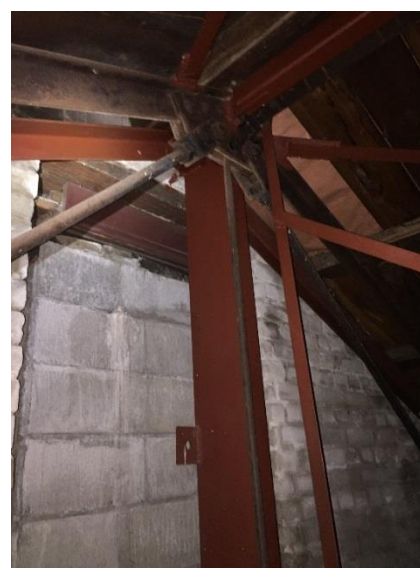
Figure 24 – West Gable front element strengthening girt has no effect on outwards movement as no fixing to wall and only at one location.

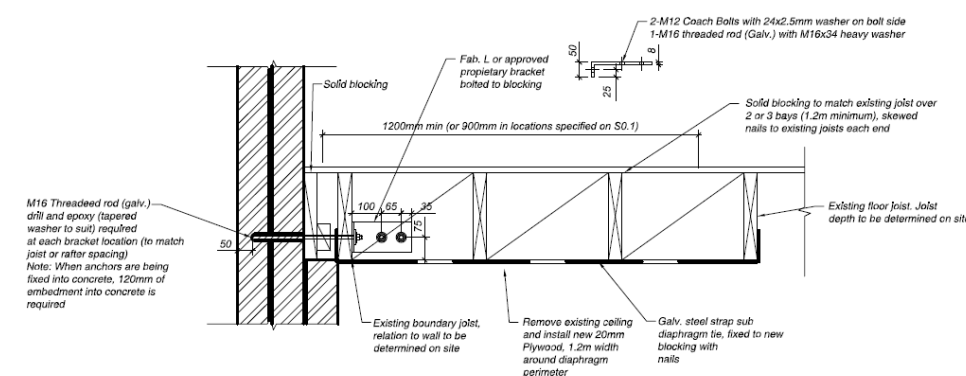
**Figure 27 – Diaphragm to Wall typical remedial detail - Joist Parallel**

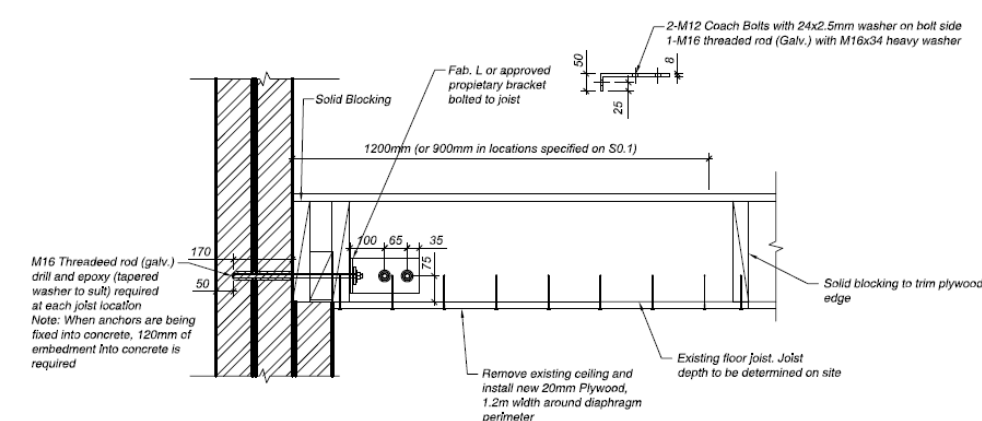
Figure 28 – Diaphragm to Wall typical remedial detail - Joist Perpendicular

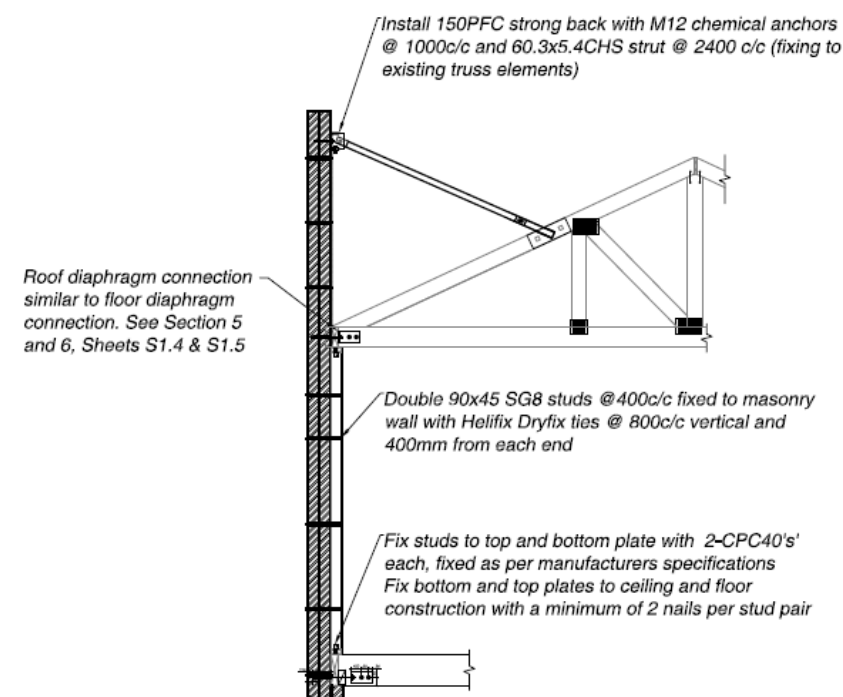
**Figure 29 – Parapet Tie back and URM Out of plane restraint typical remedial detail**

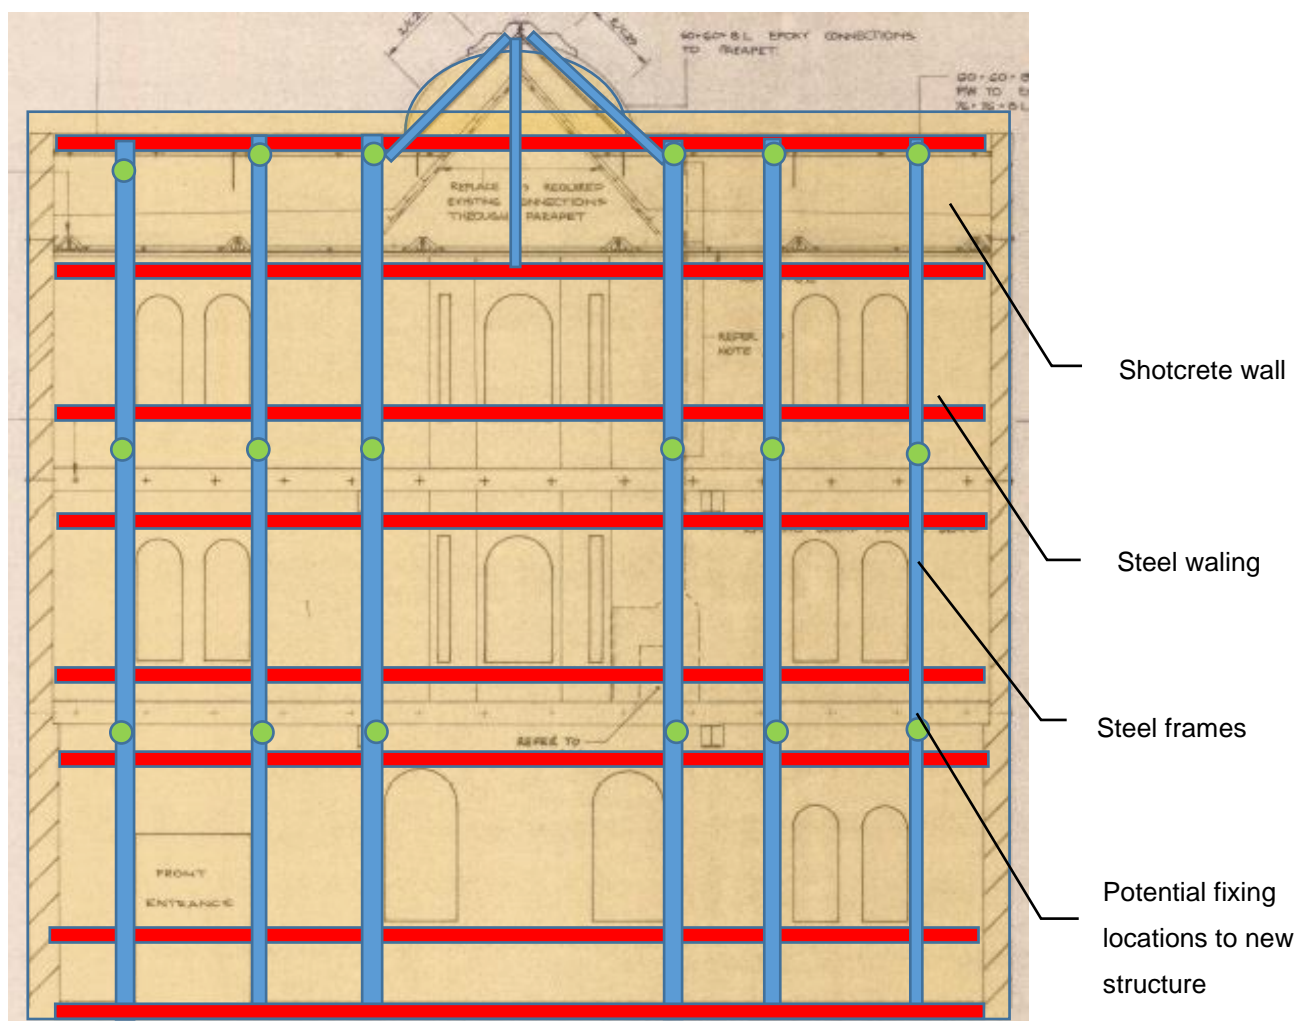
Figure 30 – Heritage Façade retention system Concept Sketch

A concept of the steel grillage system to enable its retention is shown in Figure 30.
