INITIAL SEISMIC ASSESSMENT REPORT (ISA PLUS)

8-17 Cambridge Place Arcade, Invercargill

Client Name: HWCP Management Ltd

Date Issued: 9/04/2018

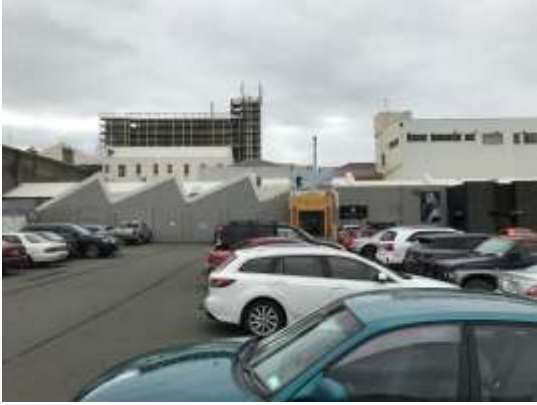
<p>The West boundary wall comprises of URM with a saw tooth profile most likely from a historical industrial building now demolished. This is most likely the critical structural element for the building.</p> <p>Note there is no seismic gap to the buildings to the North, South or East and there is less lateral load resistance in these buildings meaning that load from 59-61 Esk and 21 Cambridge Place and 40 Tay Street will be passed into the structure of the building in question if all the buildings remain in place.</p>
2

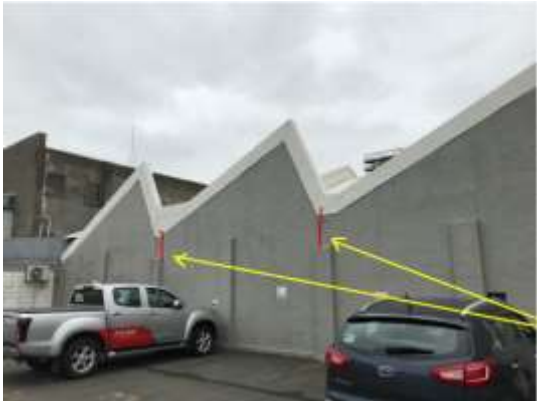
No specific / significant items of structural damage were observed other than vertical cracks to the West boundary wall from the valley points on the saw tooth wall to the pier just below.

<p>Vertical cracks to the West boundary wall from the saw tooth valleys to the piers below.</p>
3

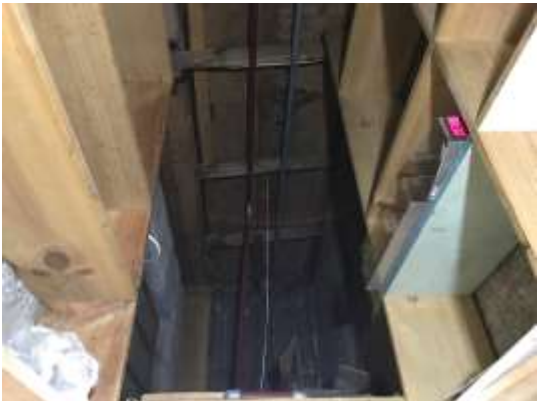
<p>Roof structure construction from boundary walls (URM) and internal RC walls showing inadequate connection between the two longitudinal walls for out of plane force transfer or any diaphragm action.</p>

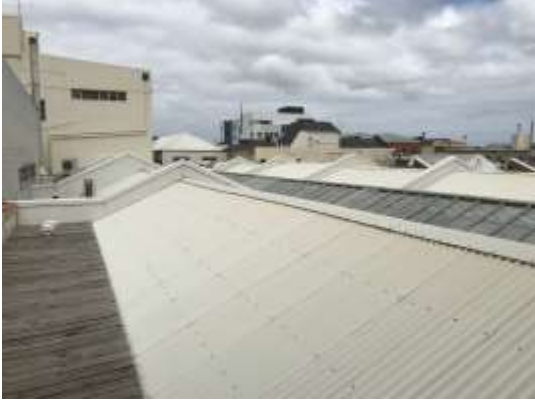
<p>Inter tenancy walls rise above the roof construction limiting the diaphragm spans.</p> <p>The glazing elements cut the roof diaphragm in half over the central walkway and will be vulnerable to differential movement of the roof plane in this area</p>
