INITIAL SEISMIC ASSESSMENT REPORT (ISA PLUS)

19-21 Cambridge Place Arcade, Invercargill

Client Name: HWCP Management Ltd

Date Issued: 9/04/2018

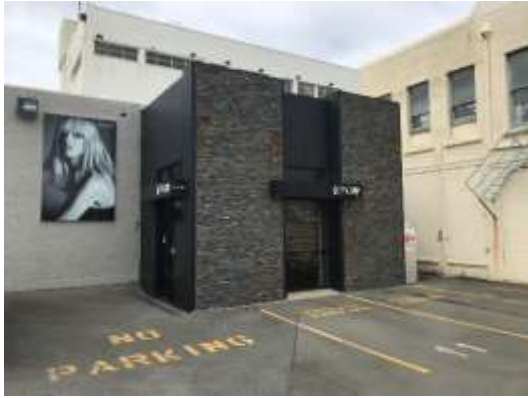
No#	Photo	Comments
1

No specific / significant items of structural damage were observed other than vertical cracks to the West boundary wall from the valley points on the saw tooth wall to the pier just below.

<p>The West boundary wall comprises 230mm thick URM brickwork walls to the original building and 120mm thick PC tilt panels to the entrance porch. The former is most likely the critical structural element for the building.</p> <p>Note there is no seismic gap to the buildings to the North, South or East and there is less lateral load resistance in these buildings meaning that load from 59-61 Esk and 40 Tay Street will be passed into the structure of this building and 8-17 Cambridge Place if all the buildings remain in place.</p>
2

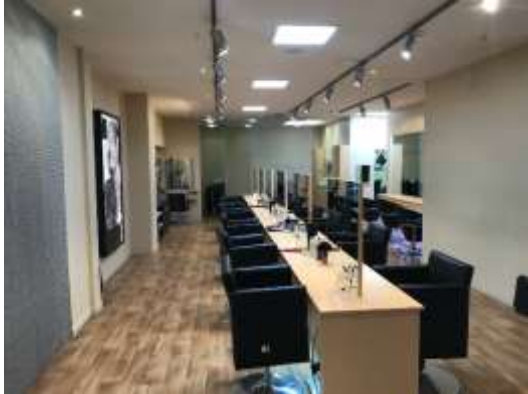
<p>The internal wall between units 19 and 21 was removed in the 2010 refurbishments with no defined bracing structure added so the roof diaphragm not spans twice its original length.</p>
3

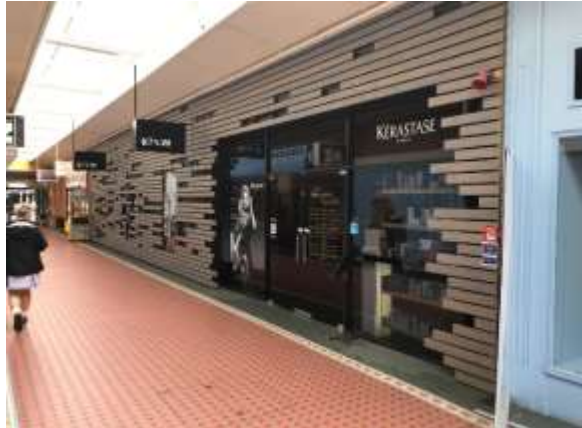
<p>The RC wall / frame to the arcade elevation stabilises the building in the N-S direction but is not separated from the adjacent properties hence loading from these building may affect the buildings overall capacity.</p> <p>The glazed skylight effectively cuts or separates the roof plane diaphragm and will be susceptible to failure under any differential roof plane deflections.</p>
