INITIAL SEISMIC ASSESSMENT REPORT (ISA PLUS)

'Valor Fitness & Health' - 7 Dee Street, Invercargill

BMC Reference: 1711-2266

Date Issued: 9/04/2018

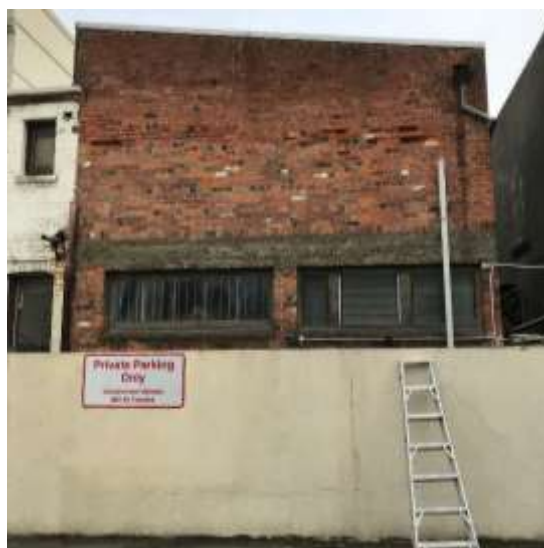
The building is in a poor condition with evidence of high levels of erosion to the bricks and mortar to the exposed elevations.

Photo 1: Rear of building showing second floor elevated roof section.

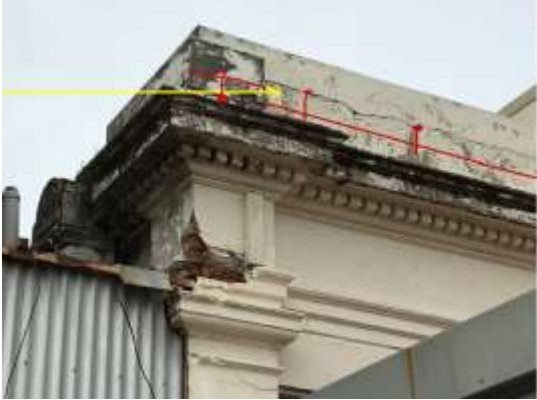
<p>The façade comprises of URM with plaster render and potentially stone or concrete detailing to the dentilled string course.</p> <p>A horizontal crack has propagated at the change in section of the end detail of the parapet wall</p> <p>Note there is no seismic gap to the building to the South and there is better lateral load resistance in this buildings meaning that load from this building will be passed into the structure of 5 Tay St if it remains in place.</p>
2

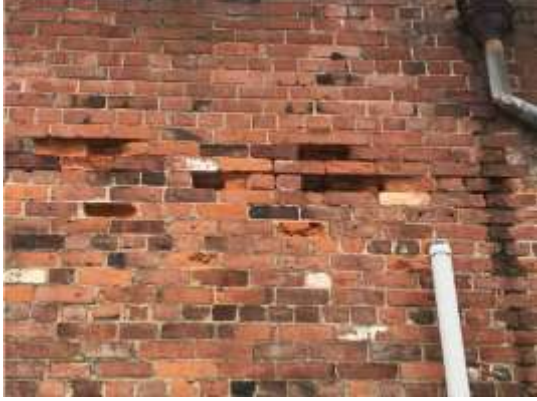
<p>The brickwork is suffering from significant erosion to both the bricks and the mortar as identified by this panel to the East (rear) elevation.</p>
3

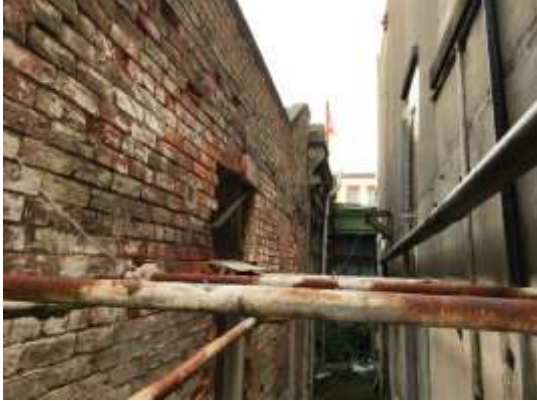
<p>The brickwork erosion continues to the North (side) elevation with this view towards the West (front) elevation. The parapet wall thickness can be seen to be in the order of 230mm thick.</p>
4

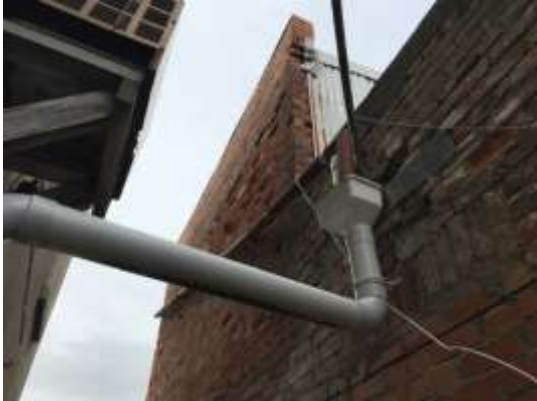
<p>The brickwork erosion continues to the North (side) elevation with this view towards the East (rear) elevation including the 2 storey high element of the building. The parapet wall thickness can again be seen to be in the order of 230mm thick.</p>
