INITIAL SEISMIC ASSESSMENT REPORT (ISA PLUS)

'Thai Dee' - 9 Dee Street, Invercargill

Client Name: HWCP Management Ltd

BMC Reference: 1711-2266

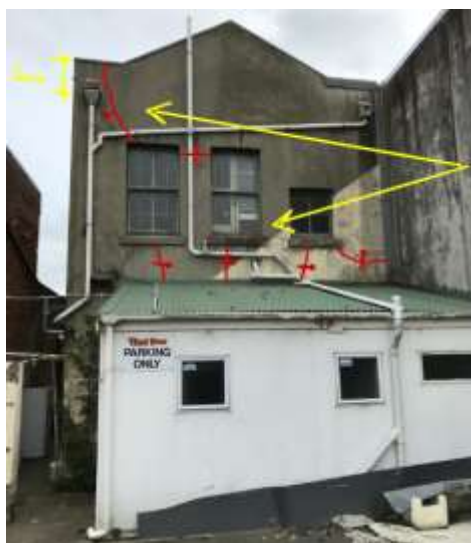
The building is in a poor condition with evidence of water ingress through the roof in a number of locations at first floor. External wall finishes exhibit cracking in a number of locations to both the plastered URM walls and the reinforced concrete façade wall / frame elements.

Photo 1: Rear of building showing lines of cracking.

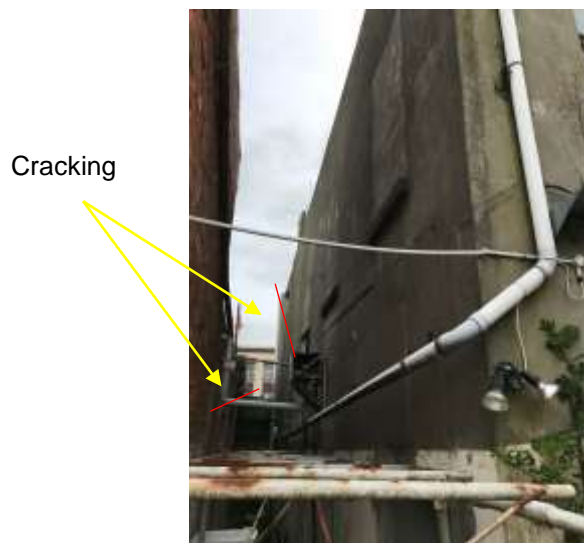
Photo 2: Side of Building showing lines of cracking.

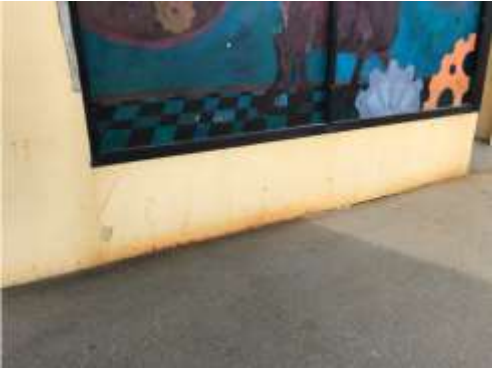
No#	Photo	Comments
1

<p>The façade comprises a RC wall / frame with plaster render.</p> <p>Cracking was noted to the ground floor panel below the façade window.</p> <p>Note there is a 50-25mm seismic gap to the building to the North and 1.2m to the South therefore with a stiff tilt panel reinforced concrete building to the North it is unlikely there will be any significant load transfer between the adjacent buildings.</p>
2

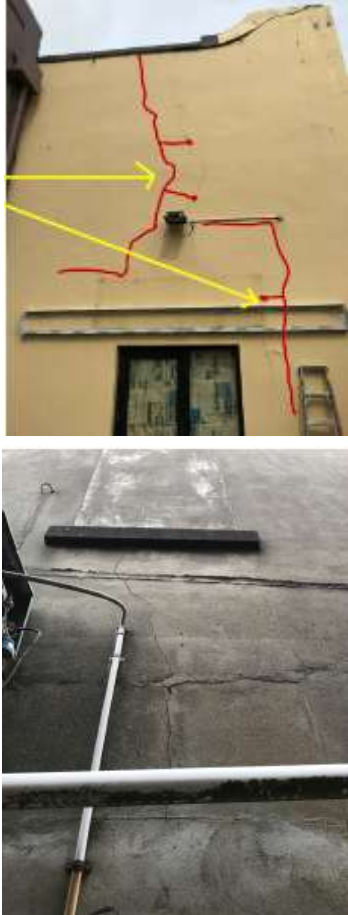
<p>The brickwork is suffering from cracking to the rear and side elevations as identified by this panel to the North (side) elevation.</p> <p>The south elevation is also exhibiting vertical and horizontal cracking to the plaster finishes.</p>
3

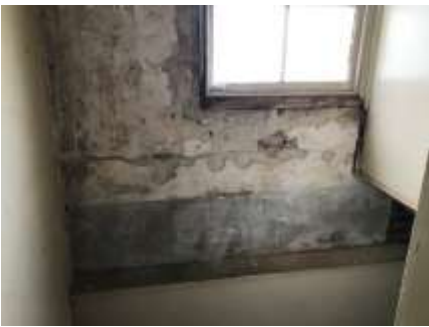
<p>Internal finishes of the rear elevation URM wall at first floor level exhibits a horizontal crack to the external interface of the rear extension mono-pitch roof.</p>
