**INITIAL SEISMIC ASSESSMENT REPORT (ISA PLUS)**

Former Frog 'n' Firkin

31 Dee Street, Invercargill

Date Issued: 9/04/2018

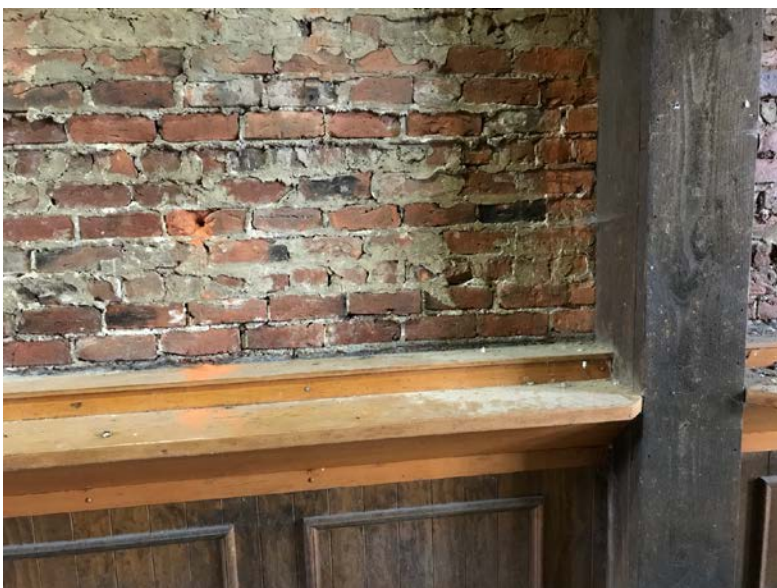
Figure 3 - South wall of building – URM wall and timber wrapped steel column of steel portal frame

The perimeter side walls and rear wall are full height and constructed of URM. Intrusive investigation identified the URM walls as double skin with total width of the 220mm. The quality of the URM walls varied, with the south wall being identified as soft brick and soft mortar. Refer to photo below in Figure 3.

The general condition of the building was poor. Damp mould covered the ground level floor due to major water leaks in the roof and gutters. The exposed exterior brick is in very poor condition. The south wall has areas of high mortar erosion.

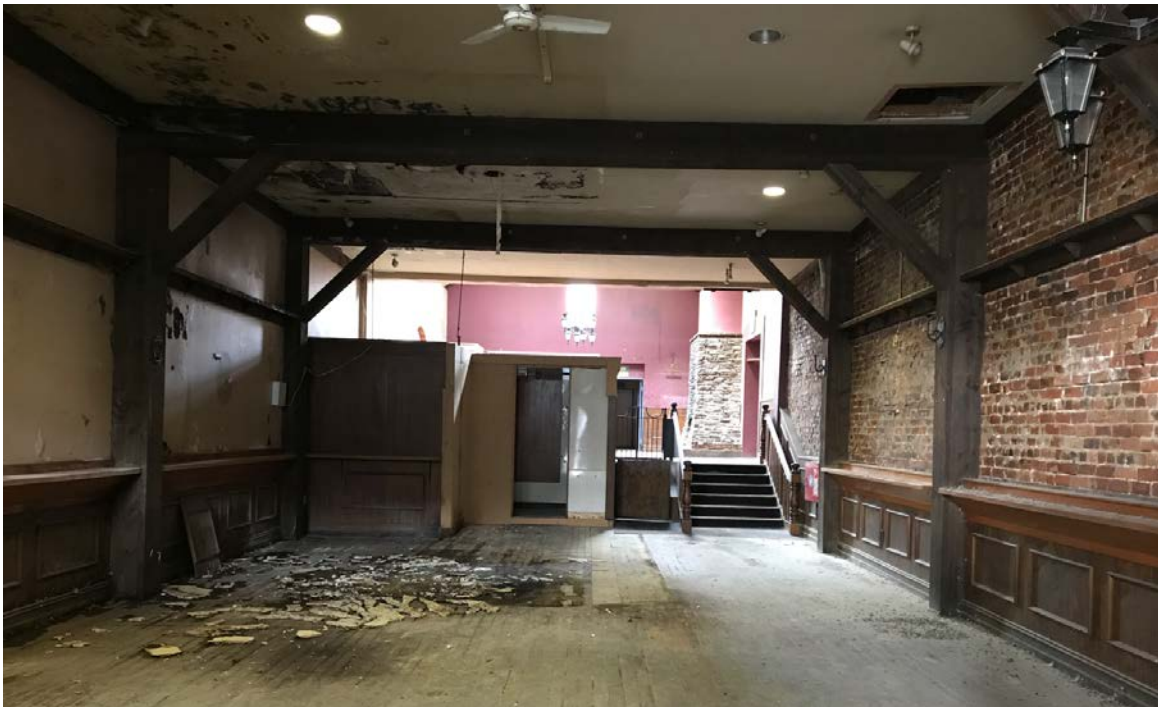
Figure 4 – Steel portal frames supporting first floor. Photo is looking east toward the rear of the building.

For seismic loads in the north south direction (transverse direction), the lateral loads are resisted by steel portal frames and the rear URM wall. As the first floor, diaphragm does not extend to the rear wall, the lateral loads from the front of the building and the first floor are resisted by the steel portal frames. For photo of ground floor with steel portal frames, refer to Figure 4 below.

At the first-floor framing, there is a visible sag in the steel portal beams. Cracking noted in the URM walls. Mould was noted on the ground floor.

Steel portal frames rely on joint fixity with moment resisting capacity for its strength. For the age and type of construction, it is assumed that these portal frames have a pinned connection, no moment capacity, at the base and limited fixity at the beam column joint. If there is limited fixity at the joint, the lateral capacity would of the steel portal frame would be minimal.

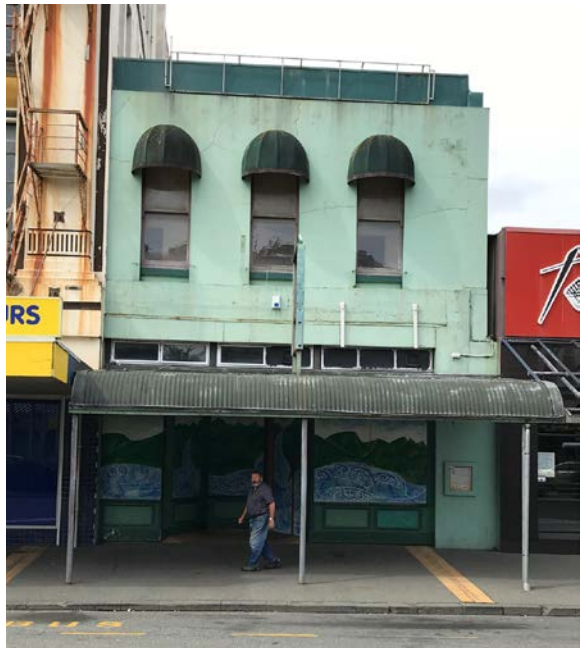
<p>Potential soft storey at shopfront.</p>
2

In the transverse direction (east-west direction), there is a soft storey critical structural weakness. A soft storey in a building occurs when a significantly more flexible building level supports a more rigid building level. This occurs at the shopfront, where a relatively heavy rigid first floor façade is supported by a “open” ground floor framing with no distinct lateral force resisting elements.

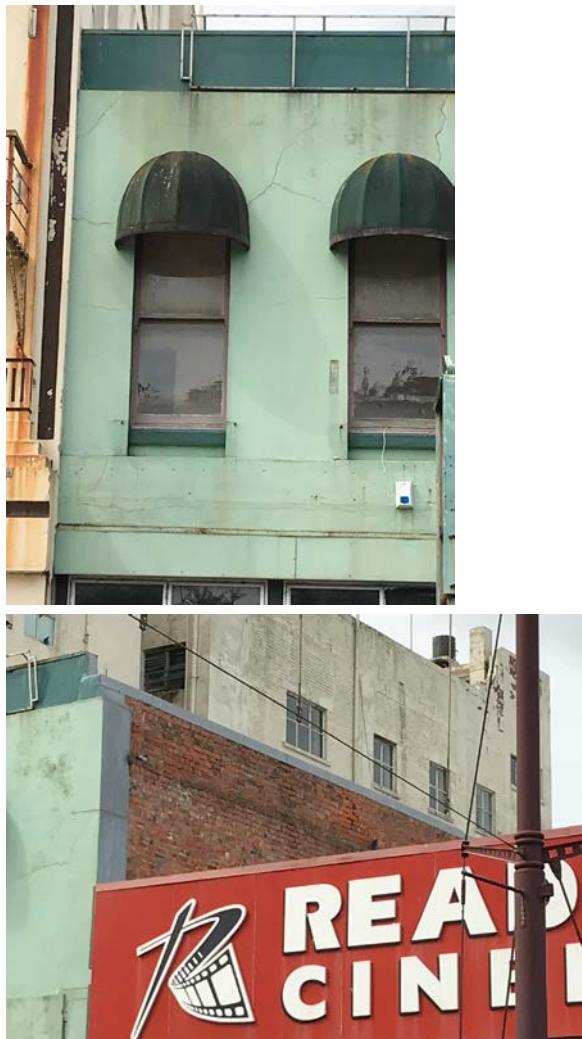
<p>No evidence of a seismic gap.</p> <p>Severe mortar erosion to the south wall.</p>
