**INITIAL SEISMIC ASSESSMENT REPORT (ISA PLUS)**

Bonsai Restaurant/Quest Building

31-35 Esk Street, Invercargill

Date Issued: 9/04/2018

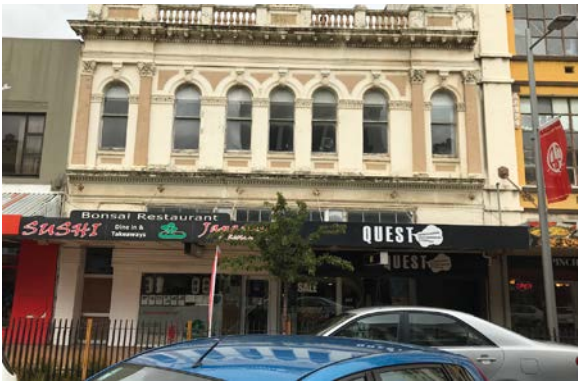
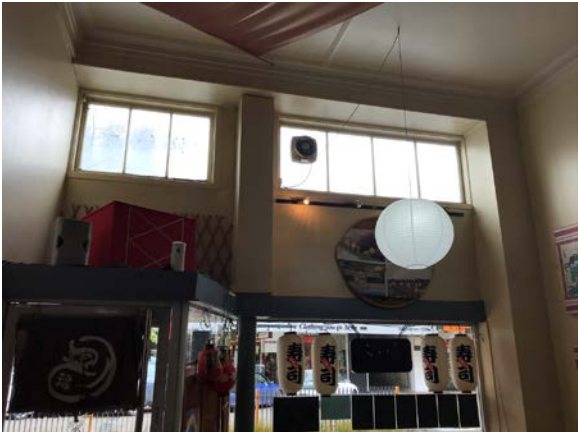
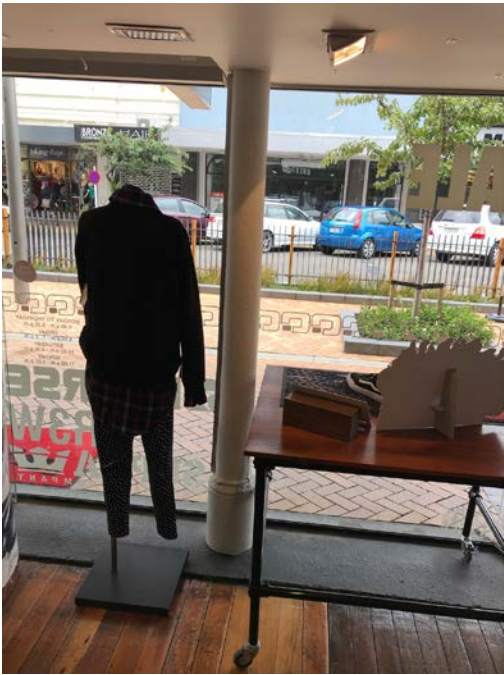
No#	Photo	Comments
2

Potential soft story at shopfront.

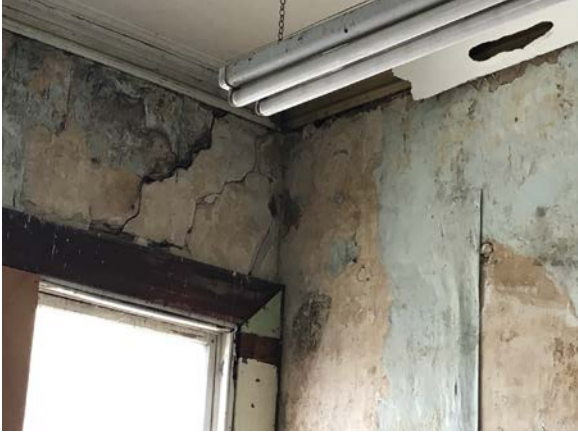
No#	Photo	Comments
3

Cracking in first floor URM wall likely due to pounding.
4

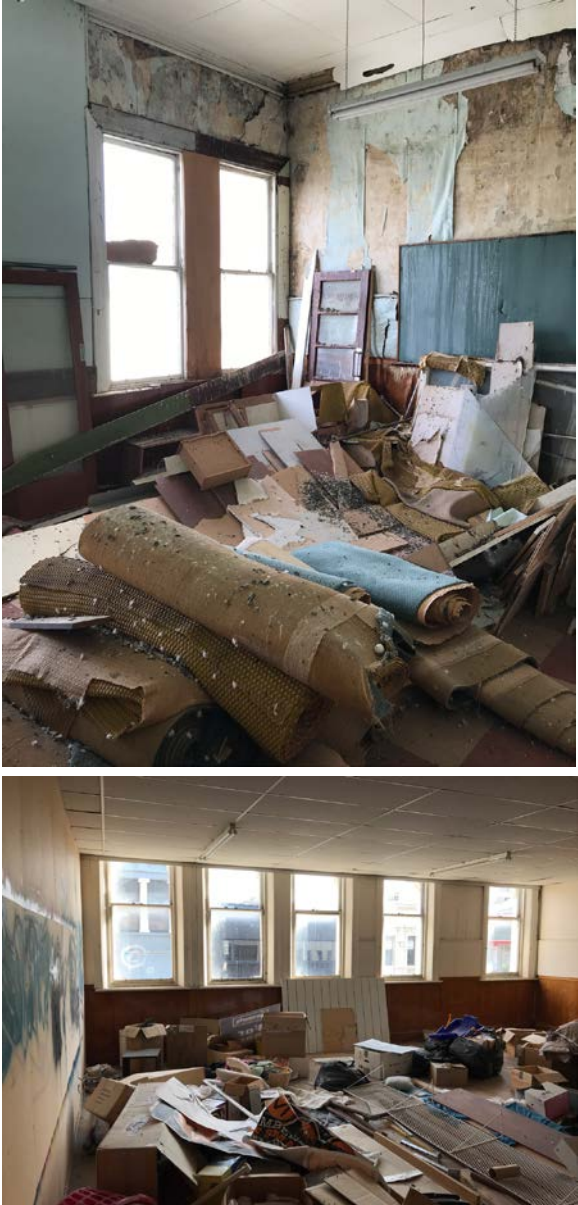
The building is in poor condition. The first floor was insanitary with major roof leaks and smelled damp and mouldy. Faeces, from what appeared to be from birds, were found throughout.

First floor unkempt. Smelled of damp and mouldy. Faeces, from what appeared to be from birds, were found.

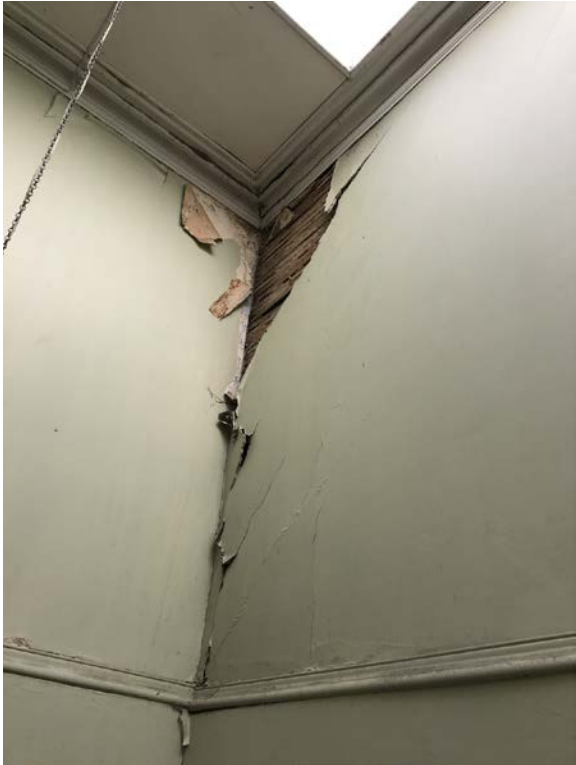
No#	Photo	Comments
5

Damage to wall lining
6

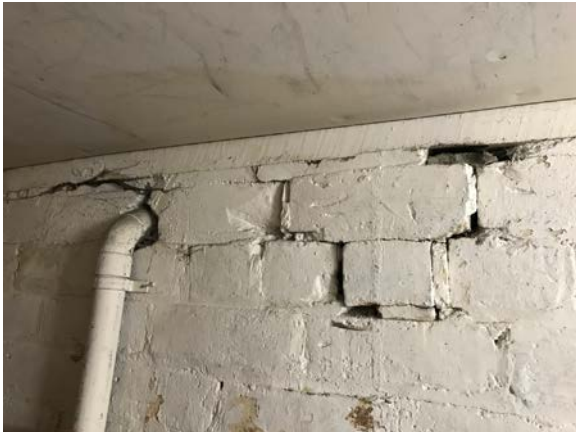
Ground floor, rear URM wall
