INITIAL SEISMIC ASSESSMENT REPORT (ISA PLUS)

Turkish Kebabs Building

37 Esk Street, Invercargill

Date Issued: 9/04/2018

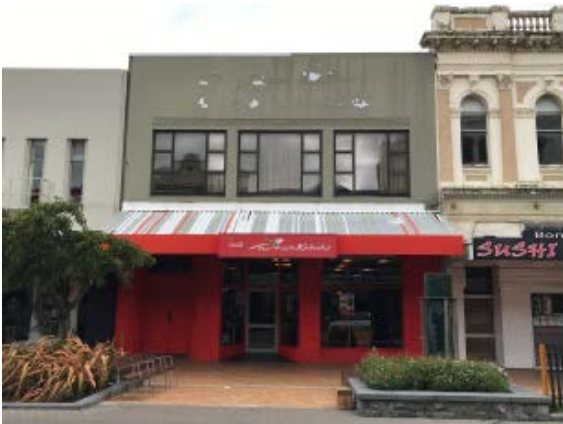
No#	Photo	Comments
1

The shopfront has a potential soft storey. Refer to Section 5.1.

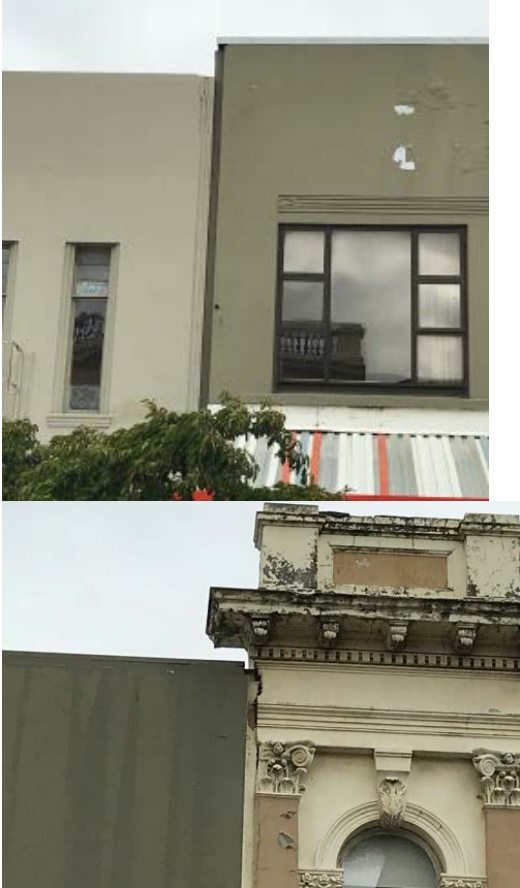
No#	Photo	Comments
2

<p>Note there is no seismic gap to the adjacent buildings. There is poor lateral load resistance in these buildings meaning their load could be passed into the structure of 37 Esk Street structural.</p>
3

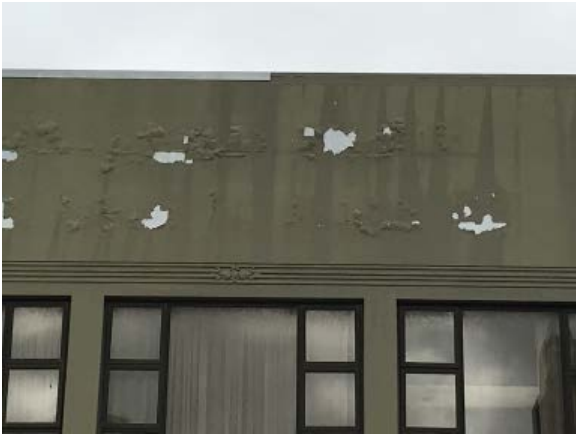
<p>Cracking in URM at shopfront.</p>

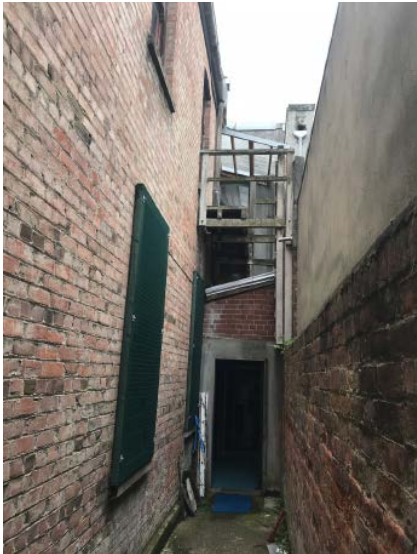
No#	Photo	Comments
4

<p>Alley way under first floor of old part of building. Poor drainage and likely overflow of downpipes will compromise old foundation strip footings.</p>
5

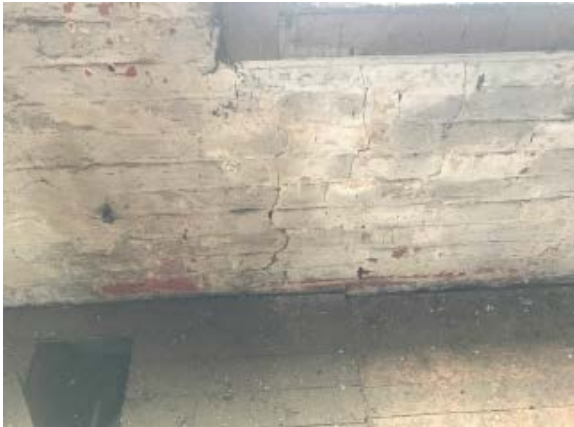
<p>Cracking in URM wall at level 1.</p>

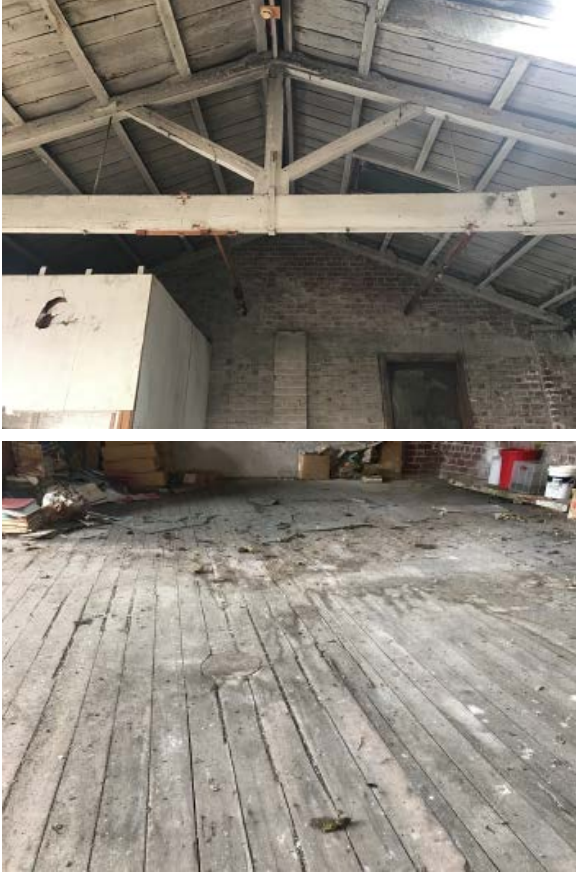
No#	Photo	Comments
6

Moisture ingress and sagging floors.
