INITIAL SEISMIC ASSESSMENT REPORT (ISA PLUS)

Max Fashions and Pascoes The Jewellers

53 Esk Street, Invercargill

Date Issued: 9/04/2018

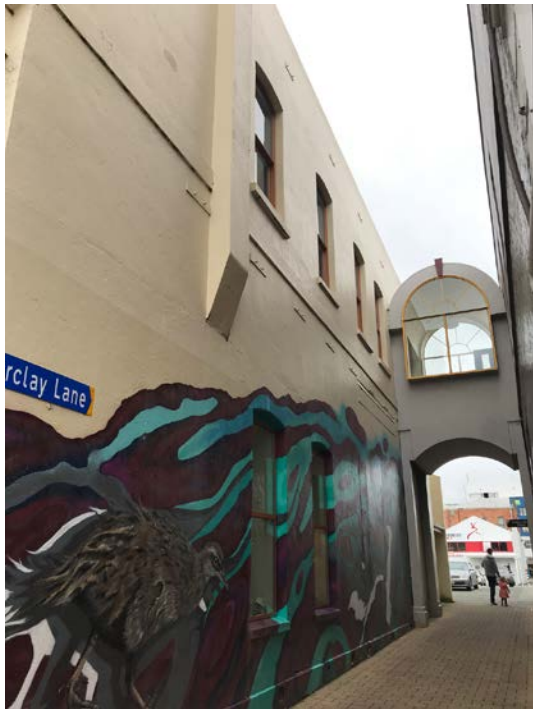
wall was retrofitted with steel strip plate anchors along the first floor and roof levels. See photo of anchors in Figure 3. Plate anchors were not seen along first floor or roof level diaphragm in either of the other three walls.

Figure 3 - Steel strip plate anchors on the west wall of the building, viewed from Barclay Lane alleyway facing south

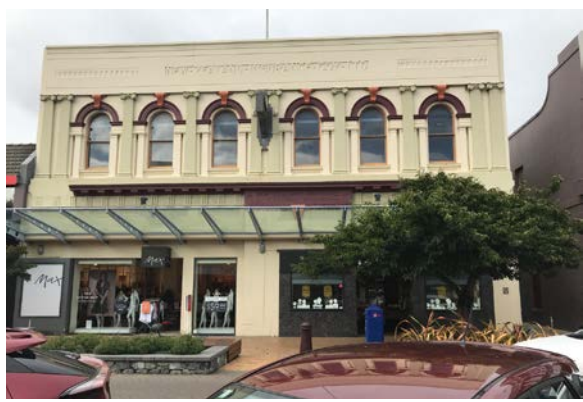
No#	Photo	Comments
1

Potential soft storey at shopfront.

In the transverse direction (east-west direction), there is a soft storey critical structural weakness. A soft storey in a building occurs when a significantly more flexible building level supports a more rigid building level. This occurs at the shopfront, where a relatively heavy rigid first floor façade is supported by a “open” ground floor framing with no distinct lateral force resisting elements. At ground level, in the transverse direction, the only lateral load resisting element is the URM wall at the rear of the building. It is estimated that the capacity of the building in the transverse direction is approximately 15-20%NBS (IL2).

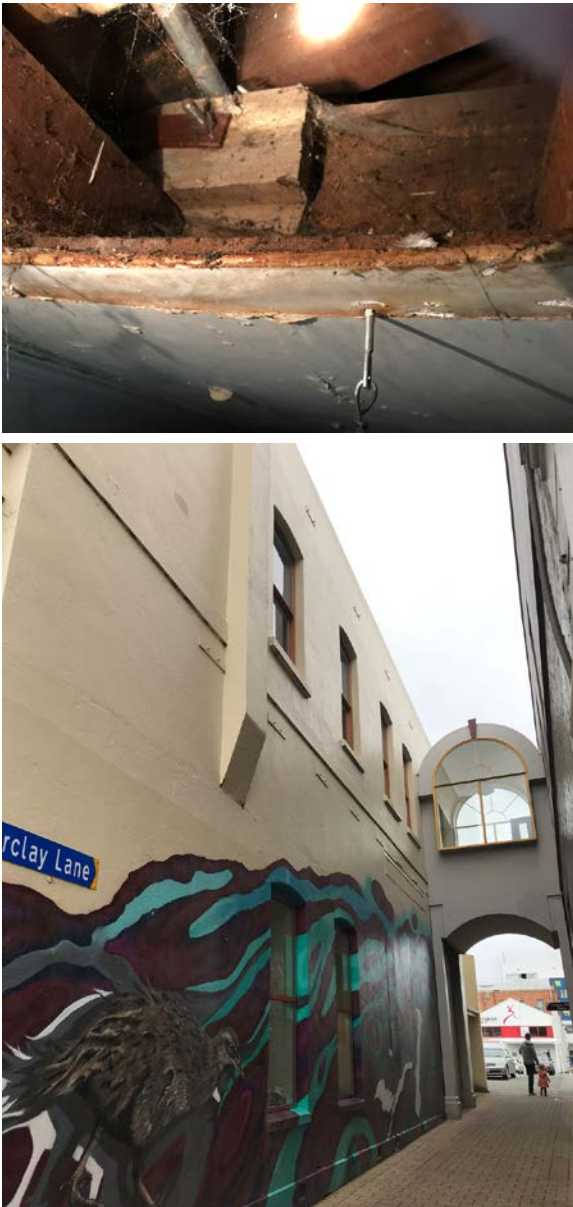
No#	Photo	Comments
6

<p>Along west wall -</p> <p>Anchor tie between URM wall and roof truss. 16mm bolts from strap into timber roof truss. Truss at 2.6m centres.</p>

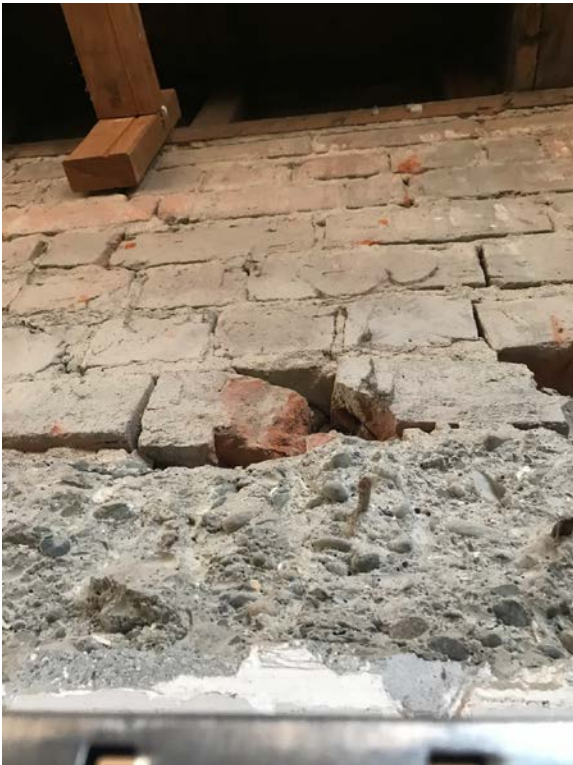
No#	Photo	Comments
7

First floor URM wall.
8

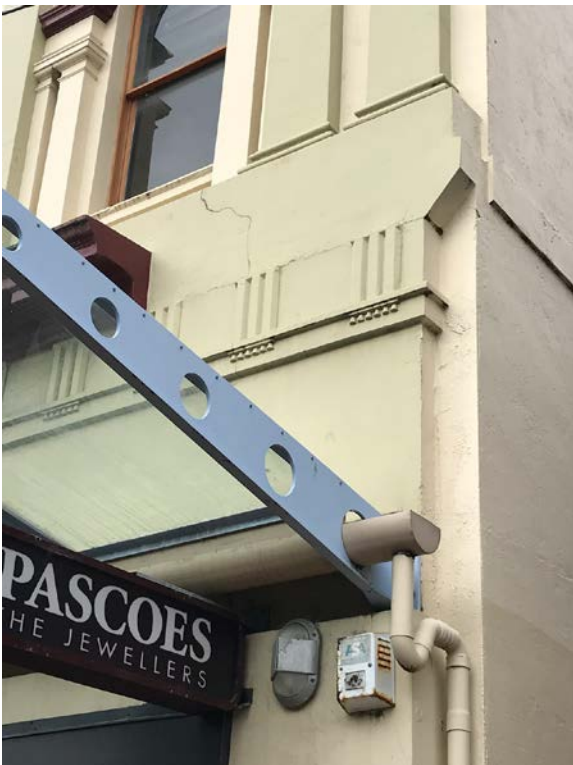
There are signs of some settlement in the foundations in the form of wall cracking to the first-floor wall above the shopfront. Foundation details are unknown. It is assumed that the URM walls sit on concrete footings.

Cracking in URM wall at shopfront - potentially from settlement in the foundations.
