INITIAL SEISMIC ASSESSMENT REPORT (ISA PLUS)

59-61 Esk Street, Invercargill

Client Name: HWCP Management Ltd

Date Issued: 9/04/2018

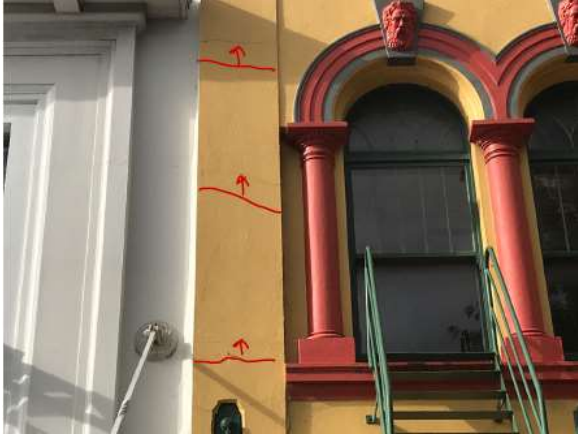
No#	Photo	Comments
1

<p>The North wall comprises a URM wall with Reinforced Concrete elements with minimal bracing structure to ground floor. This is potentially a structural weakness for the building.</p> <p>The façade exhibits a number of cracks located to the East side wall interface.</p> <p>Note there is no seismic gap to the buildings to the South, West or East and there is variable lateral load resistance in these buildings meaning that load from, 55 or 63 Esk Street and units 8-17 Cambridge Place arcade may be passed into or from this structure into the surrounding elements if all the buildings remain in place</p>
2

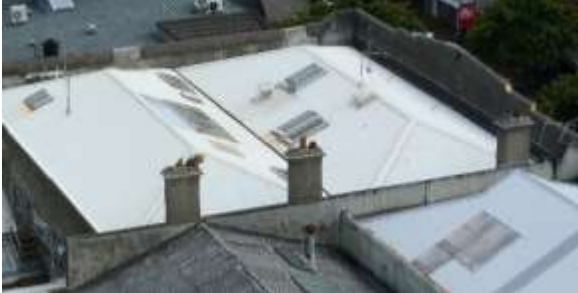
<p>The East URM wall incorporated 3No tall URM chimneys which will form a hazard risk for collapse onto the adjacent properties.</p> <p>It is also noted that the parapet heights are significant to the façade and sides, although the former is most likely a RC wall element but its effective restraint would be questionable.</p>

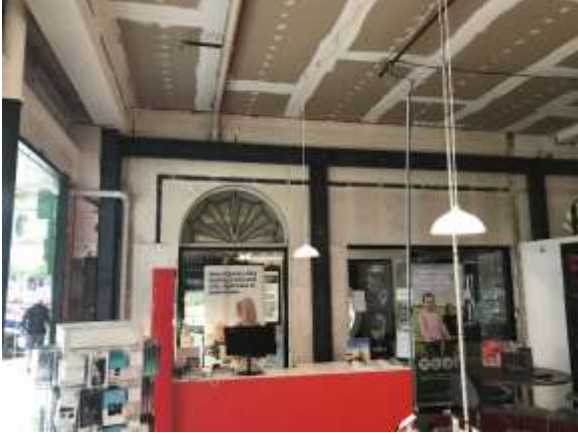
3

<p>The West ground floor unit has have some seismic strengthening recently added although archive details were not available at the time of writing this assessment.</p> <p>It is noted that the façade corner column comprises URM construction and that the joint detailing of the strengthening would produce very small moment resistance to horizontal loading.</p> <p>It is noted that the East units have not been strengthened which may present displacement compatibility issues globally.</p>
4

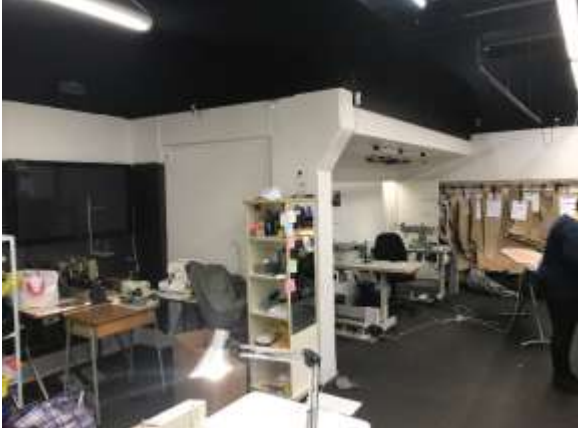
<p>The West ground floor unit has also had a RC frame installed as the location of the inter unit wall to the East units,</p>
