**INITIAL SEISMIC ASSESSMENT REPORT (ISA PLUS)**

Mediaworks, Ambrosia, Key-Wee Lock & Repair Company, Les Sheikh Design

2-10 Kelvin Street, Invercargill

Date Issued: 09/04/2018

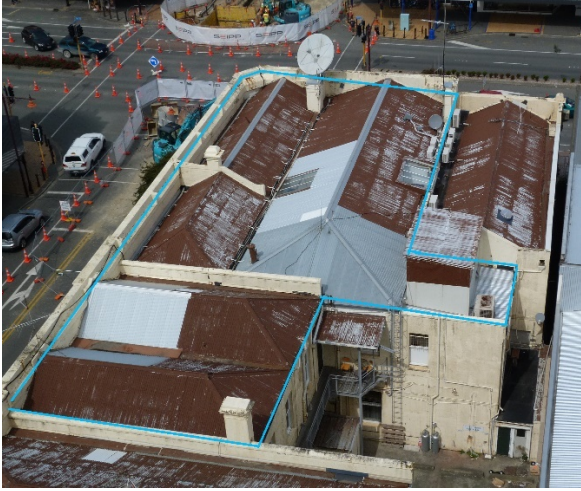
Outline of roof area at 2-10 Kelvin Street
2

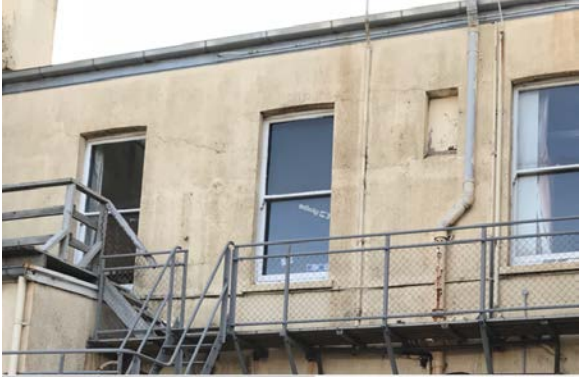
Cracks, in western URM wall, extending from window corners
3

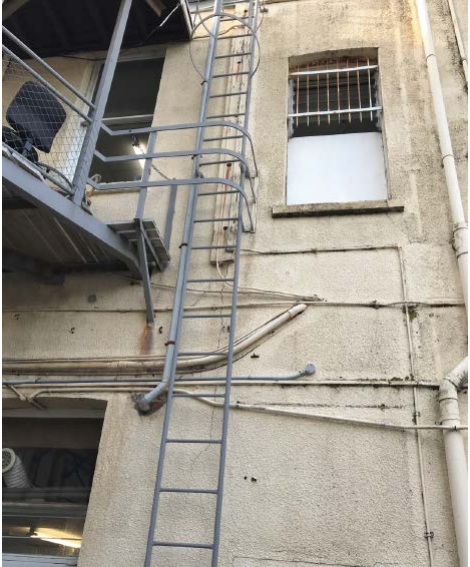
Vertical crack in URM wall

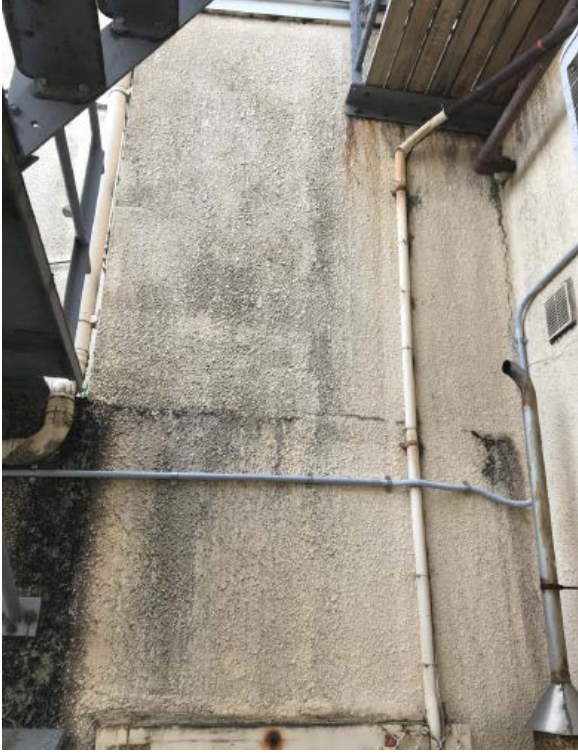
<p>Horizontal crack in URM wall extending from fire escape balcony</p>
5

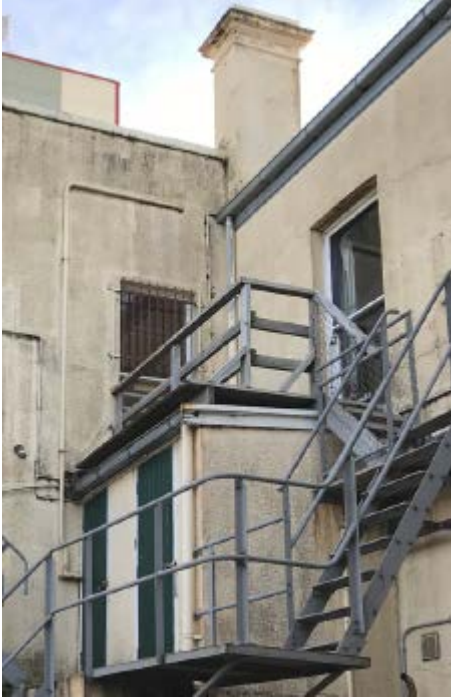
<p>URM chimney and fire escape leading to nowhere</p>

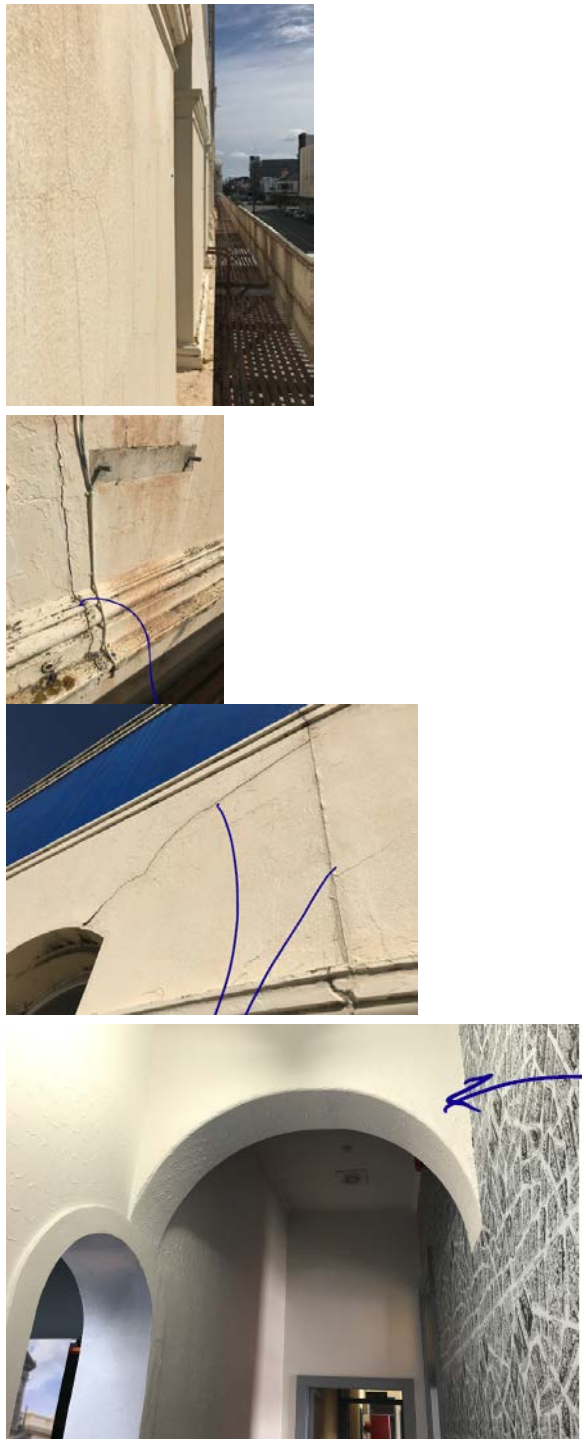
<p>Bow in URM wall at first floor along eastern elevation. Bow greater than 100 mm. As a result of bow cracks greater than 10 mm evident in URM wall.</p> <p>Cracking/bowing due to internal URM wall shunting external elevation at this location.</p> <p>Internal wall that has shunted and bowed external wall above</p>

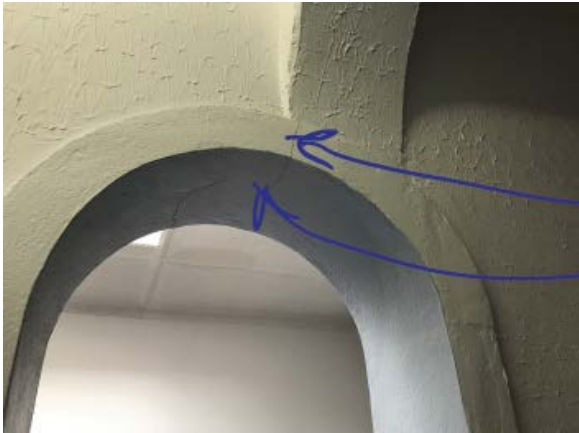
Cracking to arch
8

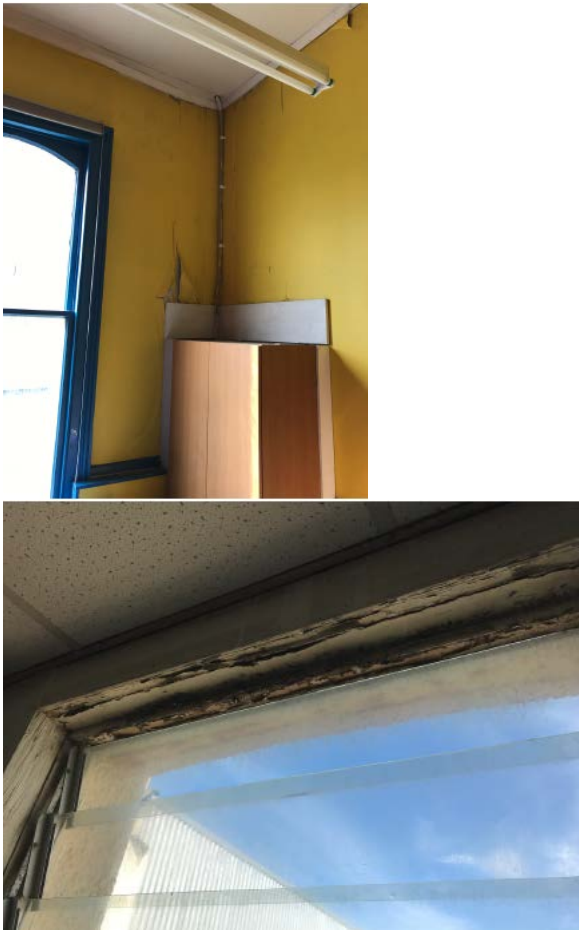
Evidence of water ingress

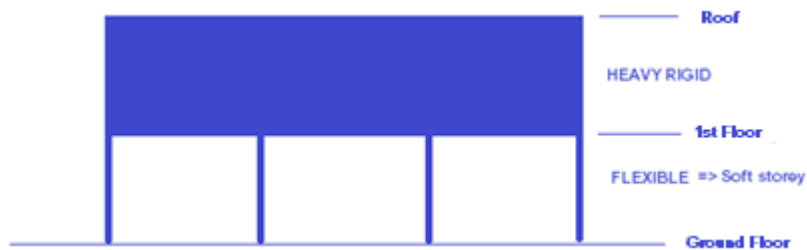
Figure 3 - Building elevation of soft storey structure example

In the transverse direction, the limiting element of the lateral load carrying capacity is the out-of-plane capacity of the URM wall at the shopfront and a soft storey along Tay Street. A soft storey in a building occurs when a significantly more flexible building level supports a more rigid building level. This occurs at the shopfront, where a relatively heavy rigid first floor façade is supported by a “open” ground floor framing with no distinct lateral force resisting elements, see Figure 3.

The soft storey is a critical structural weakness and the estimated capacity of the lateral force resisting system is approximately 15-20%NBS (IL2).

If required, a Detailed Seismic Assessment (DSA) or a more detailed assessment could be carried out with intrusive investigation work into the nature and capacity of the timber framing connections to the front and rear URM walls at the roof and first floor level. This more detailed assessment could enable an understanding of other aspects of its seismic performance and potentially raise the lateral capacity of the building to above 34%NBS.
