INITIAL SEISMIC ASSESSMENT REPORT (ISA PLUS)

Suzie's Tapas, Kim's Sunshine Sushi, Tasti Blitz, and Cargill Tea

12-16 Kelvin Street, Invercargill

Date Issued: 09/04/2018

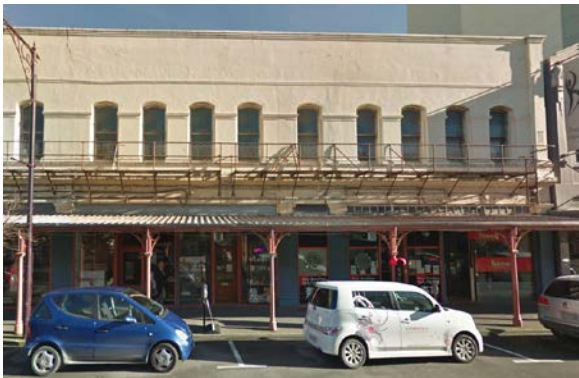
<p>Potential soft story at storefront.</p> <p>At the north wall of the building, no evidence of a seismic gap.</p>
2

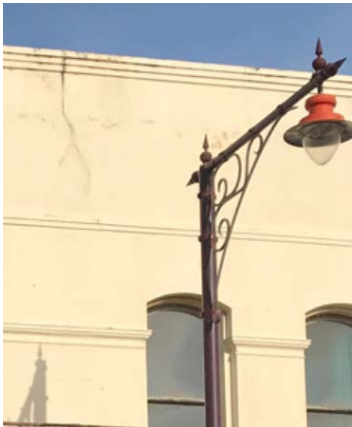
- Cracking in URM shopfront parapet
- Cracking in west URM wall at mid height of windows
- Pounding damage between single storey and double storey sections of structure

<p>Cracking in URM shopfront parapet.</p>

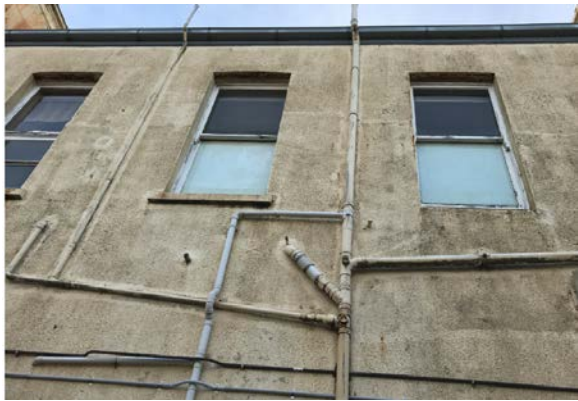
Cracking in west URM wall, at mid height of windows.
4

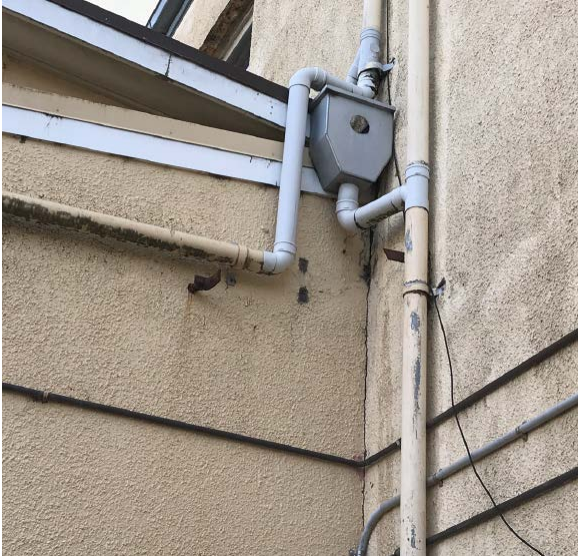
Pounding damage between single storey section of structure and double storey section of structure.
5

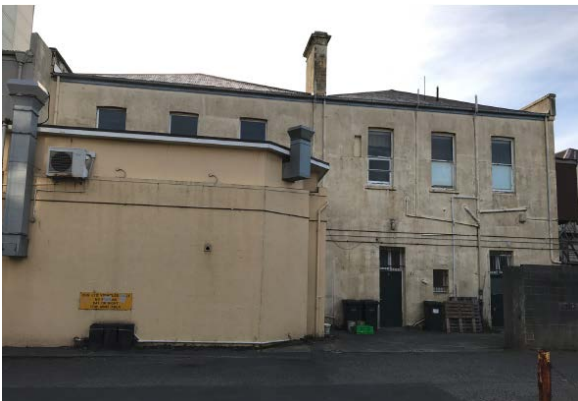
Single storey portion of building at rear of Suzie's Tapas.

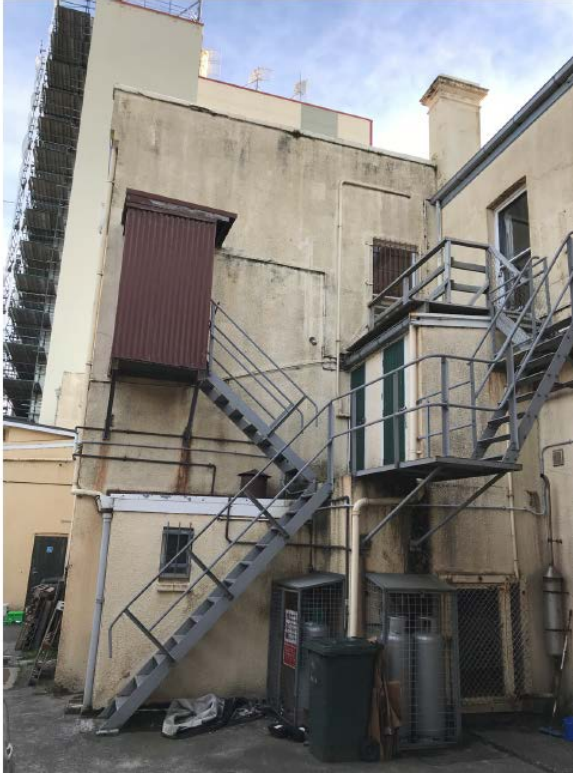
<p>Along south wall - Fire escape. Only access to first floor of building</p>
7

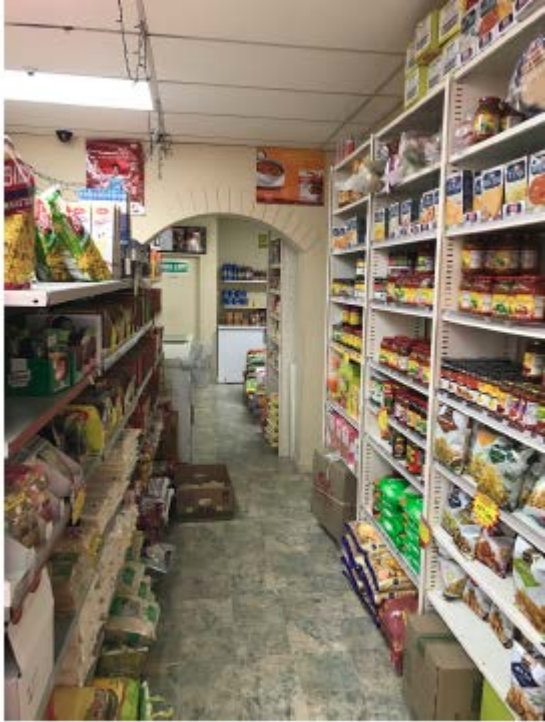
<p>Spice shop with arched frame through centre</p>

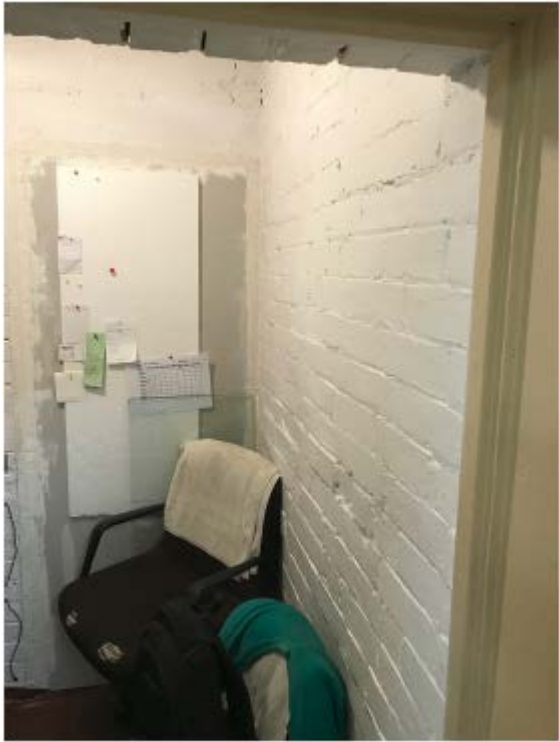
URM office in centre of building at ground floor
