INITIAL SEISMIC ASSESSMENT REPORT (ISA PLUS)

Beauty and Beyond

18 Kelvin Street, Invercargill

BMC Reference: 1711-2266

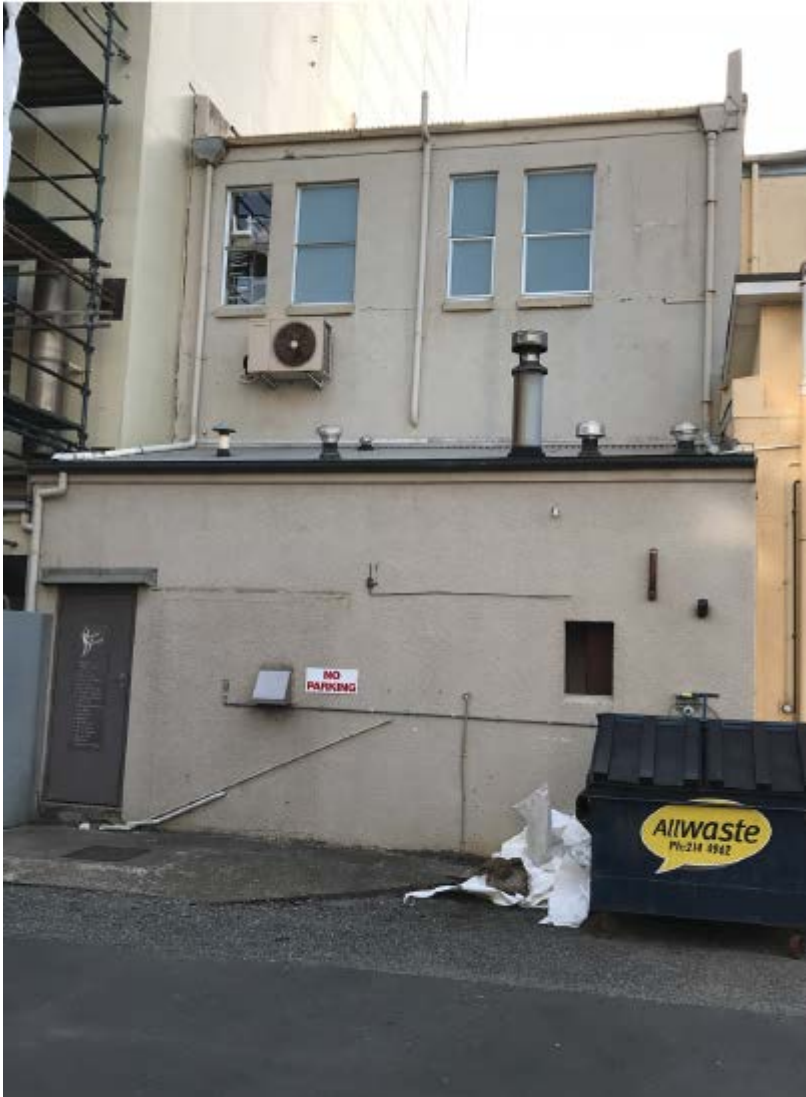
Figure 3 - Rear elevation of building

The perimeter side walls and rear wall are full height and constructed of unreinforced masonry (URM), see Figure 3 for an image of the rear of the building. At the shopfront, the ground floor is 'open' with URM wall/piers above. The URM wall/piers are likely supported by a steel beam spanning between URM wall/piers across the shopfront. The canopy is supported by 4 braces attached to the URM piers and spandrel above first floor.

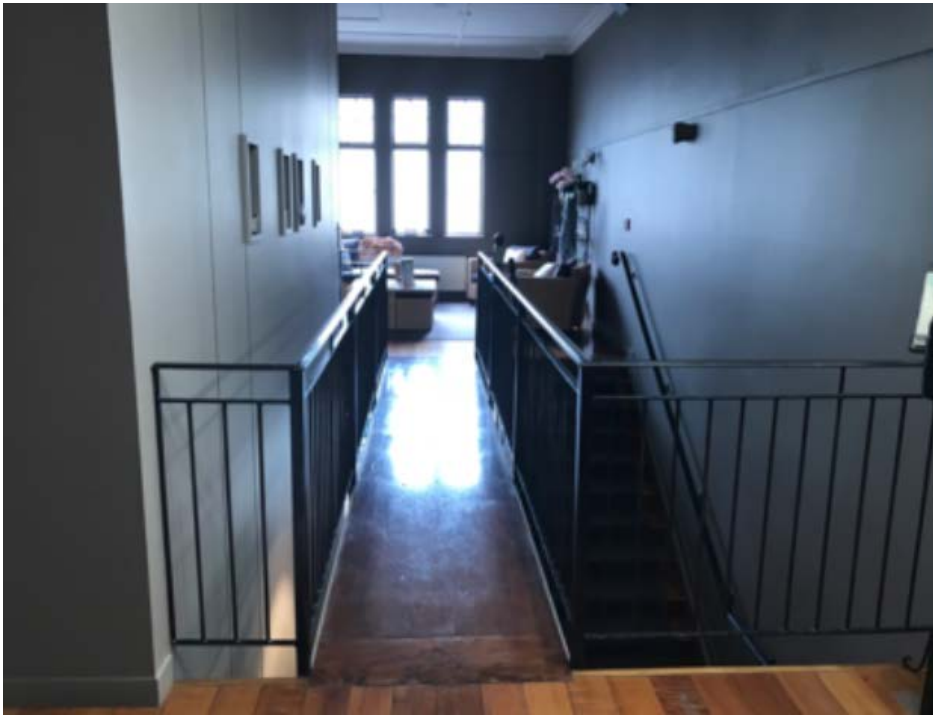
Figure 4 – First floor at stairwell opening

The first floor is constructed from timber planks on timber joists. The joists are supported by the perimeter URM side walls and interior supports. The first floor has a large opening at the central stairwell, as shown below in Figure 4.

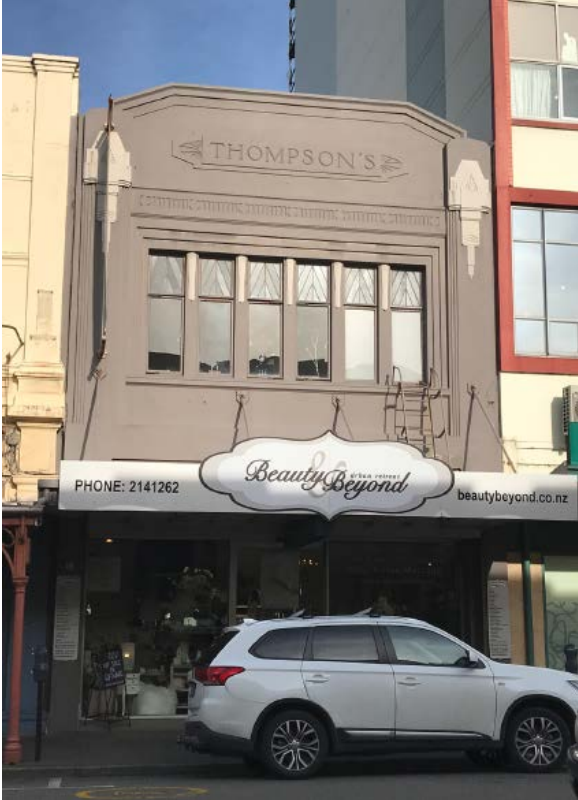
<p>A photograph of a three-story building with a light-colored facade. The top story has a decorative cornice with the name 'THOMPSON'S' in the center. Below this is a row of five windows with decorative mullions. A white awning extends over the ground floor entrance, featuring the 'Beauty Beyond' logo and the text 'PHONE: 2141262' and 'beautybeyond.co.nz'. A white SUV is parked on the street in front of the building. To the right, a portion of a taller, modern building with a red and yellow facade is visible.</p>	<p>Note there is no seismic gap to the adjacent buildings.</p> <p>The shopfront has a potential soft storey.</p> <p>Adjacent building to the north (Kelvin Hotel) is 8 stories.</p>
2

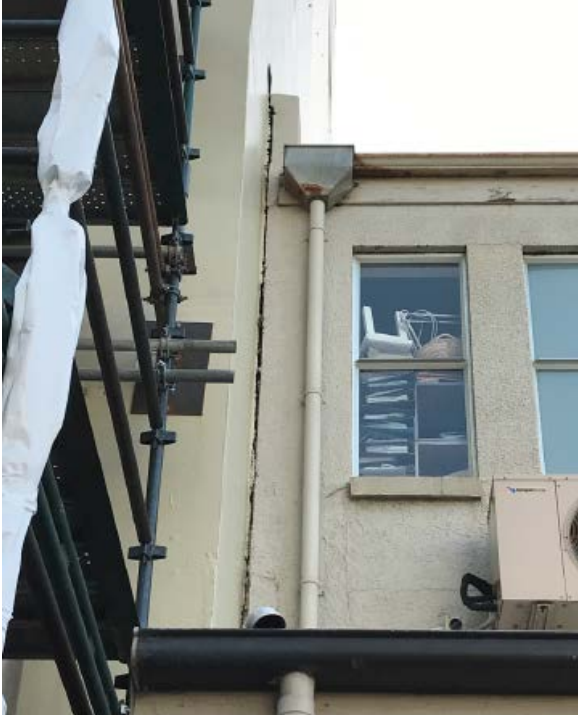
- Pounding damage
- Cracking in URM along rear elevation

<p>A close-up photograph of the corner of a building. A vertical crack is visible in the light-colored masonry wall. To the left, a dark metal staircase with a white-painted railing is visible. A window with a dark frame is located on the right side of the frame. A white downspout runs vertically along the wall. A black horizontal pipe or railing is in the foreground.</p>	<p>Pounding damage observed between 18 Kevin St and the building to the north (Kelvin Hotel)</p>

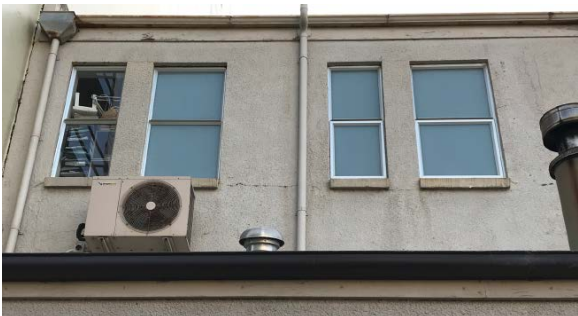
Cracking in URM along base of window frames on the rear elevation, showing potential out-of-plane failure of this rear URM wall.
4

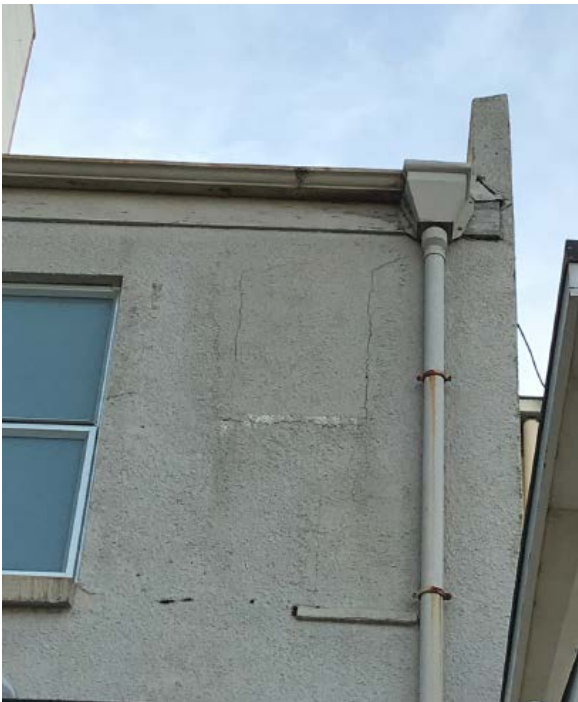
Step cracking to top right hand corner of the rear elevation of the building
5

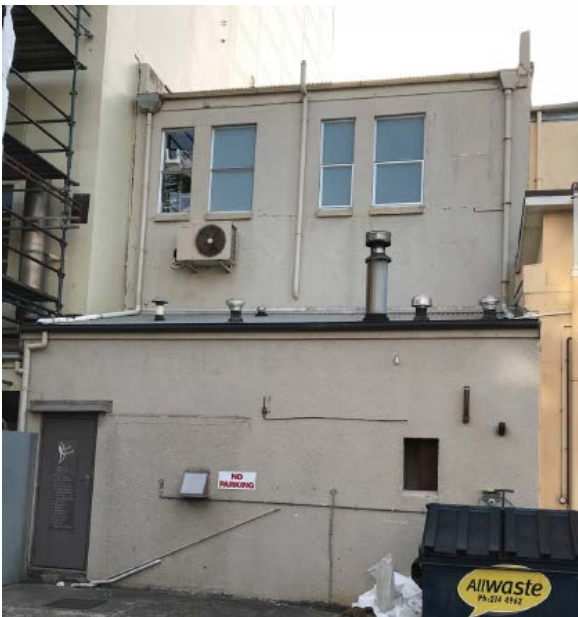
URM wall along the rear elevation is not continuous between ground floor and first floor.

In addition to the soft storey, the ground floor rear URM walls are offset horizontally to the first-floor rear wall by three metres. This off-set creates another discontinuity in the load path of the lateral load resisting system. The load path requires the timber diaphragm to distribute these loads to the in-plane URM walls. It is believed that the timber diaphragm is connected to the URM walls only by a friction connection. The timber diaphragm has a large opening at the stairwell, which decreases the shear capacity of the diaphragm.
