INITIAL SEISMIC ASSESSMENT REPORT (ISA PLUS)

Balance and Flow - Pilates Studio

30 Tay Street, Invercargill

BMC Reference: 1711-2266

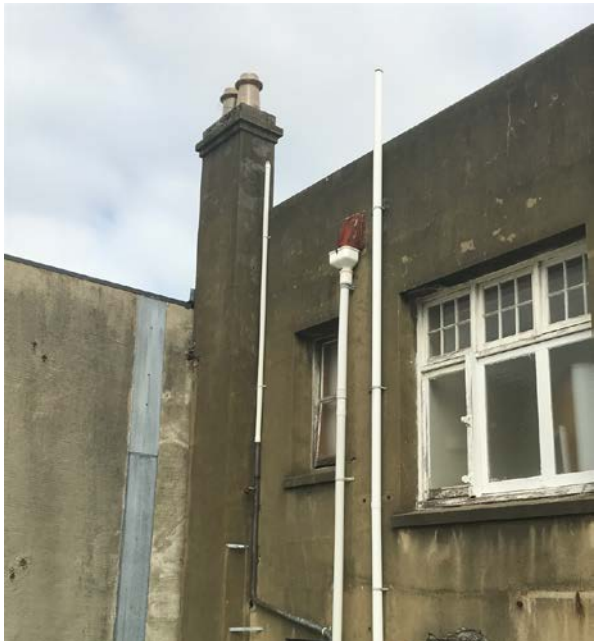
<p>Cracking and spalling of plaster at base of parapet to rear (North) elevation wall, indicating potential out-of-plane failure of this element</p>
5

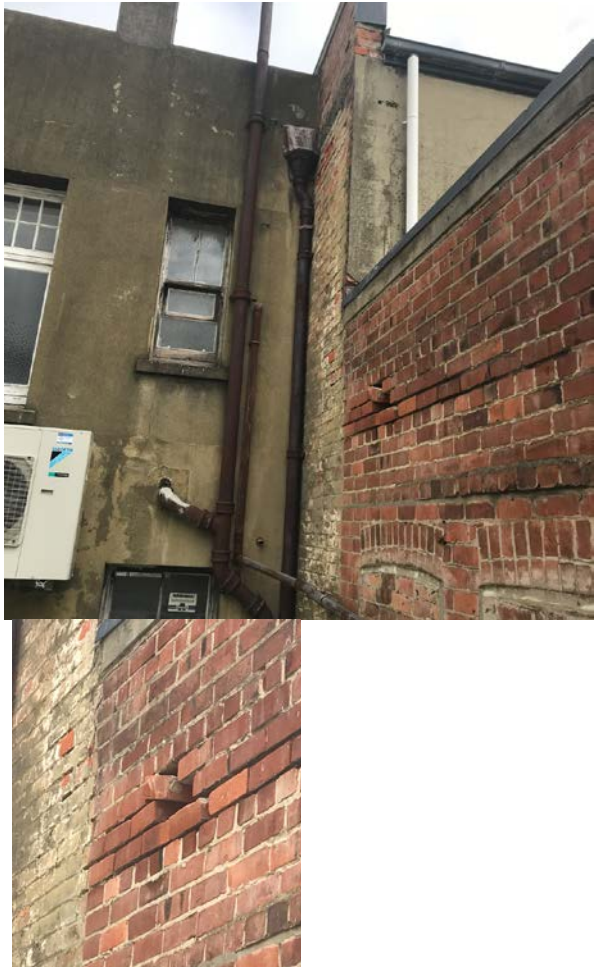
<p>Loose bricks in masonry wall of party wall adjacent to single storey area of building, presenting a hazard.</p>

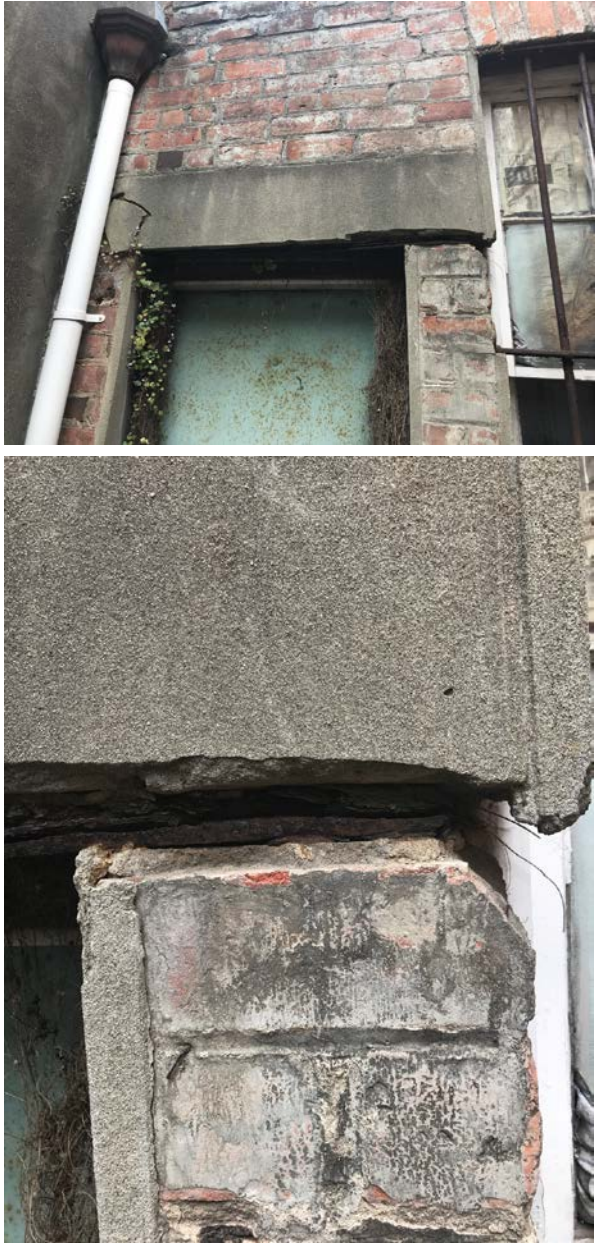
<p>Corrosion of steel lintel above door in N elevation ground floor wall, expansion of this element has caused deformation of the masonry wall over.</p>
