INITIAL SEISMIC ASSESSMENT REPORT (ISA PLUS)

40 Tay Street, Invercargill (including Units 23-25 Cambridge Place Arcade)

Client Name: HWCP Management Ltd

BMC Reference: 1711-2266

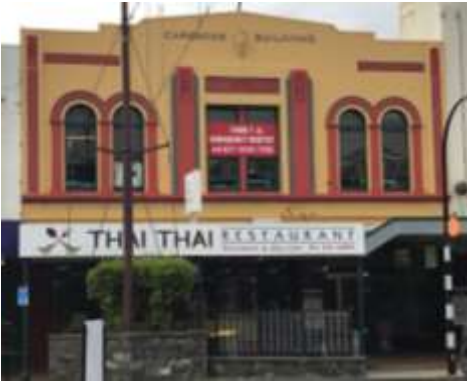
<p>The South wall comprises of URM and Reinforced concrete construction with minimal bracing structure to ground floor.</p> <p>Note there is no seismic gap to the buildings to the North, East or East and there is variable lateral load resistance in these buildings meaning that load from 19- 21 Cambridge Place and 36 and 42 Tay Street may be passed into the structure of the building in question if all the buildings remain in place.</p>
2

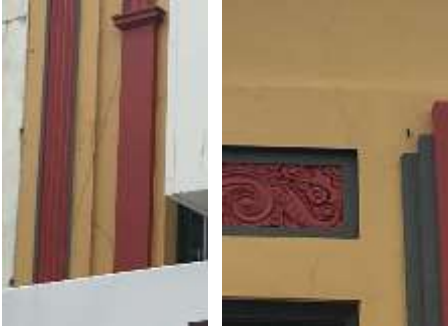
<p>Vertical cracks to the South Façade URM wall elements indicate the wall is exposed to loading which has exceeded the walls capacity or the walls capacity has deteriorated to an extent that normal service loading has exceeded this reduced capacity.</p> <p>The West side wall is URM full height. This is most likely the critical structural element for the building.</p>
3

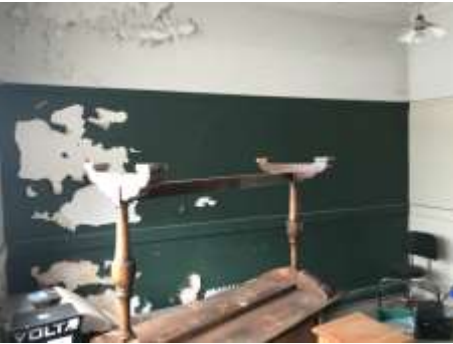
<p>The first floor East wall to the inset plan exhibits a significant crack to its URM wall turning from horizontal to vertical over most of the storage room length.</p> <p>This is typical of a loss of support at floor level which is not manifested at ground floor below which is the Lollie Shop façade.</p> <p>Further investigation is recommended if the building is to remain in its current form for more than a year from this report issue.</p>
