INITIAL SEISMIC ASSESSMENT REPORT (ISA PLUS)

42 Tay Street, Invercargill

Client Name: HWCP Management Ltd)

Date Issued: 9/04/2018

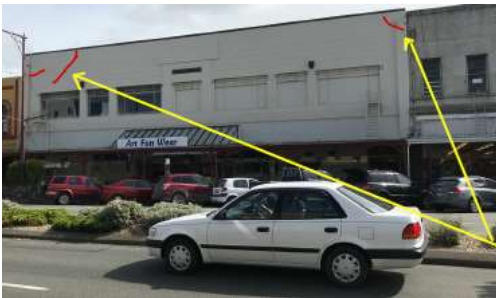
No#	Photo	Comments
1

<p>The South wall comprises RC wall and frame construction with minimal bracing structure to ground floor. This is potentially a structural weakness for the building.</p> <p>Note there is no seismic gap to the buildings to the North, East or East and there is variable lateral load resistance in these buildings meaning that load from 19- 21 Cambridge Place, 40 and 48 Tay Street and the 3 storey RC frame element addition may be passed into the structure of the building in question if all the buildings remain in place.</p>
2

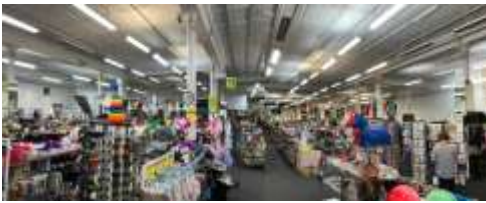
<p>The floor plan is fully open with gravity only supports within the space.</p> <p>The floor and roof diaphragms are therefore critical to the buildings stability.</p>
3

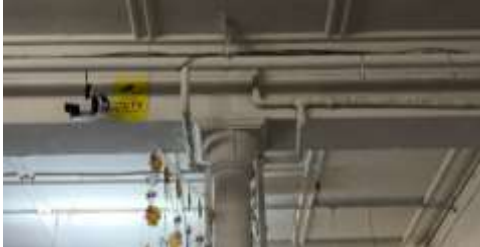
<p>The Cast iron column to beam connection indicates no mechanism to provide any resistance to horizontal loading of the building globally.</p> <p>Cast Iron has very low capacity to cyclic moment loading in any case.</p>

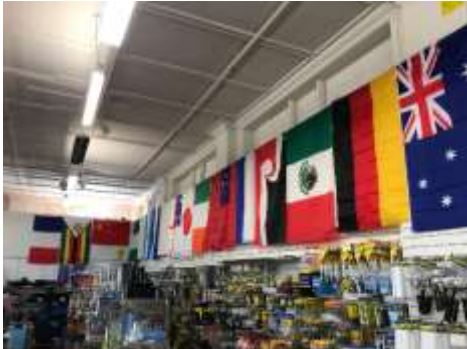
4

<p>The East URM wall is detailed with window at high level which will limit the in- plane and out of plane resistance of the walls.</p>

The East side boundary wall element with respect to out-of-plane (OOP) performance, acts as a cantilever from ground floor level, given the lack of effective restraint provided by the roof construction detailing typical of this era of building. This is likely to be the critical element from a seismic perspective for this part of the building. The assumed parameters relating to this vertical cantilever brick wall are, height = 9.3m approx., thickness = 350mm. BMC has carried out an OOP calculation resulting in a 17%NBS performance for this wall (see Appendix A for calc sheet). Note this does not allow for either the loss of brick section or mortar jointing which is not visually evident on site or the stress concentration resulting for the integrated windows.

The in-plane performance of the brick walls is likely to also be inadequate (<34%NBS) given the degree of window openings to the underside of first floor and roof along the buildings length.
