INITIAL SEISMIC ASSESSMENT REPORT (ISA PLUS)

48 Tay Street, Invercargill

Client Name: HWCP Management Ltd

Date Issued: 9/04/2018

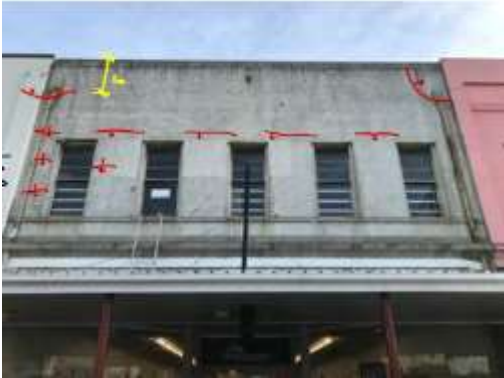
<p>The South wall comprises URM wall and frame construction with minimal bracing structure to ground floor. This is potentially a structural weakness for the building.</p> <p>The ground floor has no significant bracing provision at the façade.</p>
2

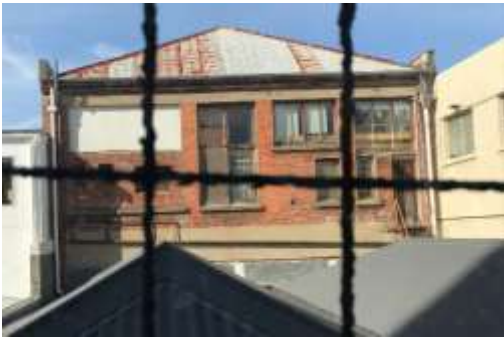
<p>The North elevation of the main element is URM 230mm thick with little effective structure to transfer out of plane loading up to the roof structure and a pier element which acts purely as a cantilever.</p>
3

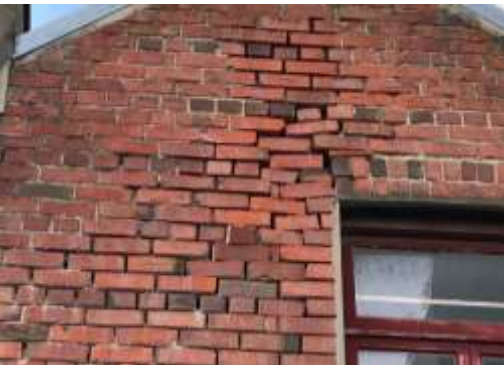
<p>The rear element's East gable URM wall</p> <p>This was noted at the time as an immediate safety hazard (bricks falling out) and 'make safe' repairs enacted.</p>

Based on our assessment of the building, BMC consider continued occupancy for the next 6-12 months only is appropriate subject to the immediate isolation / repair of the 'make safe' works to the rear elements and, the conditions of the *Building (Earthquake-prone Buildings) Amendment Act 2016*, without subsequent inspections.

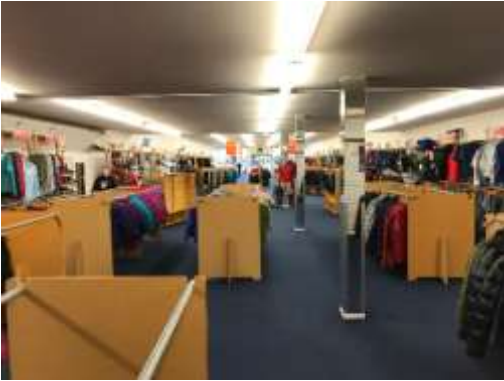
<p>The ground floor plan is practically fully open with no bracing structure along its length.</p> <p>Note there is no seismic gap to the buildings to the North, West or East and there is variable lateral load resistance in these buildings meaning that load from Southland Times, 42 and 50 Tay Street and the single storey RC frame element extension may be passed into or from this structure into the surrounding elements if all the buildings remain in place.</p>
