INITIAL SEISMIC ASSESSMENT REPORT (ISA PLUS)

Jay Jays, 2 Degrees Mobile, and Sass Cafe

49 Esk Street, Invercargill

Date Issued: 9/04/2018

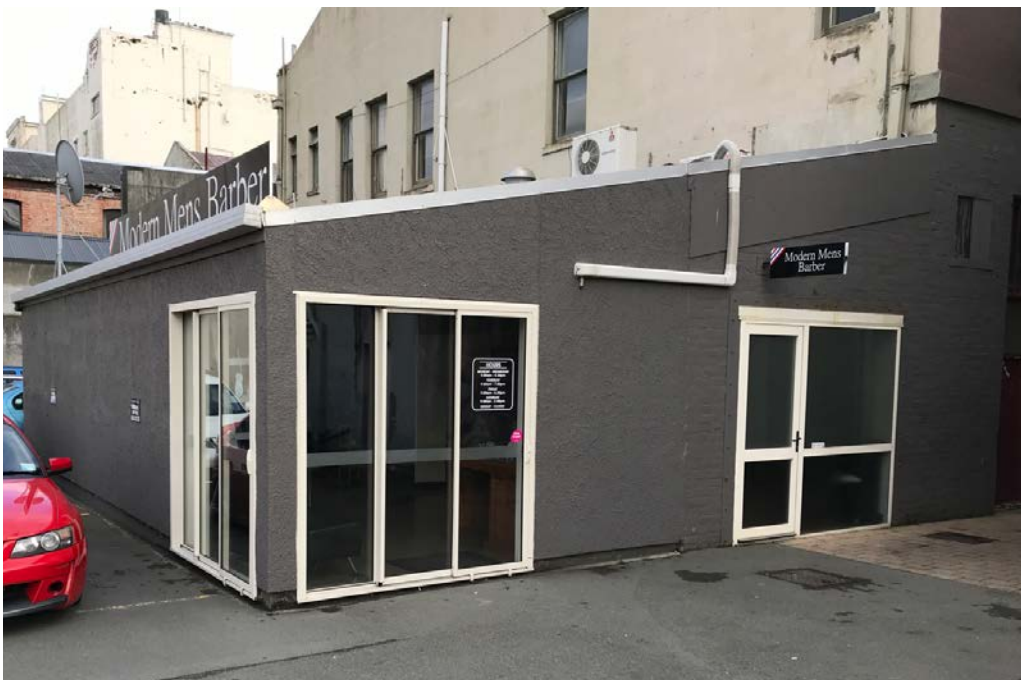
Figure 4 - Rear addition to building

The addition at the southeast corner of the building appears to be of a lean-so style of construction. It has a mono pitched roof with light weight construction, as shown below in Figure 4.

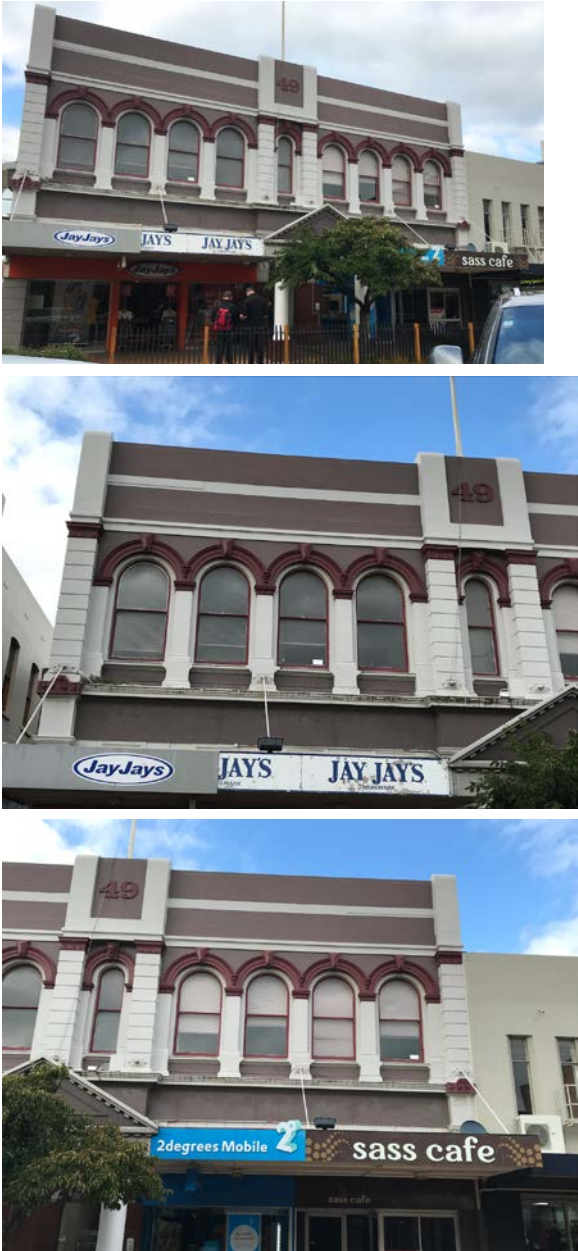
No#	Photo	Comments
1

<p>No seismic gap to the adjacent building to the west. On east side of the building, there is an alley. There appears to be poor lateral load resistance in adjacent buildings to the west. As this building is the “last” building in a line, the lateral loads, (east-west direction) from the adjacent buildings could be concentrated on into the 49 Esk Street structure.</p>

In addition to the soft storey critical structural weakness, the building is located at the end of a row of buildings of a similar era with no seismic gap and similar soft storey weakness. To the west is the row of buildings and to east of the building is Barclay Lane alleyway. The building’s position as “last in line” in a row of buildings with no seismic gaps and poor lateral resistance, will likely exacerbate the damage caused by the soft storey weakness of the building. This could cause out-of-plane failure of the east wall, resulting in the collapse of the side wall into Barclay Lane. As such, it is estimated that the lateral load carrying capacity of the building in the transverse direction is approximately 15-20%NBS.

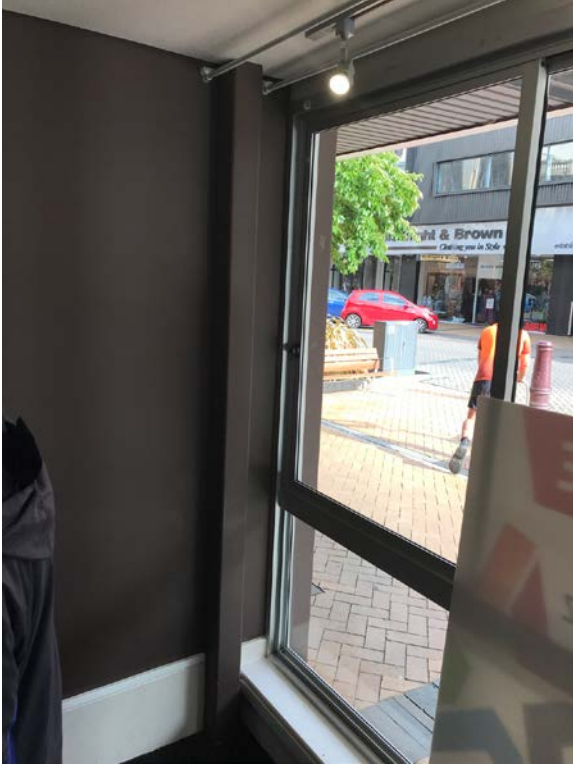
<p>At storefront - steel SHS with cast iron column adjacent.</p>
7

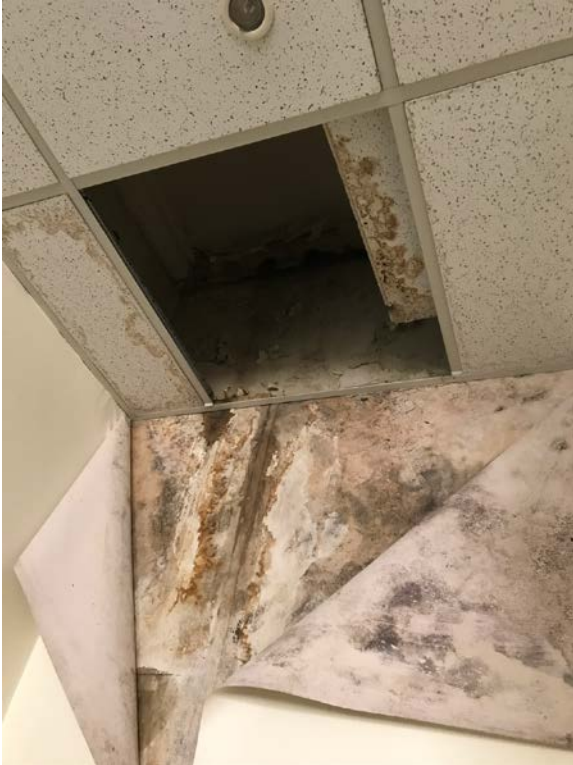
<p>Damp with visual mould in ceiling cavity at roof.</p>

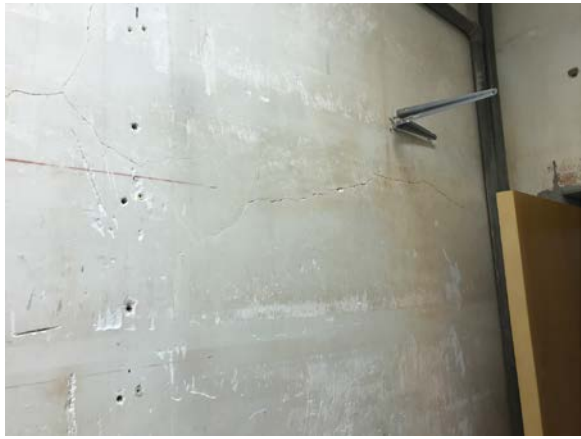
375mm thick brick wall with approximate 1mm wide cracks at 800mm centres at level 1 wall.
9

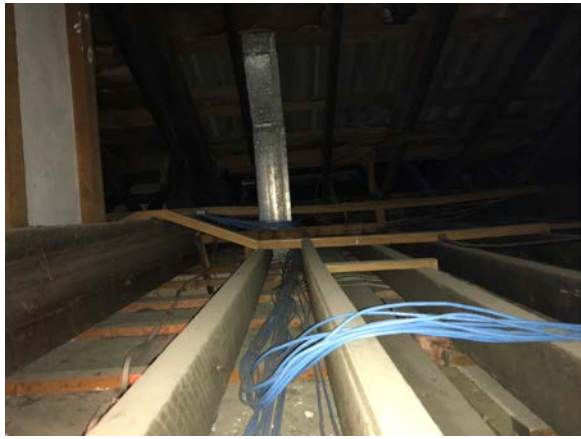
Roof trusses at 3.5m centres.
