INITIAL SEISMIC ASSESSMENT REPORT (ISA PLUS)

50 Tay Street, Invercargill

BMC Reference: 1711-2266

Date Issued: 9/04/2018

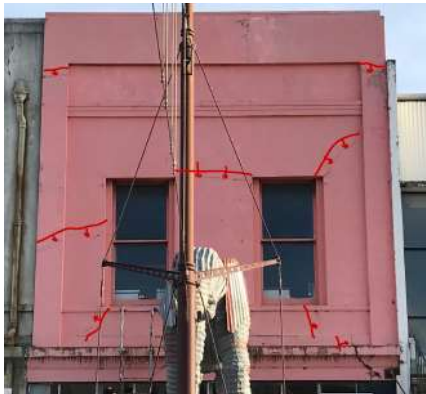
| No# | Photo | Comments |
|---|---|--|
| 1 | | <p>The South wall comprises a URM wall and frame construction with minimal bracing structure to ground floor. This is potentially a structural weakness for the building.</p> <p>The façade exhibits a number of cracks located in locations typical of out of plane movement and support deformations.</p> <p>The ground floor has no significant bracing provision at the façade.</p> |

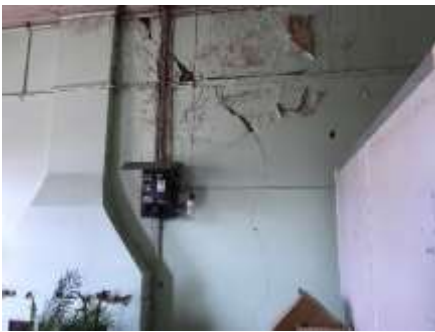
| No# | Photo | Comments |
|---|---|--|
| 2 | | <p>The West side wall exhibits a diagonal to vertical crack behind the chimney breast at approximately the storey height back from the front elevation. It is noted that the opposite side wall has a canopy tie in place but the West does not but the canopy has post supports at its outer edge.</p> <p>Potentially the canopy was tied back to the West side wall as the East but after this cracking propagated the posts were installed and the brace removed.</p> |

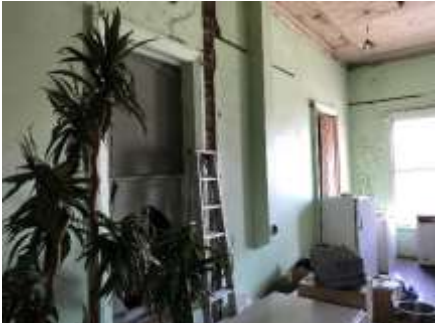
| No# | Photo | Comments |
|---|---|--|
| 3 | | <p>The East side wall has a number of windows which have not been infilled although the adjacent property side wall is now directly adjacent to it. The East URM wall's Out of Plane capacity will be further limited in this location.</p> |

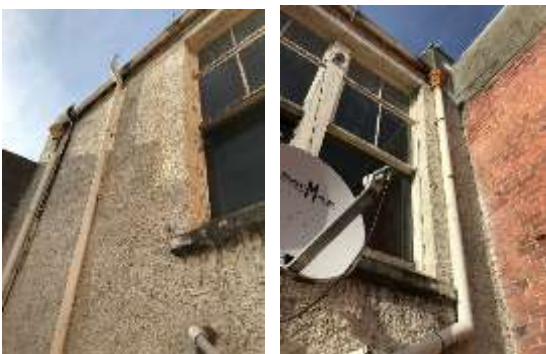
| No# | Photo | Comments |
|---|---|--|
| 4 | | <p>Note there is no seismic gap to the buildings to the North, West or East and there is variable lateral load resistance in these buildings meaning that load from, 48 and 54 Tay Street may be passed into or from this structure into the surrounding elements if all the buildings remain in place.</p> |
