**INITIAL SEISMIC ASSESSMENT REPORT (ISA PLUS)**

Woosh

58 Tay Street, Invercargill

BMC Reference: 1711-2266

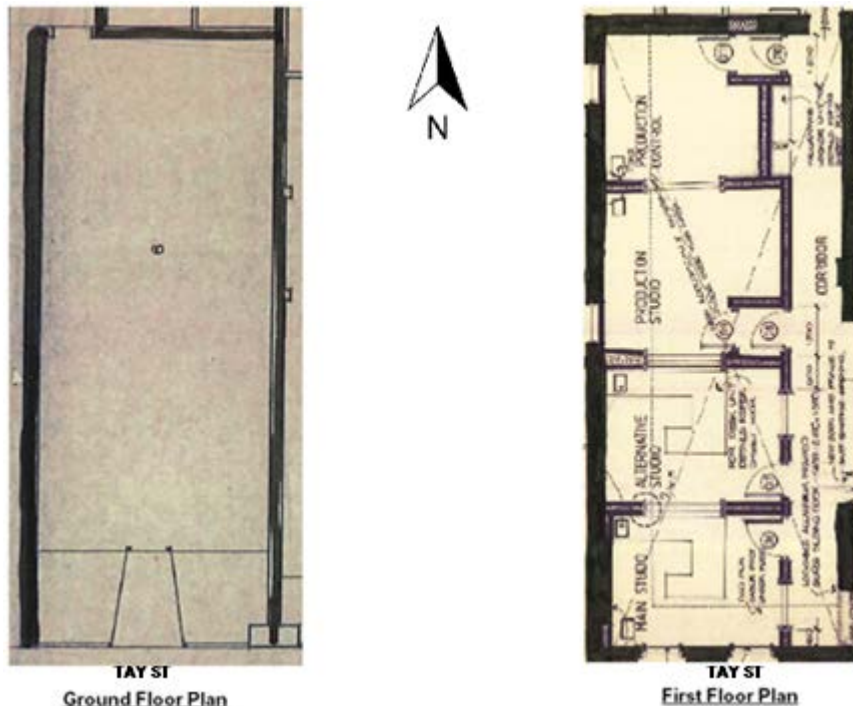
Figure 2 - Building floor plan

The general condition of the building is average at ground floor with many walls stripped of their linings. External and internal cracks in the URM walls and concrete wall indicate that the structure has potentially sustained minor earthquake damage.

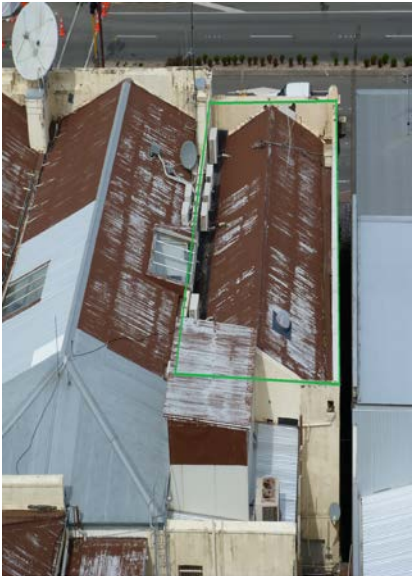
Outline of roof area at 58 Tay Street
2

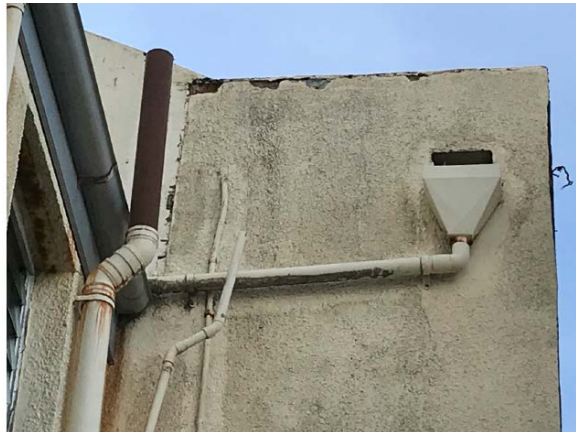
Cracks in rear URM wall

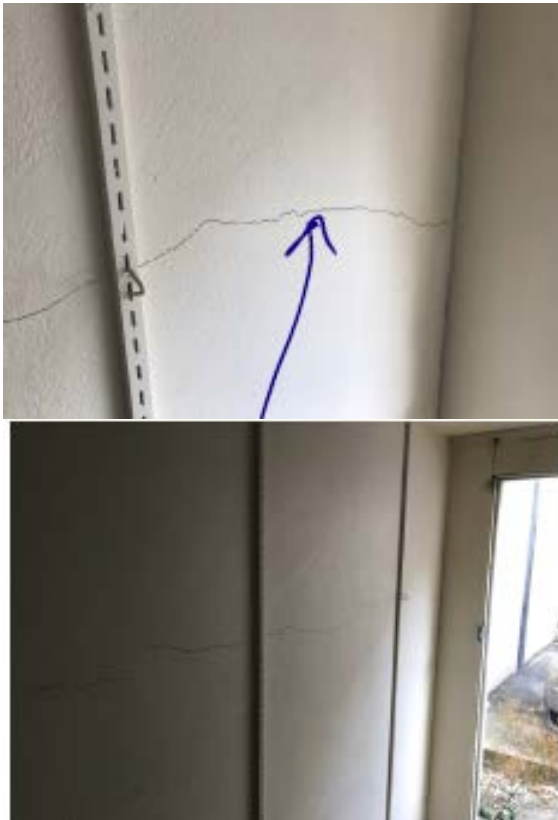
Horizontal 1.5 mm crack in concrete wall in back entrance hallway

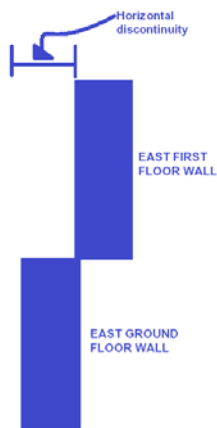
Figure 3 - Horizontal discontinuity along east elevation of building

The horizontal discontinuity occurs along the eastern external wall. The wall at first floor is stepped in from the external wall at ground floor. This horizontal offset of the URM walls creates a discontinuity in the load path of the lateral load resisting system, see Figure 3 below.

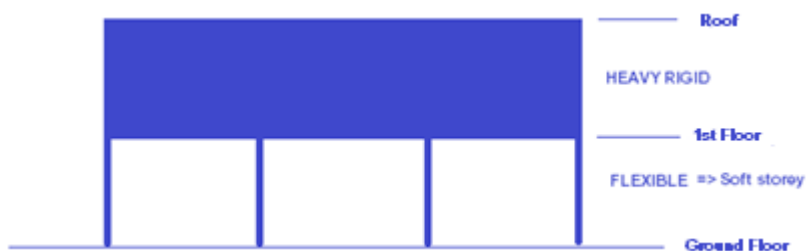
Figure 4 - Building elevation of soft storey structure example

In the transverse direction (north south direction), there is a soft storey critical structural weakness. A soft storey in a building occurs when a significantly more flexible building level supports a more rigid building level. This occurs at the shopfront, where a relatively heavy rigid first floor façade is supported by “open” ground floor framing with no distinct lateral force resisting elements, see Figure 4.

At ground level, in the transverse direction, the only lateral load resisting element is the URM wall at the rear of the building.

Due to the soft storey and the horizontal offset of the URM walls, the estimated lateral load resisting capacity of the building in the transverse direction is approximately 15-20%NBS (IL2).
