The Club Hotel, Bluff

A Heritage Impact and Archaeological Assessment

Report Prepared for: Bluff Oyster and
Food Festival Charitable Trust

Reviewed by: Dr Naomi Woods
Submitted: August 2018

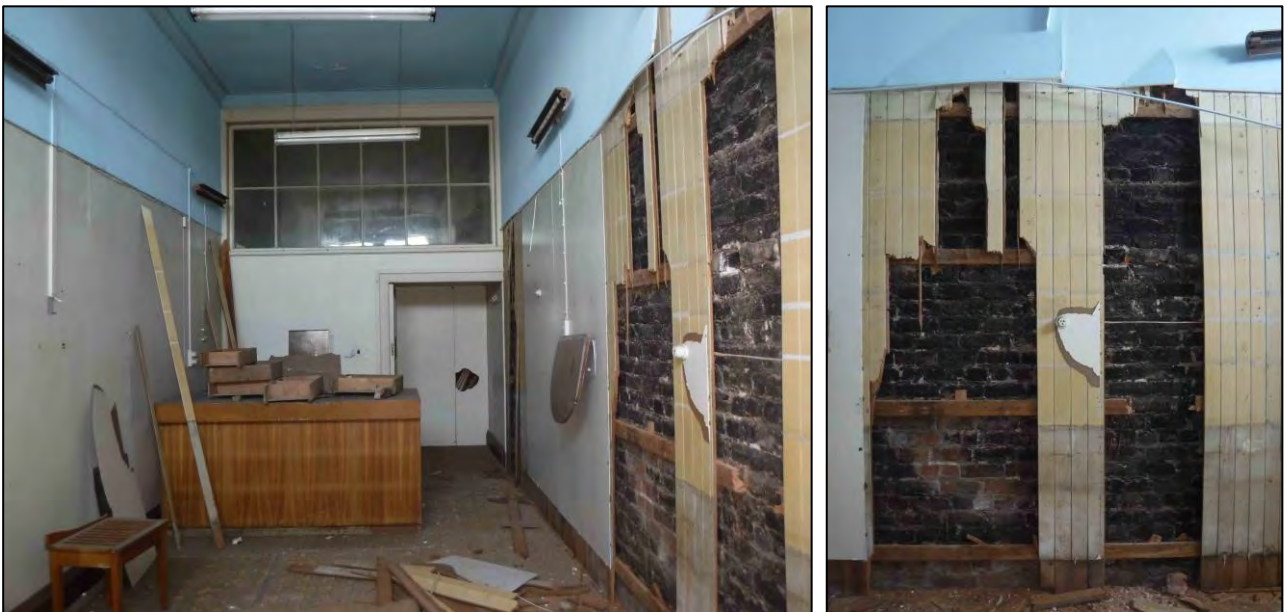
Figure 7-24. Left: photograph of Room A1 facing south. Right: detail of the tongue and groove lining over the charred brickwork exposed on the west wall.

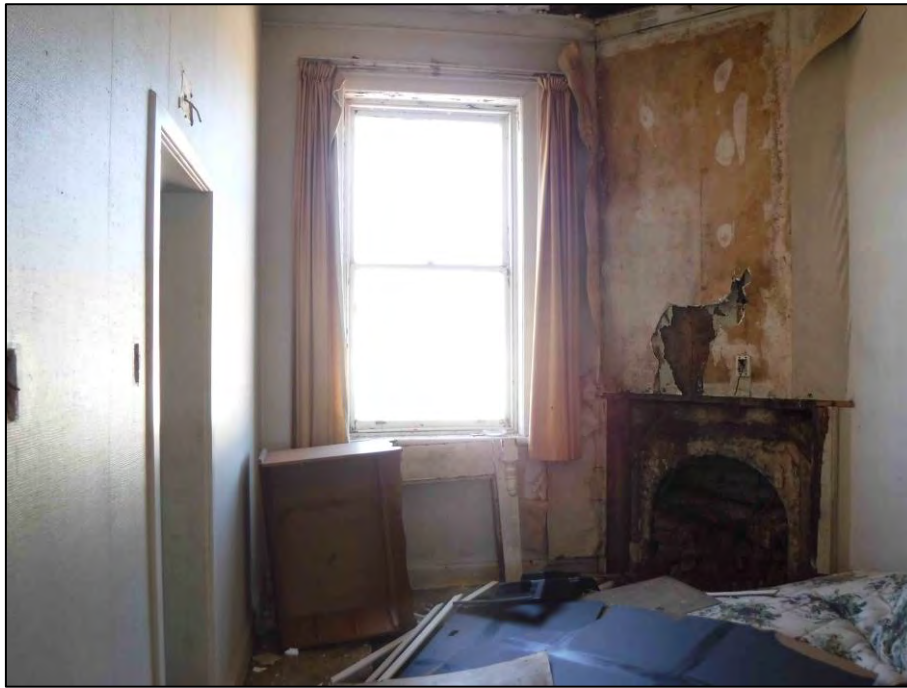
Figure 7-25. Photograph of Room A11 showing the corner fireplace. Note the water damage.

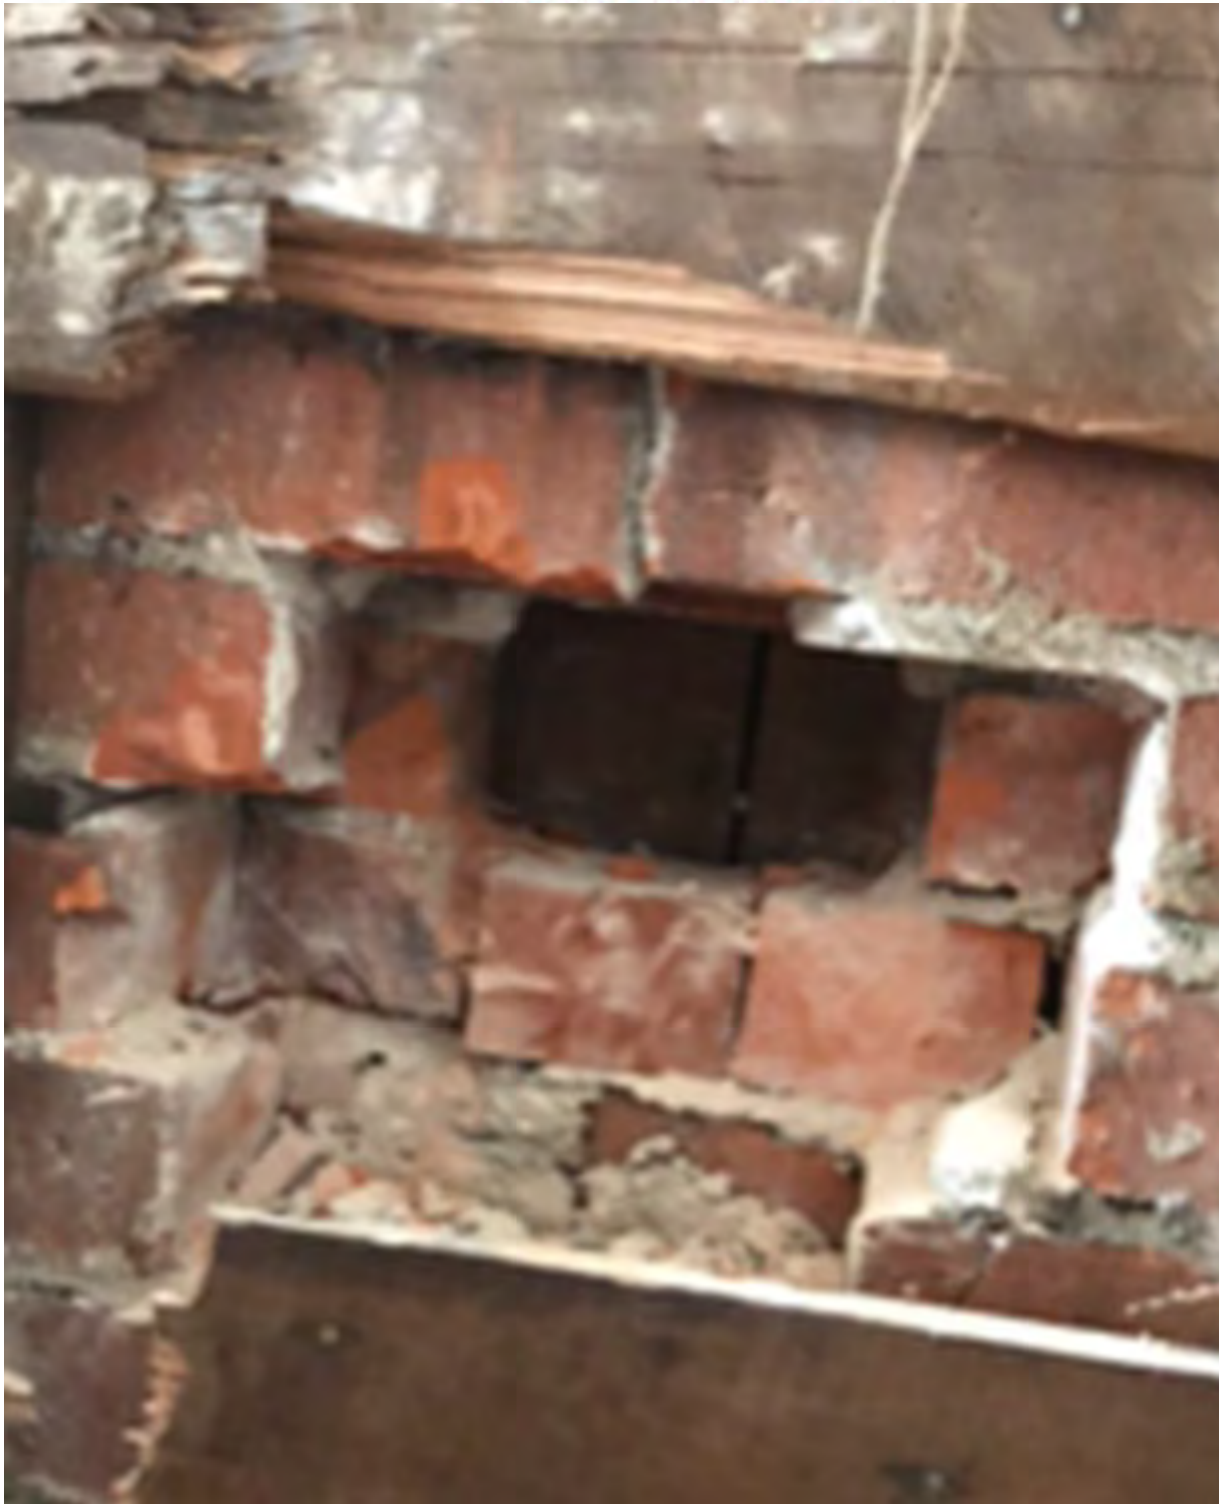
Fig 4: East Wall Boundary, showing rear of the adjoining house where boards have been found on the neighbours inside wall.

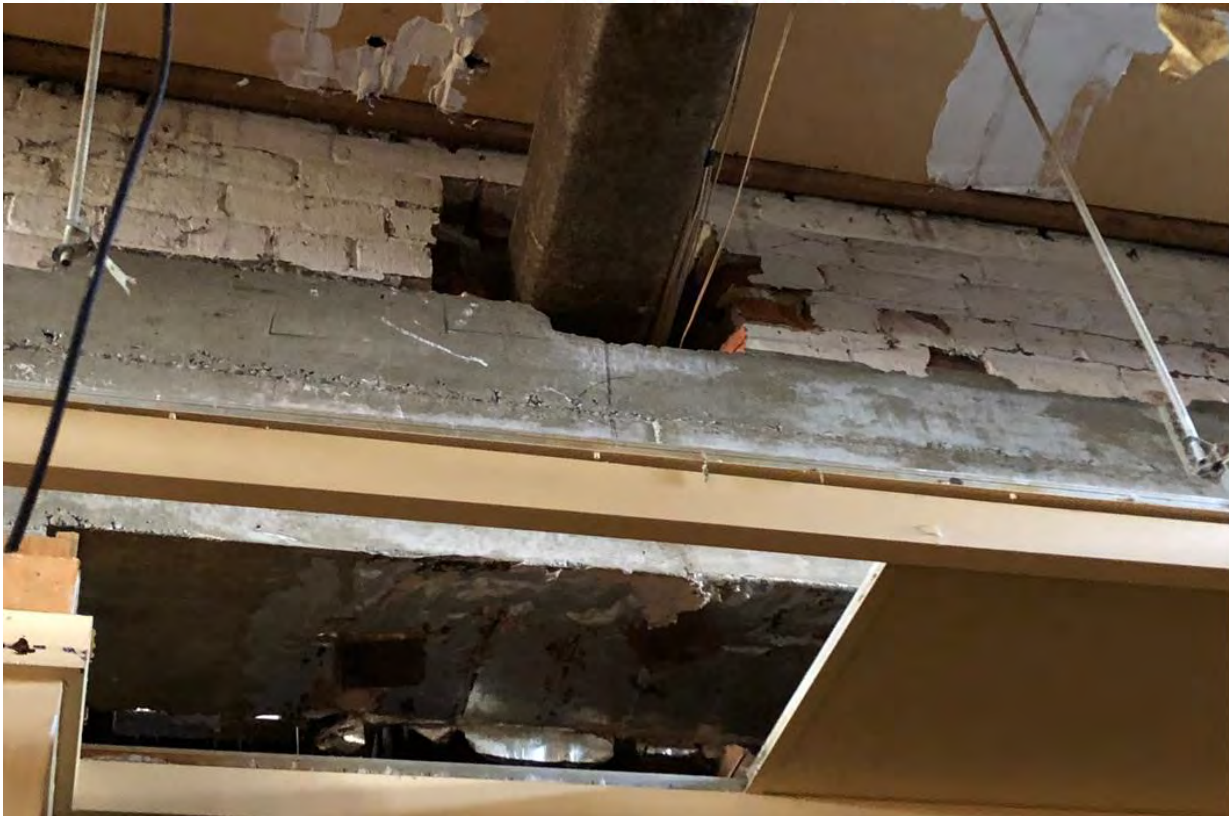
F 1.0 Historic entries for newer ducts have caused major structural damage which has tried to be fix with insut concrete but the bricks at the interface are crumbling.

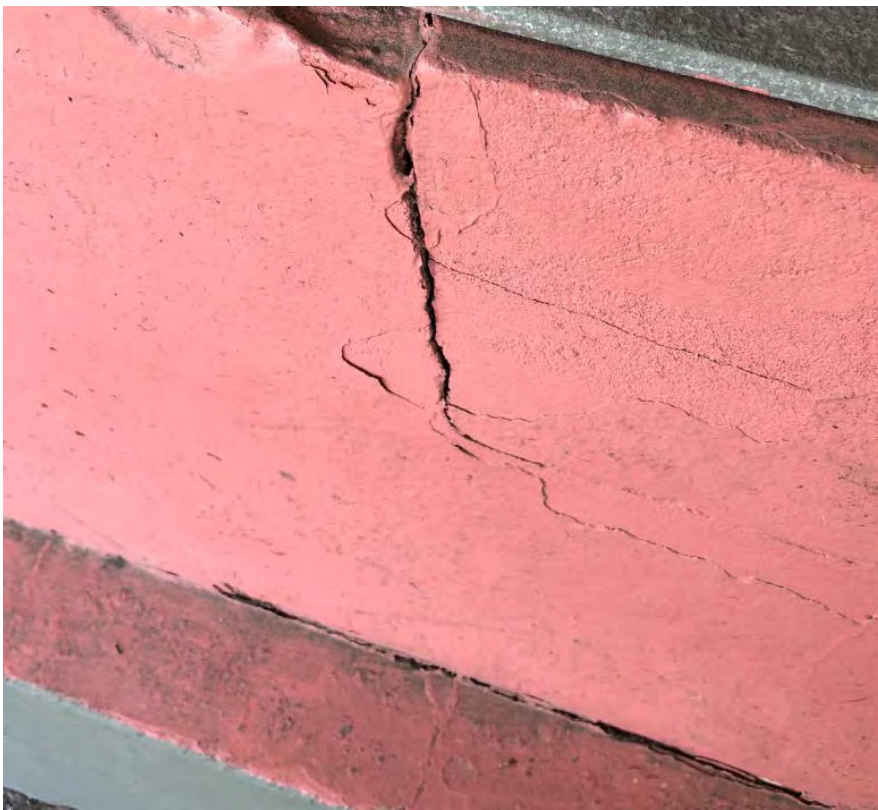
F 2.0 Major cracks in unrienforced foundation beams make it difficult to consider any strengthening solution as load paths to the ground have been compromised.

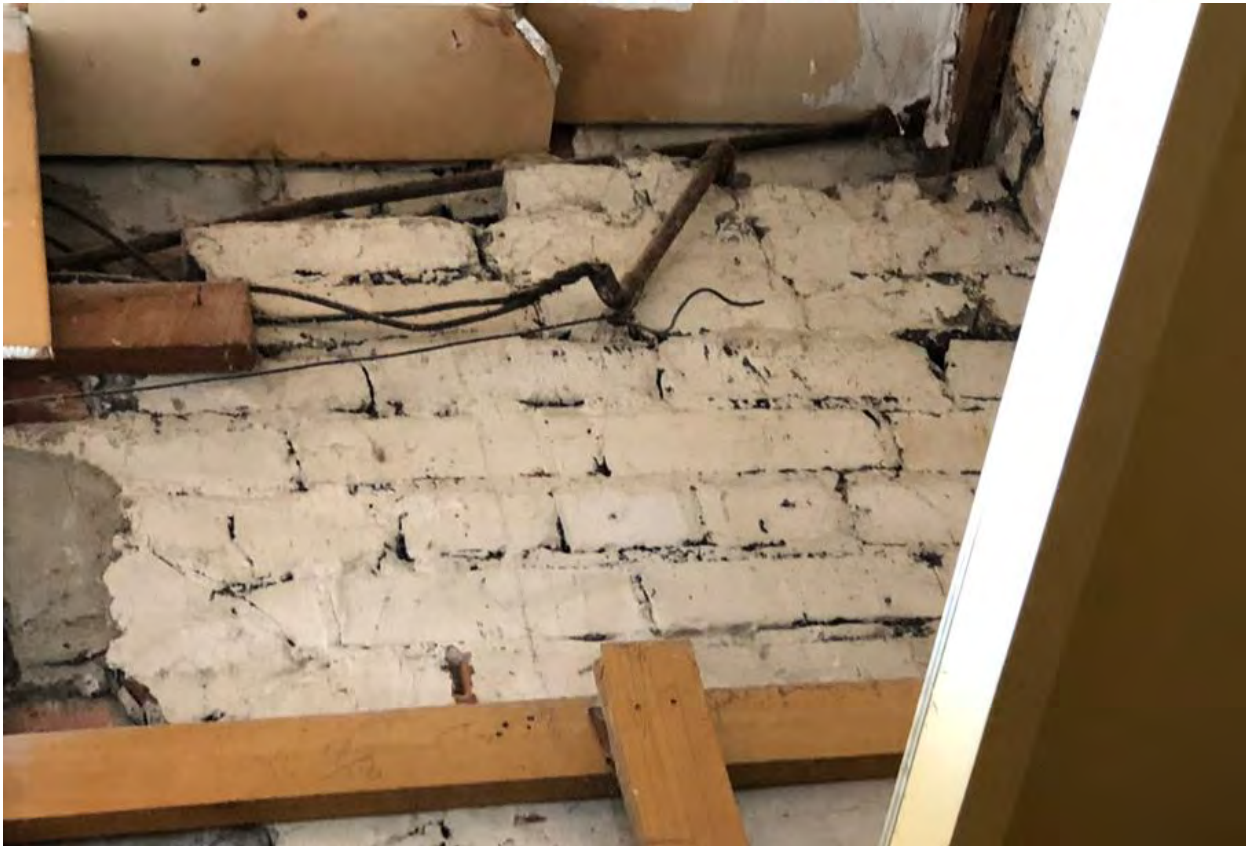
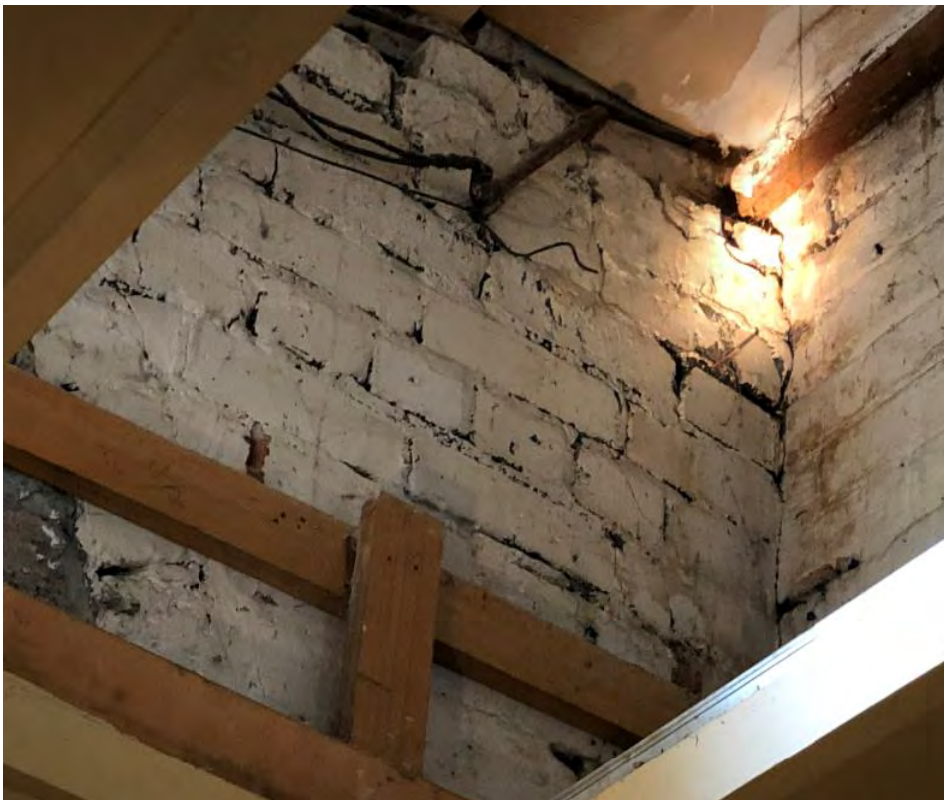
F 3.0; This is the North wall adjacent to the ICC building, where the outer wall is believed to be a common wall with the neighbouring building, one can see where the new front shear wall in bricks has been simply butted up to the older wall with no inter linking of the course in adjacent brick placements. The upper photo shows concrete and rubble placement and the lower F4.0 shows the side butting of bricks.

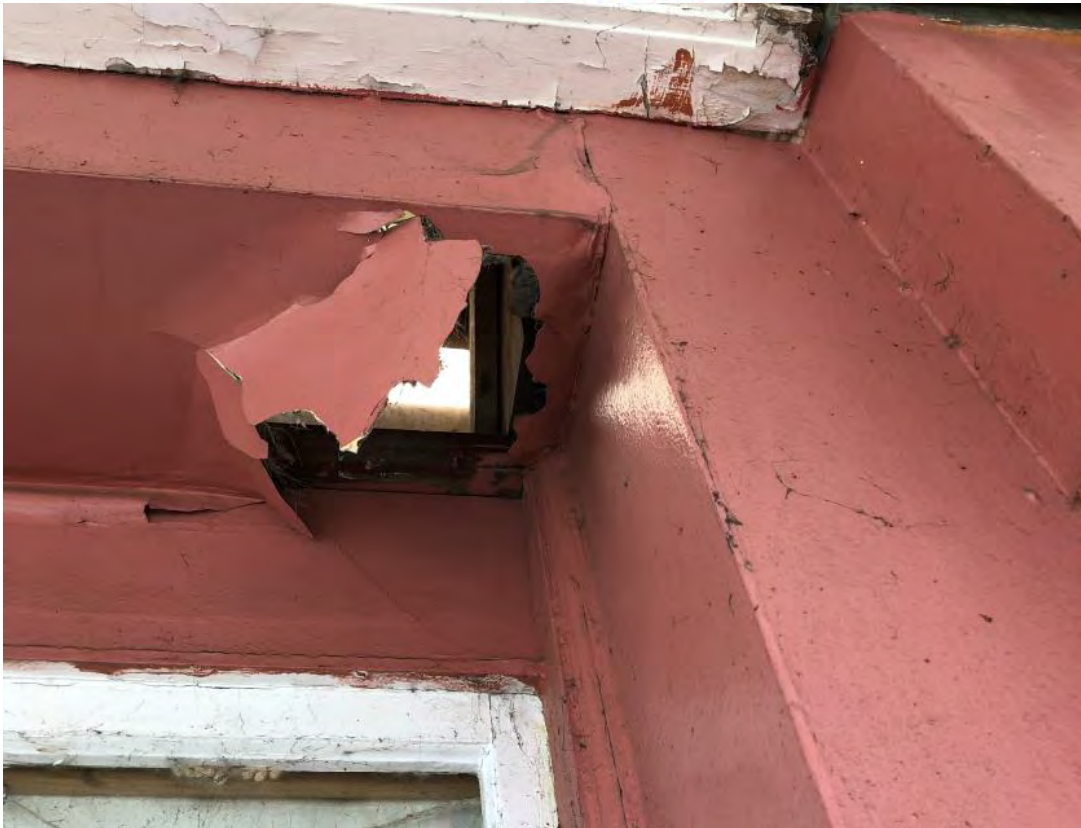
F 5.0; You see the use of timber open lintels above the lower windows which is most unusual as this offers not lateral load lines between adjacent column window breasts.

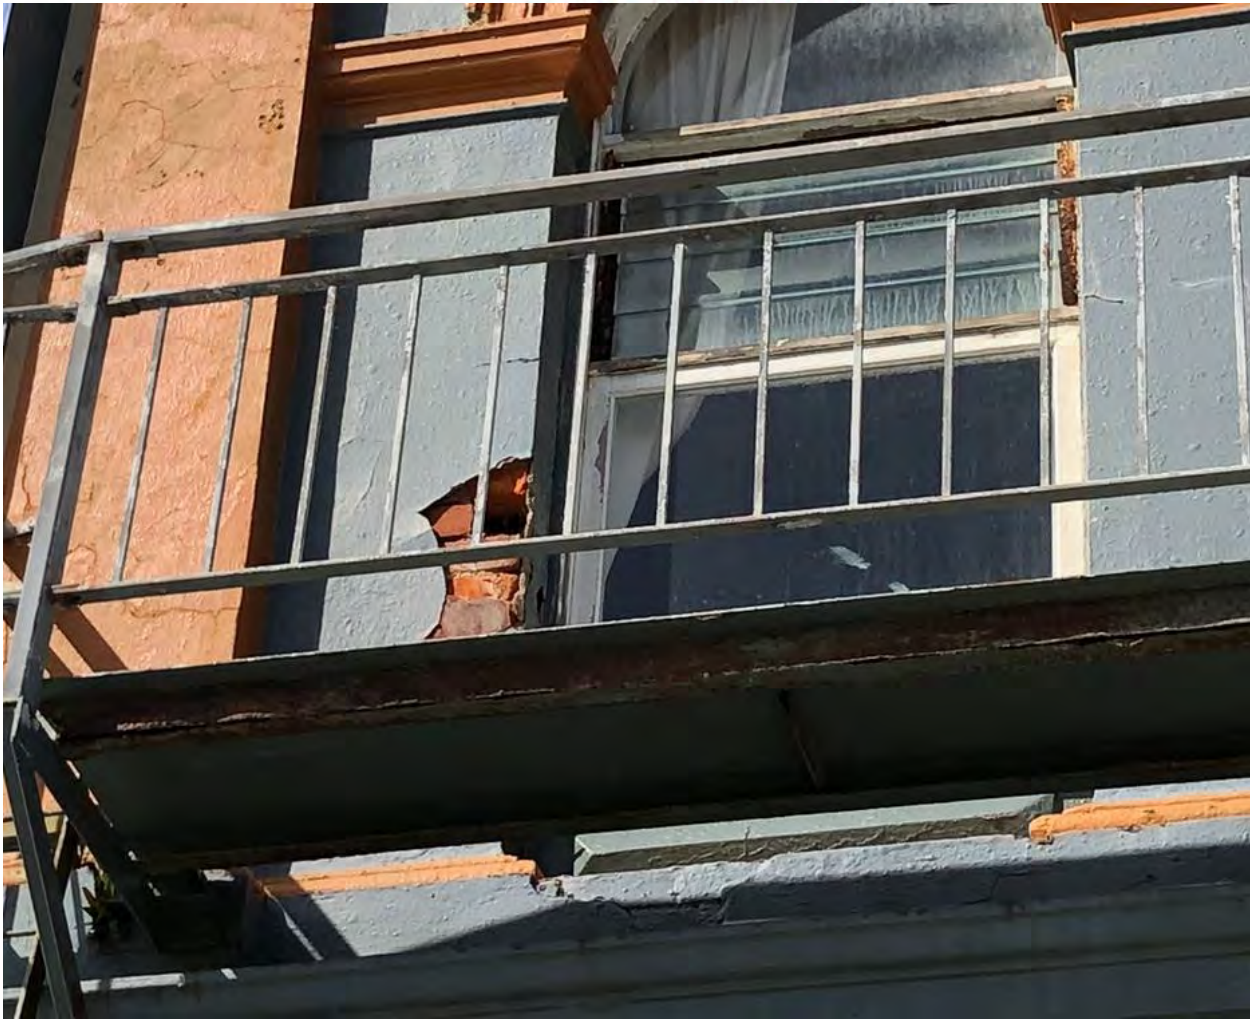
Fig 6.0; see the weathered bricks adjacent to the upper windows, there is no strength left in these bricks, the crumbling of plasters are significant with bricks being dislodged with weathering and damage which precludes these walls from any structural maintenance or refitting of new bricks as the bricks themselves have lost their inherent strength and no bond at all is left between any courses adjacent.

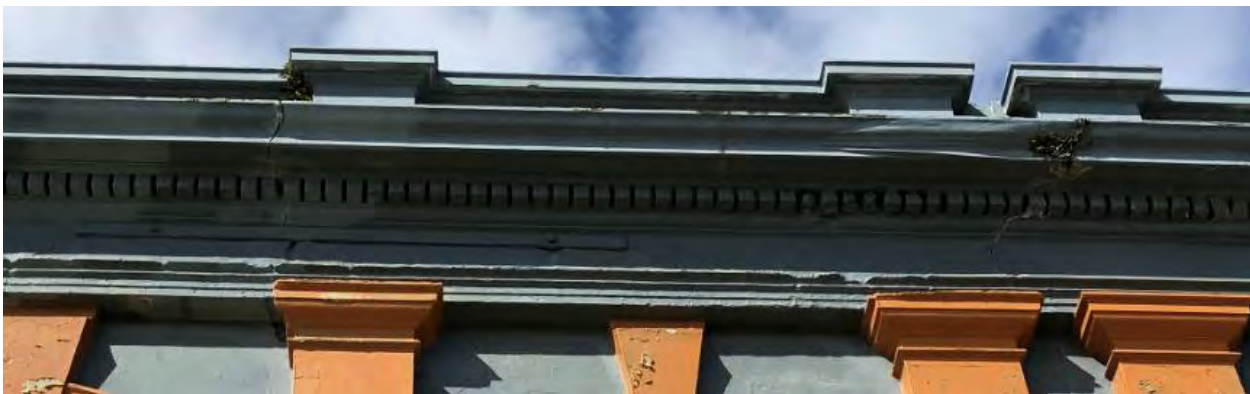
F7.0; There are numerous complete shear cracks between the upper lintels / parapets to make them ready to topple off and go through the ground veranda to the pavement, wind could well move such large parapets and hence this supports the argument that the building is now dangerous.

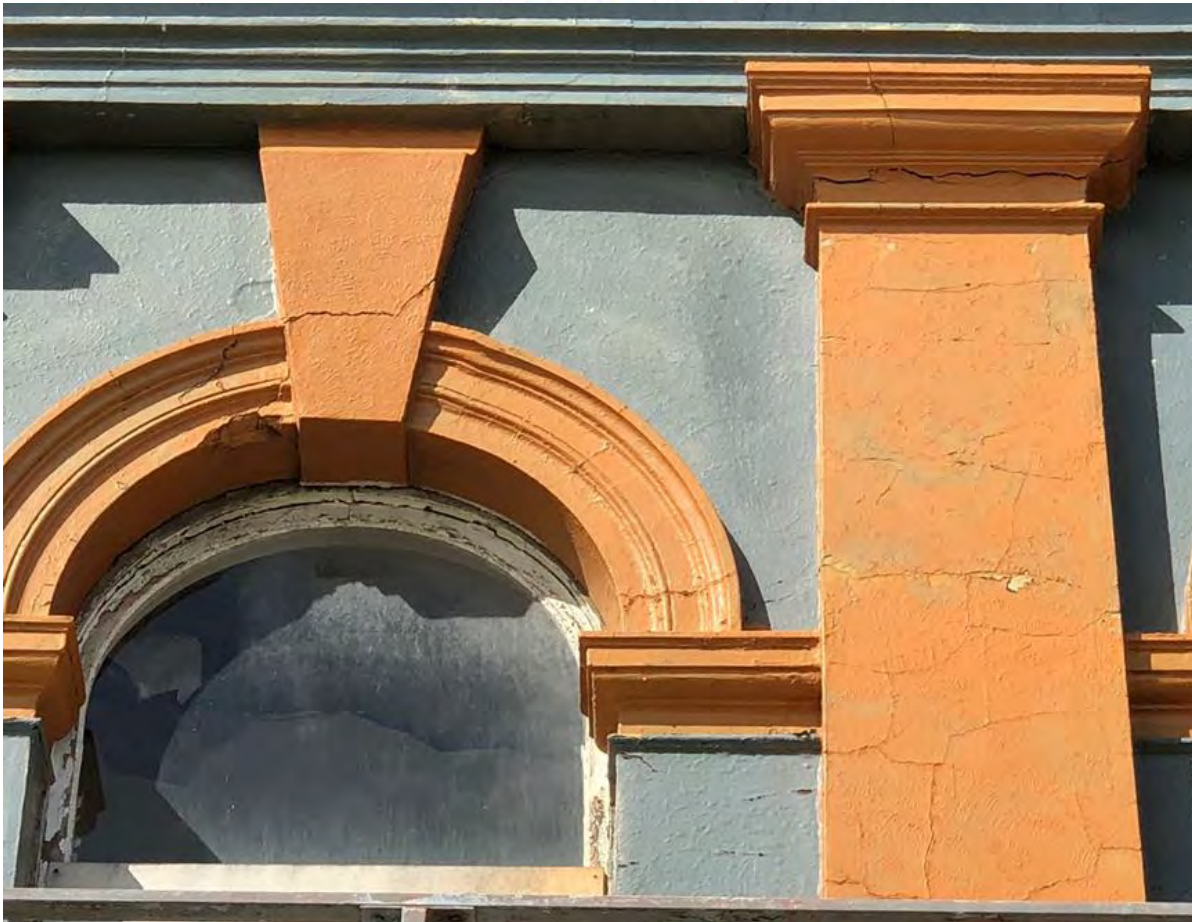
Fig 8; The cracking around the decorative corbels is not just through the plaster but such cracks go right through into the bricks placement which was poorly built from day one, the numerous cracking means large sections of these plastering features are able to come a drift with continual weathering over time and it is just typical of this whole front facade.

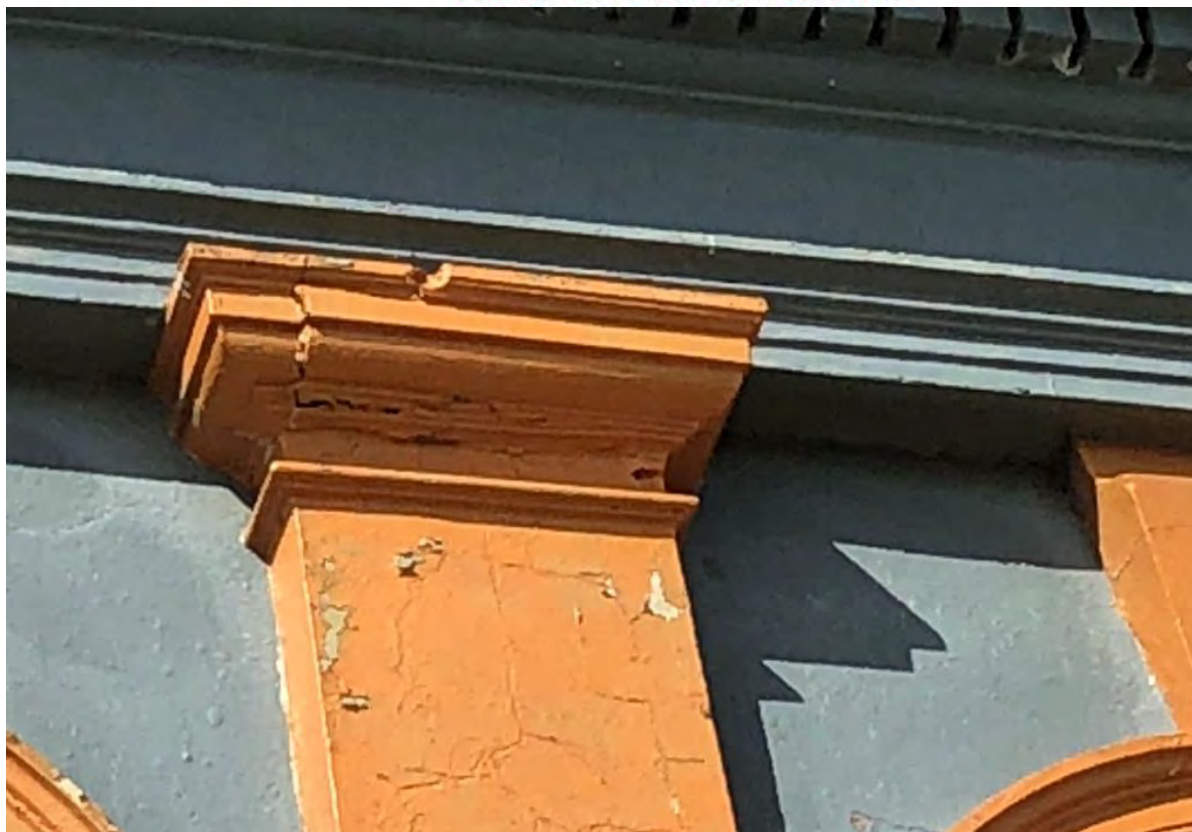
F 9; note the upper corbel cap how it has become dislodged over time, where weather has dislodged the bricks. The lower F 10.0; show the same problems but it whole cap could drop off at any stage.

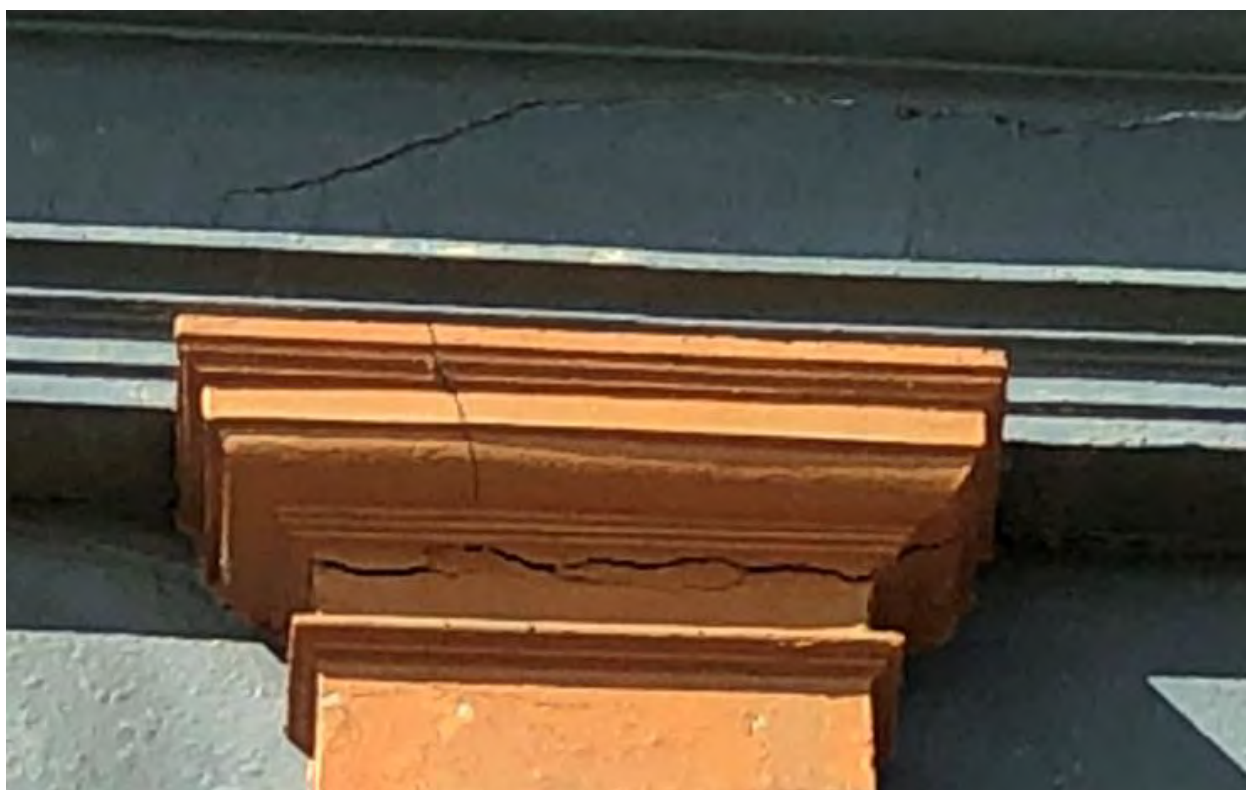
F10.0 Notice the cracking above the corbel as shown in the grey painted area, such cracks riddle the parapet all along the building, these cracks are not just surface deep they extend into the bricks internally.

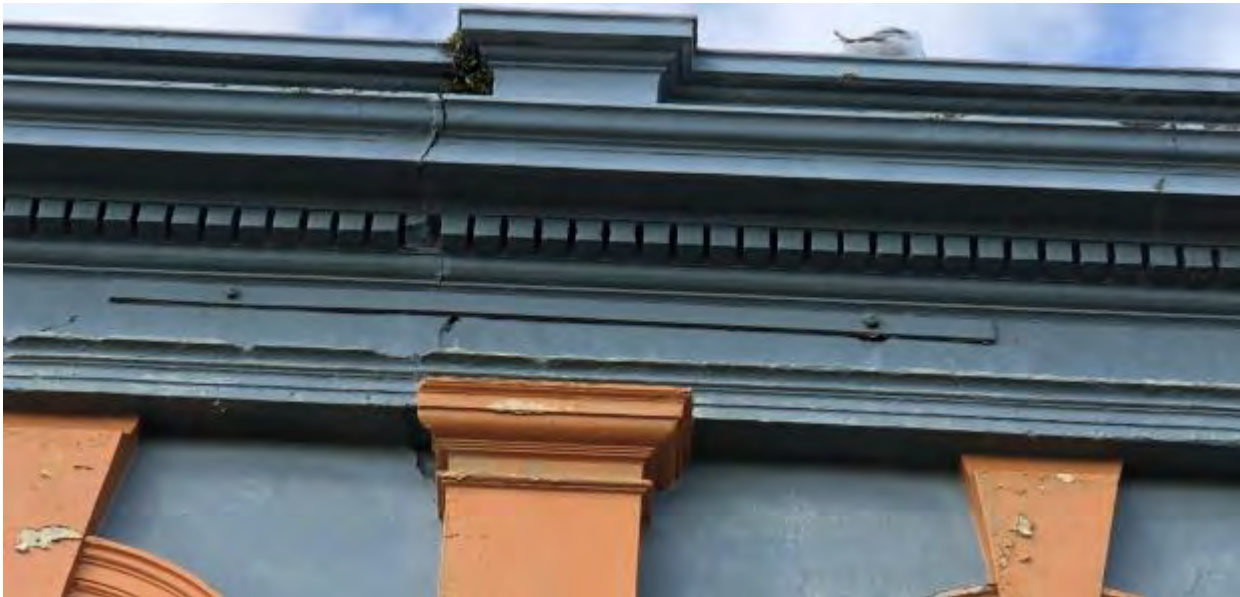
Fig 11.0; See the vertical shear cracks where the steel bar has been placed to limit future cracking, but unfortunately this will do little to stop cracking continue to plague this whole parapet.

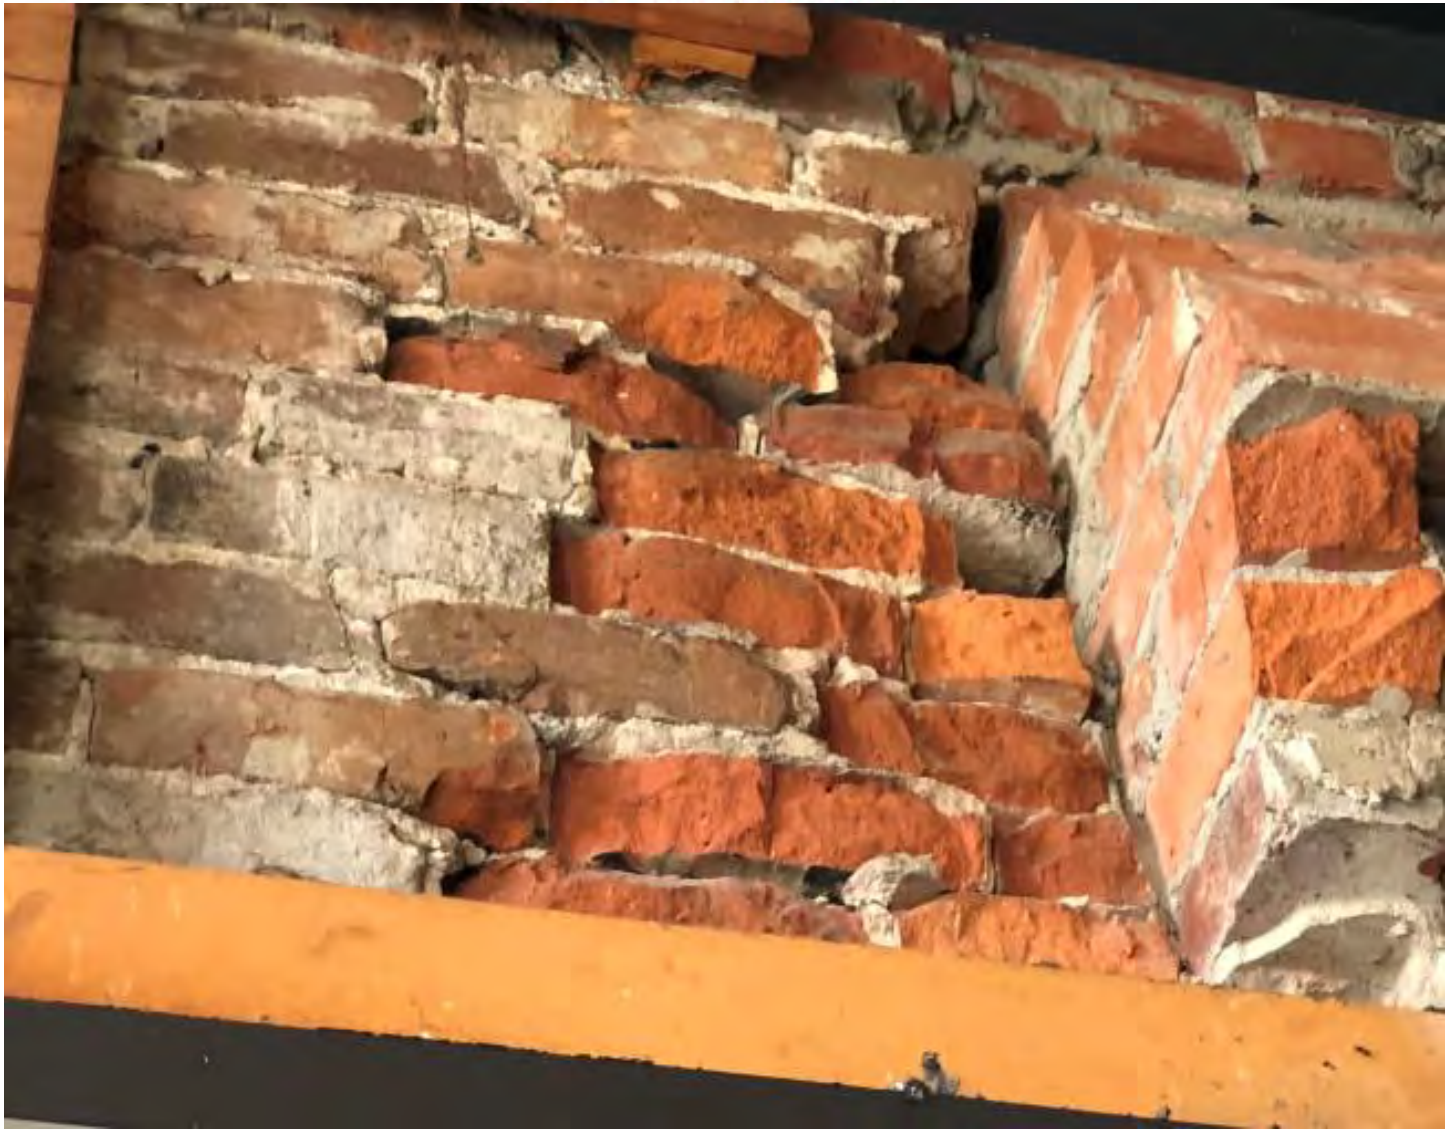
F12; This chimney breast shows how the bricks are not interlocked into the opening and flue which is poorly detailed as there is no strength between these changes, the bricks are poorly cemented together and their quality is not far off rubble as can be seen in a few of them.

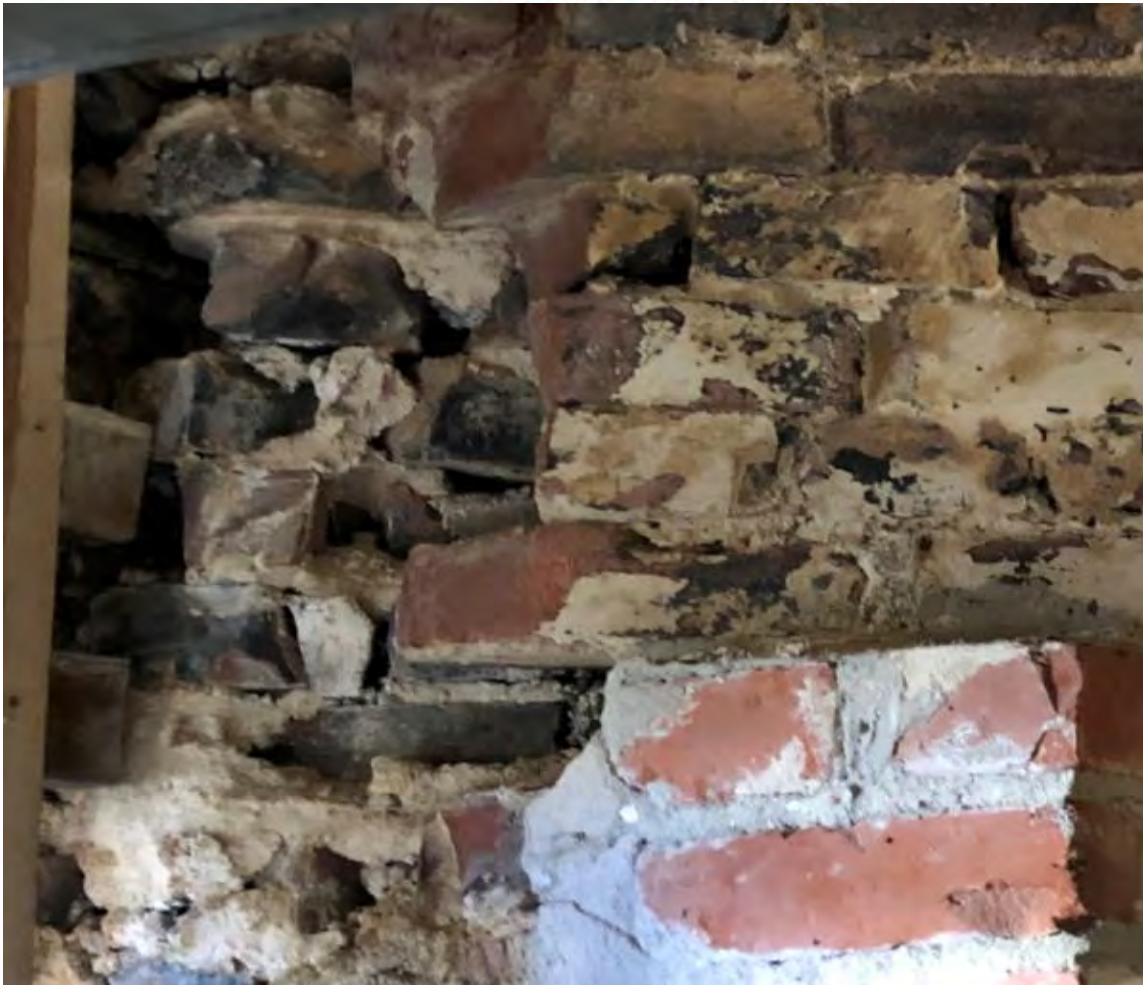
F13; Rubble of bricks are shown with poor cemented interlacing to the front bricks, such situations in this building is common.

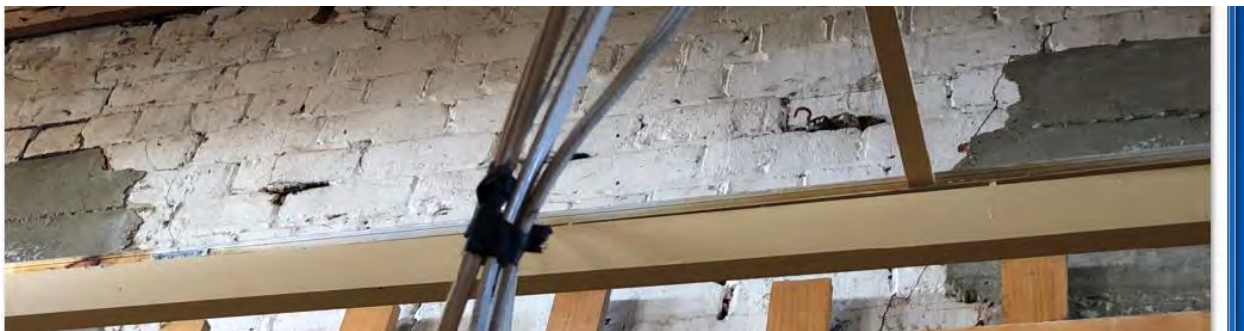
F14; Note the concrete fix ups with the diagonal shear cracks radiating up from the vertical edges about the concrete. This whole wall has been undermined with its lower removal of the historic internal load bearing wall as can be seen off the original drawings in Fig 17.

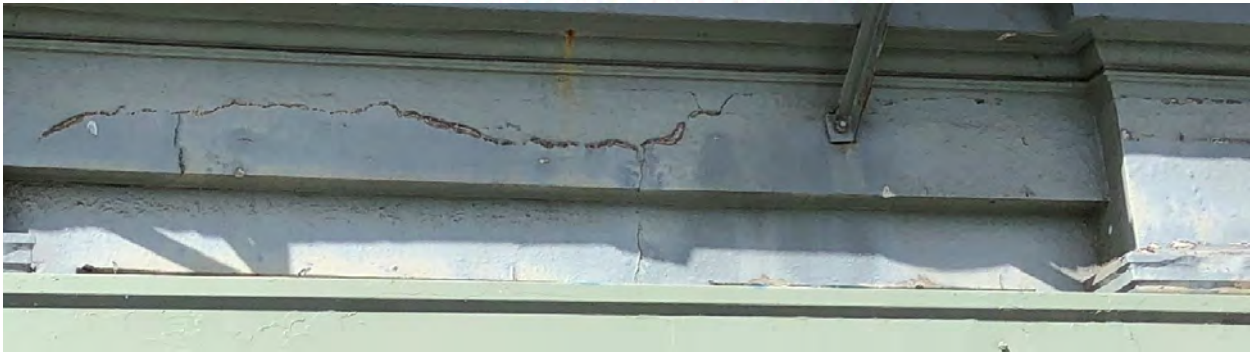
F15; Note the horizontal cracking through the lintel

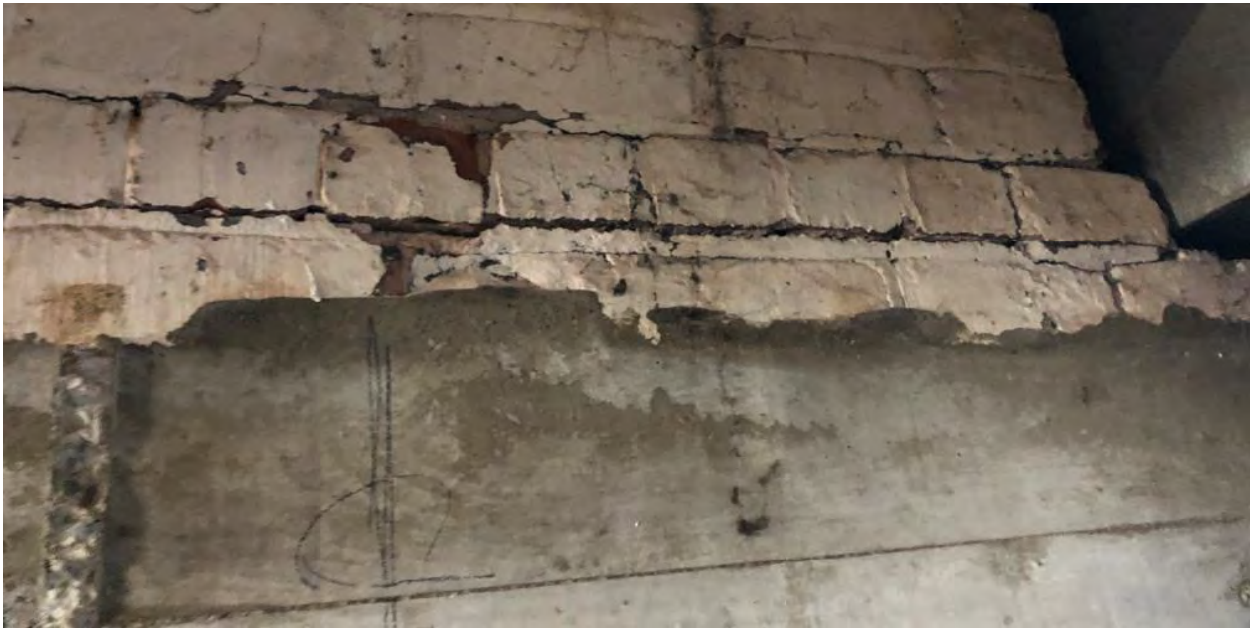
F16; There exists horizontal cracking through the brick courses which results from poor failed mortar and no doubt historical EQ loads exceeding the strength of the in place brick shear walls, or these courses could well have dropped at the similar time the concrete section of the new base lintel was poured. These part concrete lintels as placed in sections through the lower floor will contribute to significant weakening of the whole building.
