## Letter of Commentary - Inspection Review

### **J6102 - Site Inspection - 116 Gore Street, Bluff**

Consideration of how or if it is practical to strengthen the two buildings 1&2 as discussed by the Heritage Properties NZ in their email of the 19<sup>th</sup> feb 2018.

#### **Consider the Statement as proposed by the Client and others "What will it take to strengthen the building 1 and 2 to the East side of the "Club Hotel" frontage?"**

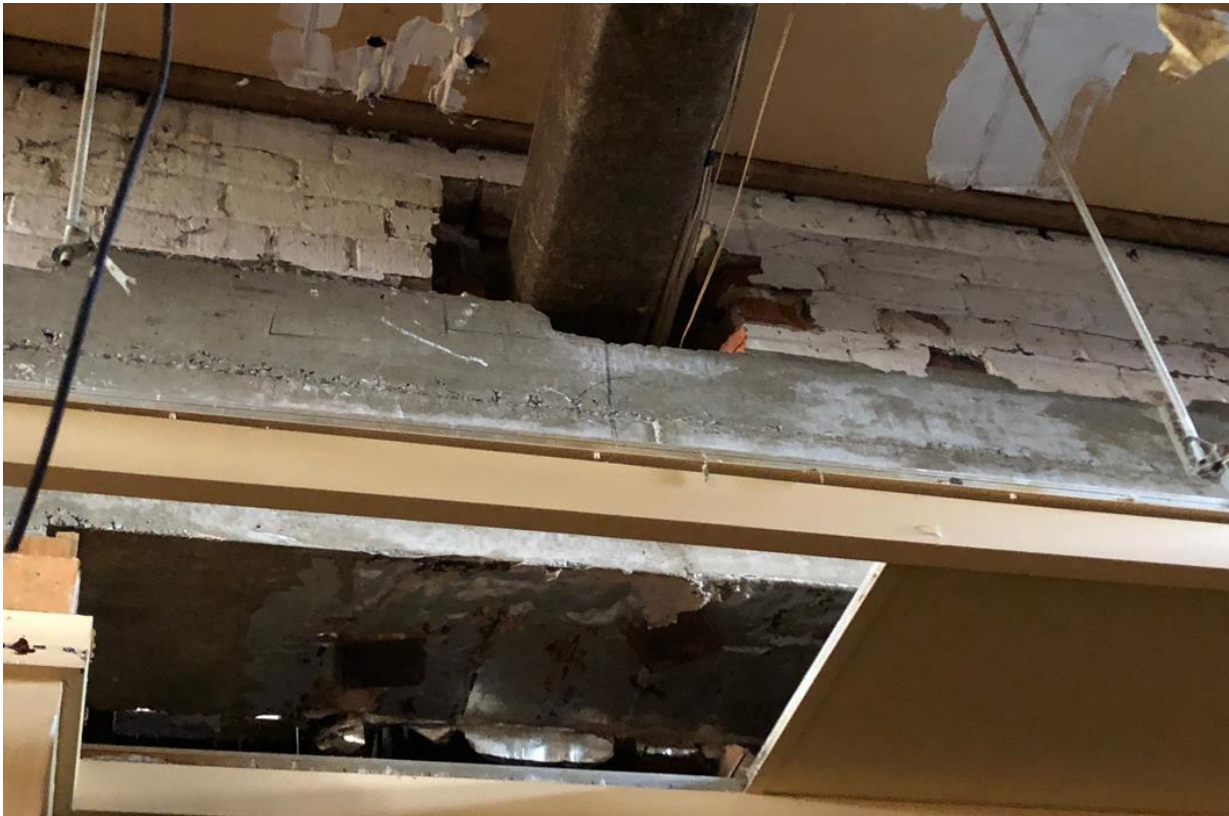
These walls (see FIG 1& 2) are past the point where they can be considered to offer any reasonable shear transfer to render themselves collectively as interlinked units outside that of individual bricks which lack structural integrity as is required by walls themselves to transfer such shear loads to adjacent structural mechanisms often in the form of columns.

F 1.0 Historic entries for newer ducts have caused major structural damage which has tried to be fix with insut concrete but the bricks at the interface are crumbling.

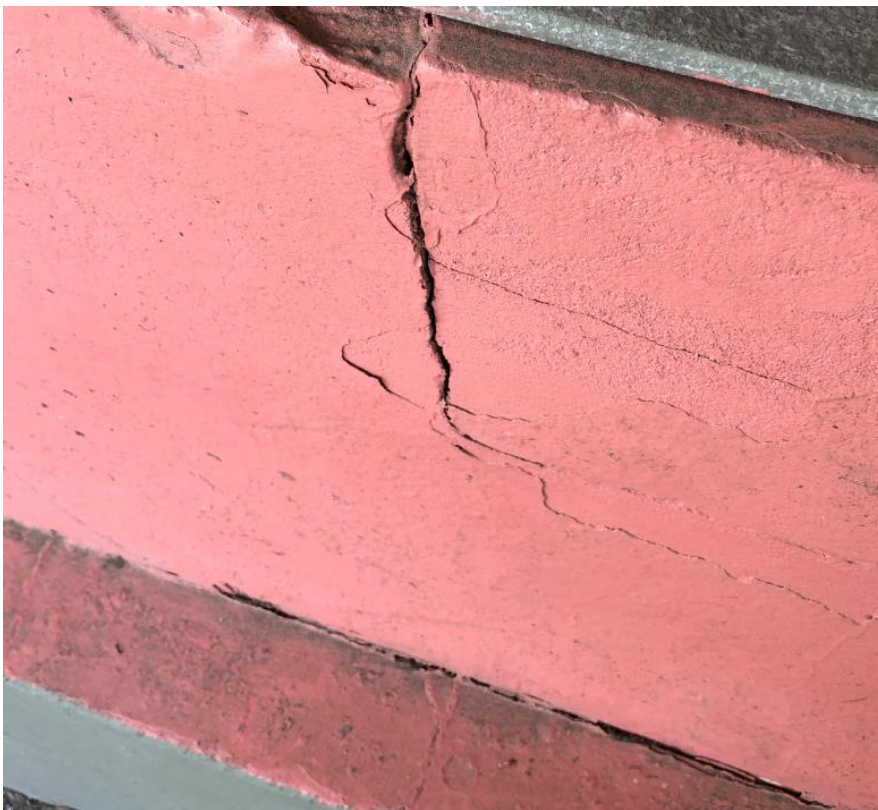
F 2.0 Major cracks in unrienforced foundation beams make it difficult to consider any strengthening solution as load paths to the ground have been compromised.

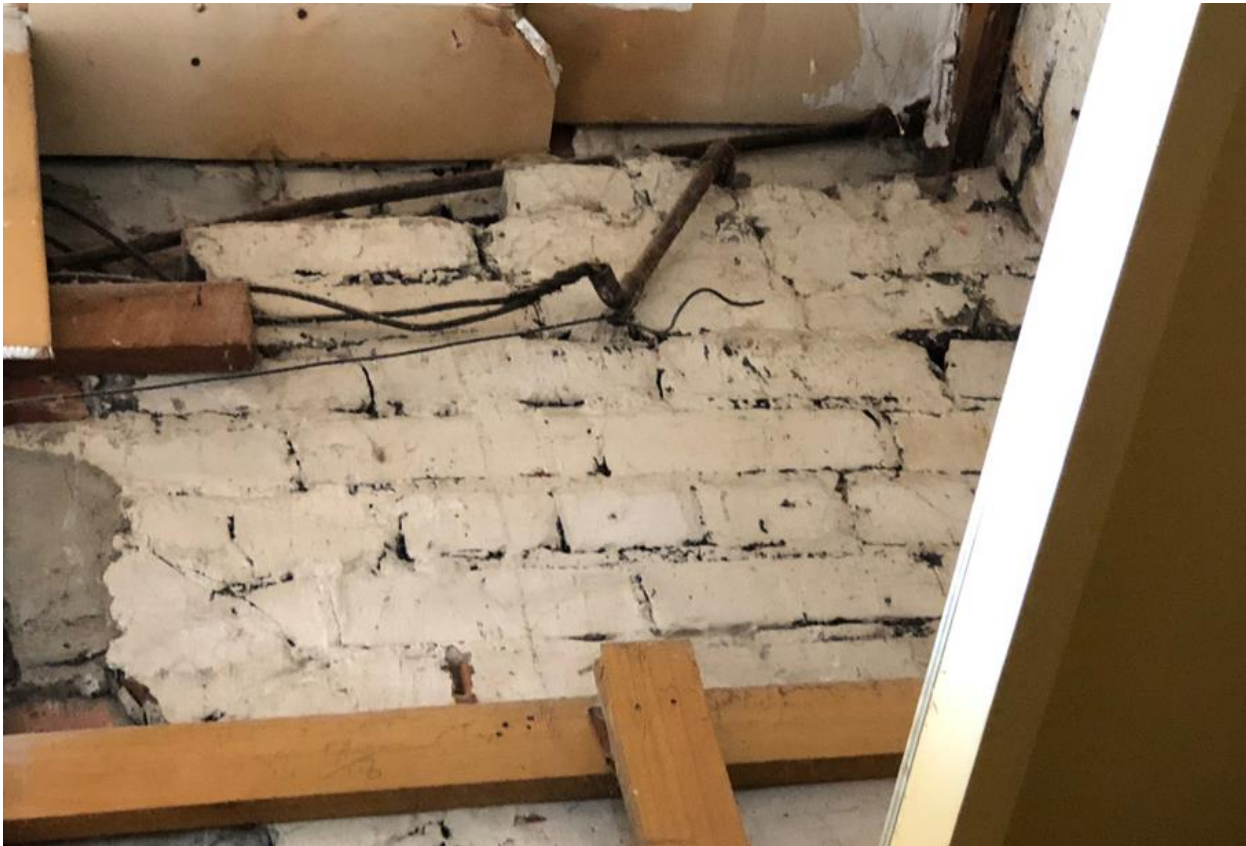
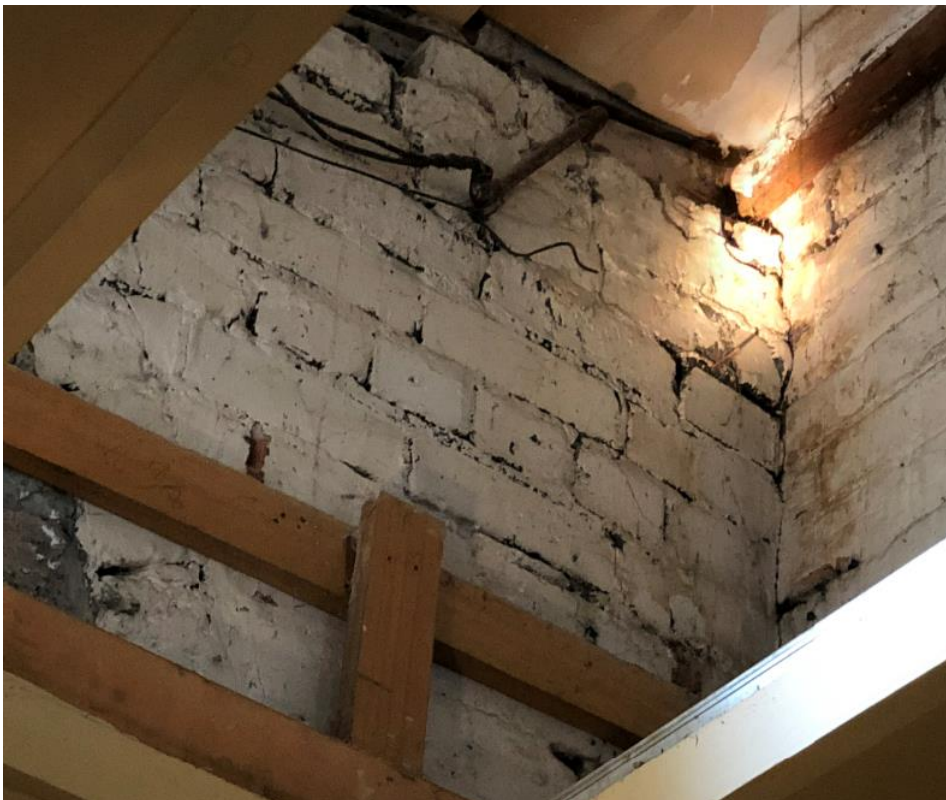
F 3.0; This is the North wall adjacent to the ICC building, where the outer wall is believed to be a common wall with the neighbouring building, one can see where the new front shear wall in bricks has been simply butted up to the older wall with not inter linking of the course in adjacent brick placements. The upper photo shows concrete and rubble placement and the lower F4.0 shows the side butting of bricks.

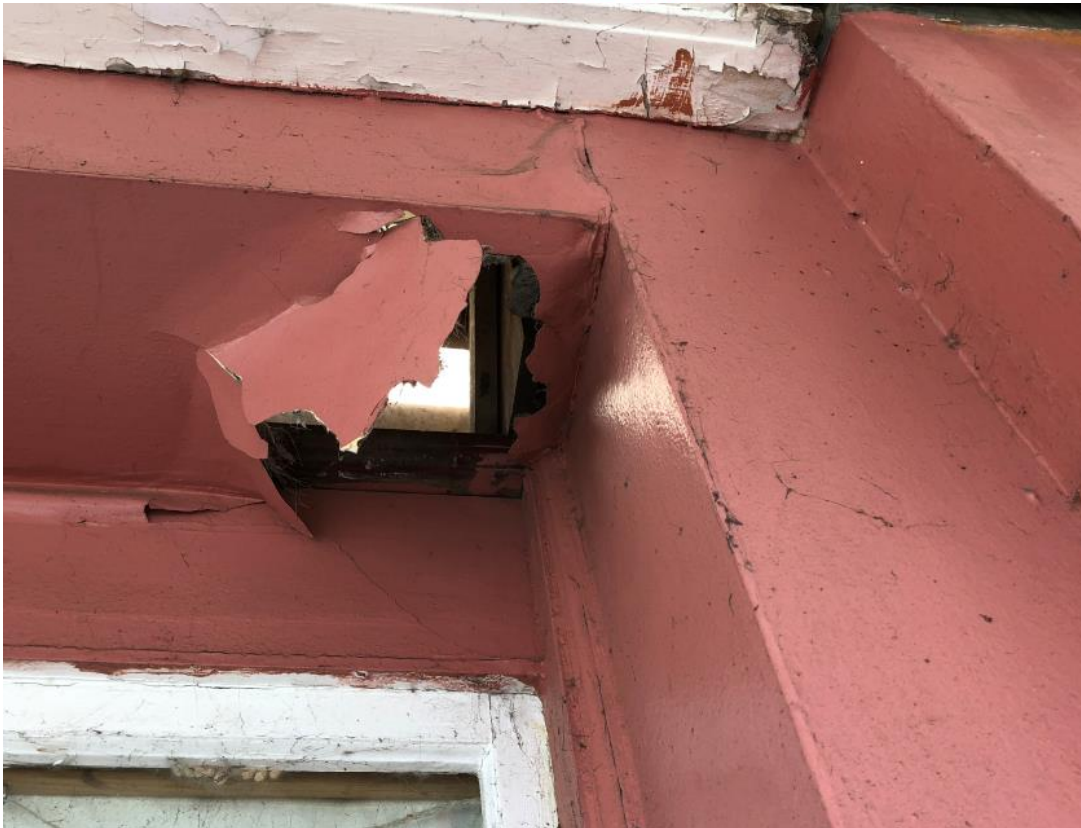
F 5.0; You see the use of timber open lintels above the lower windows which is most unusual as this offers not lateral load lines between adjacent column window breasts.

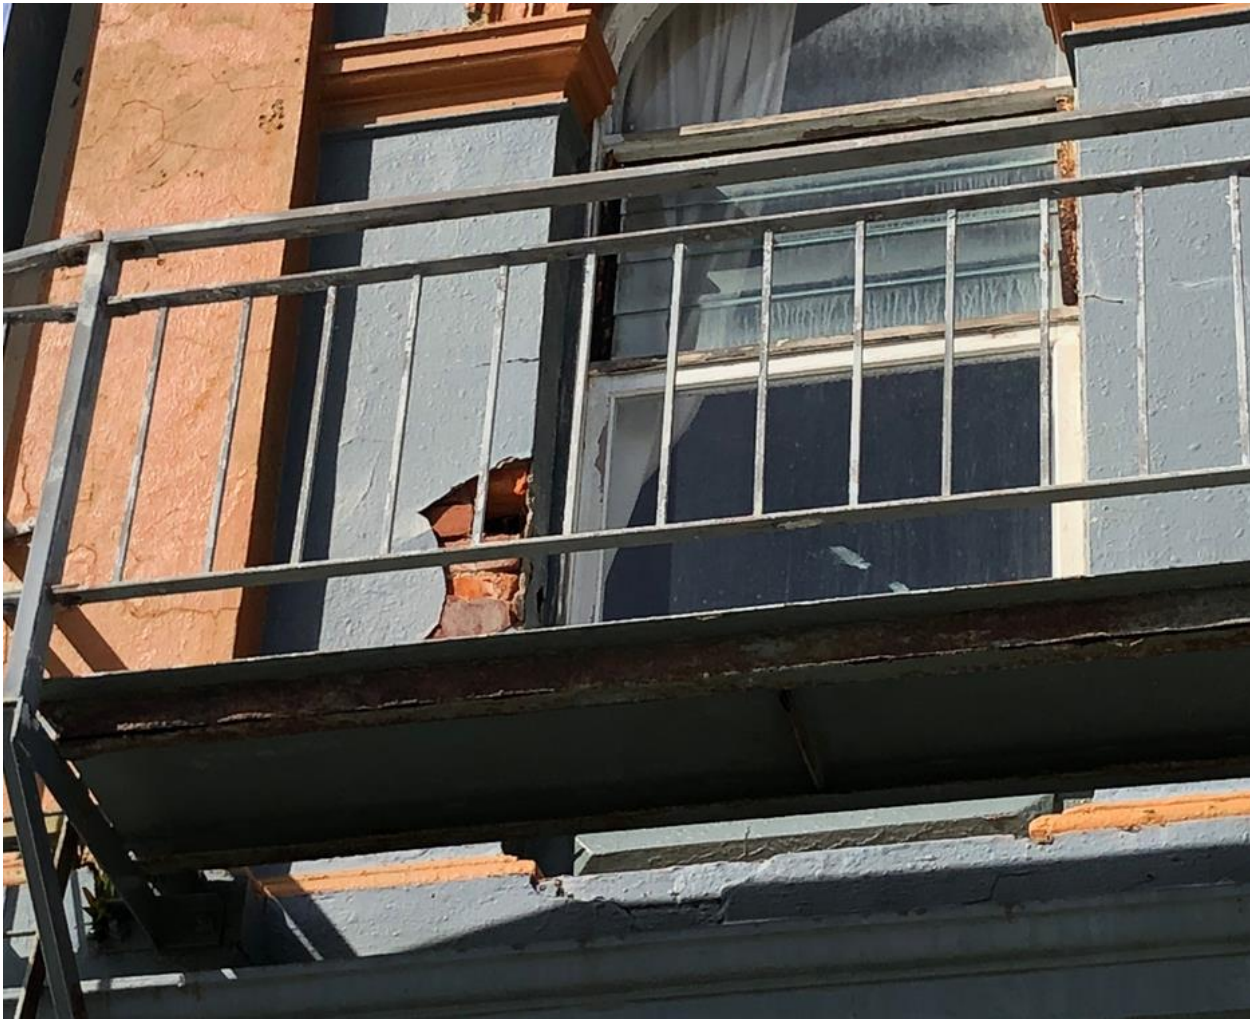
It is common to strengthen brick walls with the use of structural plaster/render systems with membranes reinforcement using adhesive plaster to the rear brick wall facings to interlink the outer bricks to form a new composite brick shear wall, but the bricks have failed past the point where their make-up can offer adequate shear strength and their stiffness has been compromised so they crumble across the whole front façade. (see photos Fig 6.0).

Fig 6.0; see the weathered bricks adjacent to the upper windows, there is no strength left in these bricks, the crumbling of plasters are significant with bricks being dislodged with weathering and damage which precludes these walls from any structural maintenance or refitting of new bricks as the bricks themselves have lost their inherent strength and no bond at all is left between any courses adjacent.

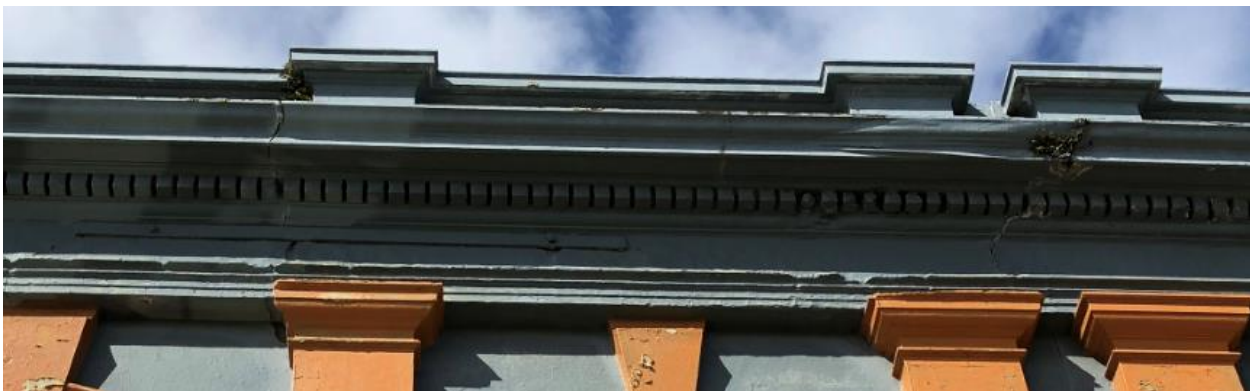
The costs to rebuild these building are very significant and outside any common use on a return basis. Regardless we must now consider if this portion of the building is not actually dangerous in itself as defined within the building act. We consider the cracks within the corbels and parts there of containing individual bricks shall fail all together and

fall off the building at some stage. (See the photos of the whole parapets Fig 7.0). We set out the definition in the act within the appendixes. This building could then fall within the Councils sole discretion as to its future and can act independently to issue any demolition or restoration permit accordingly.

F7.0; There are numerous complete shear cracks between the upper lintels / parapets to make them ready to topple off and go through the ground veranda to the pavement, wind could well move such large parapets and hence this supports the argument that the building is now dangerous.

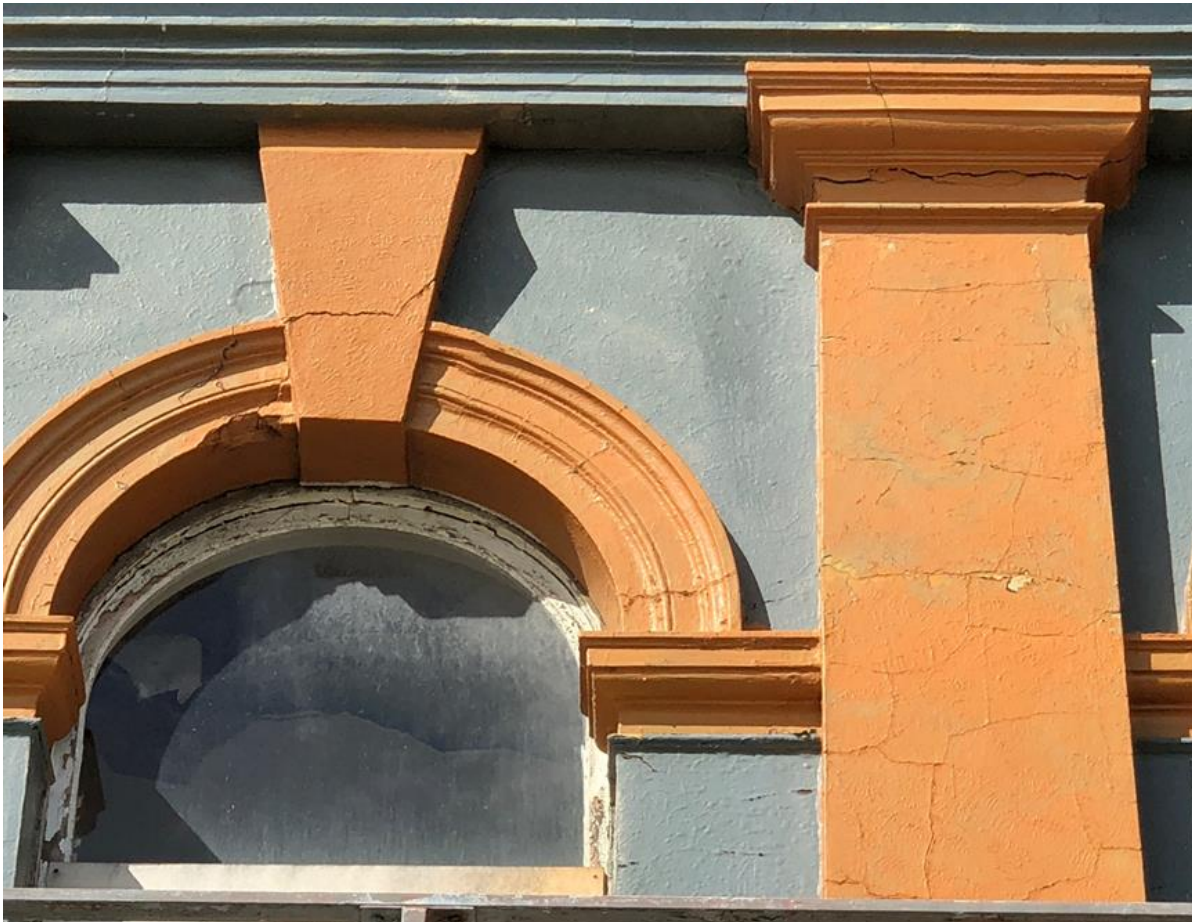
Fig 8; The cracking around the decorative corbels is not just through the plaster but such cracks go right through into the bricks placement which was poorly built from day one, the numerous cracking means large sections of these plastering features are able to come a drift with continual weathering over time and it is just typical of this whole front facade.

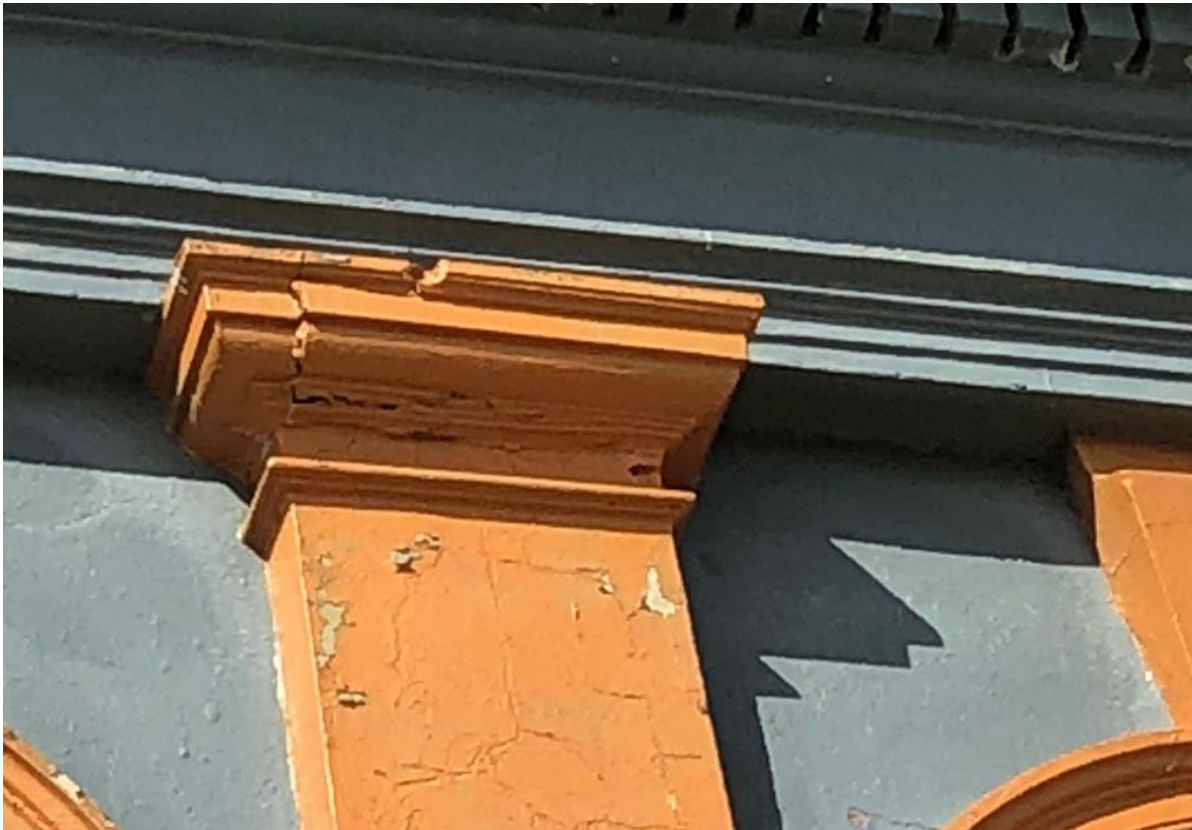
F 9; note the upper corbel cap how it has become dislodged over time, where weather has dislodged the bricks. The lower F 10.0; show the same problems but it whole cap could drop off at any stage.

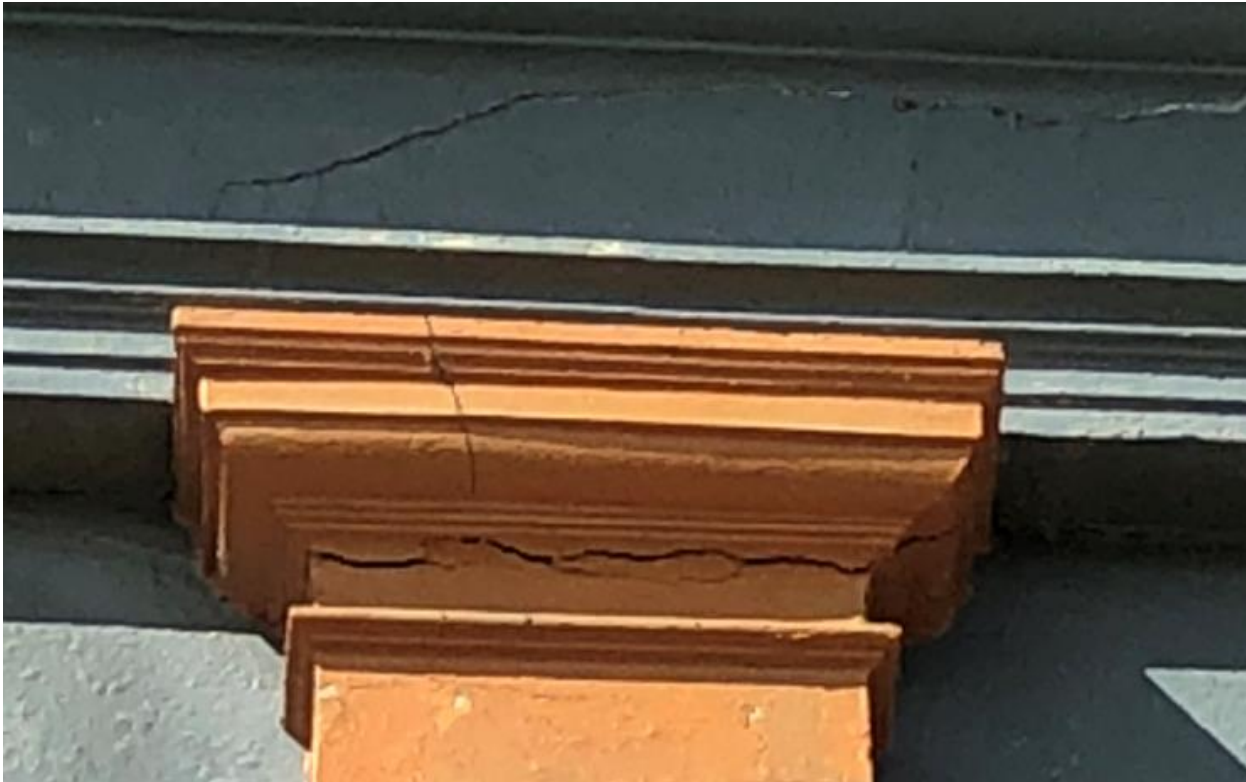
F10.0 Notice the cracking above the corbel as shown in the grey painted area, such cracks riddle the parapet all along the building, these cracks are not just surface deep they extend into the bricks internally.

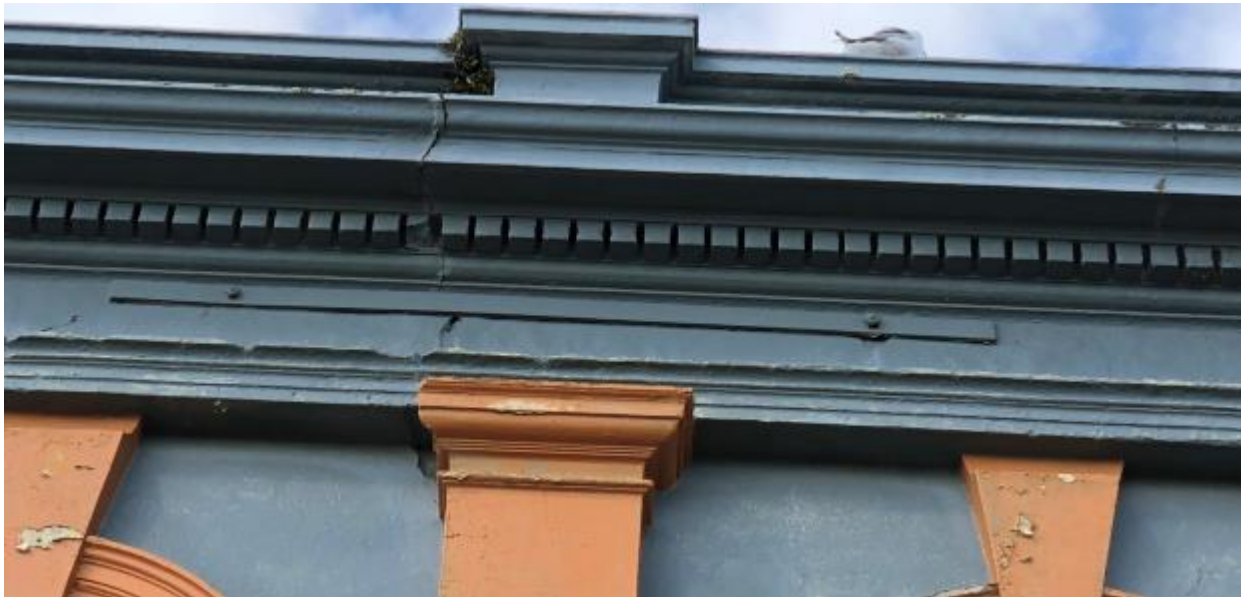
*Fig 11.0; See the vertical shear cracks where the steel bar has been placed to limit future cracking, but unfortunately this will do little to stop cracking continue to plague this whole parapet.*

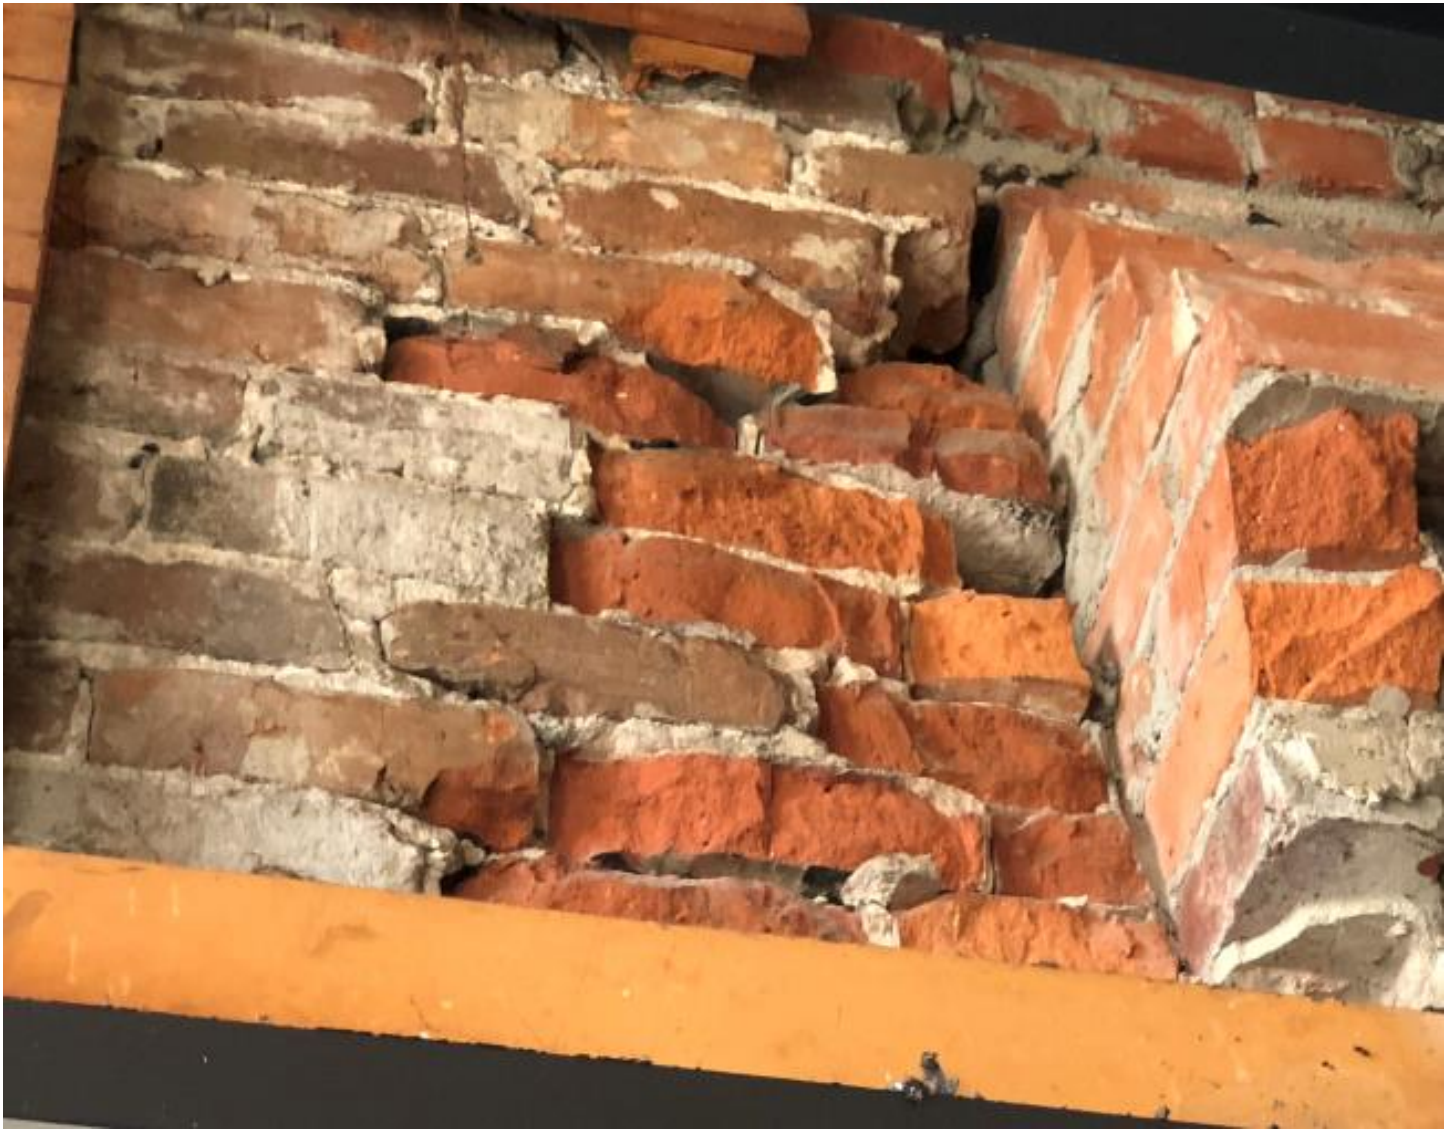
*F12; This chimney breast shows how the bricks are not interlocked into the opening and flue which is poorly detailed as there is no strength between these changes, the bricks are poorly cemented together and their quality is not far off rubble as can be seen in a few of them.*

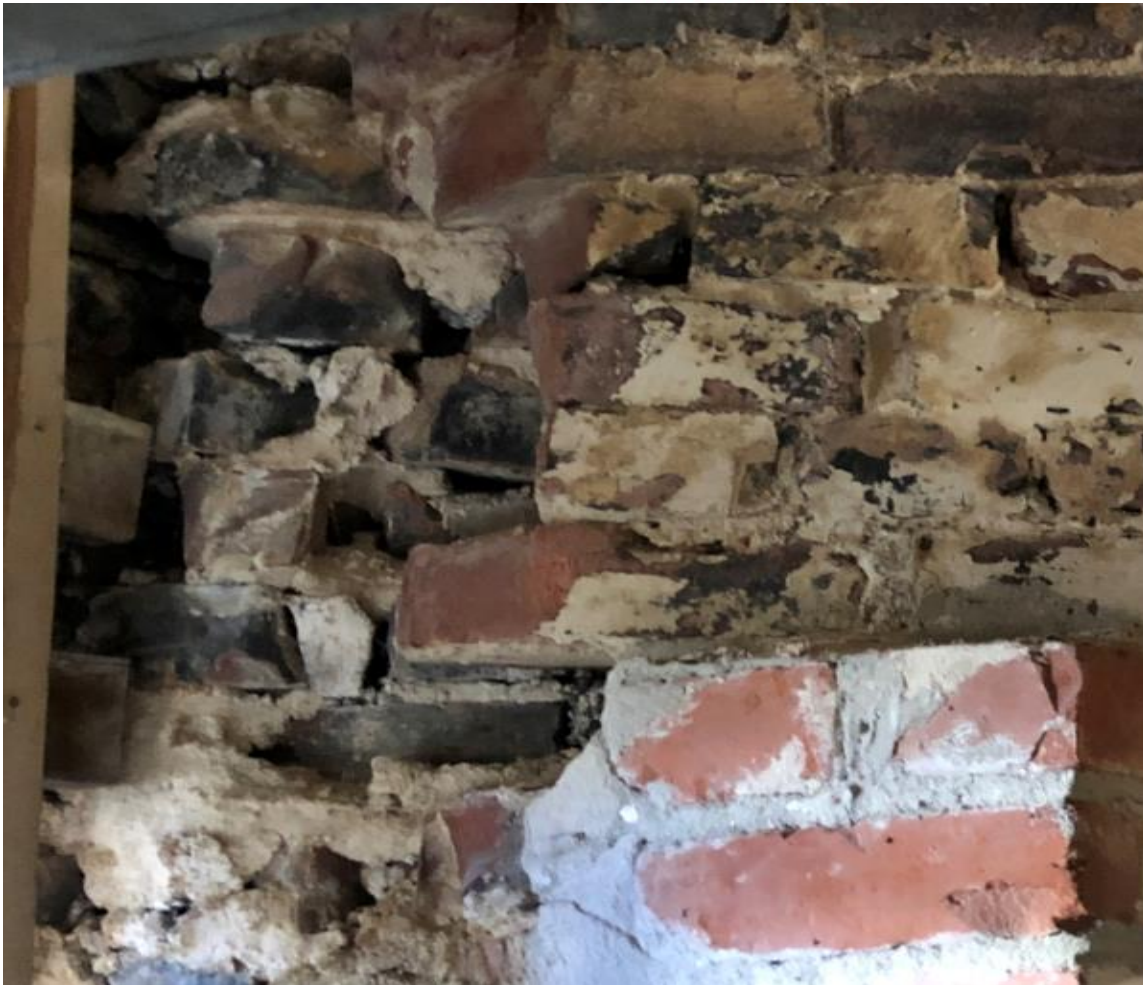
*F13; Rubble of bricks are shown with poor cemented interlacing to the front bricks, such situations in this building is common.*

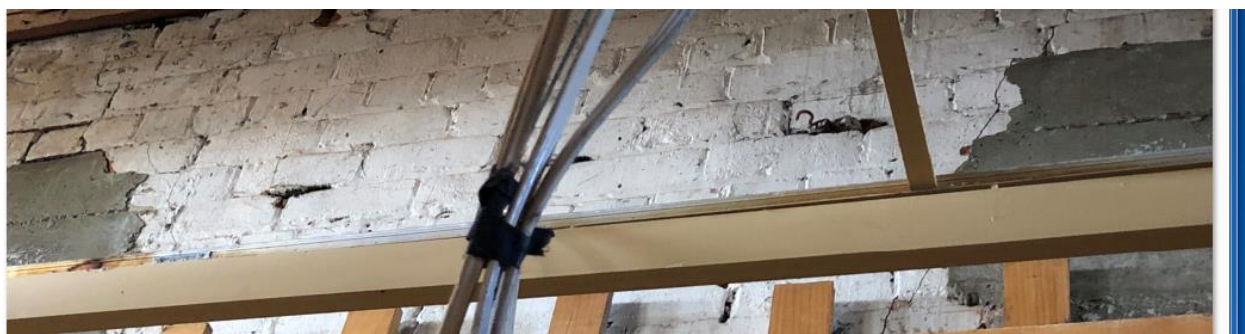
*F14; Note the concrete fix ups with the diagonal shear cracks radiating up from the vertical edges about the concrete. This whole wall has been undermined with its lower removal of the historic internal load bearing wall as can be seen off the original drawings in Fig 17.*

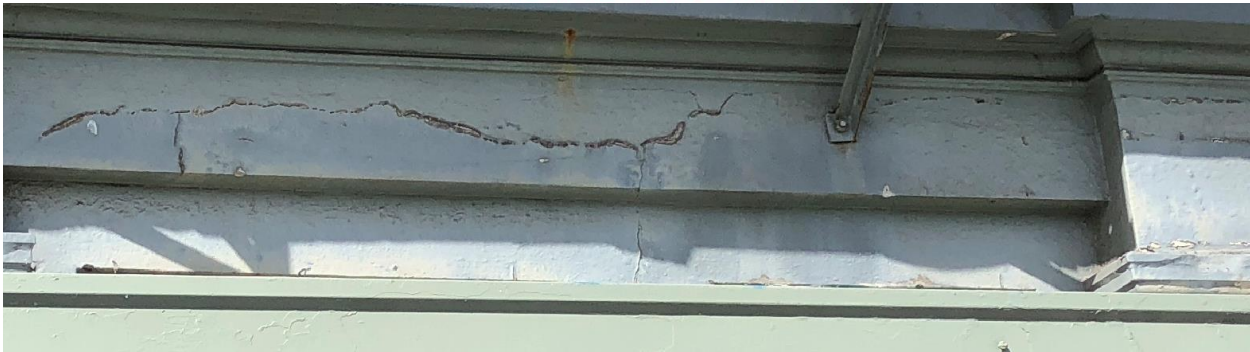
*F15; Note the horizontal cracking through the lintel*

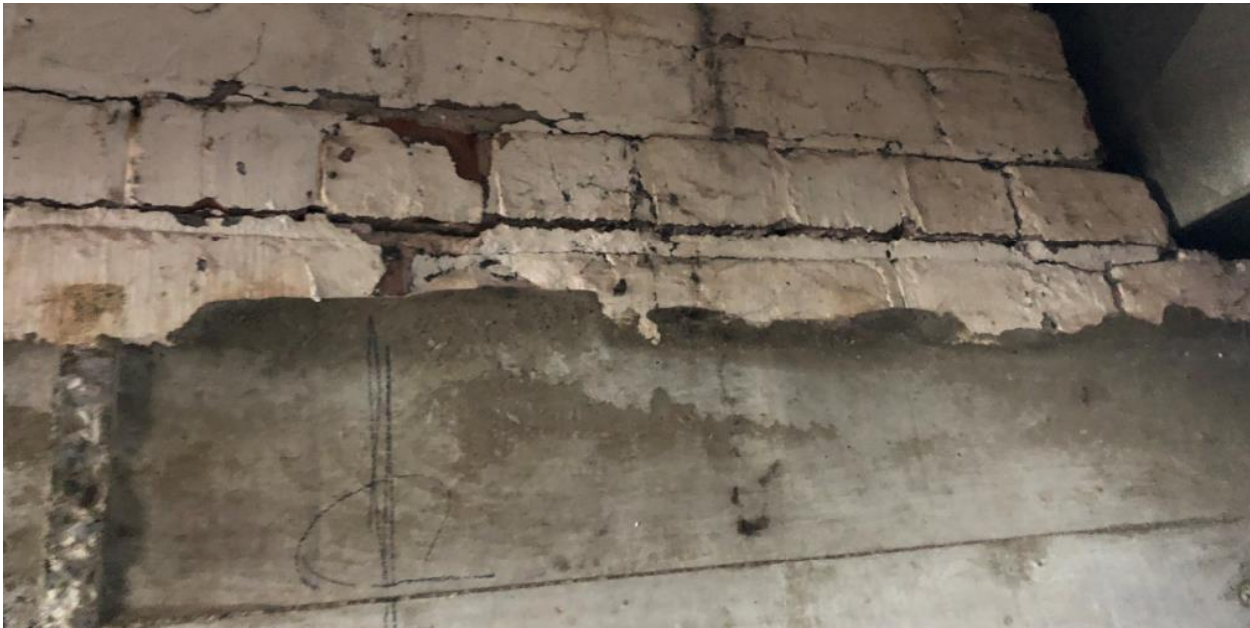
*F16; There exists horizontal cracking through the brick courses which results from poor failed mortar and no doubt historical EQ loads exceeding the strength of the in place brick shear walls, or these courses could well have dropped at the similar time the concrete section of the new base lintel was poured. These part concrete lintels as placed in sections through the lower floor will contribute to significant weakening of the whole building.*

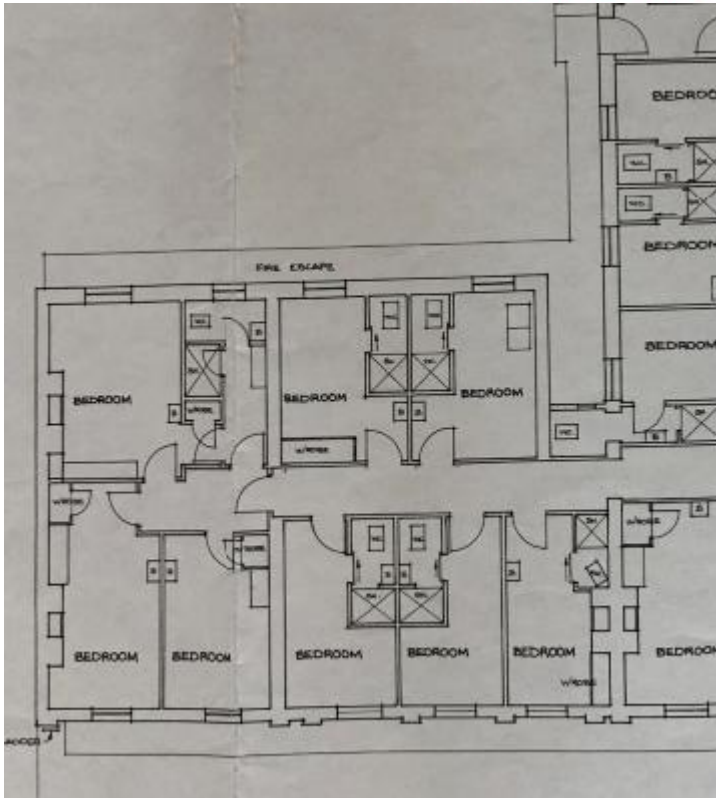
F17; facing North onto the SHW -Gore Street.

The main internal load bearing wall have been removed and in its place are poorly detailed lintels that have cracks and well simply fall over in any EQ.
