Invercargill Central Redevelopment

Addendum to Woods, Cropper, Mearns, Mitchell,
McStay and Cawte 2018. Heritage Impact Assessment of
Block II, Town of Invercargill

Report Prepared for Bonisch Consultants
Author: Dr Naomi Woods and Dr Dawn Cropper
Reviewed by: Dr Hayden Cawte
Submitted: January 2019

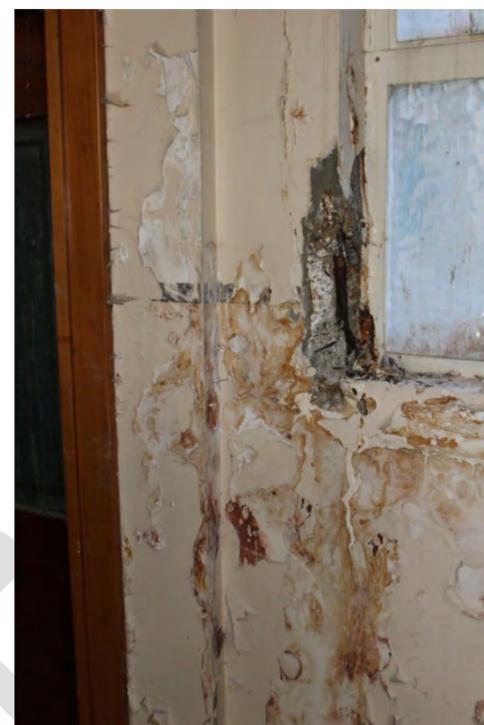
Figure 17 - Spalling concrete adjacent to window in light well area.

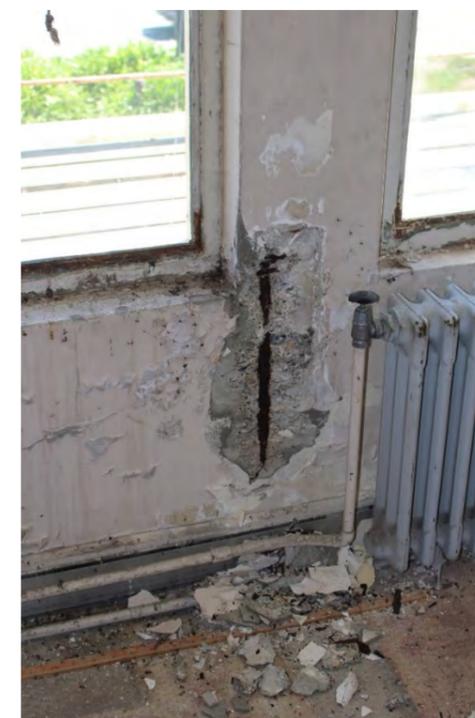
Figure 18 - Spalling to window mullion on West wall

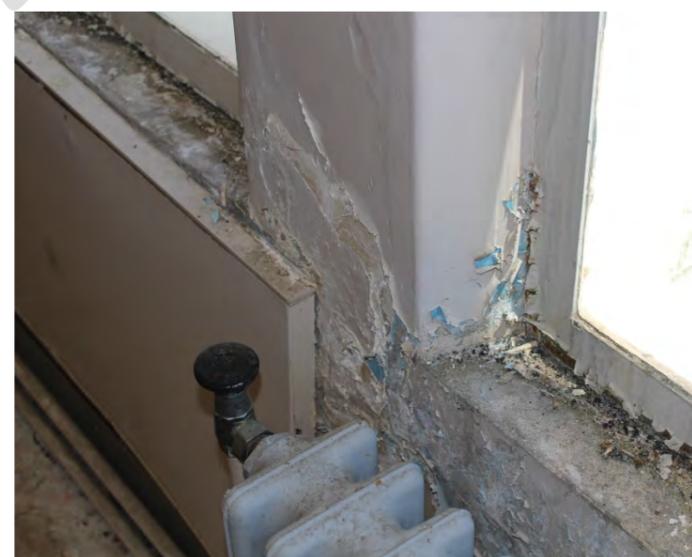
Figure 19 - Severe spalling to window mullion on West wall

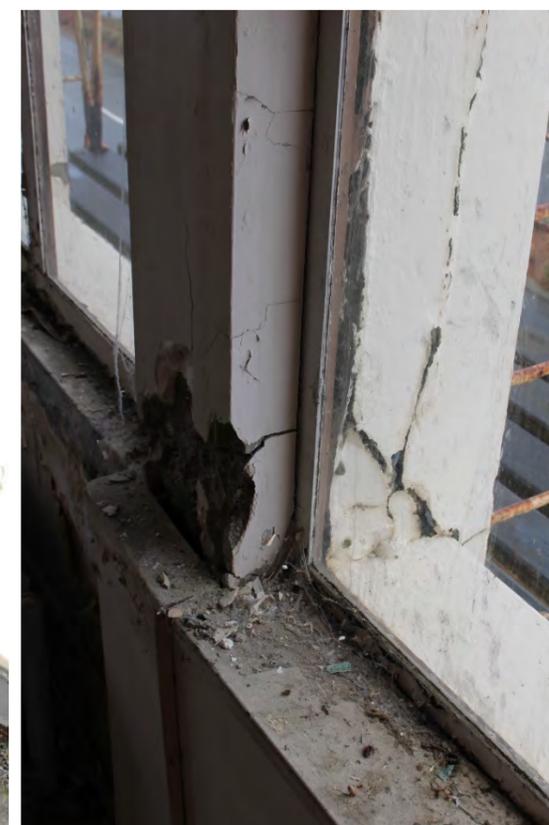
Figure 20 - Cracking extends all the way through the window mullion

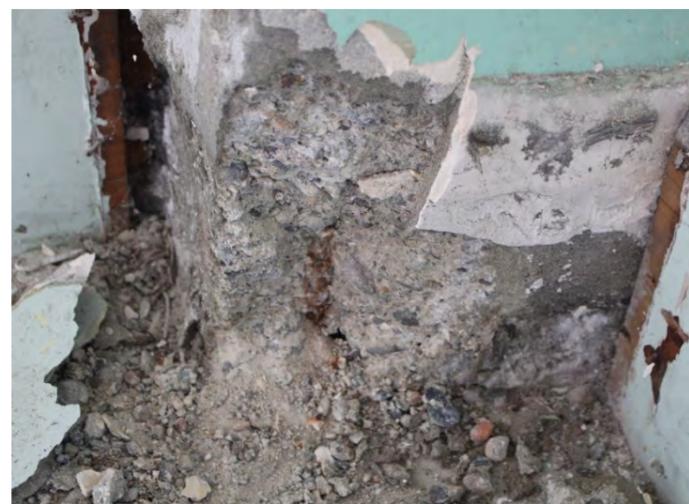
Figure 23 - Crack extends back to main column reinforcing which is rusting

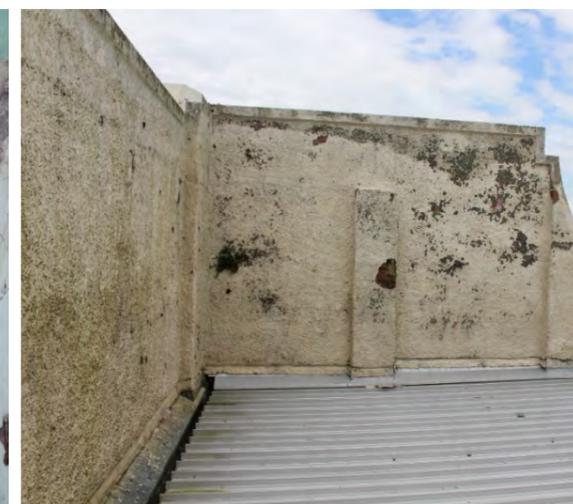
Figure 24 - East parapet wall showing brick below plaster surface

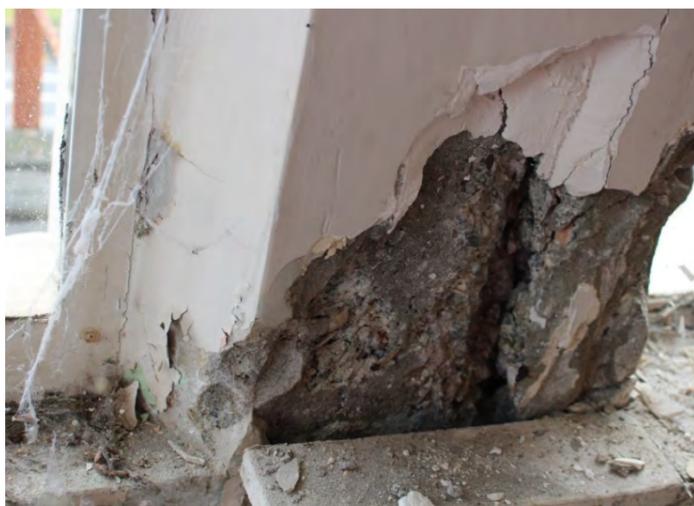
Figure 21 - Close up photo of severe cracking to mullion

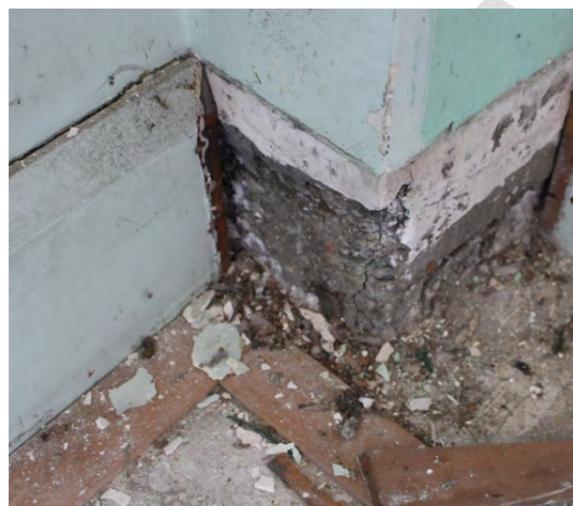
Figure 22 - SW corner column showing cracking to least exposed corner of the column

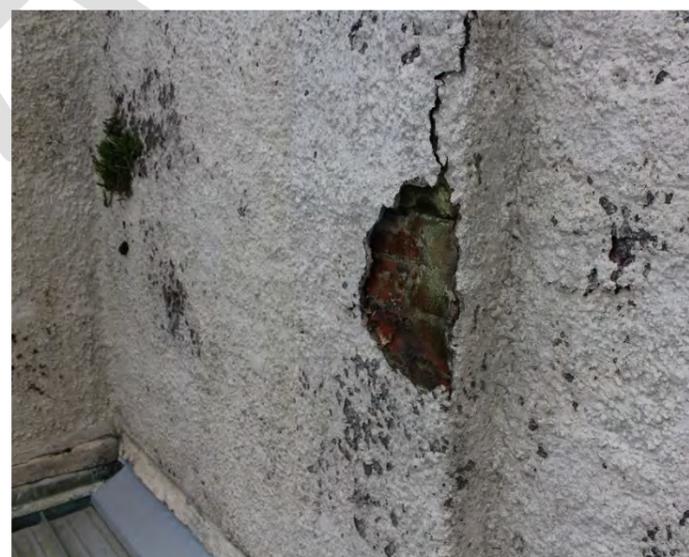
Figure 25 - Spalling plaster over brick substrate

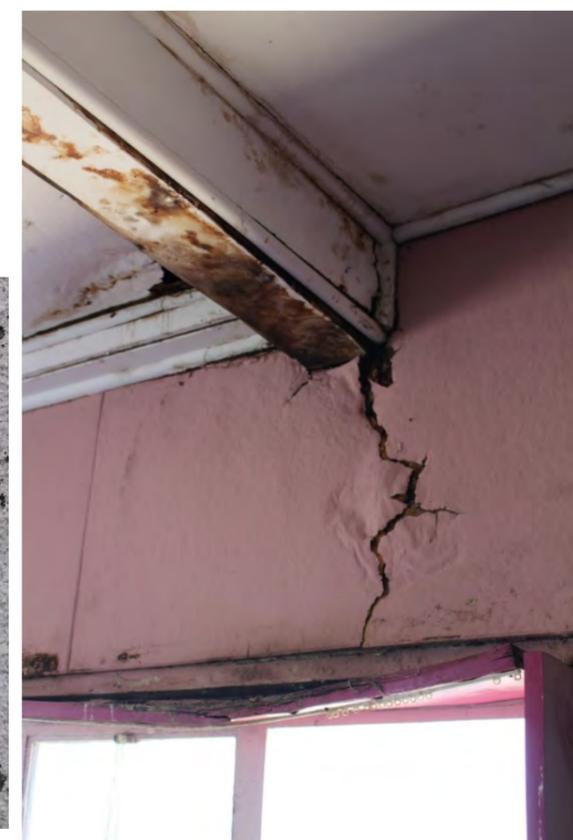
The roof is leaking in a number of areas, leading to degradation of the structure as shown in Figure 26.

Figure 26 - Roof leaks causing structural damage to beam support.

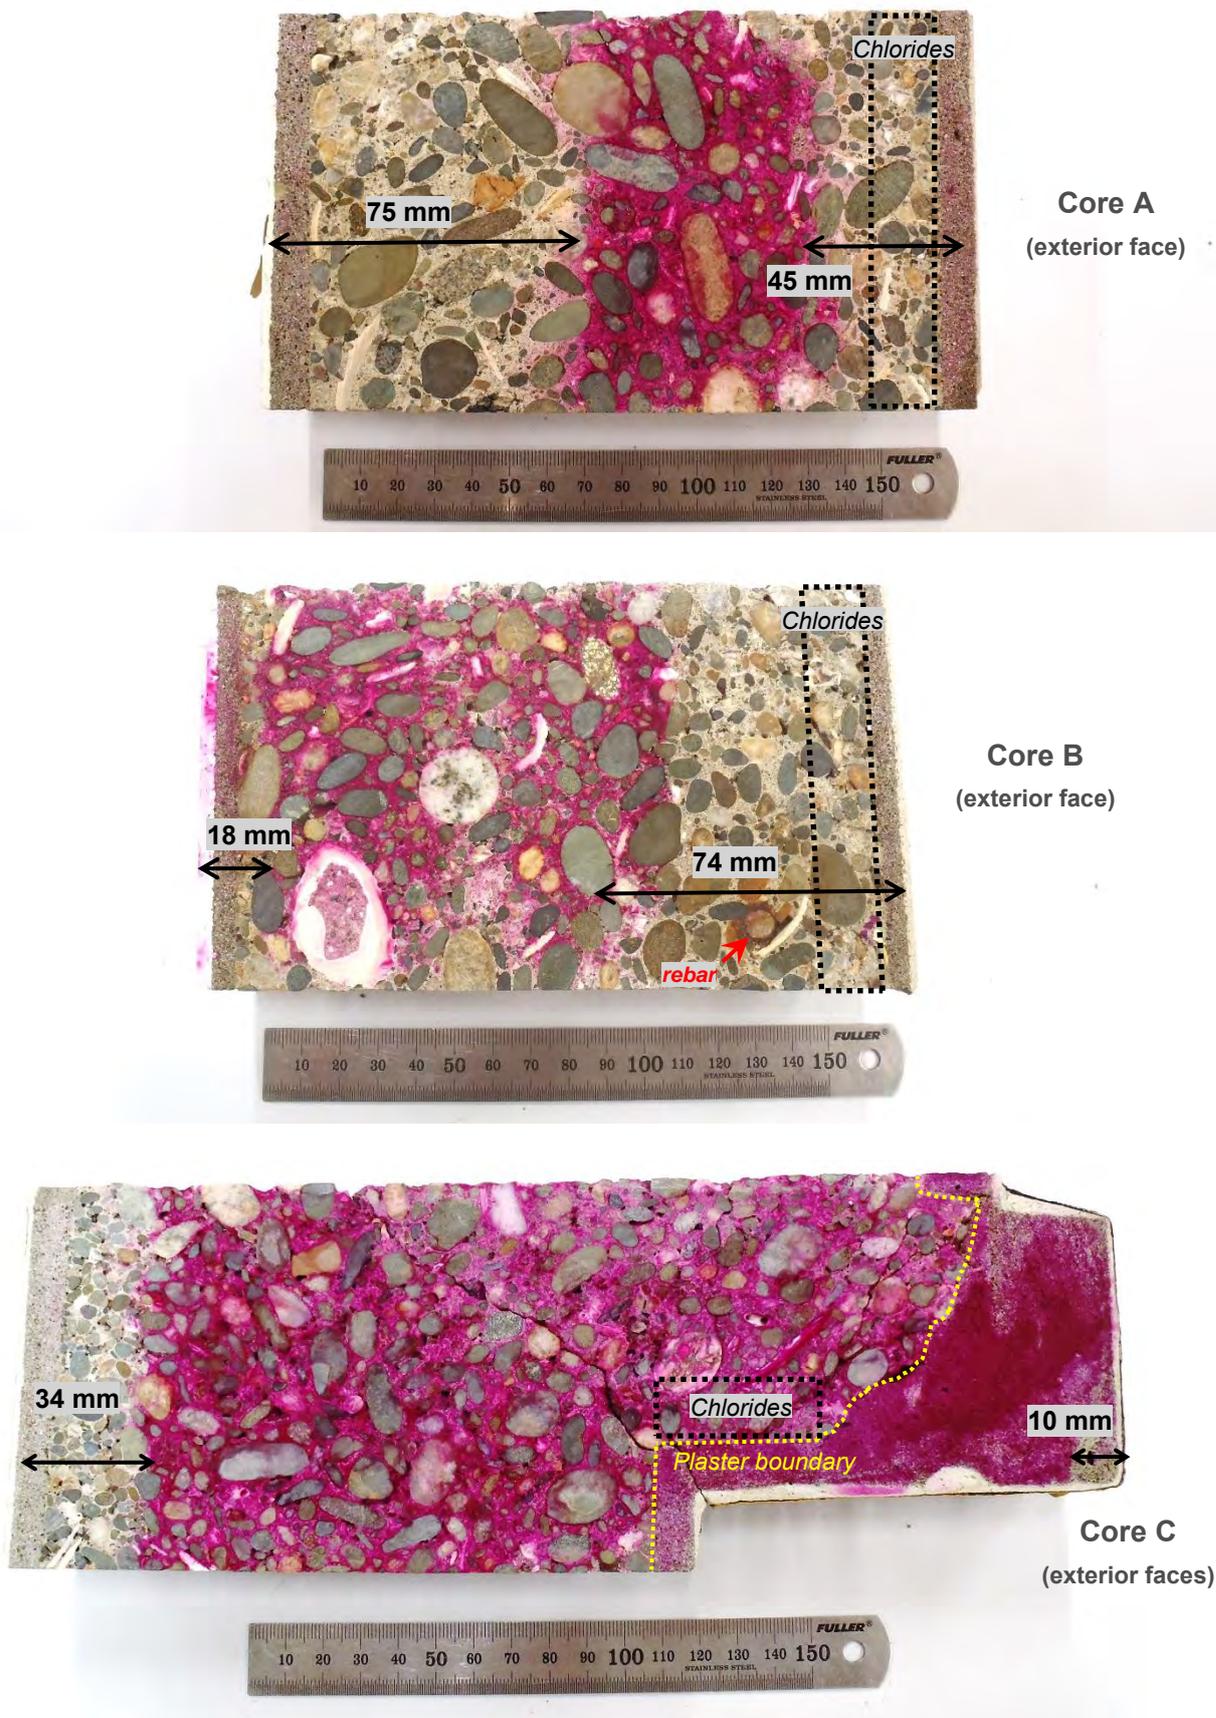
- Variable carbonation through the cores (Figure 1), which likely reflects differences in the quality of consolidation and local internal relative humidity due to micro-exposure environment. The maximum carbonation depths likely exceed typical cover depths, indicating depassivation of at least some fraction of the reinforcing steel and hence a current vulnerability to corrosion.

Figure 1. Longitudinal slices through the cores, photographed following application of the phenolphthalein reagent. The arrowed lines indicate the approximate maximum carbonation depth from each exposed end of the core. The approximate position from which the chloride sample was removed from the matching longitudinal slice is also indicated.

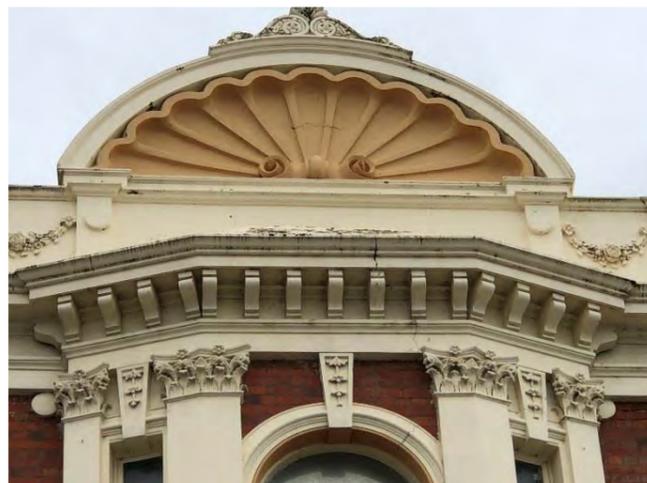
Figure 21 – North Elevation Façade exhibit cracks to the cornice and parapet cladding.

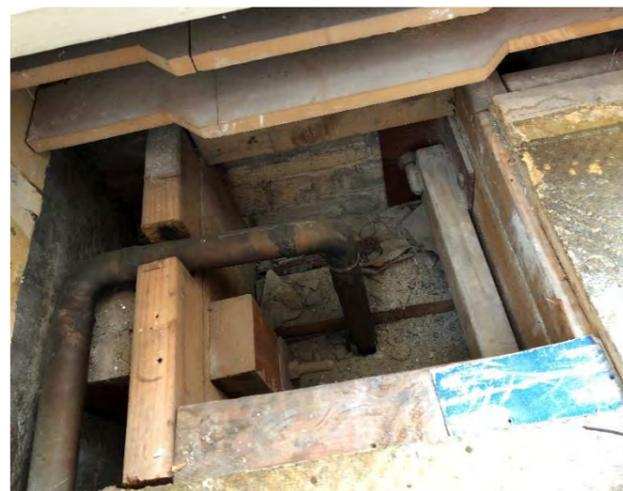
Figure 22 – North and East Elevation ties into floor diaphragm at first floor. Façade tie local to trimming joist only, minimal transfer path. East elevation fixings every second joist
