Project Number: 6-DP444.00

# Anderson House Seismic Strengthening Investigations

14 July 2020

## Summary Report

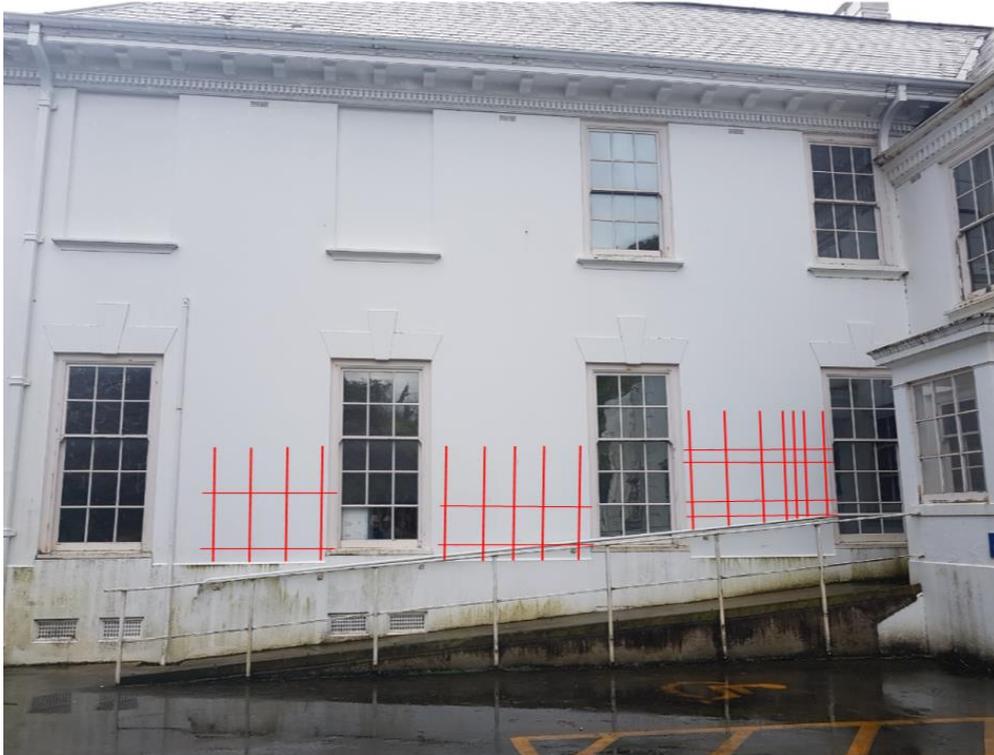
- 1 The condition of the concrete work appears to be very good, compared to other structures built during this time. It was found that there is reinforcement in the concrete which is unusual for a concrete structure of this age. Figure 1 below highlights the location of reinforcement (in red) which was identified along the back wall during the inspection.

Figure 1: Approximate steel reinforcing in concrete veneer which was identified during the site inspection

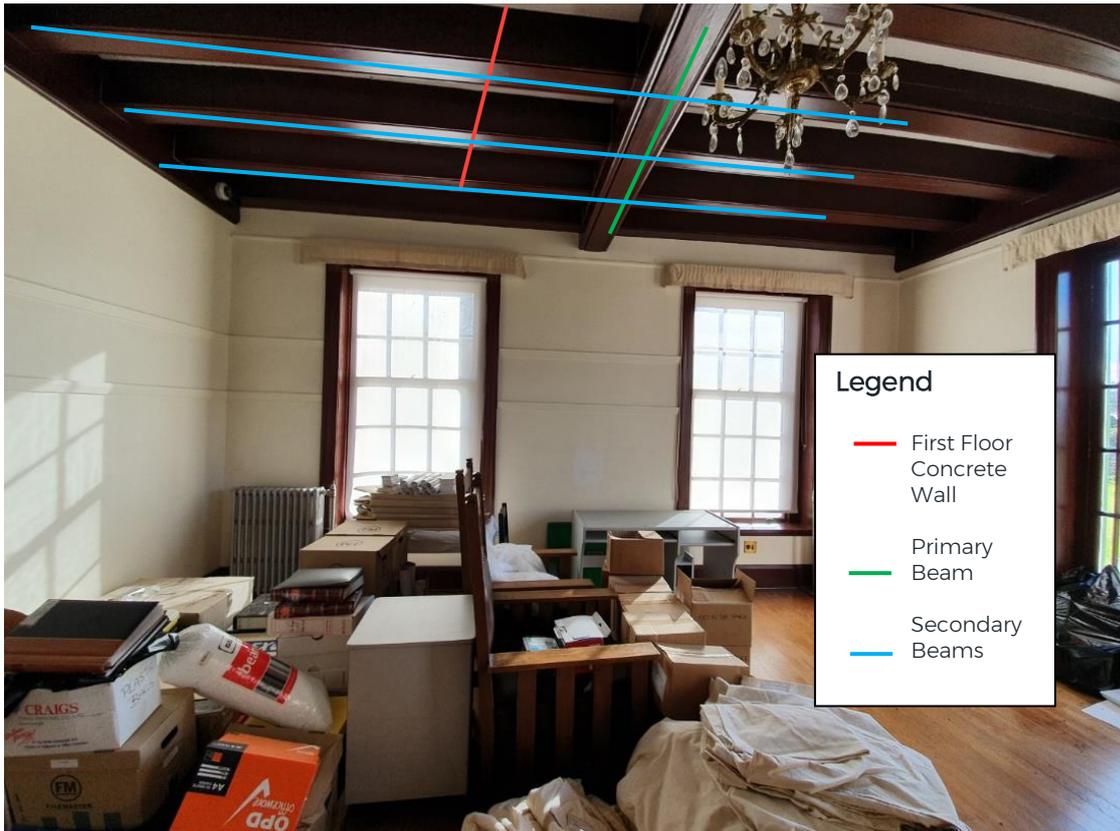
The wall between the family room and the Guest room at first floor level is made of concrete. There is no wall or beam directly underneath. It has been cast on top of the tongue and groove flooring which is supported on timber floor joists. The ceiling under this floor is quite ornate with an expressed primary and secondary beam grid system that support the floor joists. An illustration of the location of the transverse concrete wall with reference to the primary and secondary beams is presented in Figure 2

The critical member in the flooring system is the secondary beams. The walls impose a large self-weight (dead load) on the timber flooring which exceeds the calculated capacity of the secondary beams. Further to this, in an earthquake, the walls impose an additional seismic reaction on the secondary beams which could require secondary mechanisms to form to support the wall. The imposed loading on the floor has resulted in a deflection of 15 mm, measured adjacently to one wall, over the course of the buildings design life.

Figure 2: Location of First Floor Concrete Wall Shown from Ground Floor

Strengthening the floor system would require installing new steel beams which will have significant impact on the heritage fabric. The preferred structural solution is to remove the concrete dividing walls and reinstate with a lightweight timber option finished to match the existing. This would significantly reduce the demand on the floor system and allow the floor to be used for general purposes. We consider that this is the easiest and most economical solution to improve the performance of the floor system.

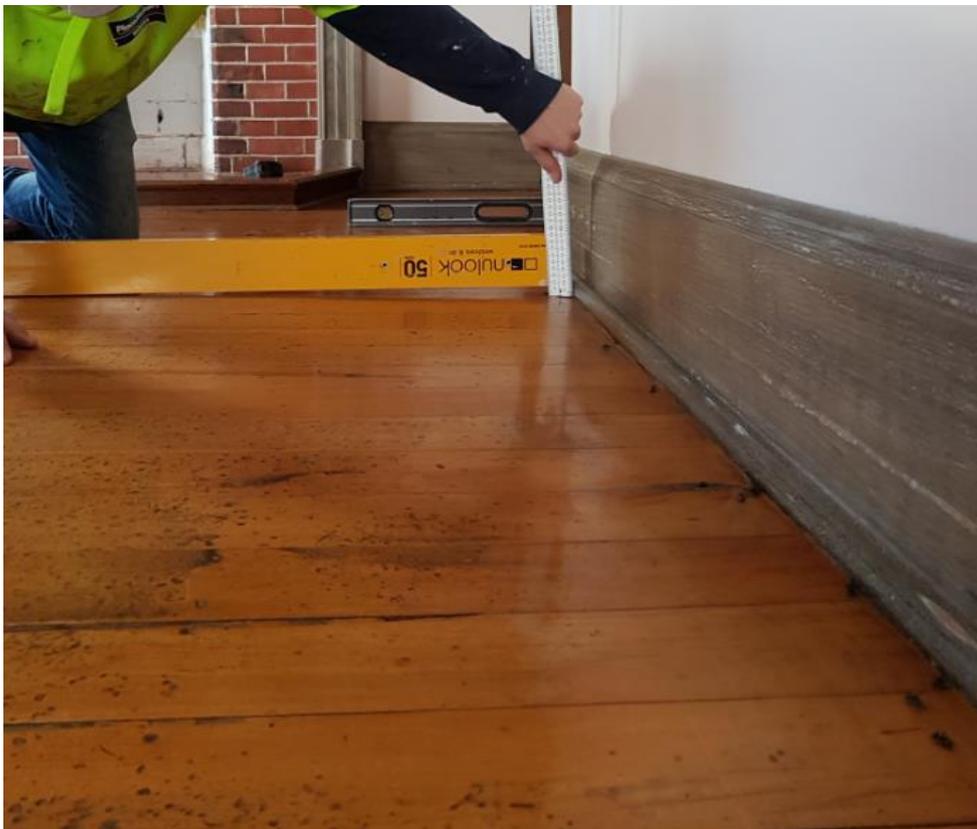
Some levels were taken on the floor in the vicinity of the concrete wall. There is a pronounced displacement of about 15mm. This is depicted Figure 3. Calculations confirm that this displacement would be expected due to the load from the concrete wall.

Figure 3: Displacement of Flooring Adjacent to Concrete Wall, Second Storey

An assessment of one concrete wall on the timber flooring was completed to confirm that it was limiting the overall new build standard percentage (%NBS) for the building. Table 1 shows the relative NBS percentages for seismic and gravity loading scenarios and indicates that the flooring system has an overall limit of 57% NBS (IL2). The measured deflection of 15 mm is expected from the behaviour of timber floors. This deflection is in line with the relative calculated deflection of 19 mm, although, both deflections are significantly over the allowable limit of 10 mm as stated in the New Zealand loadings standard (AS/NZS 1170.1:2004).

The secondary beams are overloaded in the current condition for basic gravity loading and are not capable of resisting the minimum usable live load requirements stated in the New Zealand Building Code.

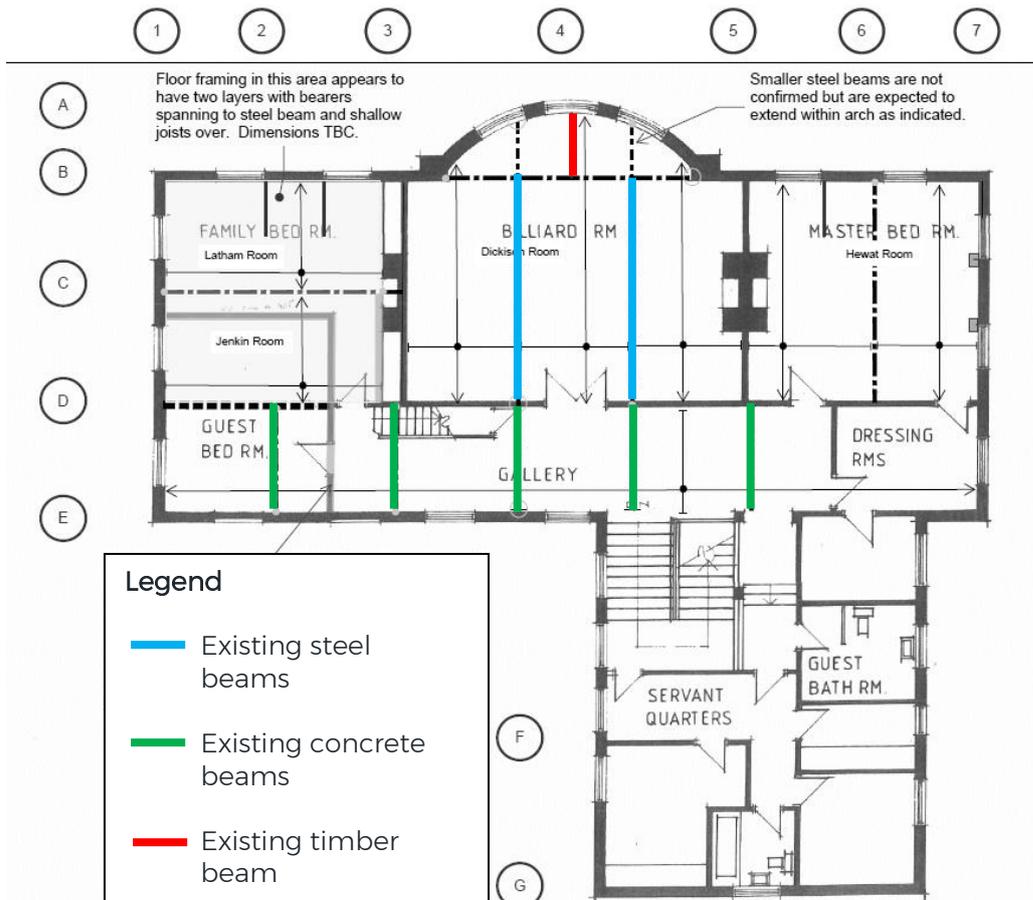
Figure 4: First floor plan of Anderson House with floor beams highlighted

There are a range of floor support beams which are visible from ground floor level, however most of them appear to be boxed in. The revised 67% NBS (IL2) strengthening scheme which was issued in 2019 before the current 2020 site investigations were based on the assumption that these beams were boxed in steel sections. The strengthening plans previously recommended have been updated to match the findings in the 2020 investigations. The first area of change is the floor beams located in the Billiard Room, which are highlighted in solid blue lines in Figure 4 below.

The investigations have shown that the steel beams in the Billiard Room are cast through the Gallery wall and protrude on the Gallery side of the wall. The beams appear to be well bonded to the wall and are considered to have sufficient pull out capacity to not require any additional strengthening.

The tie beams across the Gallery are confirmed to be reinforced concrete sections. There is no evidence of cracking at the interface with the Gallery walls which indicates that they are reinforced with ties extending into the concrete walls on each side. These are considered acceptable to transfer the external wall demands into the building without further strengthening.

There is an existing timber floor beam in the middle of the Bay Window area highlighted in red in Figure 4 which was previously unconfirmed. It was expected that there were steel beams in this area extending from the end of the highlighted blue beams. The existing timber beam requires strengthening of the end connections to ensure adequate capacity to achieve 67% NBS (IL2).

In addition, due to the existing beam being in the centre of the curve, further strengthening of the external wall on each side is required to reduce the span of the external wall. This will use the same methodology proposed for other areas with additional ties and timber blocking within the floor void.

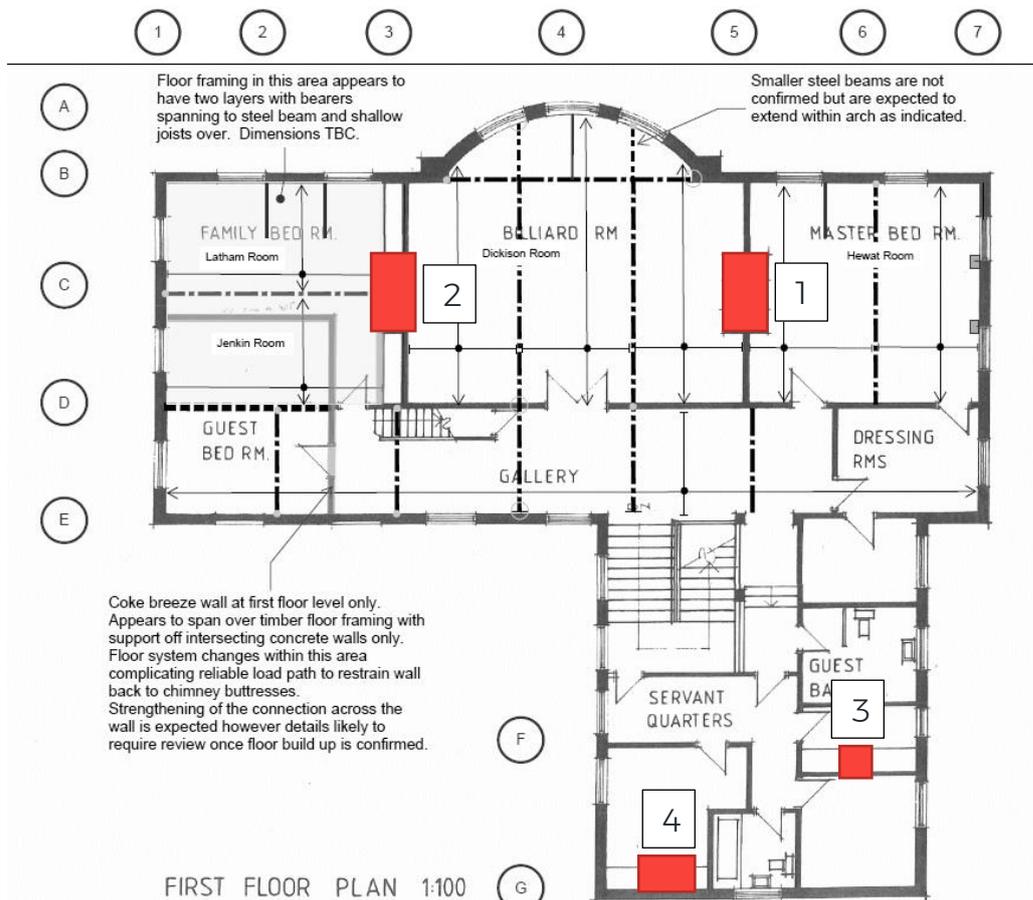
Figure 5: Plan Layout of Anderson House with Floor Beams Highlighted

There are currently four large brick chimneys around the building as highlighted in Figure 5 below. Two of these are located in the main wing and appear to be similar in terms of size and arrangement (1 and 2 in figure). The others are in the rear wing with one large chimney against the back wall, and the other small and slender chimney on the side of the rear wing (3 and 4 in figure).

Chimneys 1 and 2 in the main wing were found to be structurally sound below first floor ceiling level and are well tied into the adjacent timber framing. Above ceiling level, the large mass of the bricks are not as well restrained and pose a fall hazard. Should either of these chimneys collapse in a seismic event, they would cause significant damage to the heritage fabric of the building in addition to the life safety risk associated with falling bricks.

Chimney 3 and Chimney 4 are located away from the apex of the roof nearer to the external walls while extending to the same height as Chimneys 1 and 2. This means that they both extend much further beyond the roof line and have effectively no restraint above first floor ceiling level.

It is recommended that both Chimney 1 in the master bedroom and Chimney 2 in the family bedroom, be demolished down to first floor ceiling level and be replaced with a lightweight timber framed structure with lightweight plaster façade cladding. The timber structure is a cost-effective method to reduce the mass, while providing a plaster cladding system allows it to be shaped to maintain the heritage appearance and architectural aesthetic of the building.

It is recommended that chimneys 3 and 4 should be demolished down to first floor ceiling and not replaced. Due to the geometry of these chimneys a steel frame extending from at least first floor level would be required to reinstate them. This is achievable however we query whether the additional cost is warranted. We do not consider that these chimneys have the same heritage

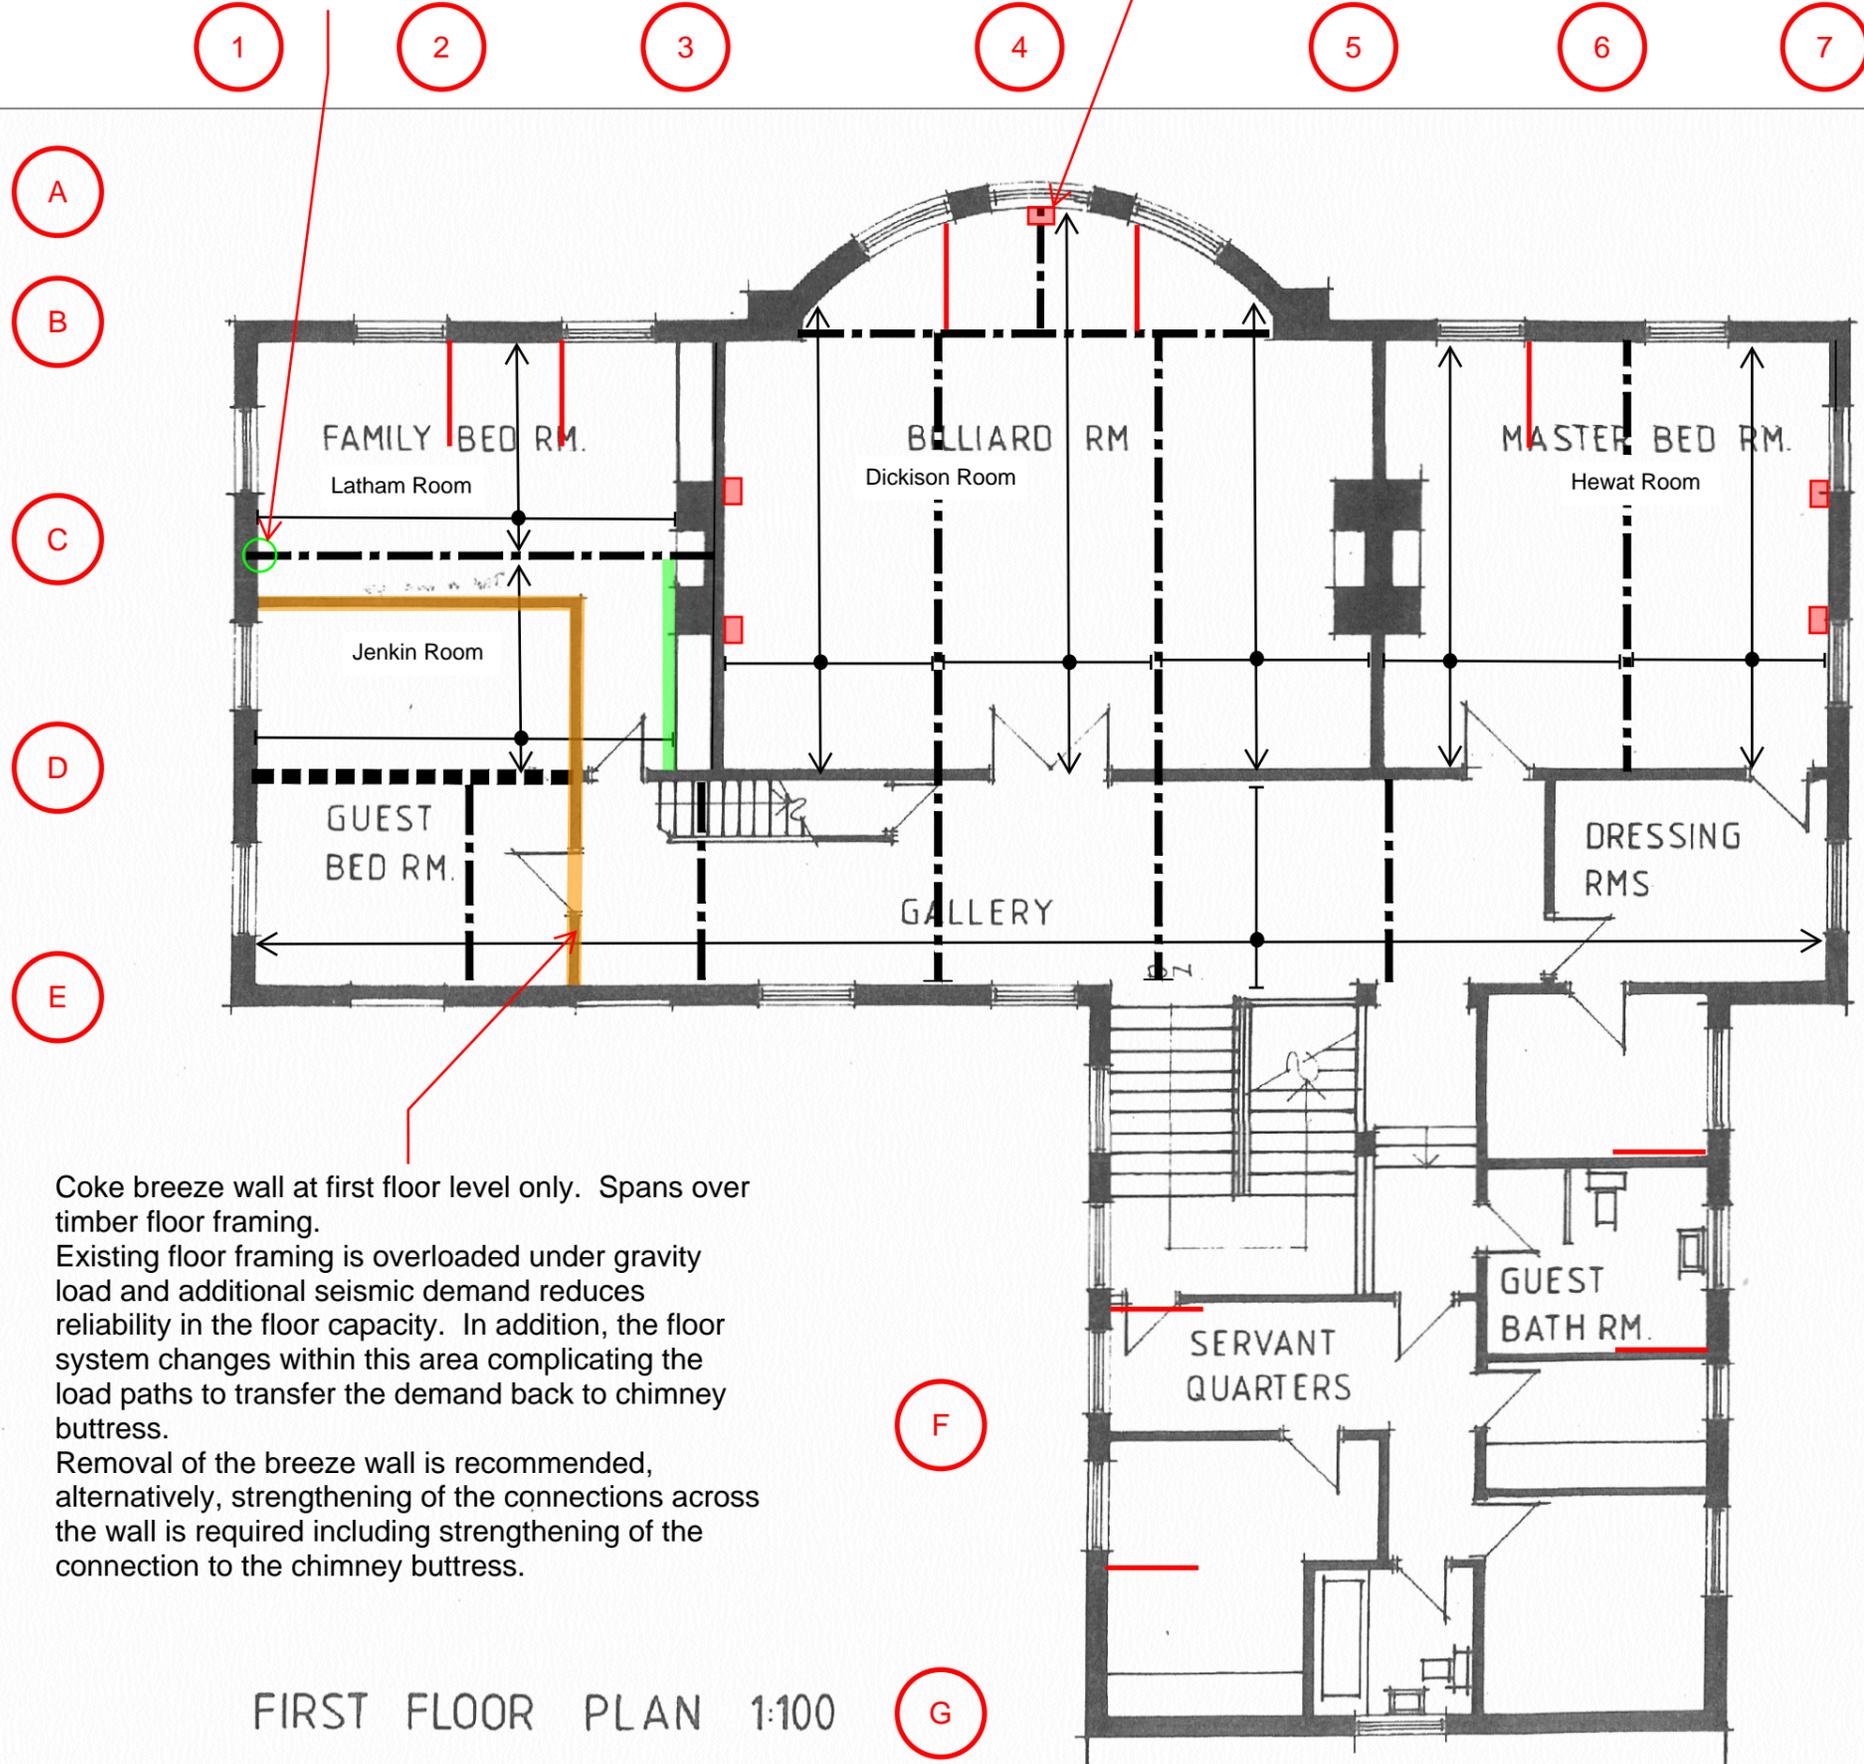
**First Floor Plan 67% NBS (IL2) Strengthening**

Coke breeze wall at first floor level only. Spans over timber floor framing. Existing floor framing is overloaded under gravity load and additional seismic demand reduces reliability in the floor capacity. In addition, the floor system changes within this area complicating the load paths to transfer the demand back to chimney buttress. Removal of the breeze wall is recommended, alternatively, strengthening of the connections across the wall is required including strengthening of the connection to the chimney buttress.

Timber beam requires strengthening with 2-M12 anchors into wall & 8-14g x 50mm long screws into timber beam through fabricated steel angle. See Sk04.

Timber beam requires strengthening of end connection similar to joist strengthening detail. See Sk01.

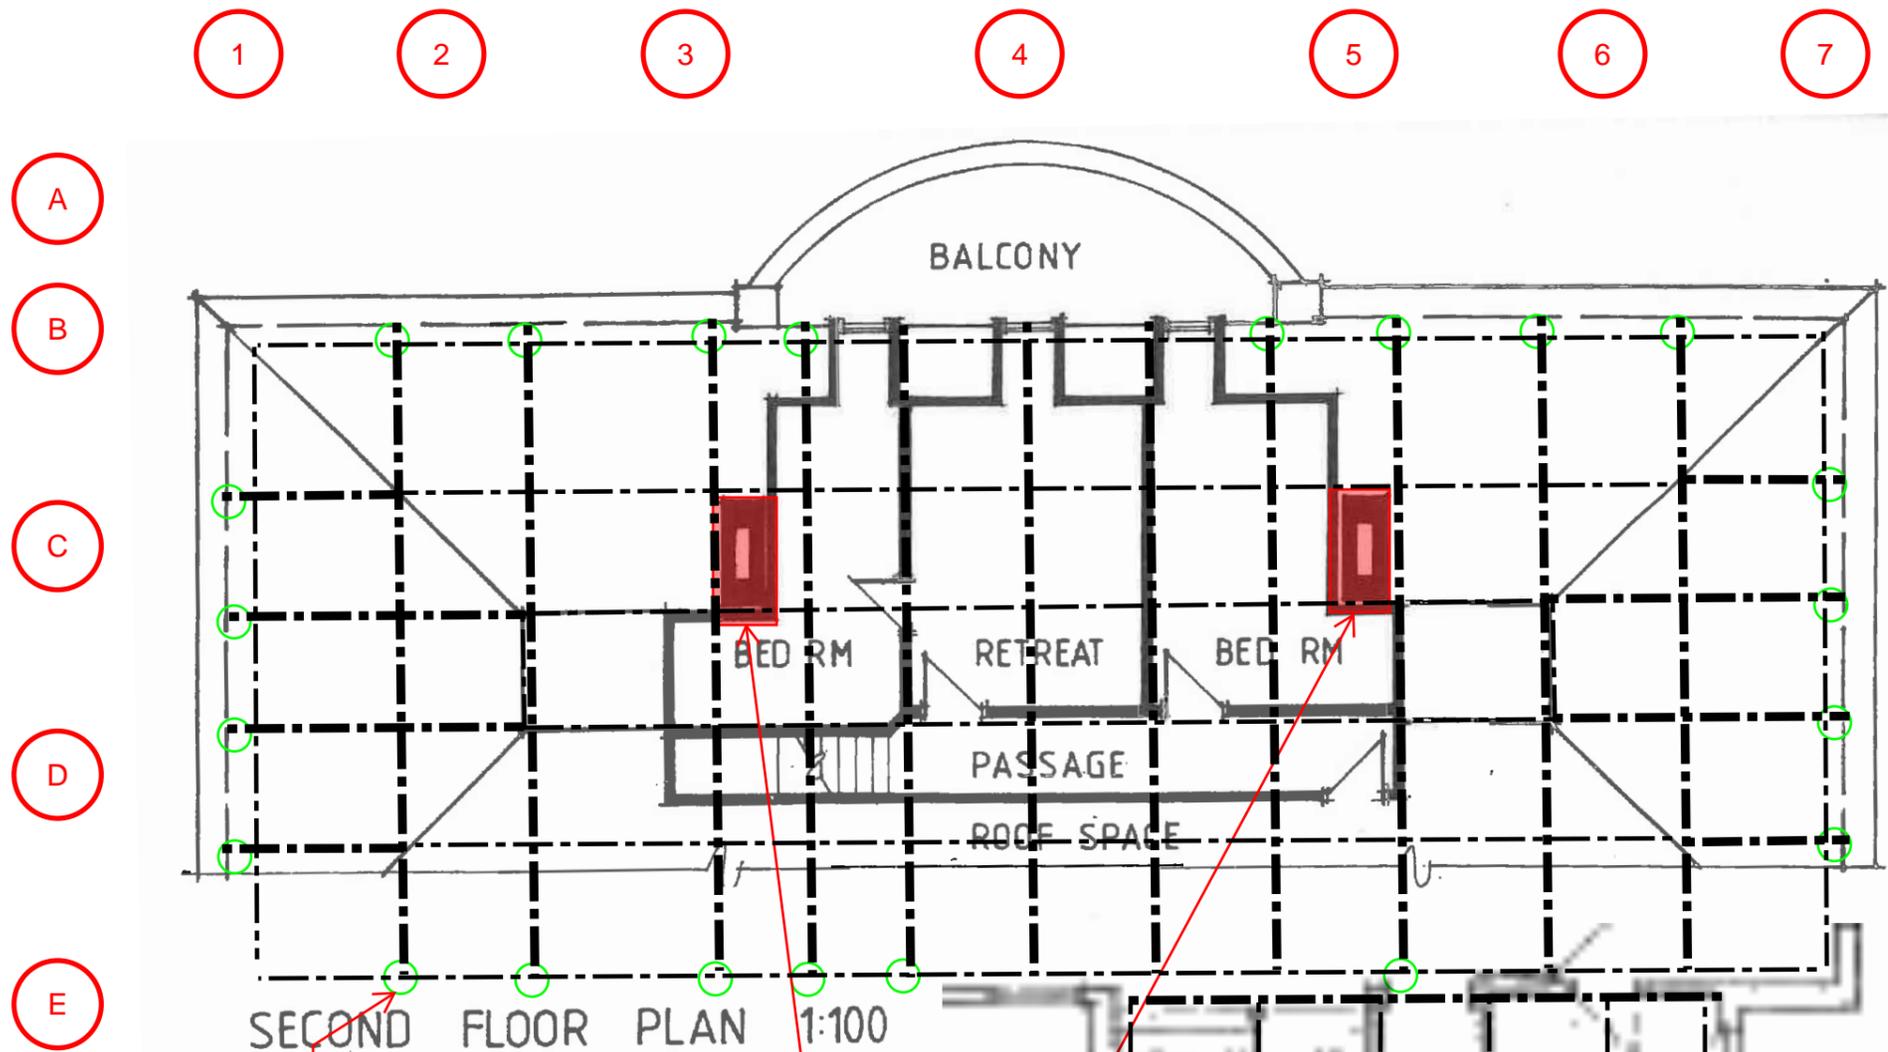
## Roof Plan 67% NBS (IL2) Strengthening

The site investigation were not able to observe an adequate connection between the roof structure (i.e. roof trusses) and the external concrete walls. This means that in an earthquake, the external walls are not restrained by the roof and the roof load is unable to be transferred down the structure.

Strengthening of the connection is relatively simple and will involve a fabricated steel bracket being installed at the end of each truss along the perimeter of the building to provide a lateral connection between the concrete walls and the roof trusses.

Typical Truss Strengthening to comprise 75x40 PFC fabricated U bracket with 4-14g-50mm long screws into truss. Provide solid packing between PFC and existing concrete wall and internal face of veneer. See Sk03.

New timber frame to extend down to first floor ceiling level. Provide 90x90 hyspan chords in each corner with 90x45 SG8 timber framing at 400mm centres between. Line with 19mm plywood fixed to timber framing with 2 rows of 3.15x50mm long flat head nails at 50mm centres each around perimeter and at 200mm centres internally. Fix timber framing to top of existing brickwork with steel angle brackets with 2-M12 threaded rods with 450mm embedment with Hilti HY-170 epoxy. Refer to example drawing of Resene Integra Facade System for cladding details with the surface finish sized, moulded and coloured to match the existing chimney. See Sk05.
