November 16, 2021

Invercargill City Council  
Private Bag 90104  
INVERCARGILL

RE: SANDY POINT WATER SKI CLUB BUILDING & RAMP REPORT

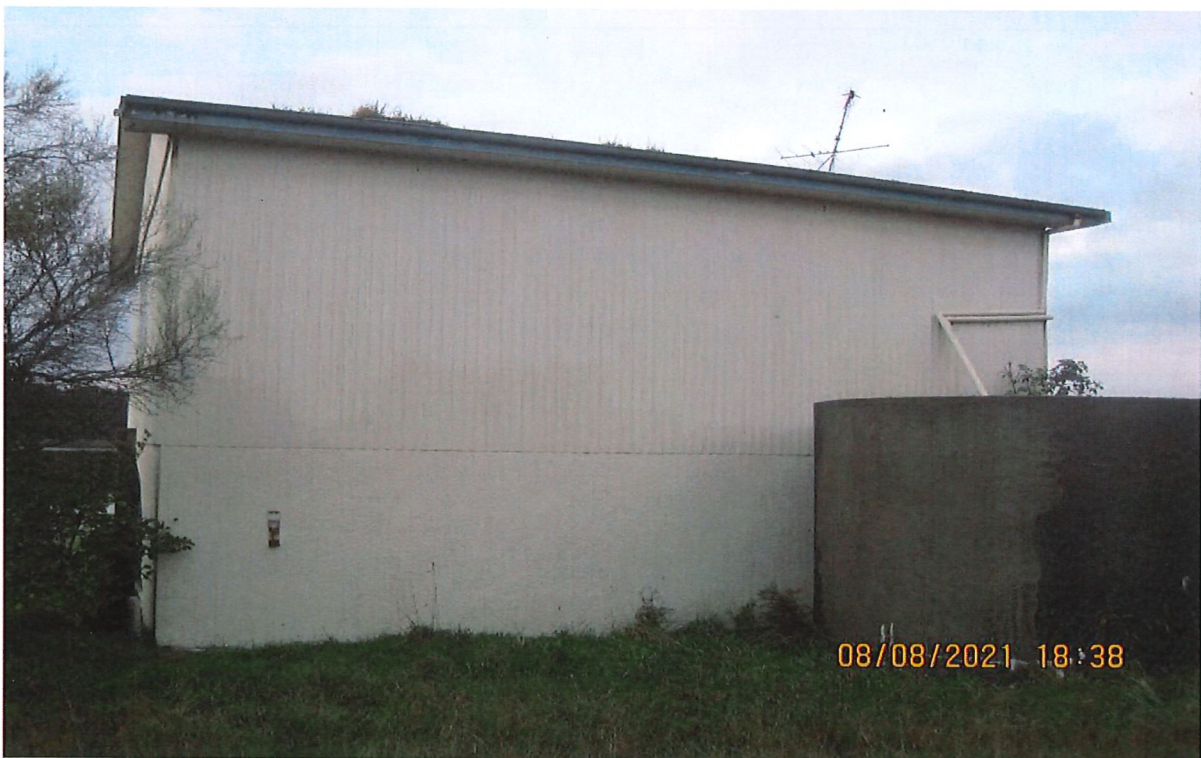
Rear view showing similar arrangement, with water tank and gutter requiring cleaning out.

The condition of the two storage tanks is unknown and these storage tanks should be emptied, inspected, cleaned out, disinfected, and refilled if the system is to be reused. First flush type fittings should be placed on all the incoming supply pipes to remove debris from the system. Weathertight, lockable tank access lids are also required.

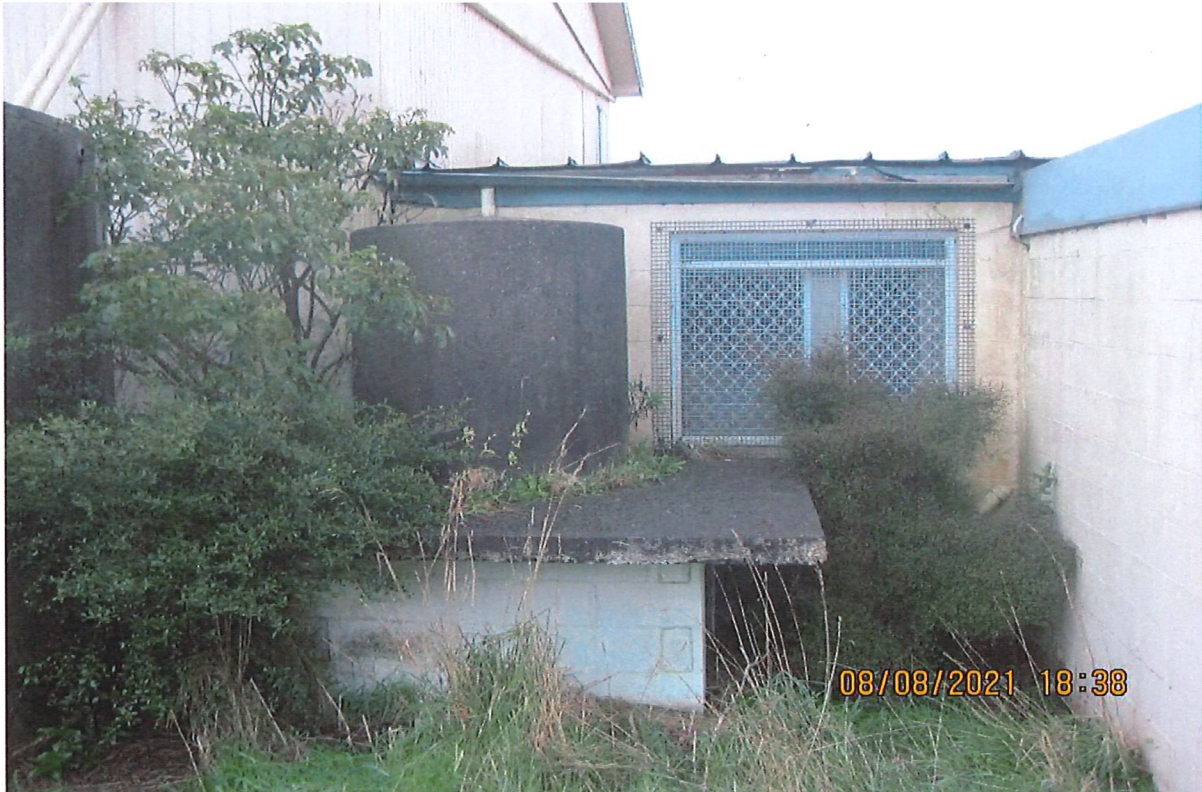
Exterior view to rear of toilets, with smaller tank. Note extensive vegetation needs cleared out and spouting replaced.

- All external spouting needs to be replaced.
- All fascia's and barge boards require to be painted. Some areas may also require replacement.
- The ground level around the rear and the sides of the building requires to be lowered below interior slab level and extended back some distance to prevent dampness entering through under the masonry block walls.

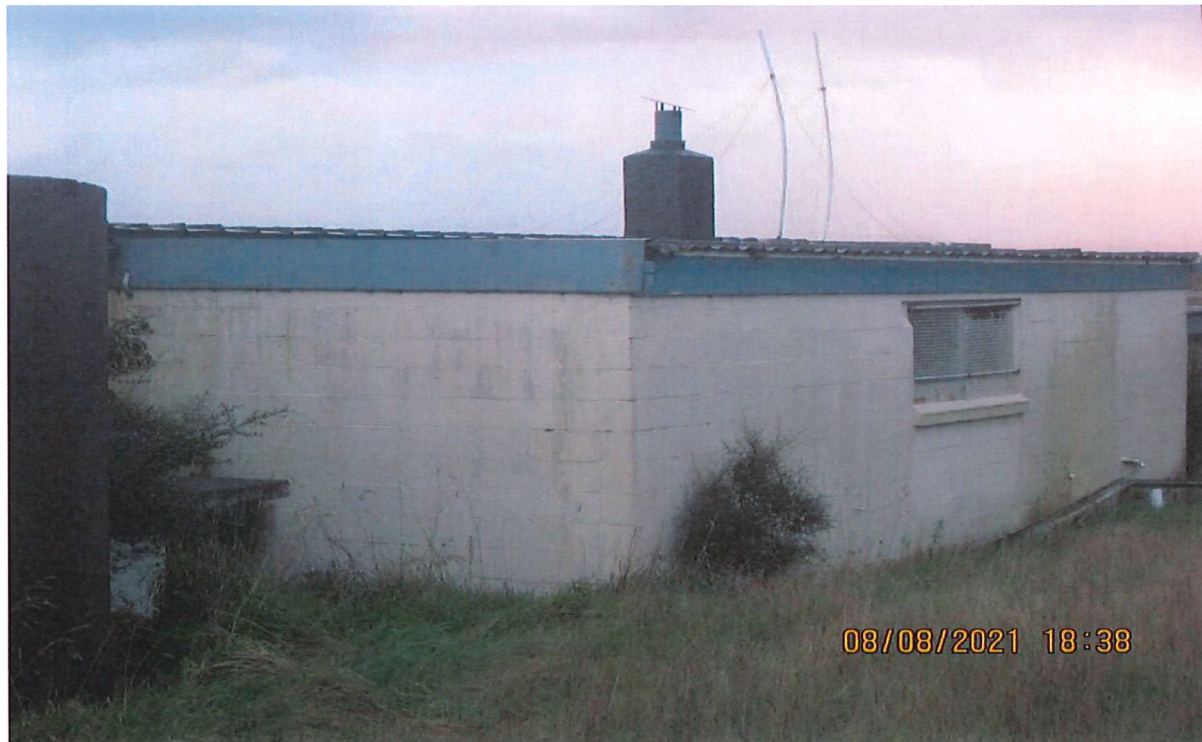
Typical view of rear wall to kitchen block. Spouting needs replaced as it has corroded away and the vegetation requires clearing along the rear wall.

The roof and spouting's of the two-storey area require closer inspection and either repaired or replaced as necessary. The ground floor level around the rear and the end of the building is either above or at floor slab level, particularly the area behind the kitchen extension. It is recommended that the present ground level is lowered below slab edge level and extended a distance back to control surface water runoff and prevent it from seeping into the building.

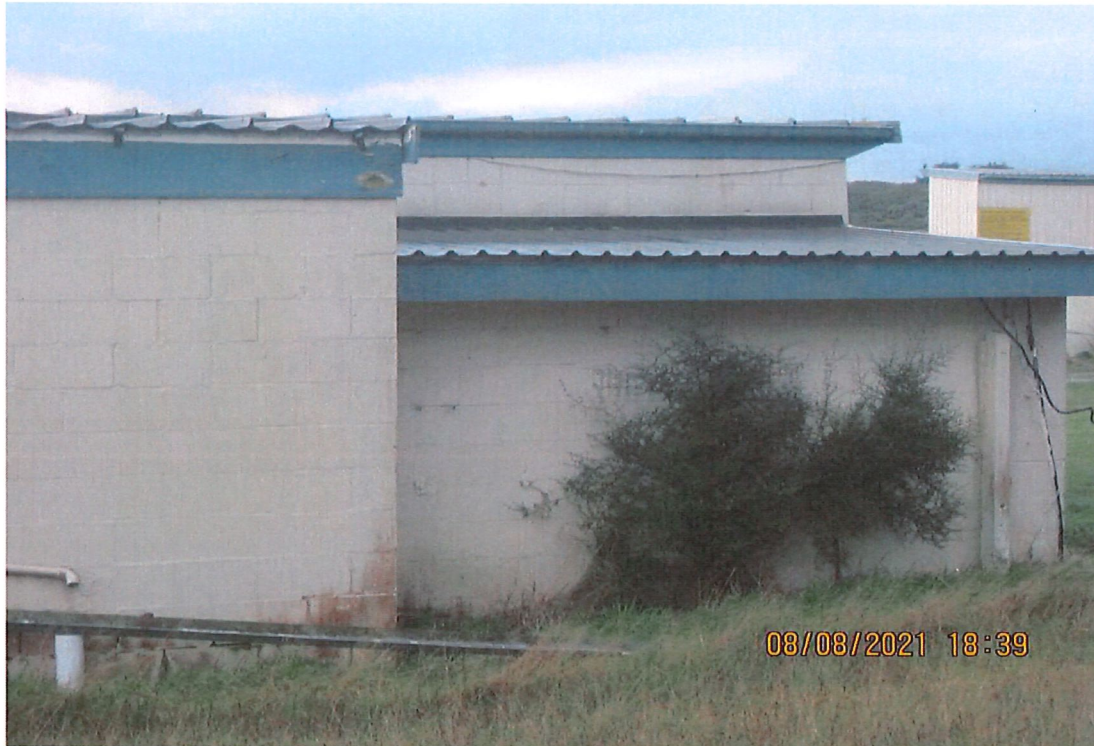
View of lower level lean-to storage shed, again no spouting and vegetation requires clearing out

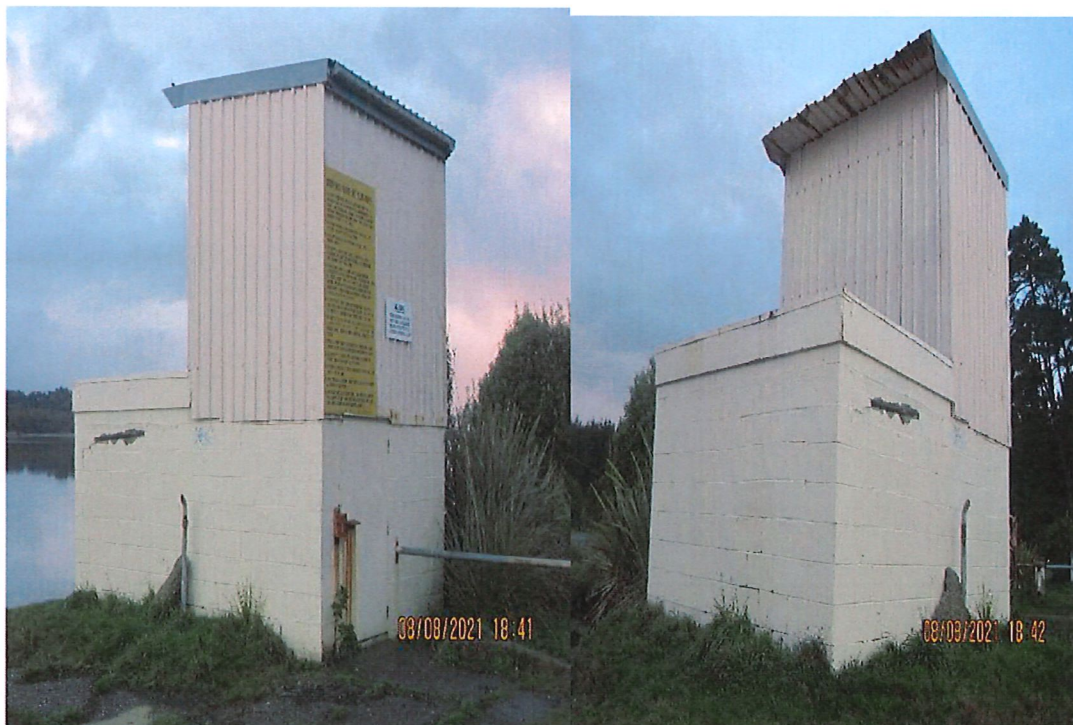
The roof cladding edges where visible from the ground are also in poor condition.

Typical condition of old viewing tower with corroded reinforcing and general deterioration of the cladding, typically at the ends.

It is our recommendation that this tower structure is demolished, and the ground reinstated to match the existing surrounds.

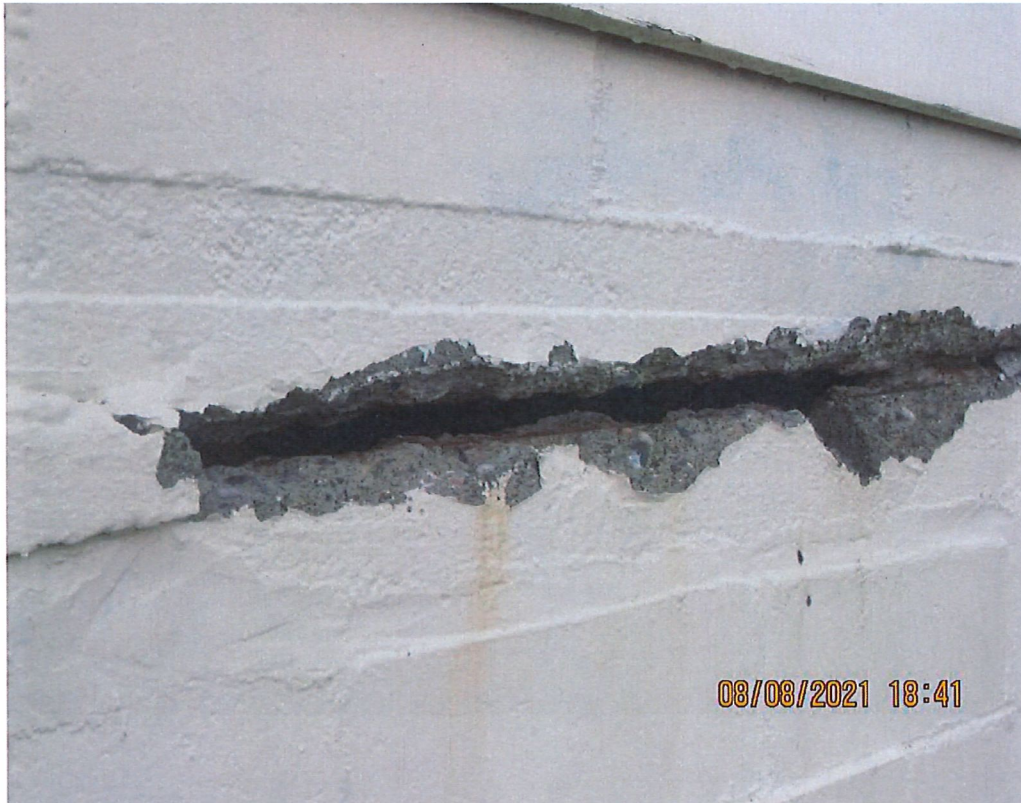
While the interior of the tower could not be accessed for review the external walls of the lower concrete support structure were inspected. One area has developed a complete hole through the concrete wall, created by the corroded reinforcing expansion that has spalled off the concrete both sides and the reinforcing has eventually completely disappeared. Other potential corrosion sites may exist in the other walls also.

Typical spalled concrete and gaping hole left from the corrosion of the reinforcing requiring fixing.

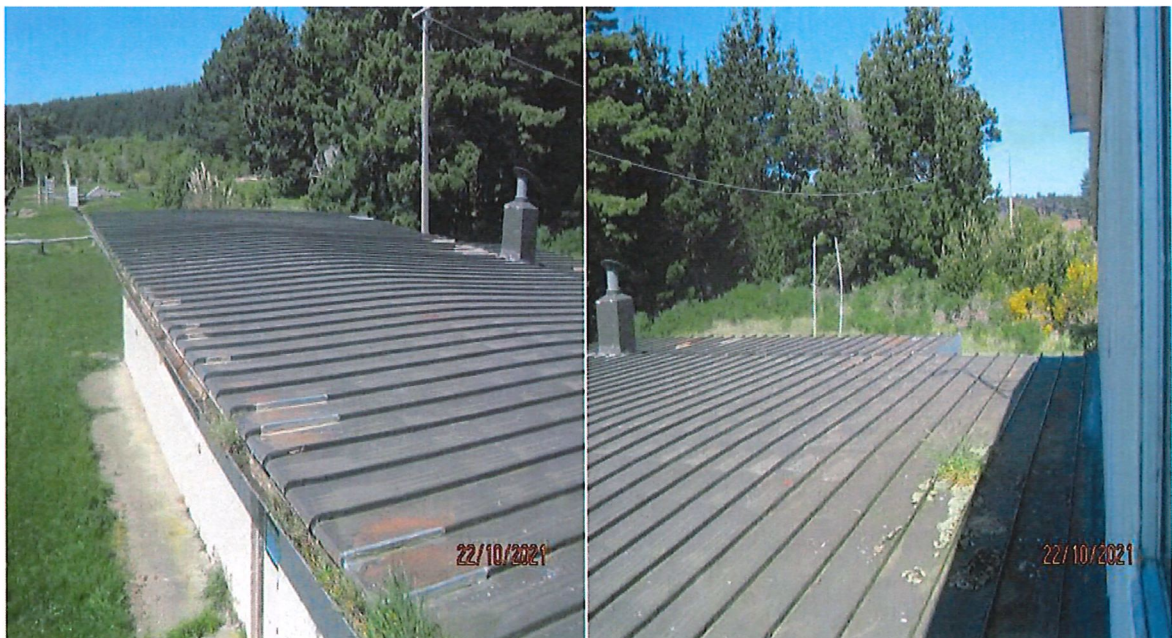
As a consequence, the roofing and the roof structure has rotted out and both the rafters and the ceilings have partially collapsed. As a minimum this area of roof structure requires to be replaced. The tray roofing is also in very poor condition with numerous holes visible and other areas patched and is in need of replacement.

Typical view of single storey very flat tray roof in poor condition along the edges with numerous patches and gutter requiring cleaning and possibly replacement.

In reality, the entire roof should be replaced and repitched as a trussed roof spanning full width, thereby eliminating the open fireplace chimney and the internal gutter. The condition of the open fireplace is questionable and should be eliminated as part of any future use or redevelopment to prevent the possibility of fire breaking out.

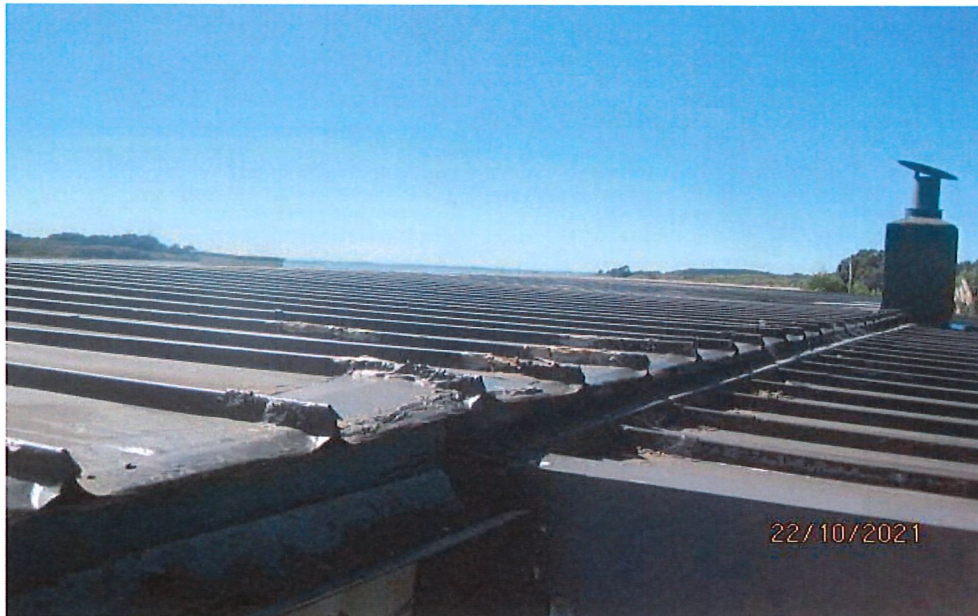
The roof structure is a very flat pitch and the roof area around the fireplace chimney and the rear kitchen has suffered significant water damage over the years from lack of maintenance. The roof between the main lounge and the lean-to kitchen roof addition is separated by the original guttering, which has become an internal gutter with the kitchen roof being installed.

Very poor condition of roofing along internal gutter between lounge and kitchen lean-to roof to the right. Chimney structure is central in the gutter with unknown detailing about the flashings and drainage works.

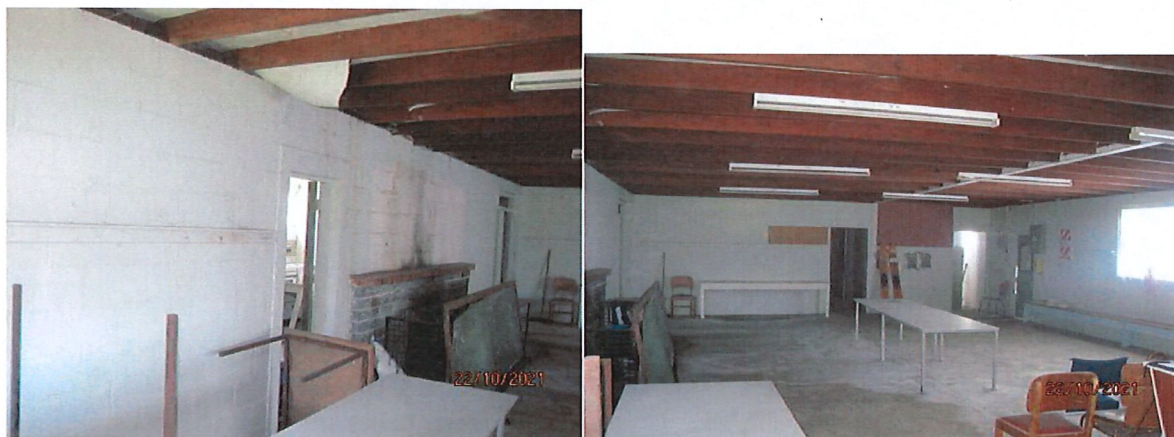
Typical view of main lounge area, open fireplace to the left photo and collapsed ceiling

- The single storey building needs extensive roof structure repairs to the kitchen, lounge and toilet areas as a minimum. It is highly recommended that the entire roof is replaced with a new pitched trussed roof over the space with new roofing. At the same time the fireplace and chimney would be removed, and the internal gutter system eliminated.

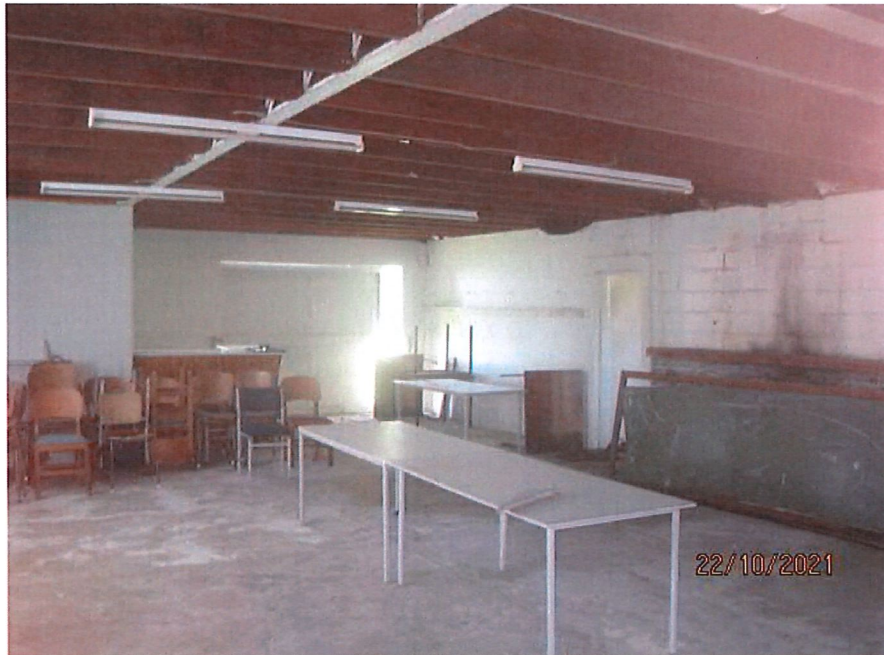
Egress from the upper floor is only available directly via the single stair flight and out though the single storey building to exit via the single front door. A large timber sliding door capable of providing vehicle or boat access is located on the eastern end of the single storey building and does not provide a suitable egress route. However, this door has been significantly damaged by vandals sufficient to enable access into the building. This damaged door needs to be either repaired or replaced.

View of east end to lounge showing fireplace to right of photo, damaged sliding door in the centre rear. Rafters are supported by light steel truss through the centre.

- Kitchen cabinetry and appliances are significantly water damaged and likely to require replacement.
- The vandalised external sliding door to the east needs to be either repaired or replaced. Thought should be given to providing an additional exit door out of this space.

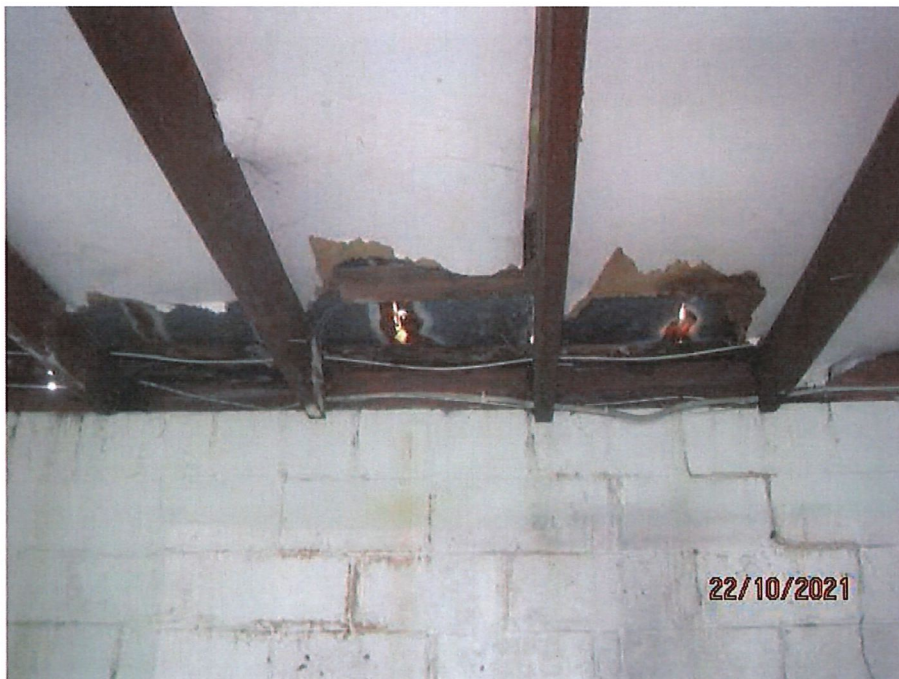
Corroded roof and water damage above fireplace. Three rafters have rotted out and have collapsed downwards.

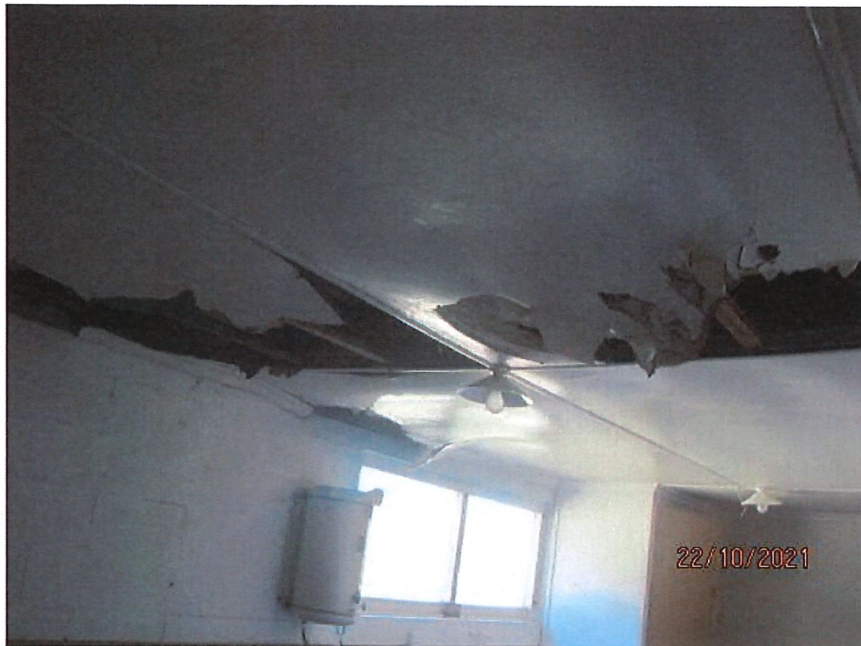
Typical damage to kitchen ceiling roof in same area with extensive damage to the roof structure.

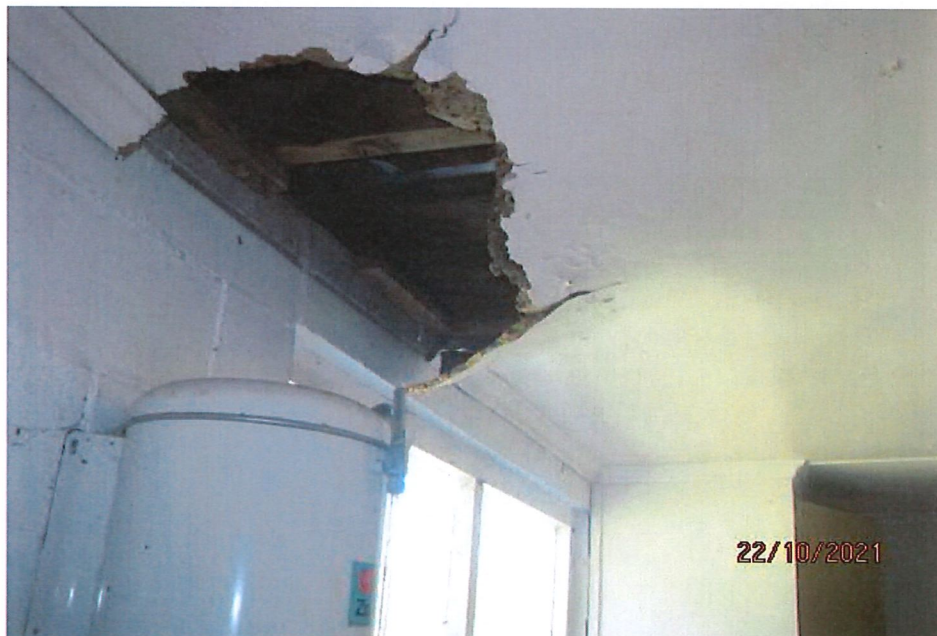
Closeup view of damage to roof above the rear kitchen wall

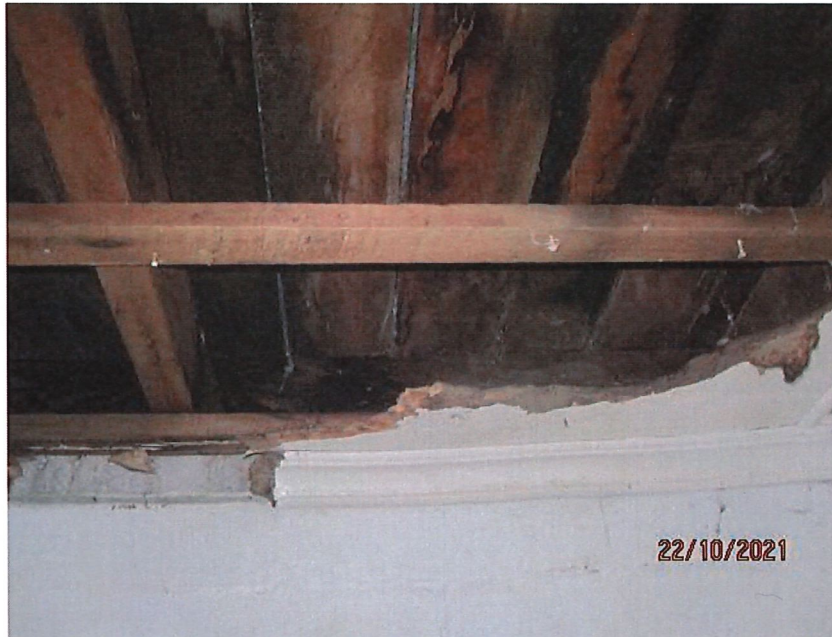
Similar view at the internal kitchen wall.

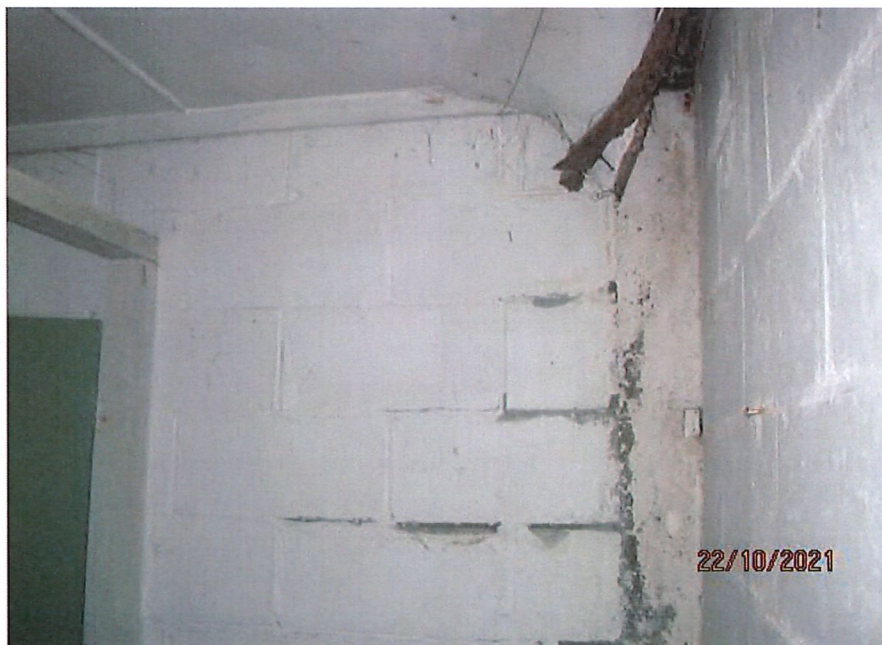
Similar damage has occurred along the roof edges in the toilet / changing room areas from corroded holes through the roofing damaging the timber roof structure below.

Ceiling damage above toilets for corroded roofing, which appears to have been sealed on the exterior but the interior has not been repaired

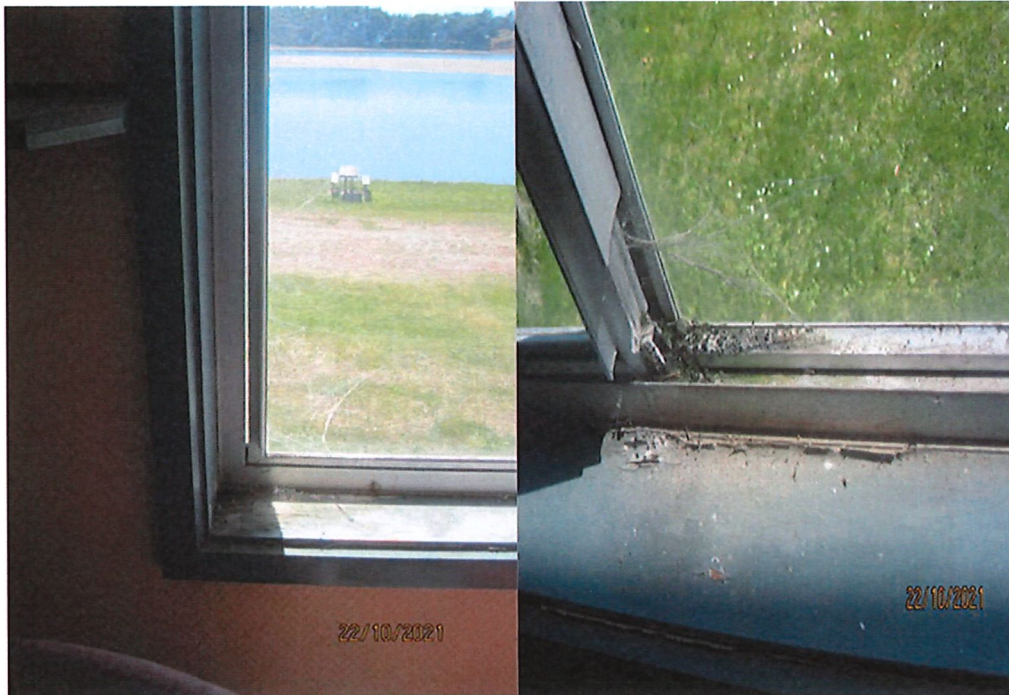
The two-storey portion of the building is in reasonable condition for its age and has reached the point of needing repainting and general tidy up. Some of the aluminium window glazing also needs attention as the sliding windows do not shut properly and the glazing gaskets to the glass require replacement.

Windows in poor condition, do not close and moisture is affecting the timberwork

- Windows at top floor all need repaired and refurbished.
- Interior paint work throughout needs to be redone.
- Fire rating of underside first floor throughout is required.

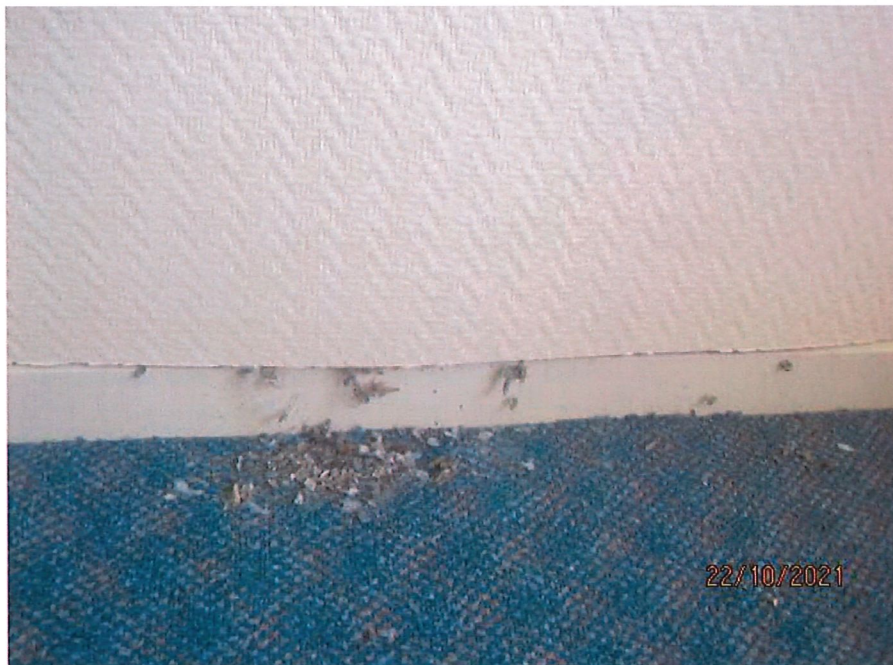
The painted Anaglypta type paper coating system used on the walls in the upstairs lounge has separated from the wall lining in several locations and has insects and debris spilling out onto the floor. It is possible that these areas may have holes, or the lining has gaps, although none were felt when touched. This requires further investigation.

Buildup of insect infestation behind lifted wallpaper requires further investigation.

- Upstairs, the roof level egress door needs replaced or removed and blocked up and water damage to wall framing reviewed and repaired.
- Damage and insect infected wall linings upstairs requires further investigation and repair as necessary.

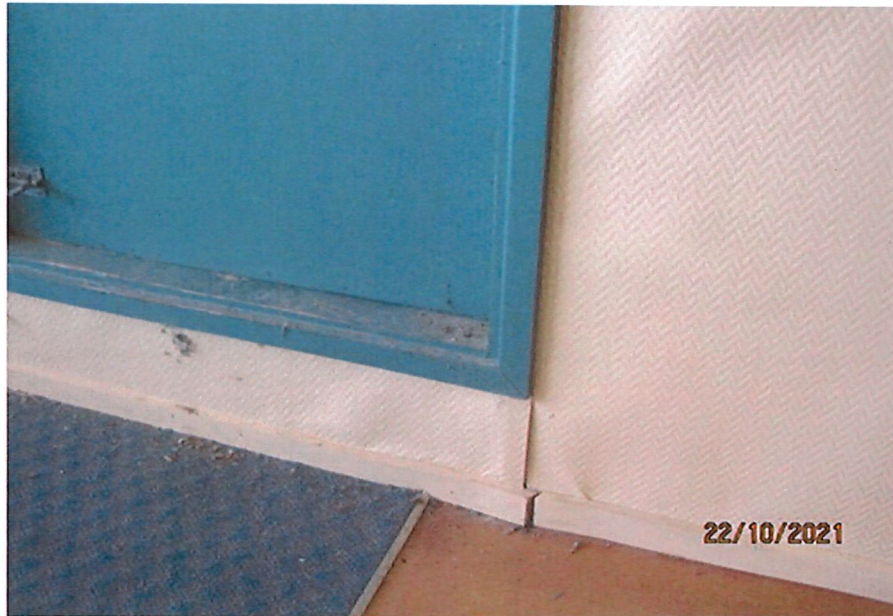
As mentioned previously the small egress door onto the adjacent roof of the single storey building is a timber door and is breaking down with exposure to the weather and moisture. Water is also entering at sill level and damaging the interior framing, linings' and trims in this area. The stud framing may be in poor condition and requiring replacement, however this could not be established conclusively without removal of the wall lining. From the exterior no form of head or jamb flashings could be observed.

Water damage evident from around the external door jamb and sill, resulting from no external flashings.

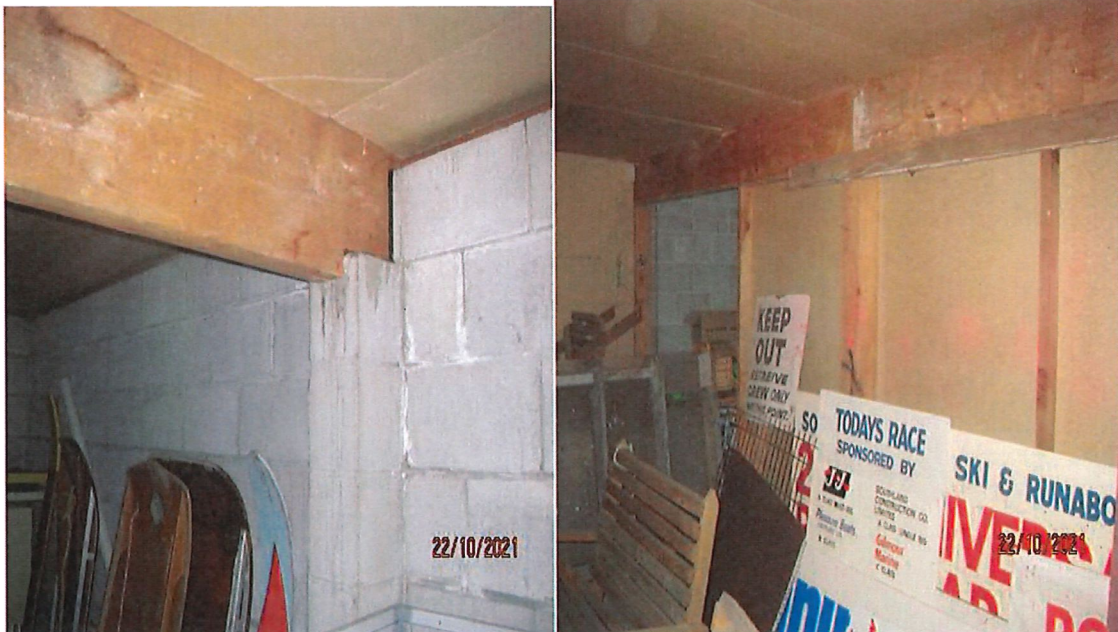
At the ground floor level, the masonry blockwork and first floor support beams are in good condition. The soffit lining of the first floor is part gib board, mainly to the rear and the other areas are MDF board. As such, there is little fire rating provided to the underside of the first floor. The timber support beams and the bottom plate for the floor joist support are not protected by any form of gib board fire lining either. The underside of the stairs has gib board full length. The space under the stairs has been utilised to provide the pump and pressure tank for the water supply drawn from the large storage tank outside.

Additional views of the timber first floor support beam and wall support not firerated or adequately tied into the structure.

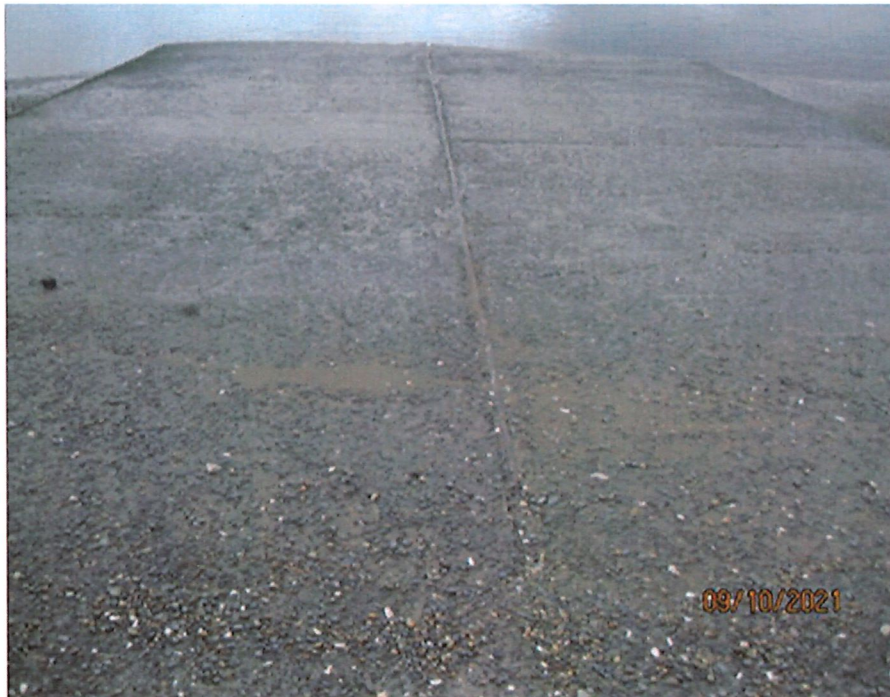
The more recent ramp located further to the west is significantly longer and wider. It is also placed at a profile matching the existing beach profile and almost fully embedded in the sand. It has been well made and in good condition for its age. It comprises of two large strips of slabs poured with a central joint. There are some horizontal cracks across, but these are more likely shrinkage cracks in the unreinforced concrete slabs.

View down main western ramp in good condition for its age

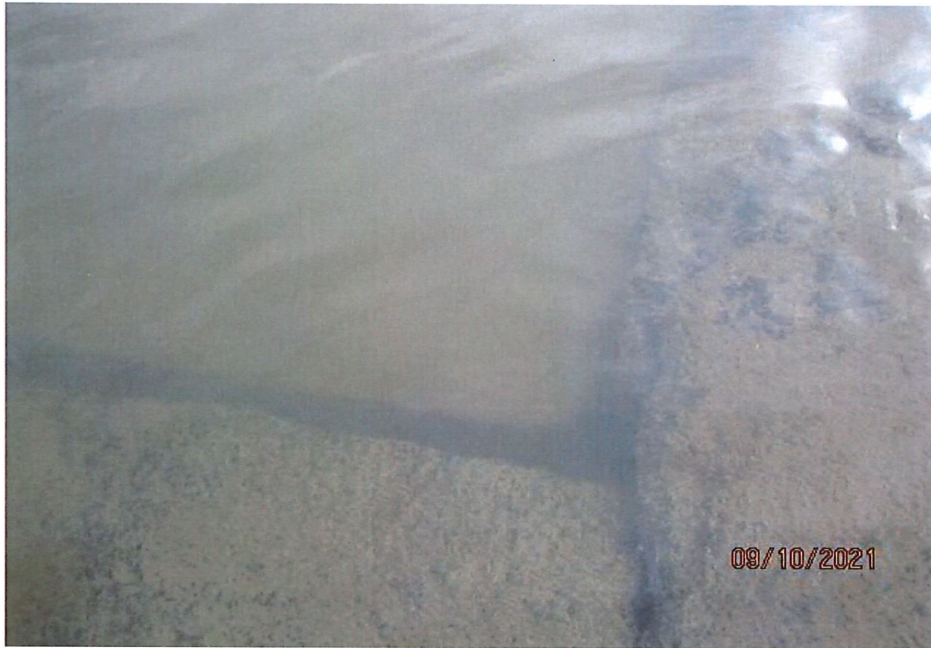
ramp at low tide. However, it was observed that on the upstream edge a large open void exists that has allowed ongoing scour action to extend back under the lower slab area. The depth can be probed up to 2m, which reduces support for this lower slab and its ability to support heavy wheel loads. It is recommended that additional fibre concrete is pumped back under this slab from the upstream edge at low tide to provide support for the slab and infill the upstream void between slabs in the existing concrete to limit potential future scour.

Slumped upstream slab at the end of the ramp showing scour hole which extends along under end of the slab requiring to be grout filled.

- The smaller eastern ramp is badly cracked, and the sides and end slabs badly slumped. This is considered a safety hazard to users and should be removed. If a second ramp is deemed a requirement, then it should be replaced with a new redesigned ramp.
- The larger ramp to the west requires a water blast clean of the marine growth within the tidal zone as a minimum and can then be used.
- It is highly recommended that the void beneath the lower end slab below low water is filled with pumped fibre concrete to prevent further scour and possible slab failure in the future.

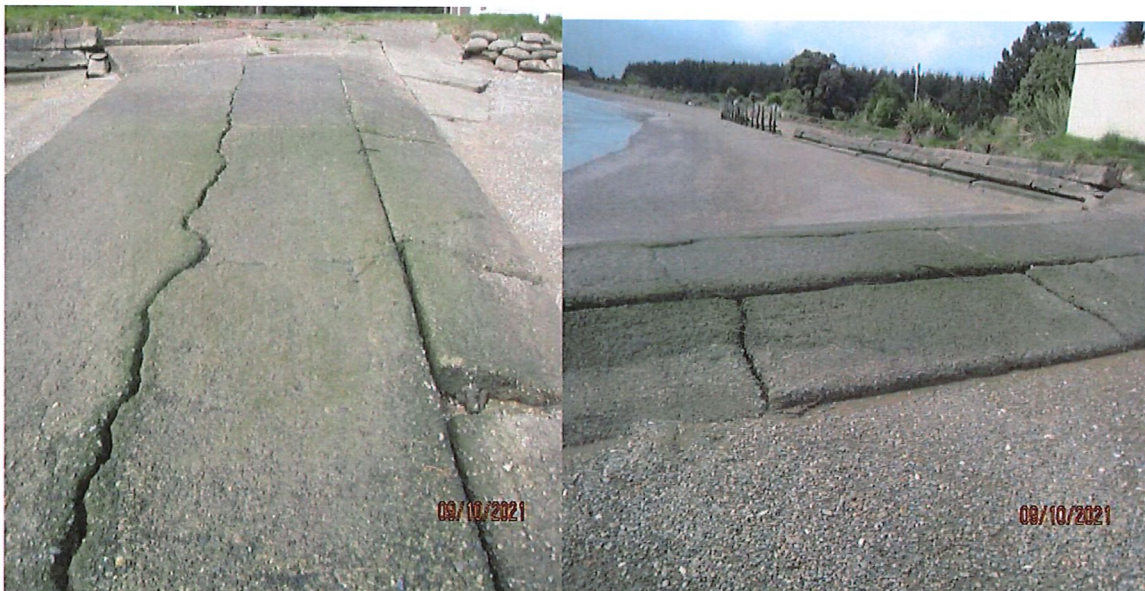
The smaller east ramp is in poor condition with major slumping of broken slabs along both sides with extensive open cracks the length of the ramp. The lower end of the ramp is also extensively cracked with large gaping cracks and steeper slumped slabs just at the end with a drop off into the deeper water. Refer to the appended photos for details.

This ramp slab sits higher above the surrounding present beach level. Originally it was probably constructed on a higher beach profile and over time the beach has receded to its current flatter and lower slope. The resulting erosion and scour of the material from under the upstream and downstream slab edges has seen these slabs slump downwards along each side. The end result is, the present situation, with a central higher slab and the outer edge slab along both sides lower. Similarly, the lower end slabs have been scoured out significantly, allowing the lower slabs to pull apart and drop into the deeper water leaving large gaping cracks across the lower region. These large open cracks allow further scour action to propagate further under the slabs and the process keeps on repeating. The lower concrete areas in the main tidal zone are also very slippery with the marine growth and the round aggregate exposed. The steepness of these slabs is difficult to walk on especially with the marine growth build-up and is also likely to be an issue for a vehicle trying to launch or retrieve a boat.

View up the smaller and steeper eastern end ramp showing extensive cracking and slumping to concrete slabs.

side view of slab showing slumping with extent of foreshore erosion over time.

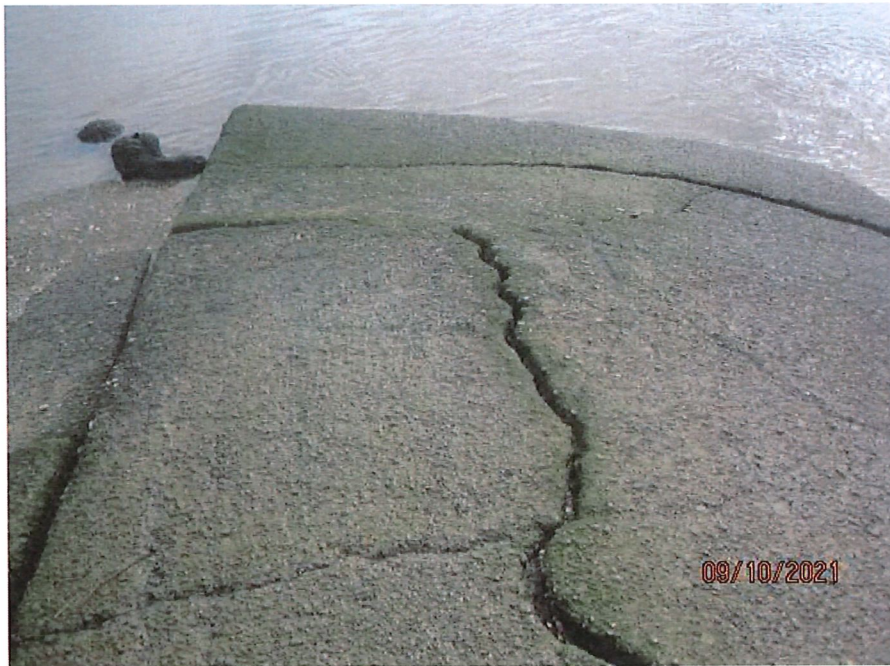
Lower end of ramp with steep drop-off and wide cracks. Very slippery due to marine growth and polished rounded aggregate.

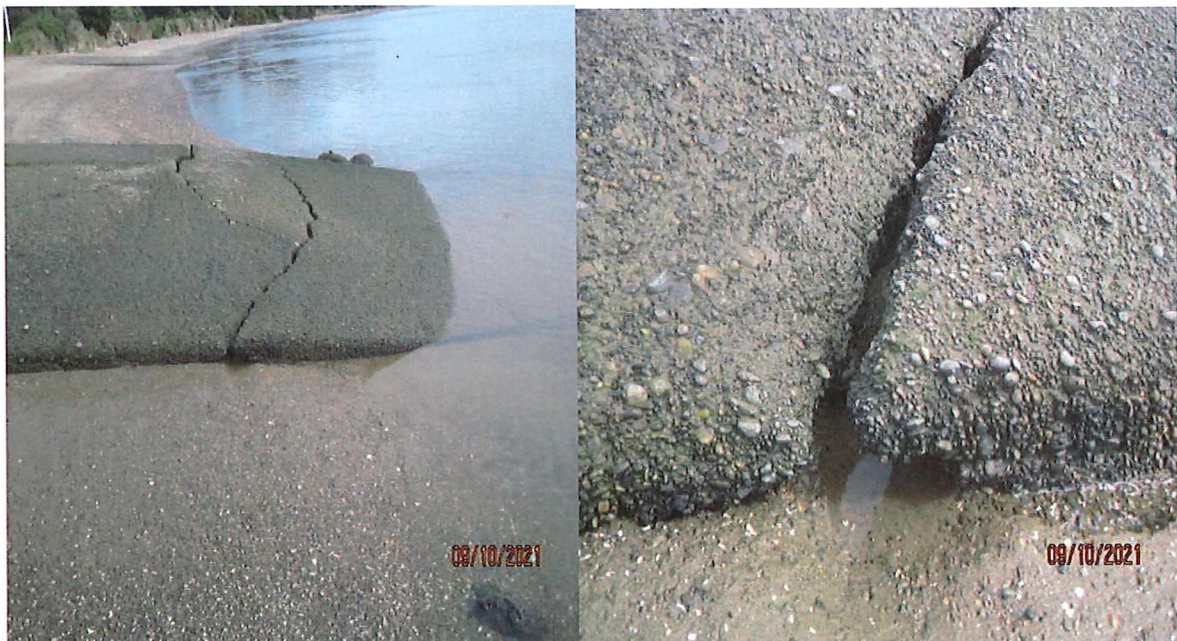
Steep ends to slab from slumping in two directions    Large open cracks in the concrete. Typical
