Appendix 4 - Structural Report

September 5, 2022
John.bluffy@gmail.com
Bluff Oyster and Food Festival
Bluff

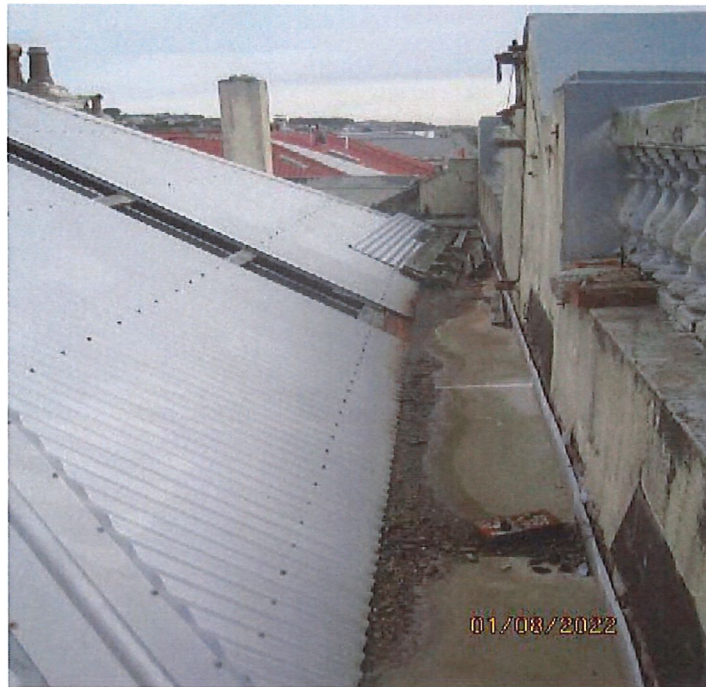
Similar view further to the west end, gutter corroded out and roof sheeting missing and open though to floor below. No cover flashing to gutter edges behind wall and open to below

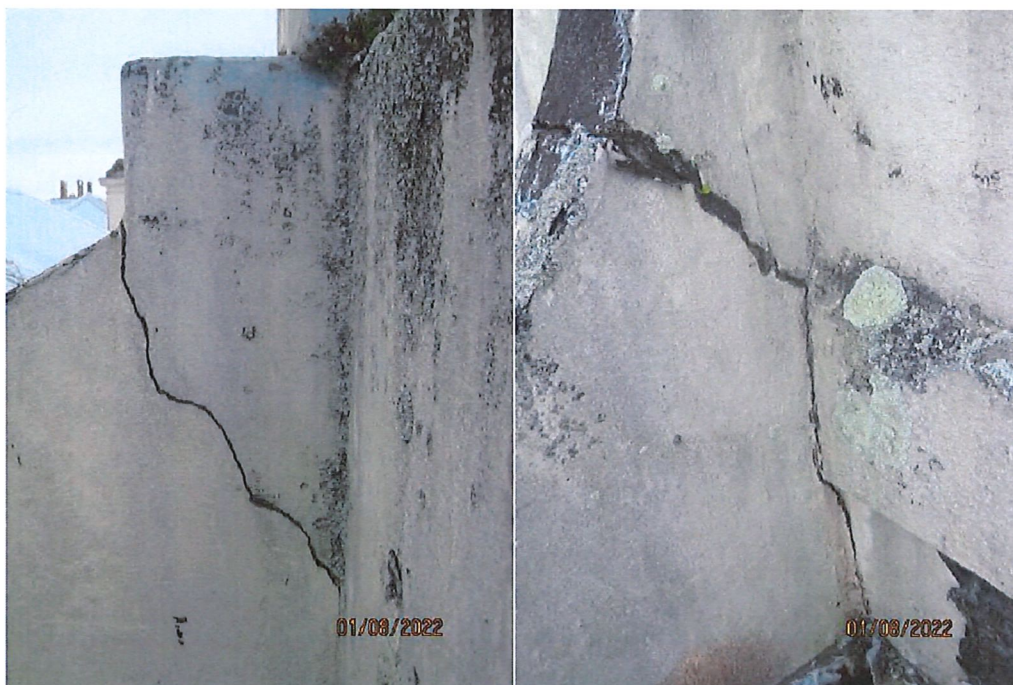
Typical views of numerous open cracking in the brick walls tying back the main façade parapet

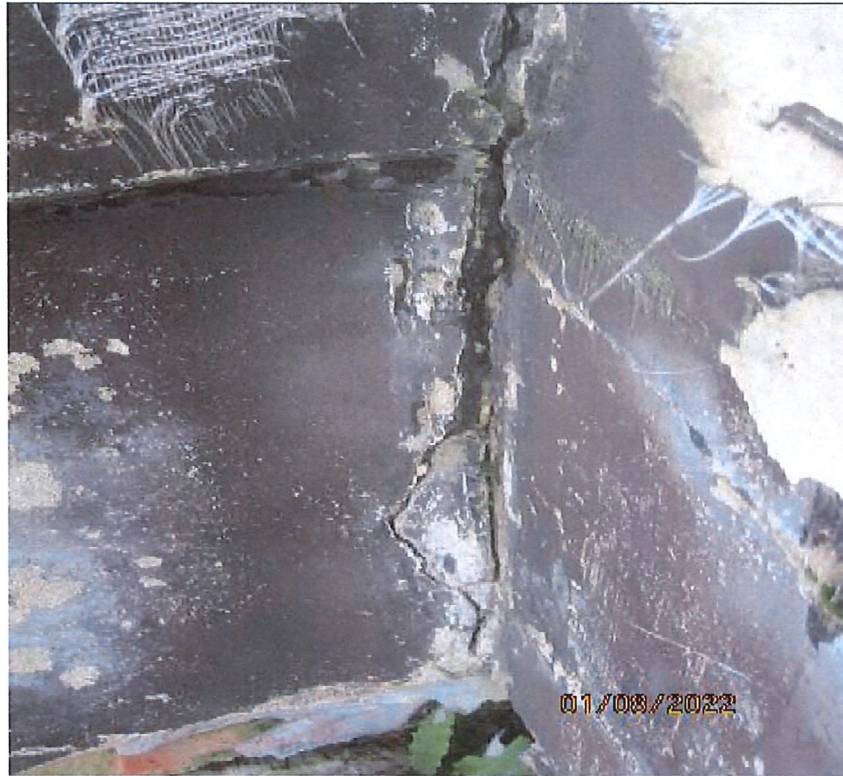
Large open cracks (15mm) extending deep into the walls supporting façade . Vegetation growing out of lower crack level

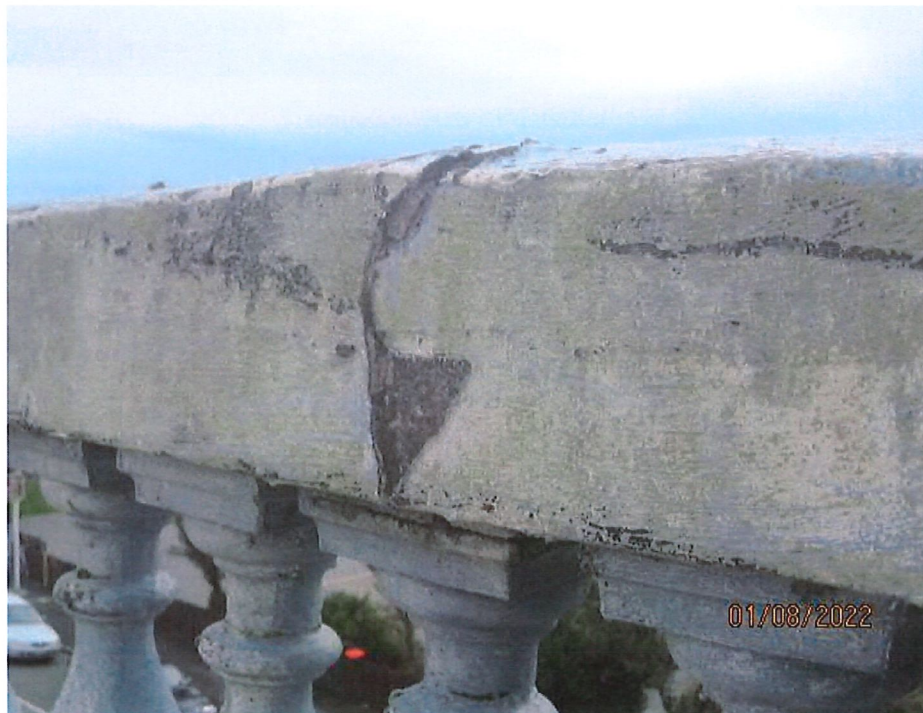
Typical condition of capping beam over pedestals showing crack and slight offset out towards the street.

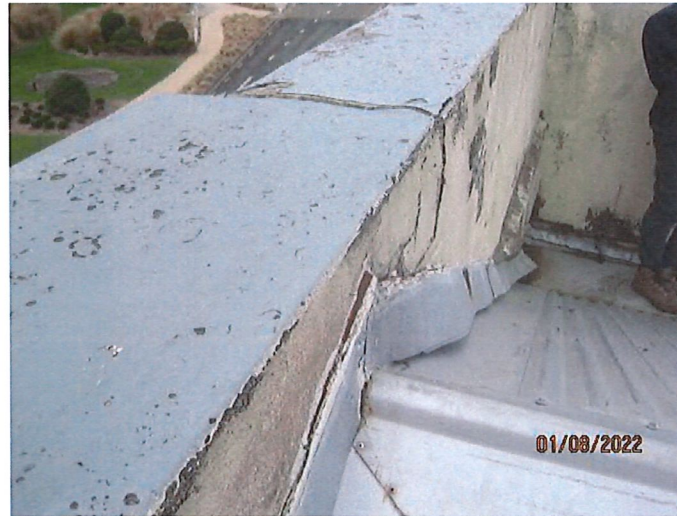
Typical condition of another section of parapet that has cracked through and moved outward. Note flashing pulled away from the rear of the parapet also with the movement

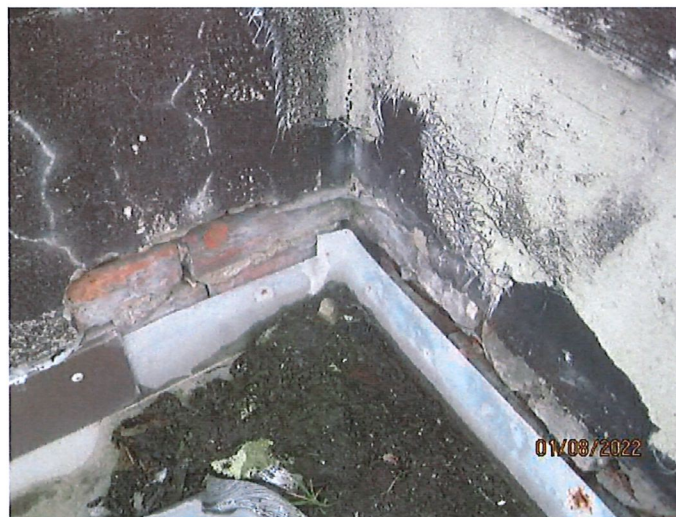
Typical view that exists all around the building parapets with no over flashing to gutter edges and open brickwork mortar joints in poor condition

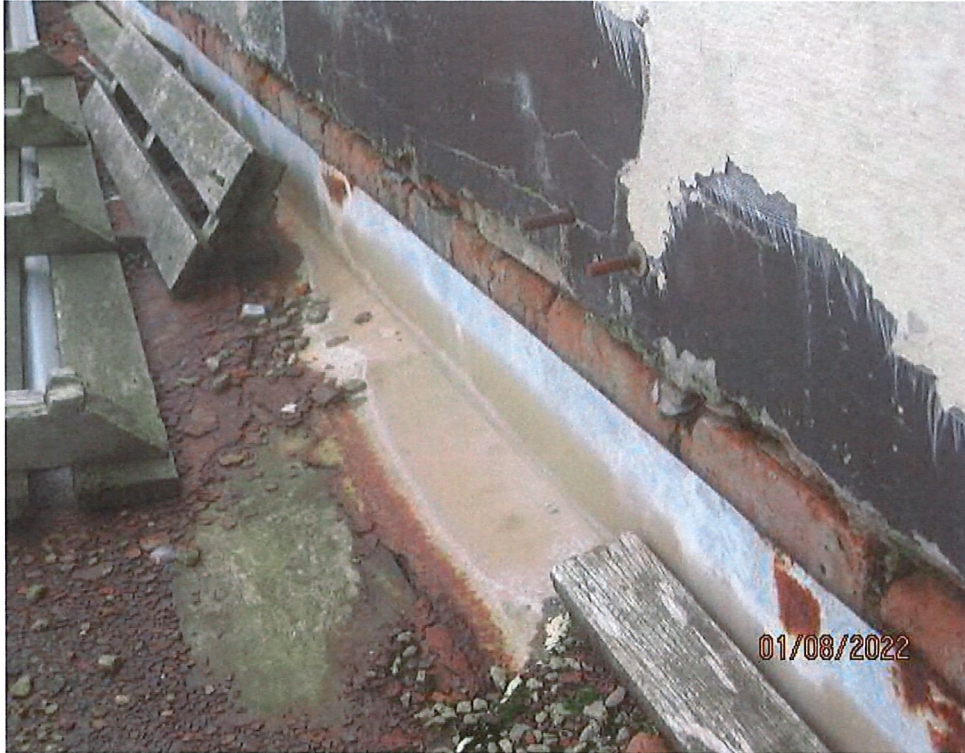
Typical condition of gutter behind façade, gutter rusted out, no over flashings to wall , deep recess extending into brick layer from missing overflashing allowing water inside the wall

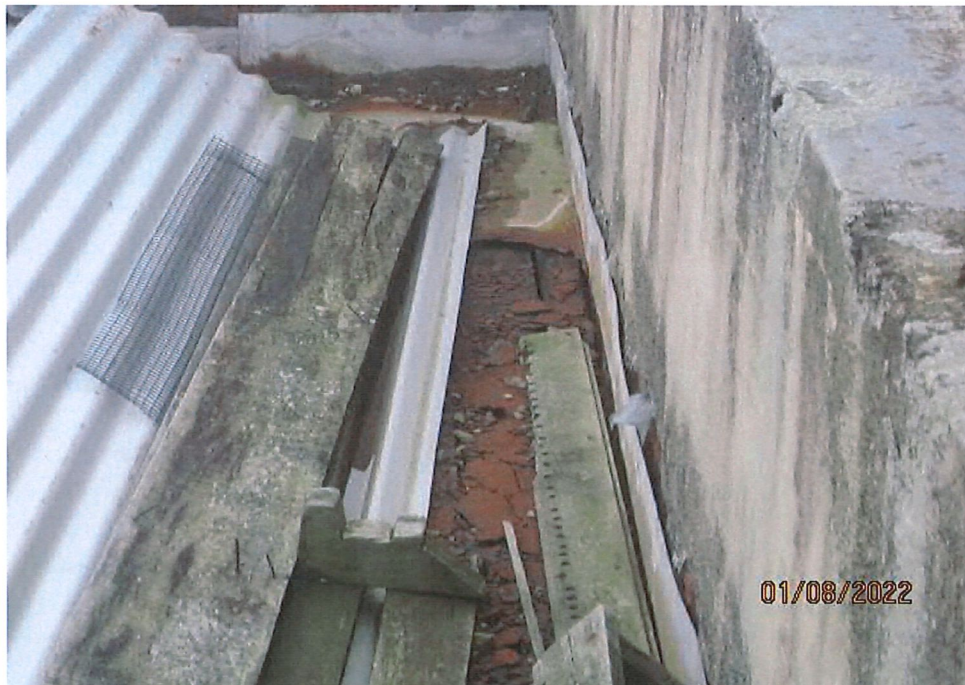
Typical condition to north end of gutter with rusted out gutter the supporting timber framing of gutter is all rotten. Open edge to upstand edge of gutter allowing water to track down behind upstand into the building

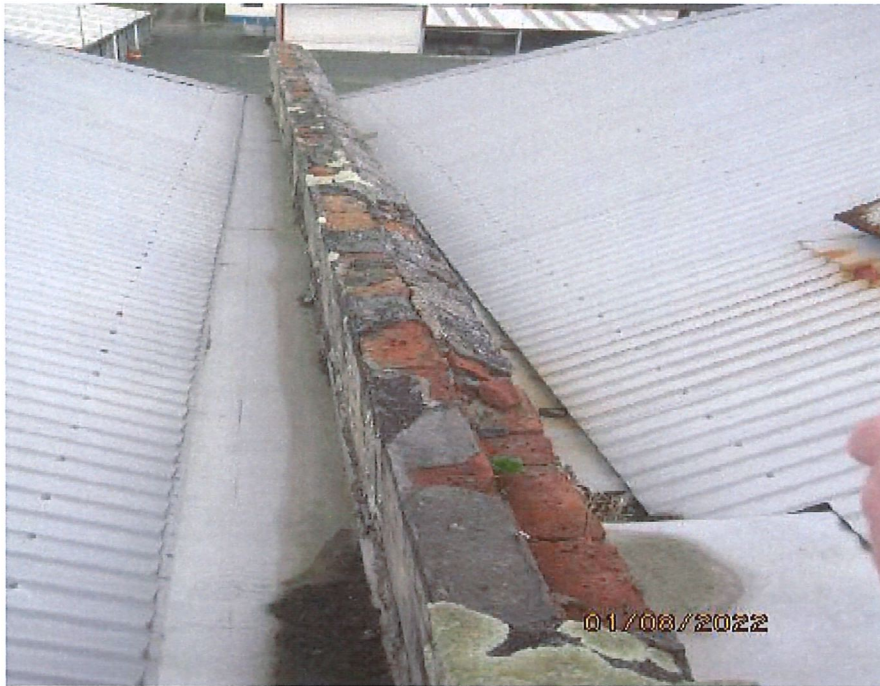
Typical view of poor condition to top of parapets of original intertenancy walls showing open brickwork and joints allowing water to track inside the walls.

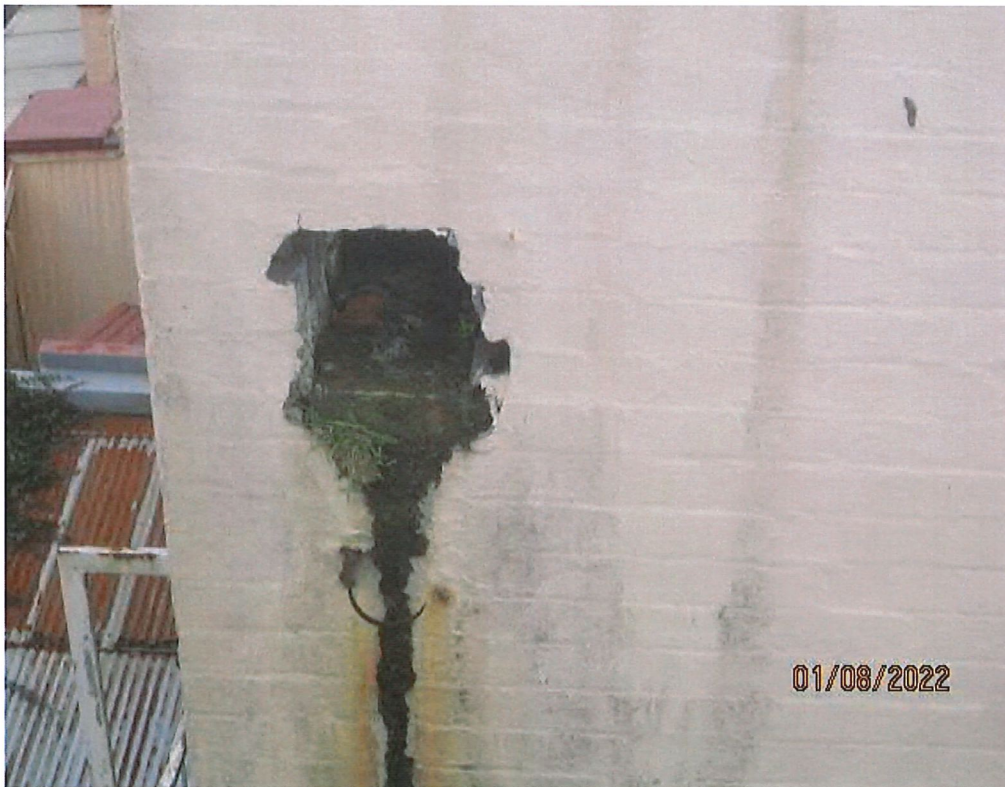
Missing gutter extension, rainhead and downpipes allowing water to flow back inside the building and also directly into the brick work layers.

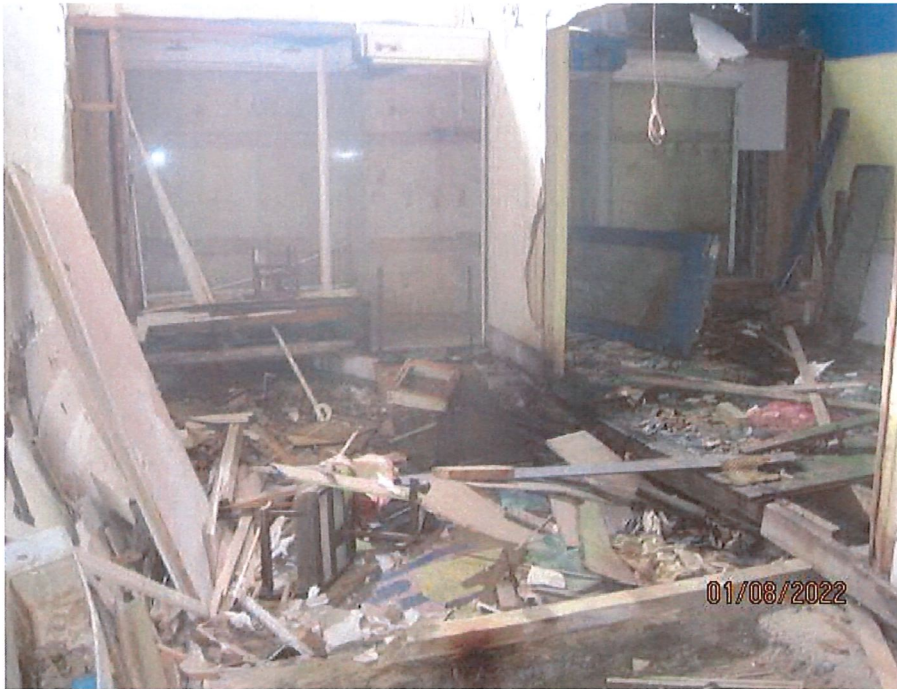
Typical damage from vandalism to ground floor area, actual flooring has been removed. Area is being saturated from water entering above first floor

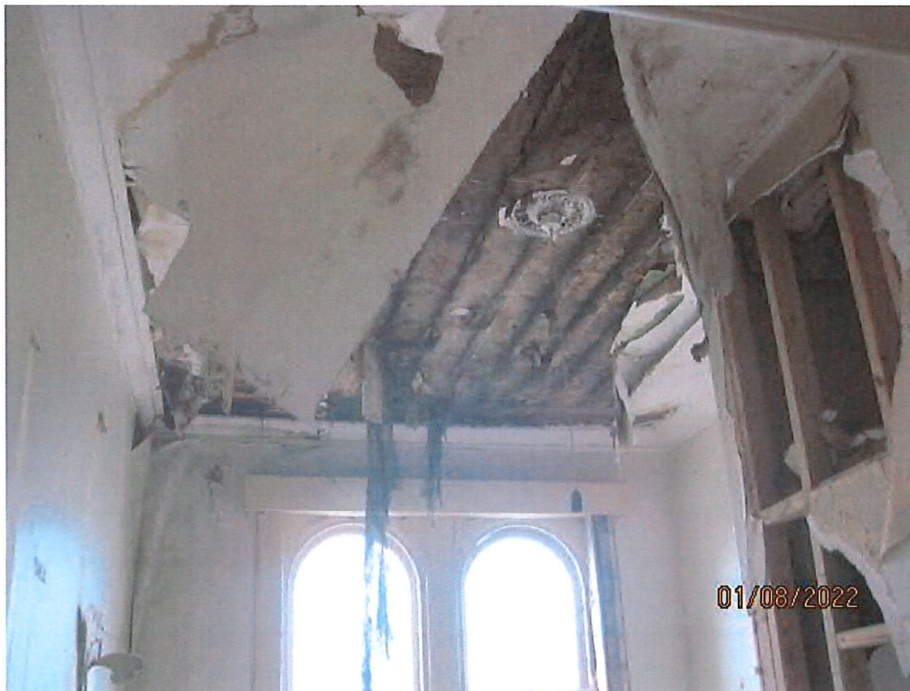
Typical water damage to ceilings, timber work and walls at first floor level. Other linings damaged by vandalism to the right of the photo

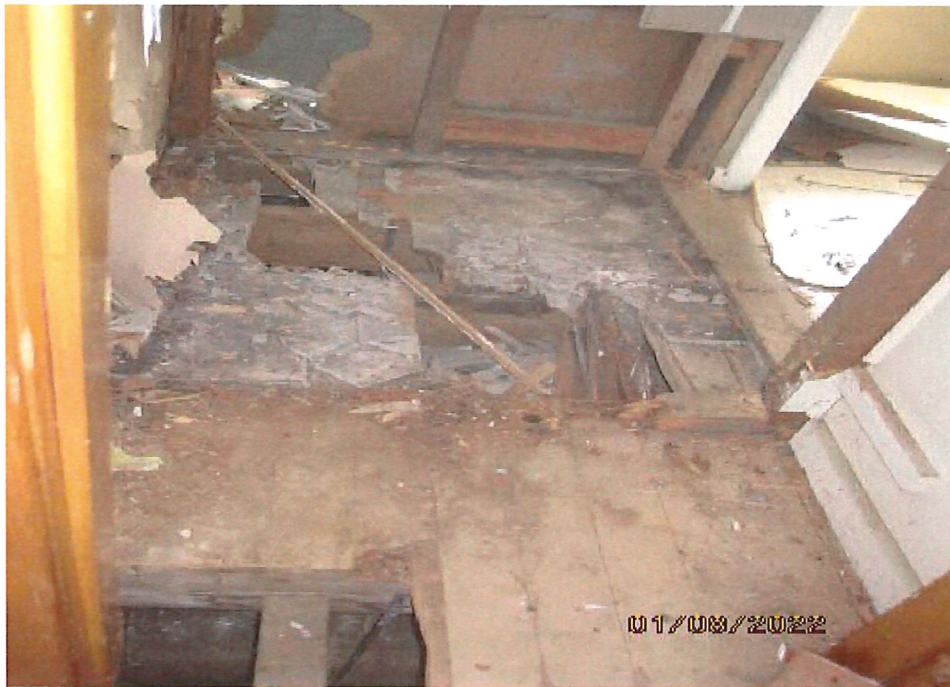
Typical view of upper floor area damage to floors and wall linings.

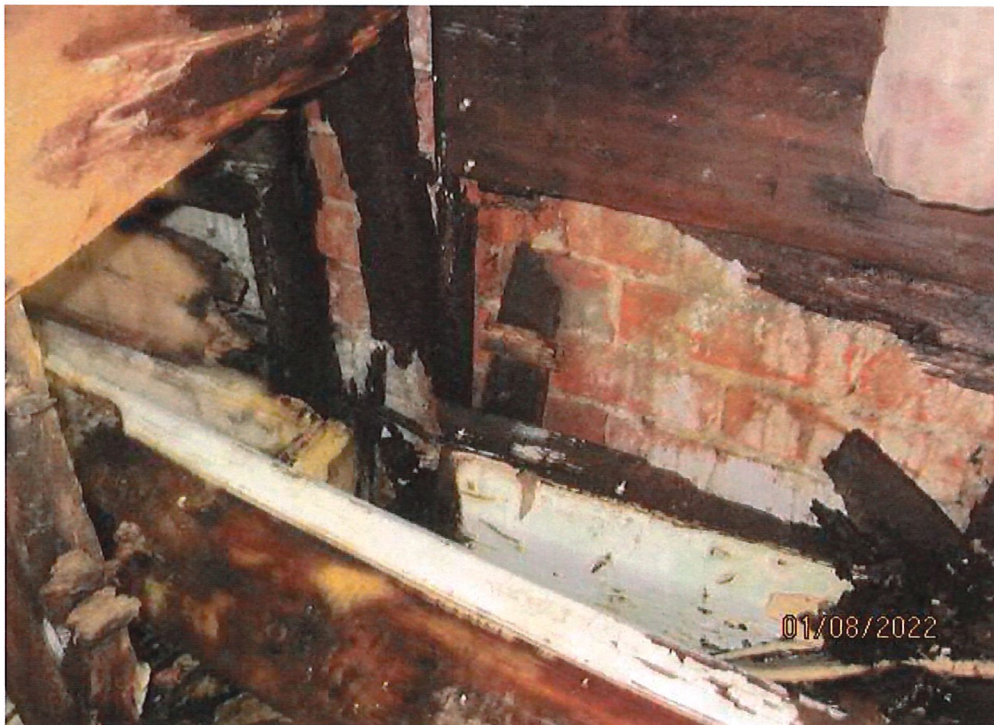
Water damaged and rotten timber wall framing to exterior wall, flooring and wall linings have also rotted away

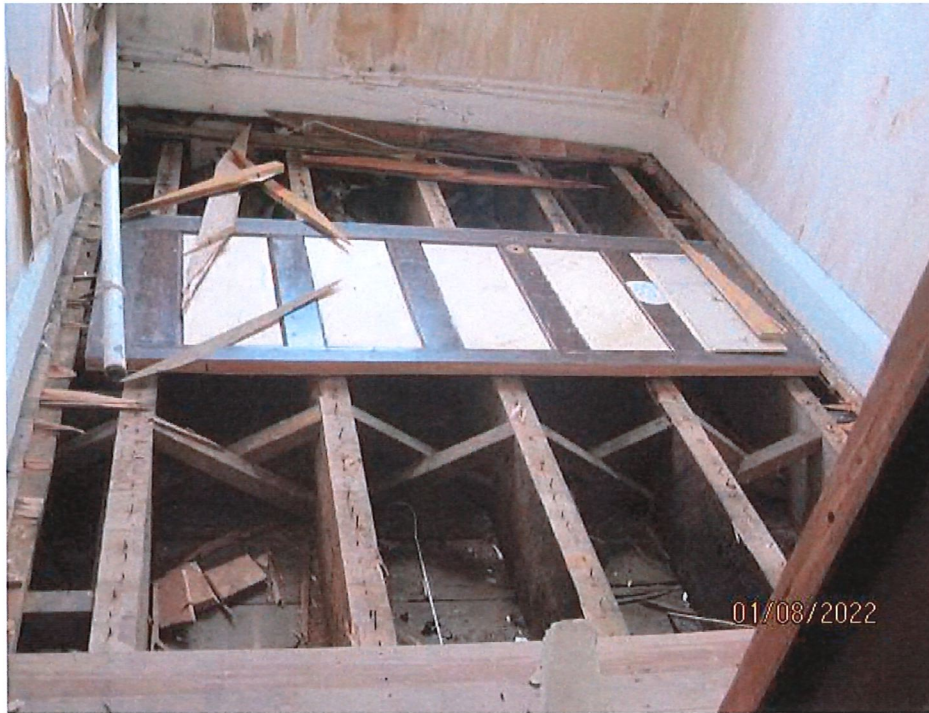
Flooring removed at first floor level typical in many rooms. Typically there is no physical connection between the floor joists and the exterior brick walls to restrain the walls

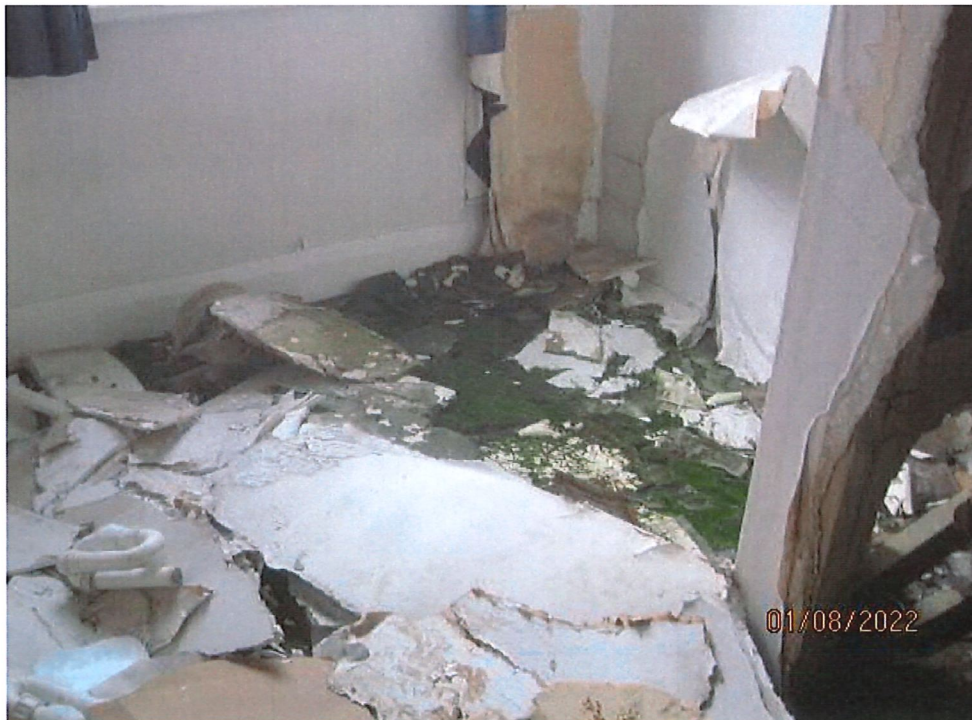
Typical damage to wall linings and the floor covered in moss from saturated flooring from water entering above. Condition of flooring and joists is likely to be deteriorated due to the saturated timber

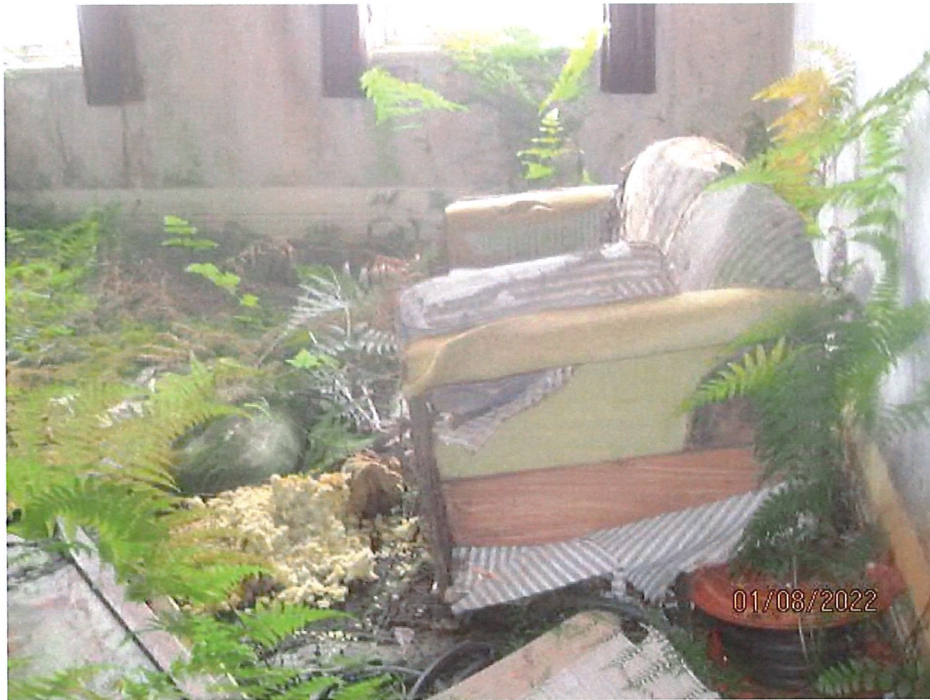
Extent of water damage over time and buildup of vegetation in one of the rooms. Room was deemed to be dangerous to enter

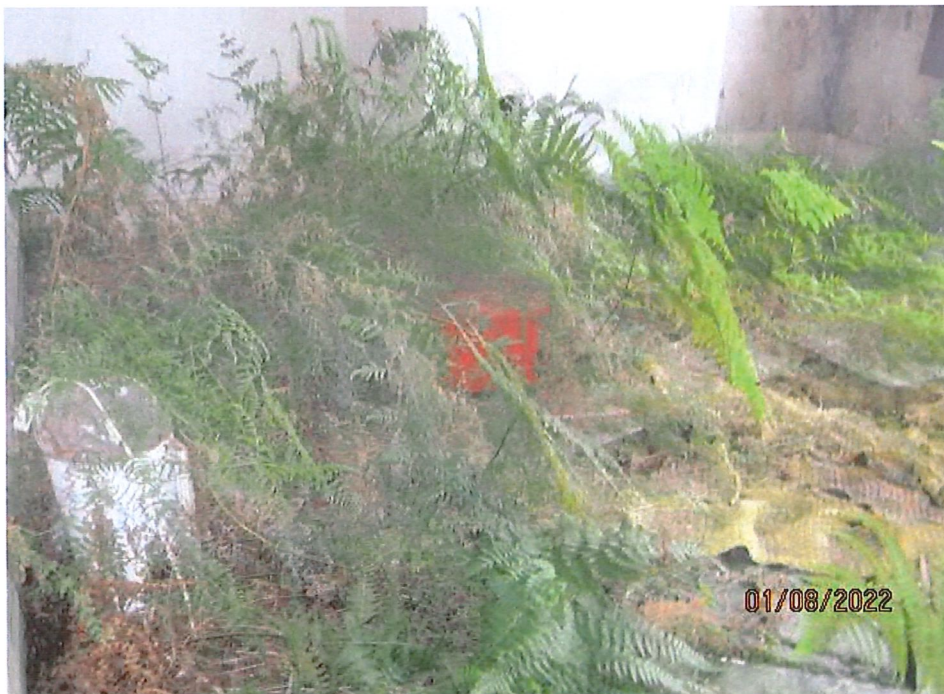
Additional view to rest of the same room showing even heavier buildup of vegetation. There is black mould on the walls also

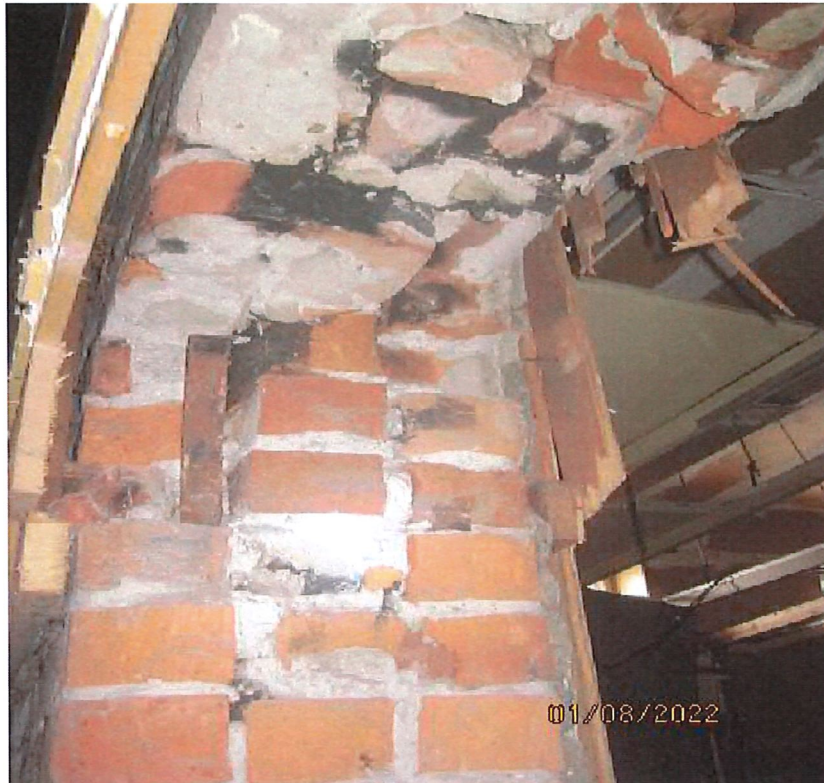
Condition of a brick opening punched through a ground floor masonry wall. No lintel or trimming frame to support wall loads from above. note areas of fire damaged brick from original fire in 1914.

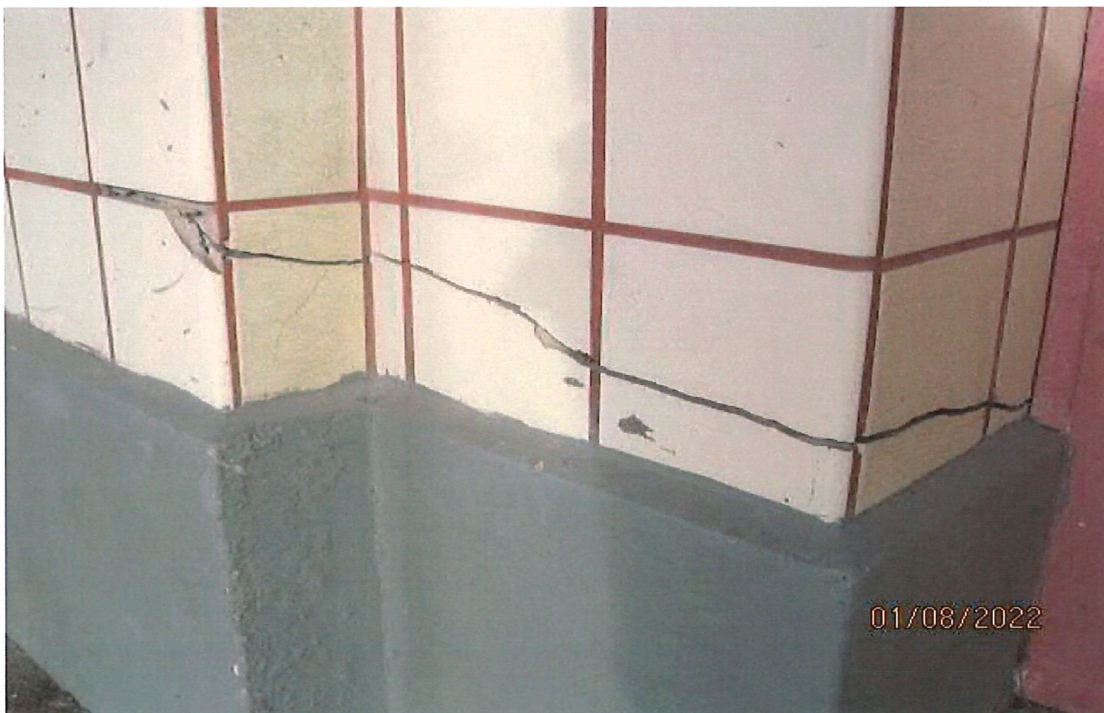
Large open tension crack visible to the base of the column by ground floor main entry door

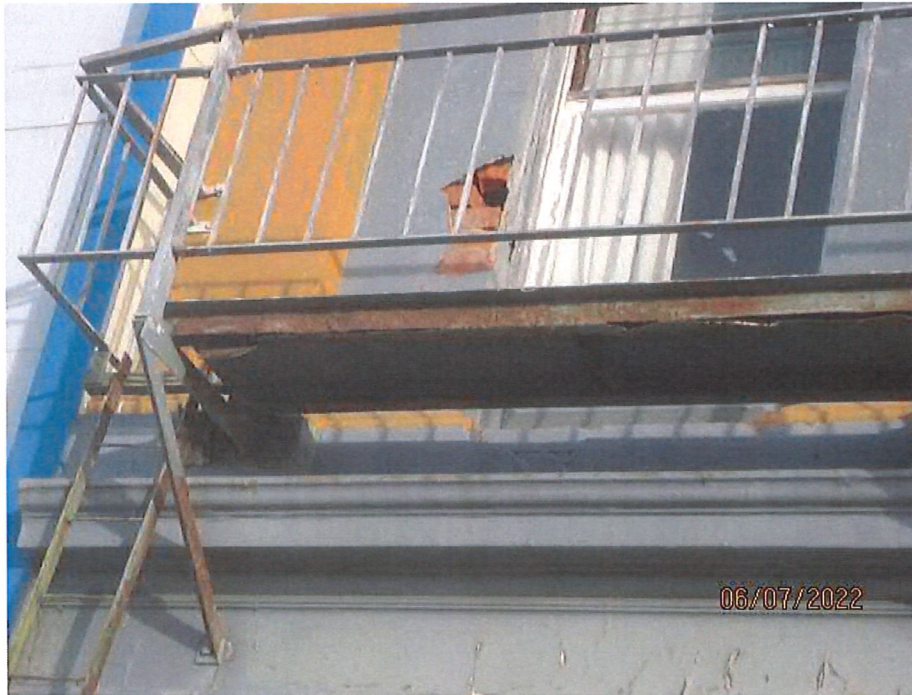
Typical exterior view of heavy steel fire escape at first floor level in poor condition and with fixings into the brick façade of unknown condition. Note also damage and spalled brick work to left of window. Extensive cracking in beam over lower openings visible at bottom of the photo.

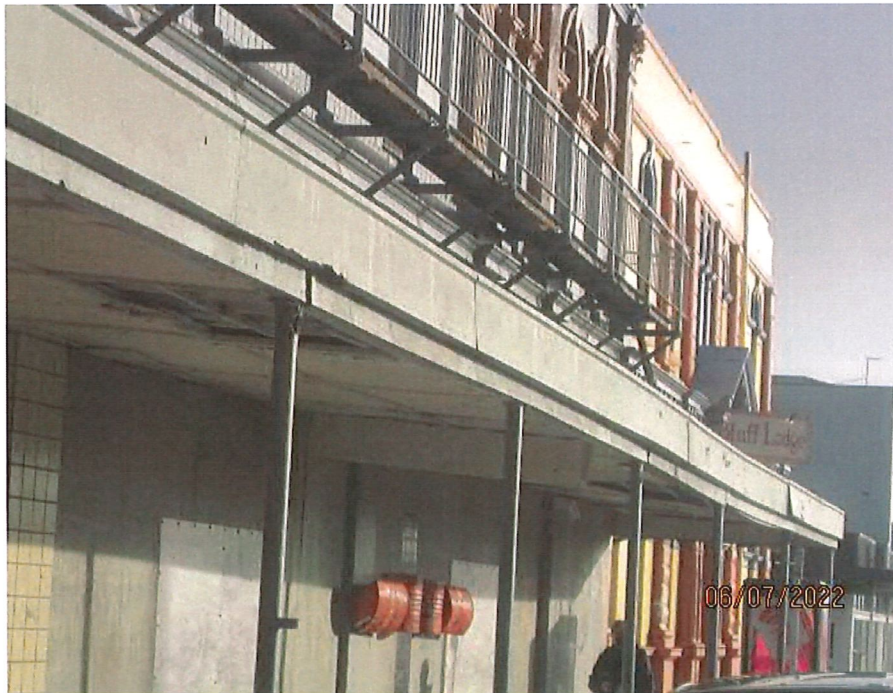
View along front façade showing veranda in very poor condition and the corroded fire escape above.

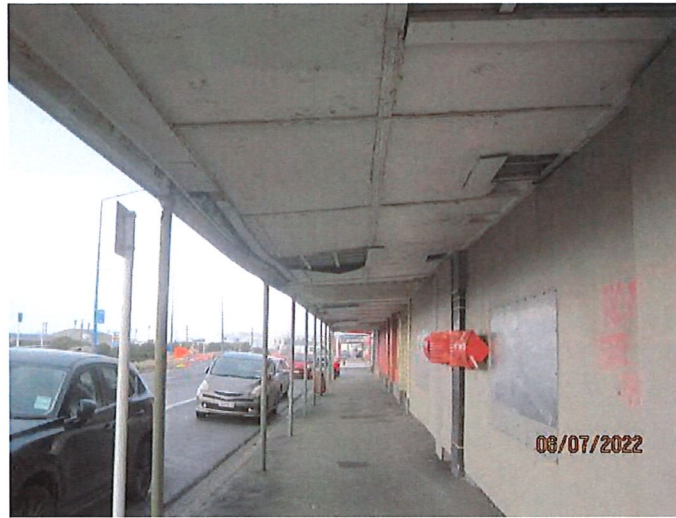
View of soffit lining to veranda in poor condition and supporting timber framing.

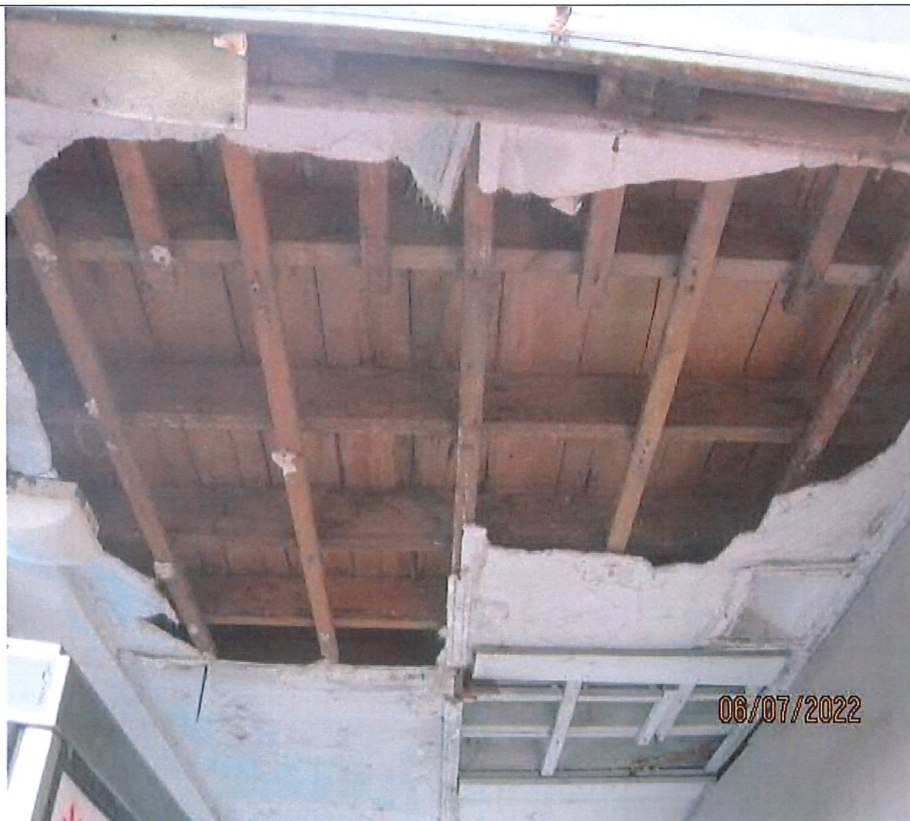
Closeup view of damaged and collapsed soffit lining showing typical construction

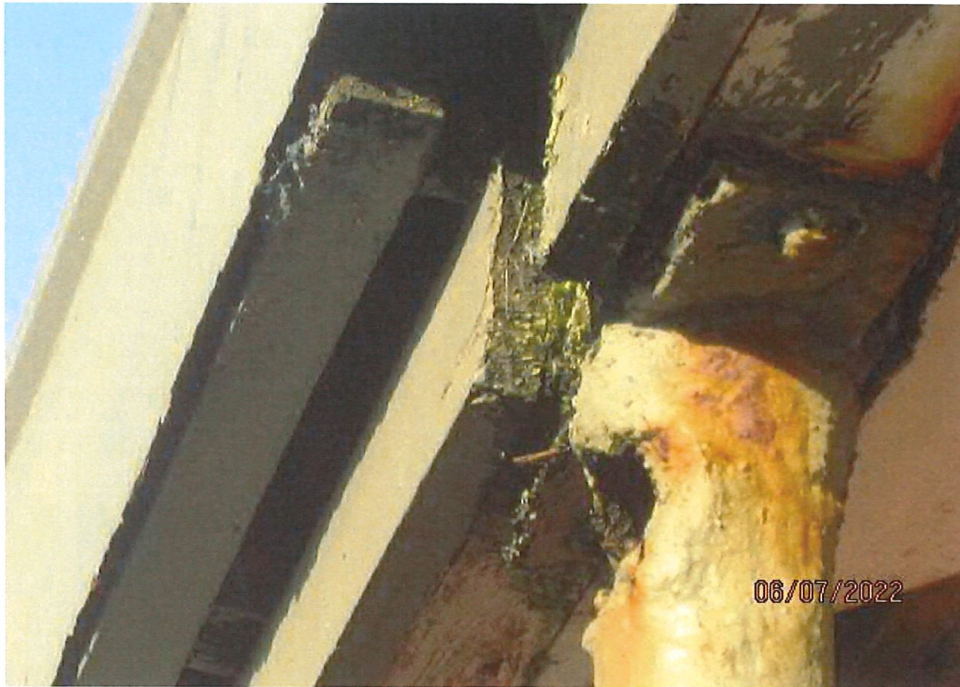
Typical view of veranda post heavily corroded and in very poor condition and the supported beam above

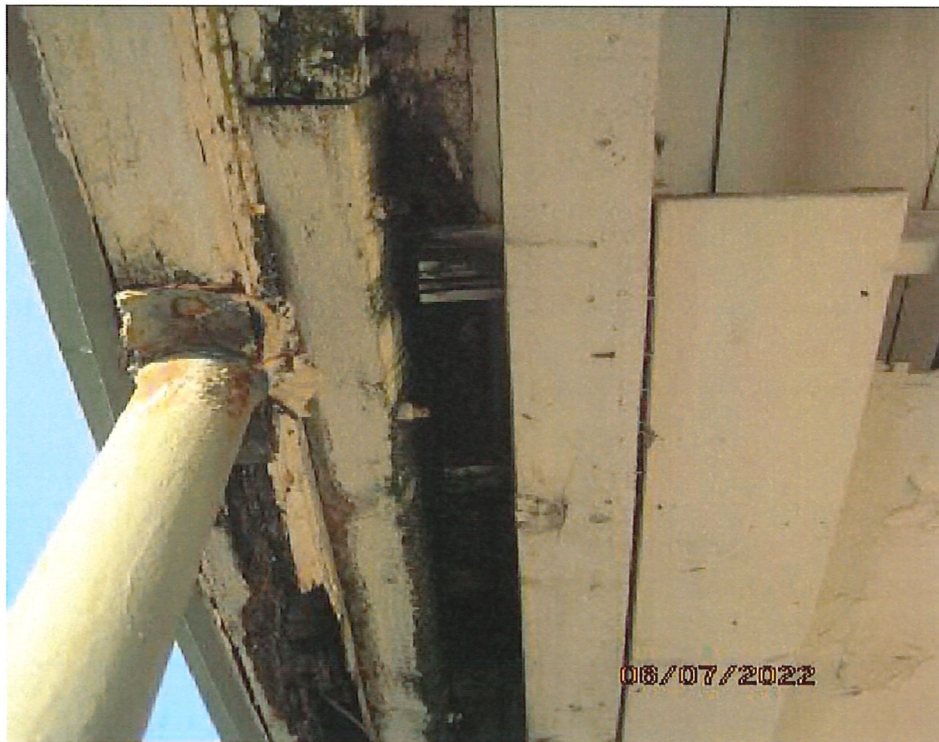
View of a similar post in poor condition and badly rotten beam above

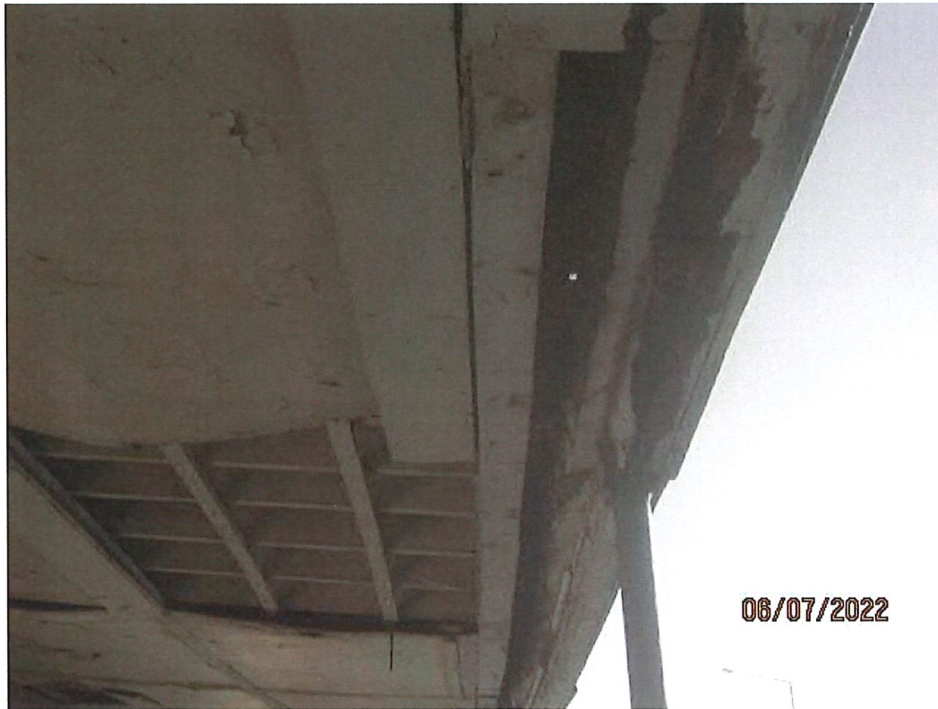
Water damage to soffit linings and outer main support beam in very condition also. Very poor condition to all nail fixings

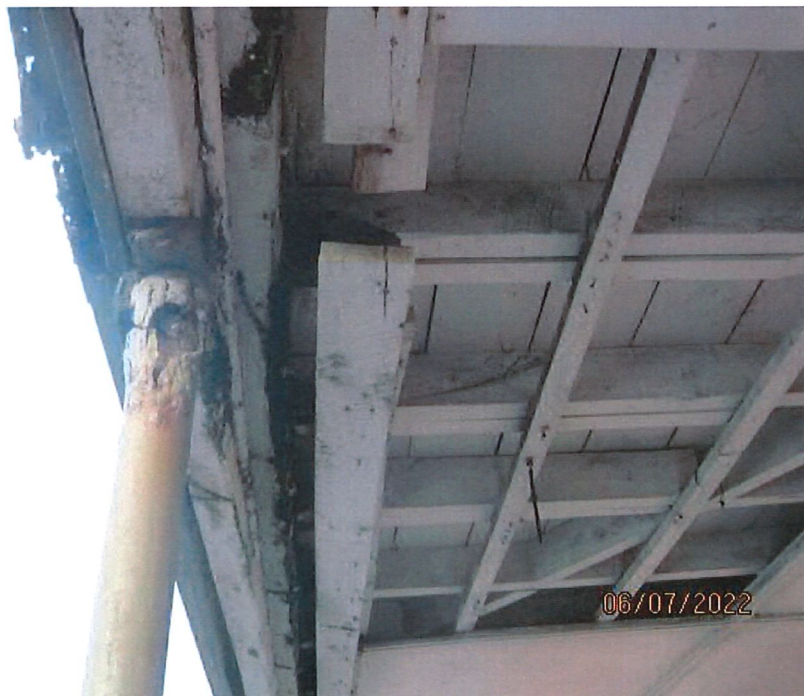
Top of post has disintegrated, and the outer beam is carrying most of the load to adjacent posts. The rafter to beam nail fixings have all withdrawn from the timber. Connection to this area of roof is very poor and on the verge of collapse.
