Government Life Building, 33 Dee St, Invercargill, 9810
DETAILED SEISMIC ASSESSMENT REPORT

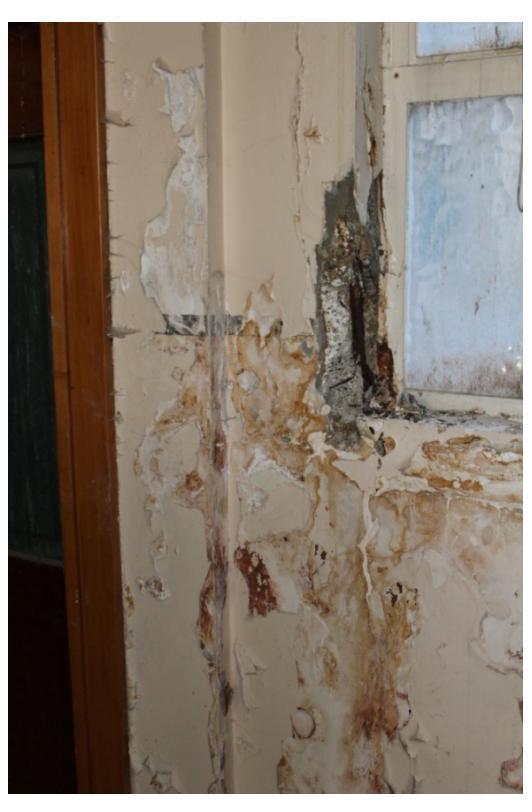
Figure 18 - Spalling concrete adjacent to window in light well area.

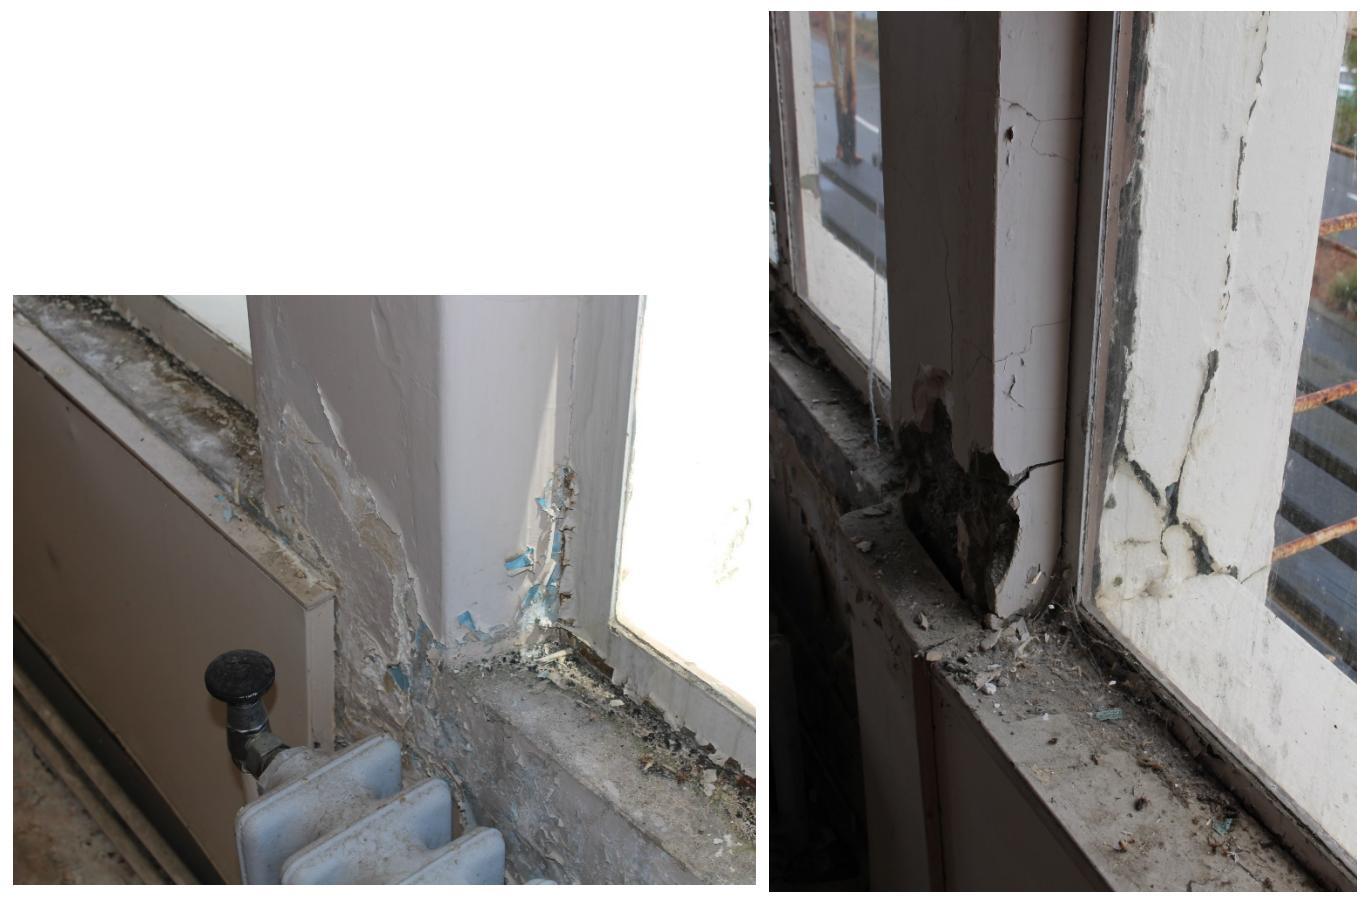
Figure 20 - Severe spalling to window mullion on West wall

Figure 20 through Figure 22 show that some parts of the structure have failed due to corrosion of the reinforcing reaching a point where the mullion in this case has failed. Temporary stabilisation of this particular mullion has been undertaken to prevent it or debris from falling onto SH6 below.

The mullion in figures 19-21 above has clearly failed due to the effects of the environment and the age of the concrete. This effect is also noted in the spandrel beams and other structural elements and will eventually, given time lead to widespread damage and potentially localised collapse of these elements.

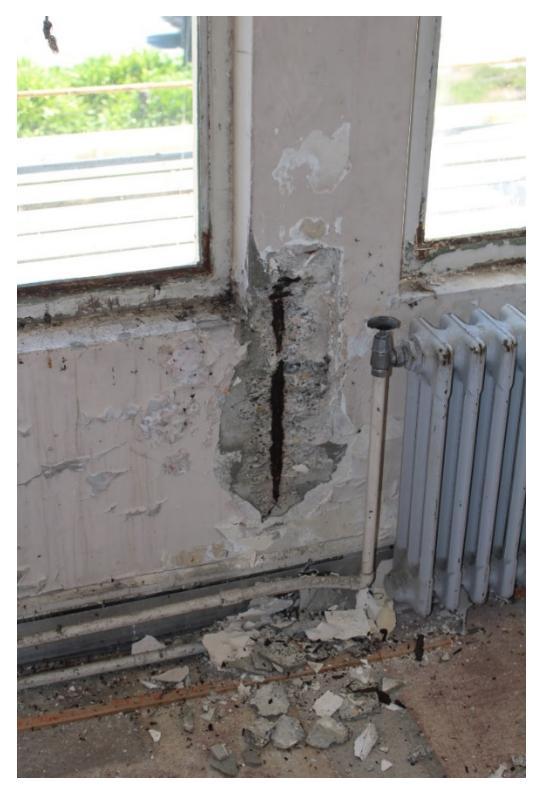
Figure 19 - Spalling to window mullion on West wall

It is clear from figure 19 and figure 22 that the vertical bars have minimal cover of approximately 20mm which exacerbates the issues as there is very little concrete outside the bar to resist the forces due to rusting.

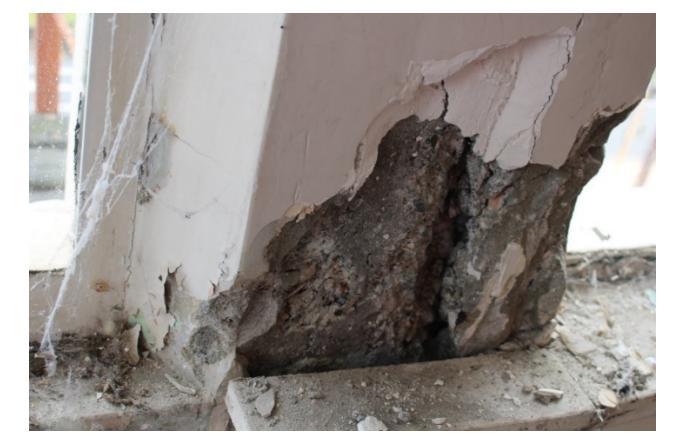
Figure 22 - Close up photo of severe cracking to mullion

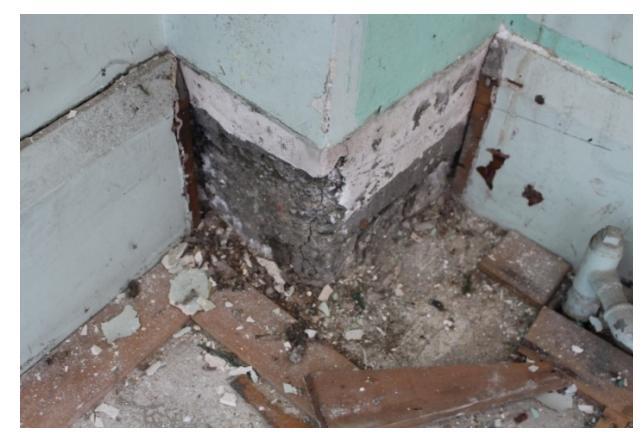
Figure 23 - SW corner column showing cracking to least exposed corner of the column

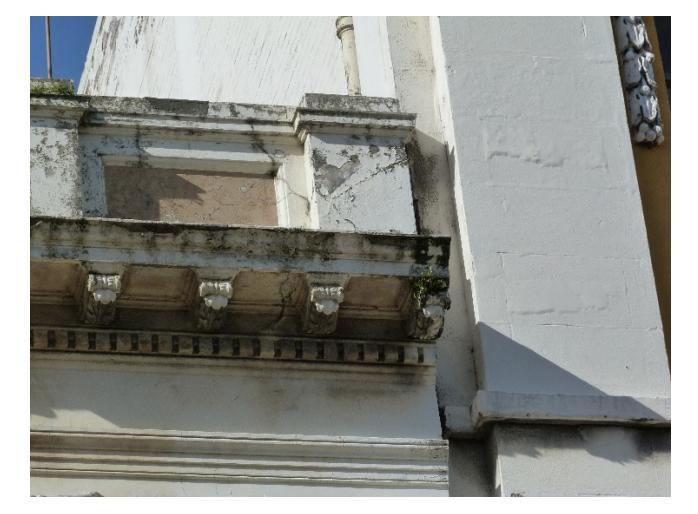
Pounding of the adjacent building on Esk St is evident as shown in Figure 23.1 and Figure 23.2.

Figure 23.1 – Pounding close up of eastern end of structure and adjacent building

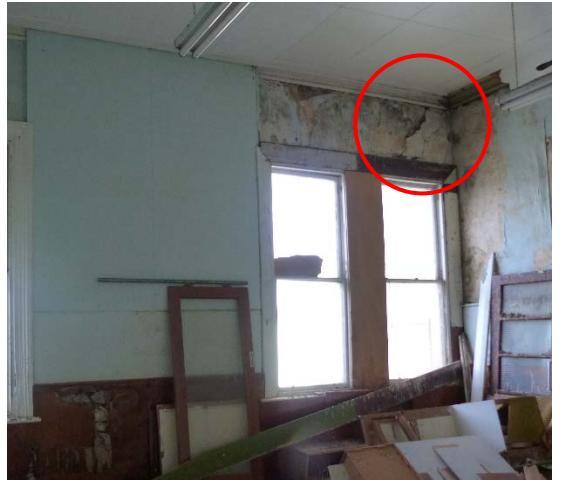
Figure 23.2 – Shear cracking inside adjacent building due to pounding with GL

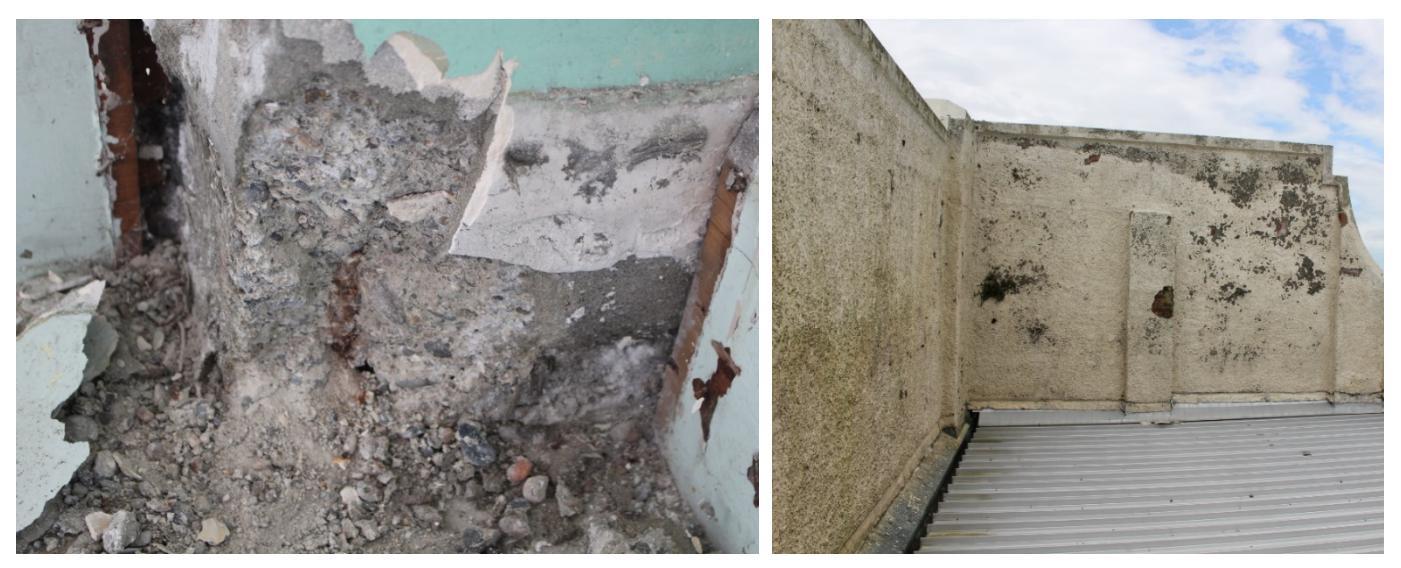
Figure 24 - Crack extends back to main column reinforcing which is rusting

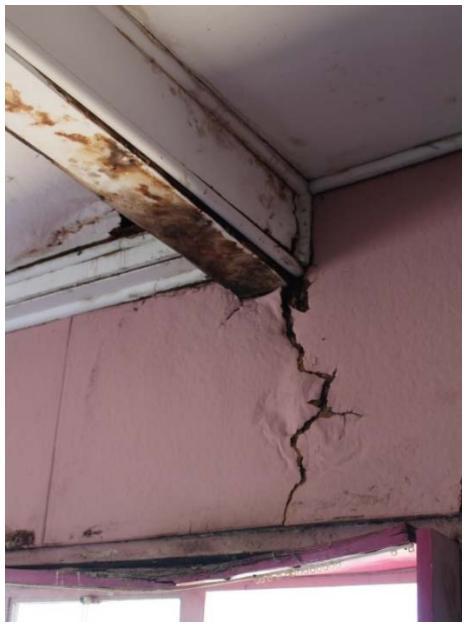
The roof is leaking in a number of areas, leading to degradation of the structure as shown in Figure 26.

Figure 26 - Roof leaks causing structural damage to beam support.

The water ingress into the roof and walls on level 4 are degrading the structural elements and will lead to loss of support to the roof structure.

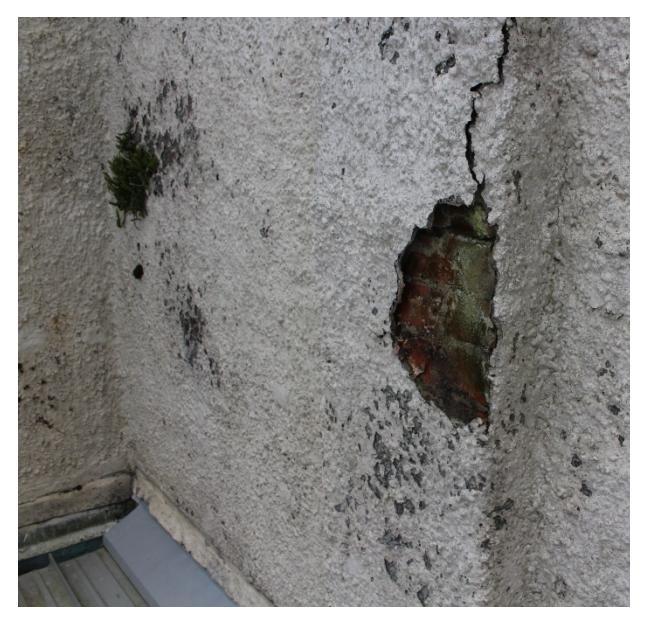
The parapets to Government Life East appear to be unreinforced brick masonry covered in plaster which is spalling off in some areas as shown in Figure 25. The mortar strength is weak due in the main to weathering and age.

Figure 27 - Spalling plaster over brick substrate

The brickwork to the parapets is exposed to the weather over a large area where the plaster and paint have degraded. The mortar is weak in these areas leading to a reduction in strength in these already weak elements.

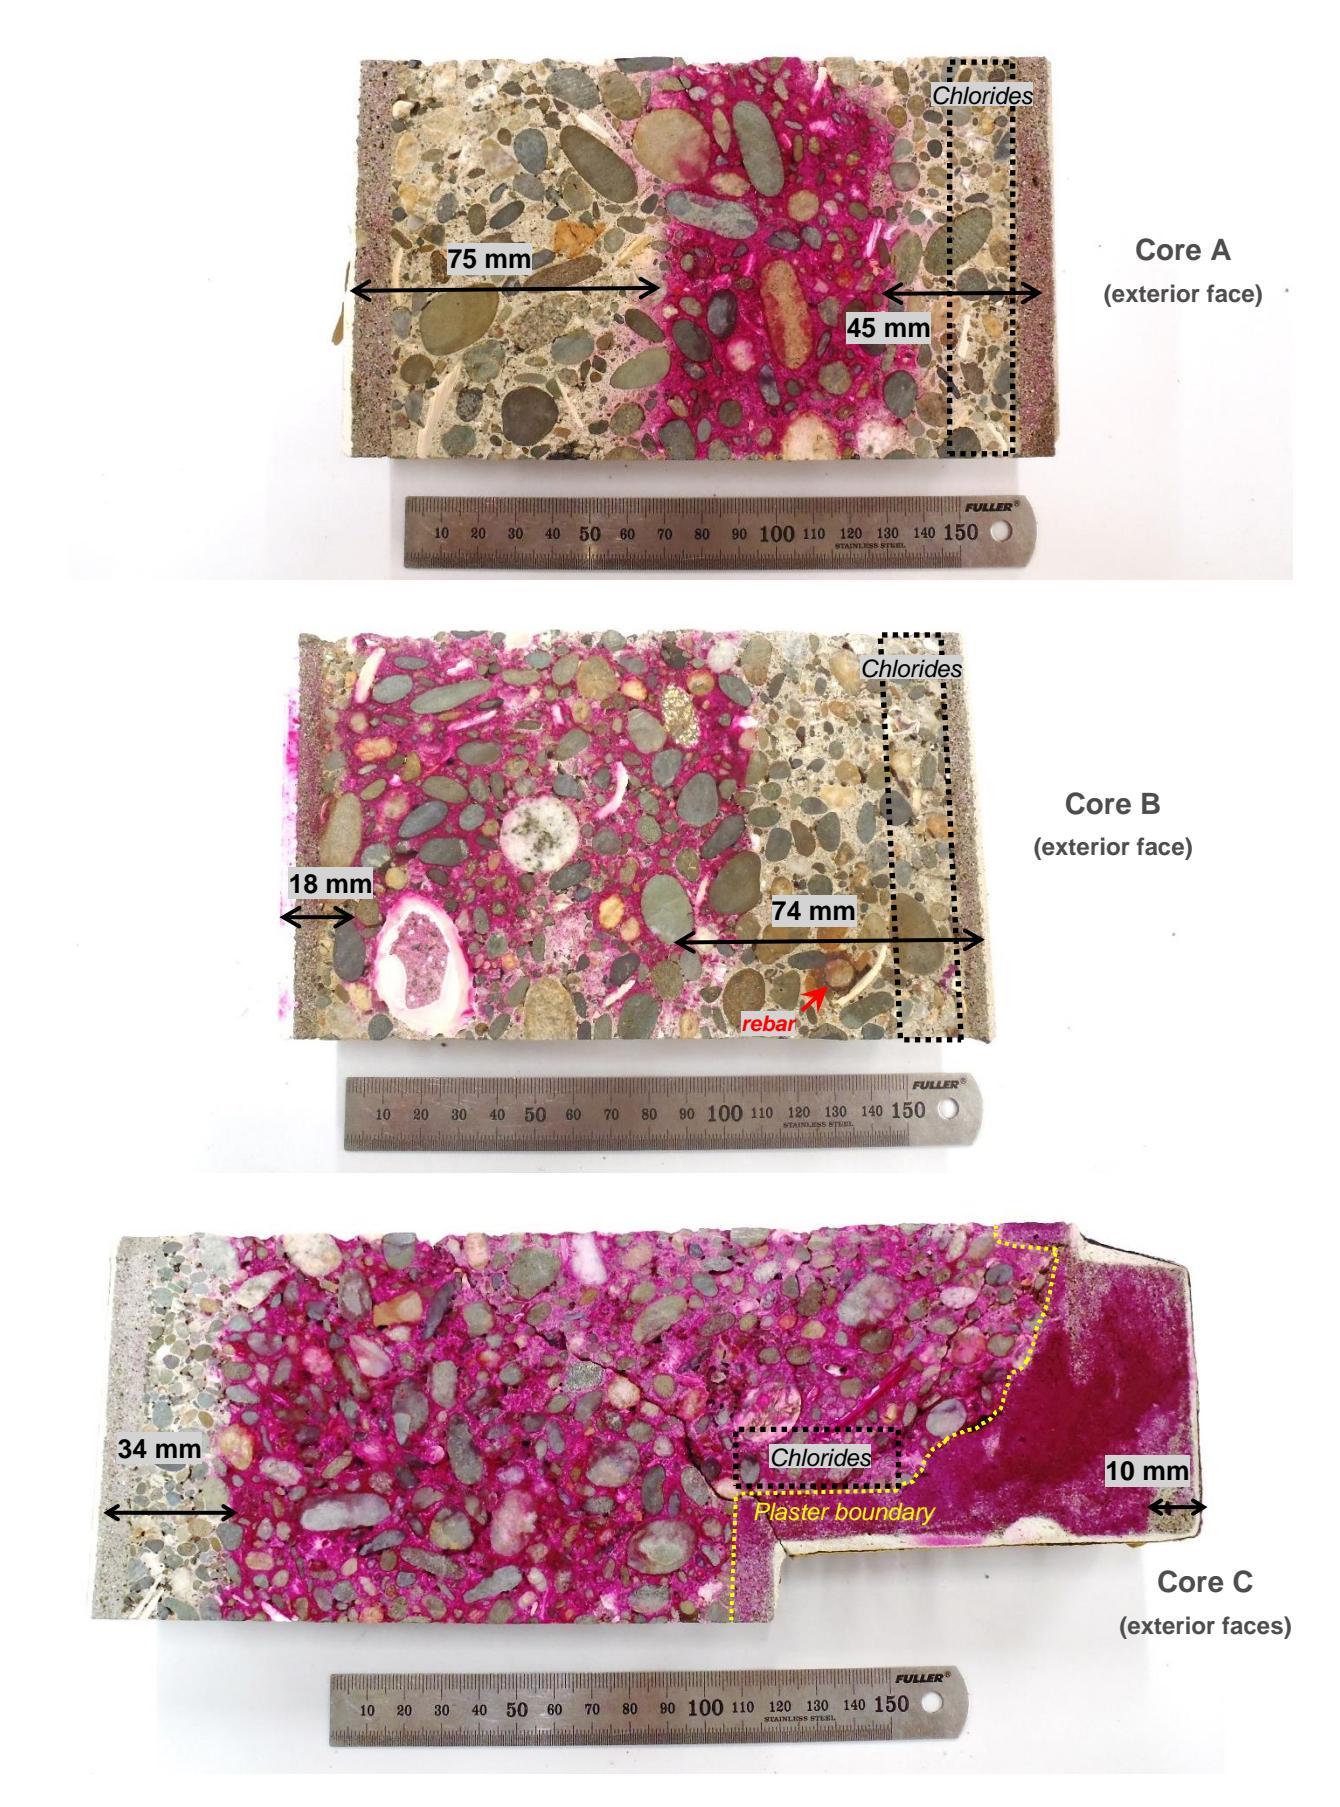
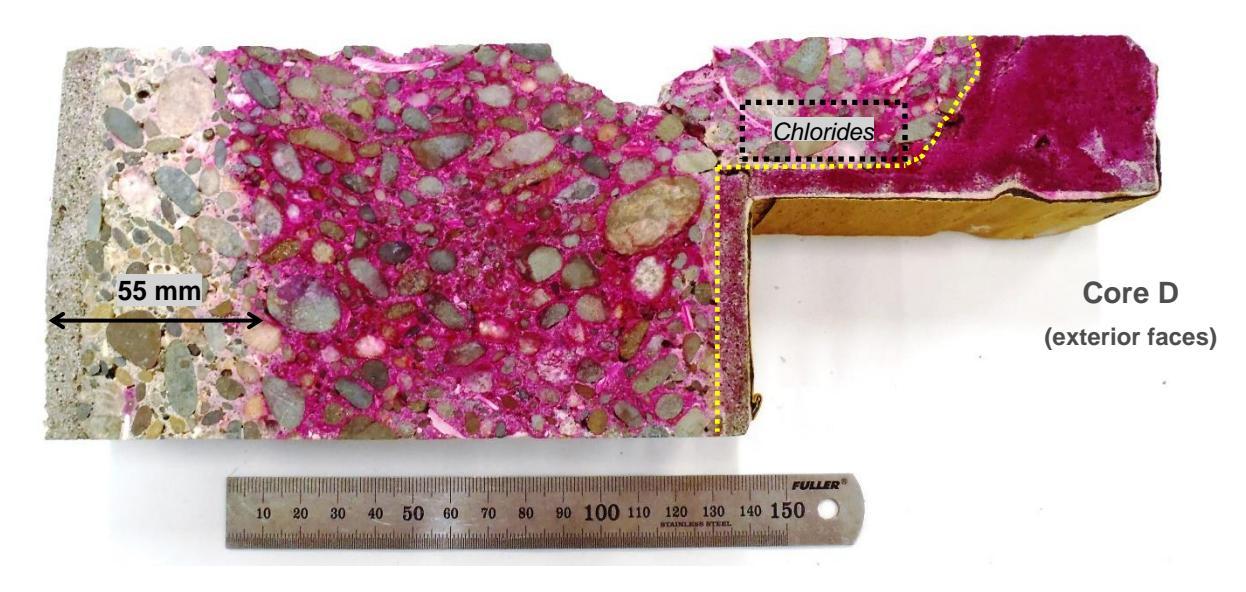
- Variable carbonation through the cores (Figure 1), which likely reflects differences in the quality of consolidation and local internal relative humidity due to micro-exposure environment. The maximum carbonation depths likely exceed typical cover depths, indicating depassivation of at least some fraction of the reinforcing steel and hence a current vulnerability to corrosion.

Figure 1. Longitudinal slices through the cores, photographed following application of the phenolphthalein reagent. The arrowed lines indicate the approximate maximum carbonation depth from each exposed end of the core. The approximate position from which the chloride sample was removed from the matching longitudinal slice is also indicated.
