Southland Times Building, Strengthening Concept to 100%NBS(IL2), Invercargill, Southland.

BMC Reference: 1711-2266

Date Issued: 22/01/2019

Summary of Southland Times Proposed Strengthening Provisions for 100%NBS (IL2)

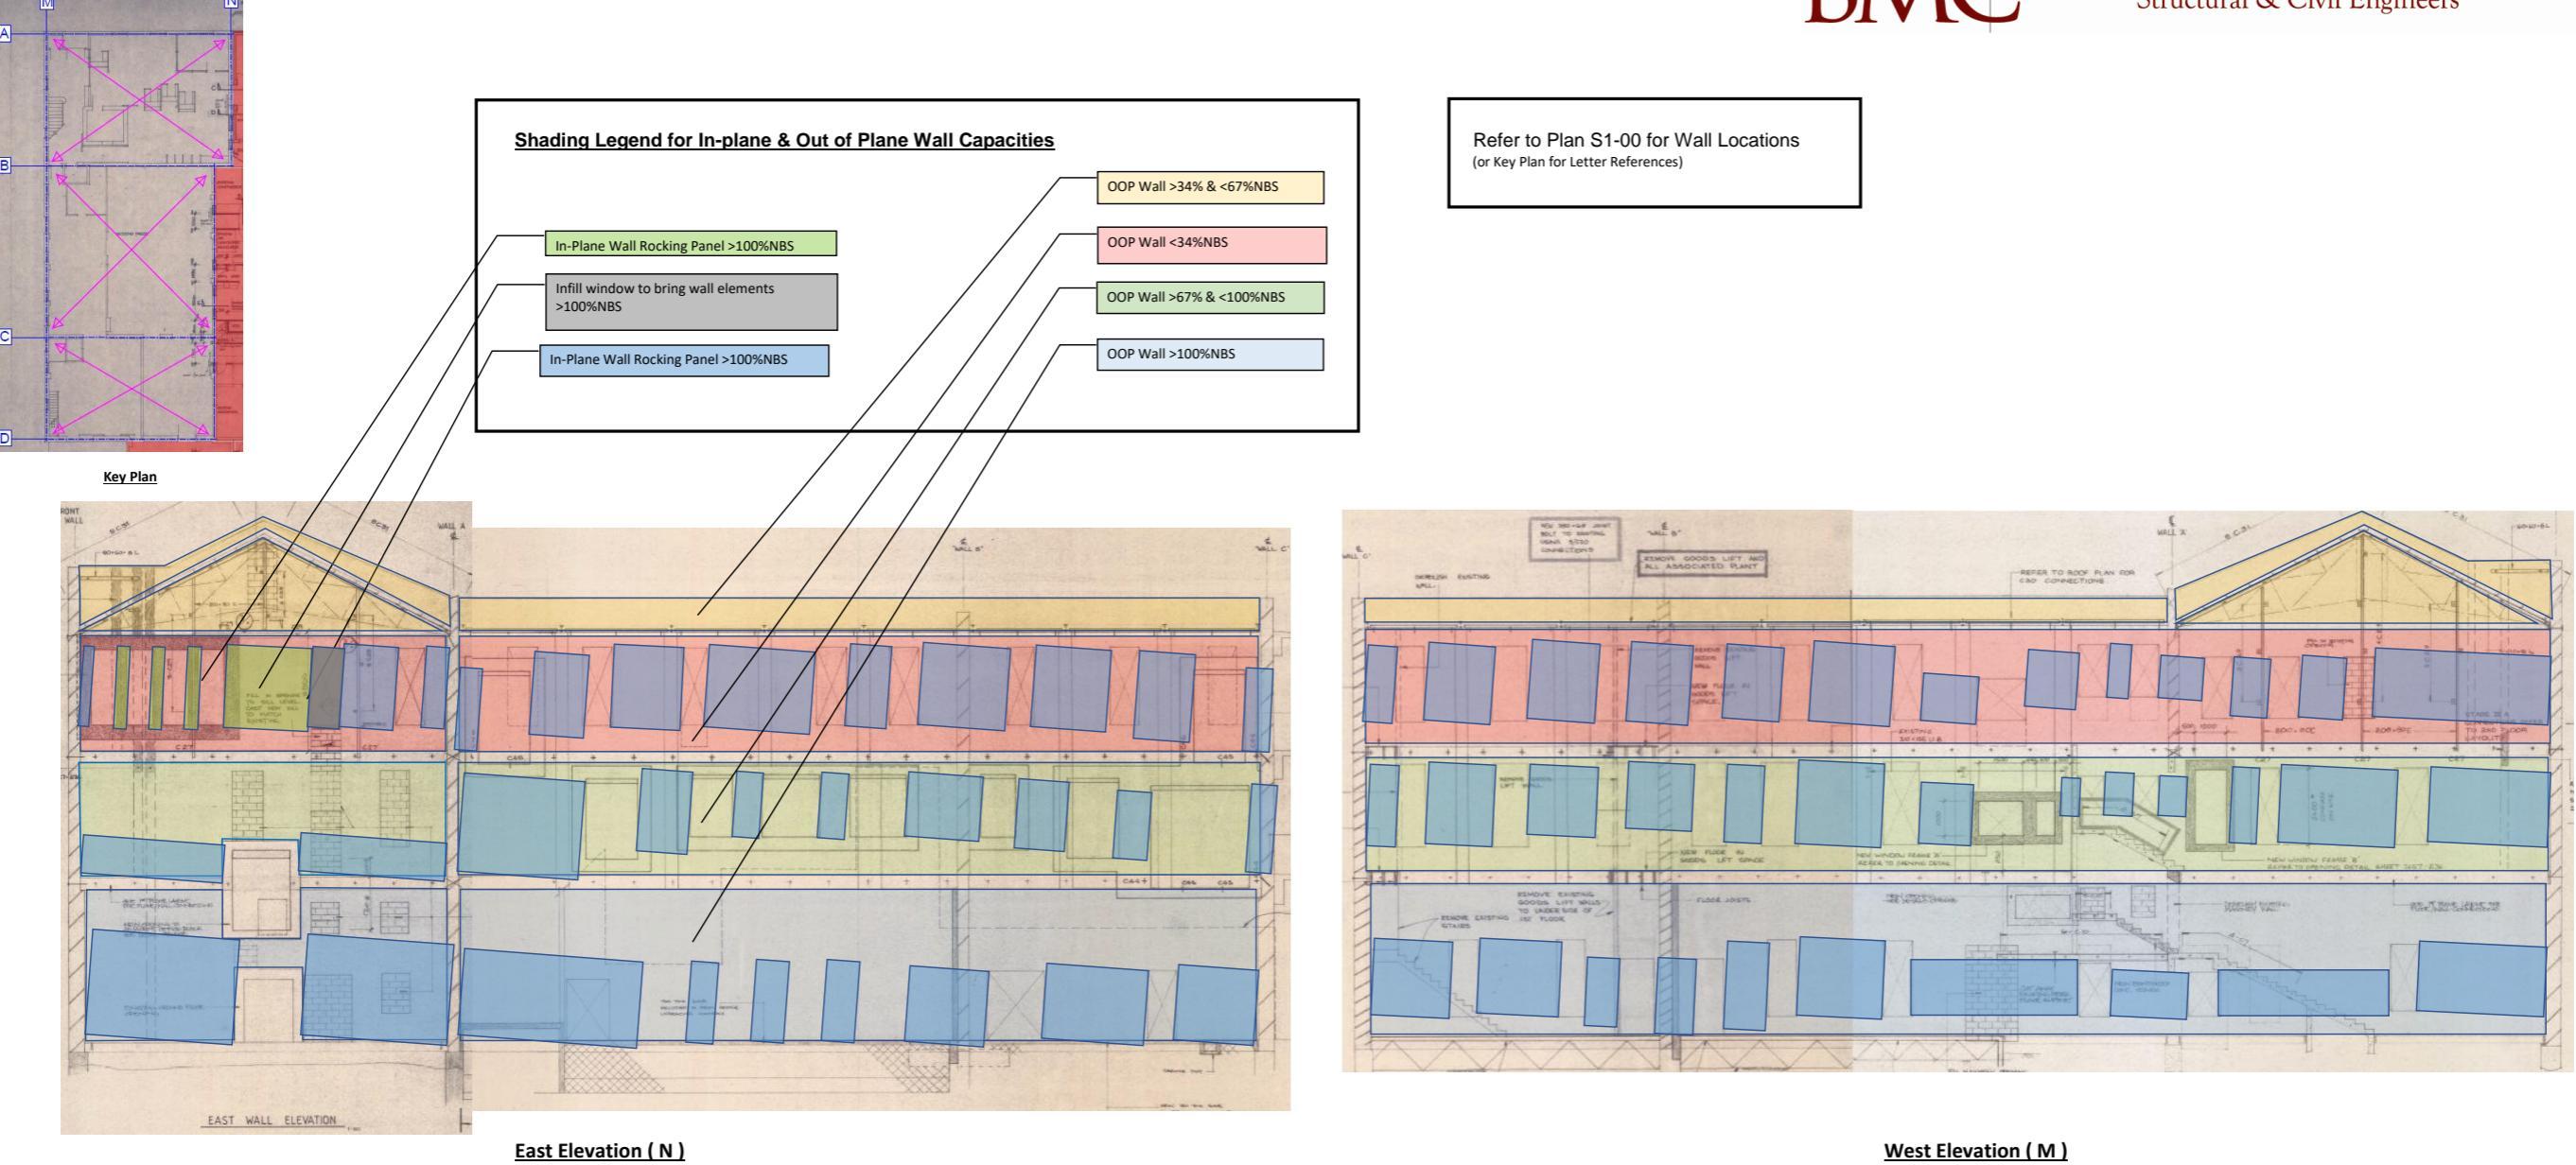
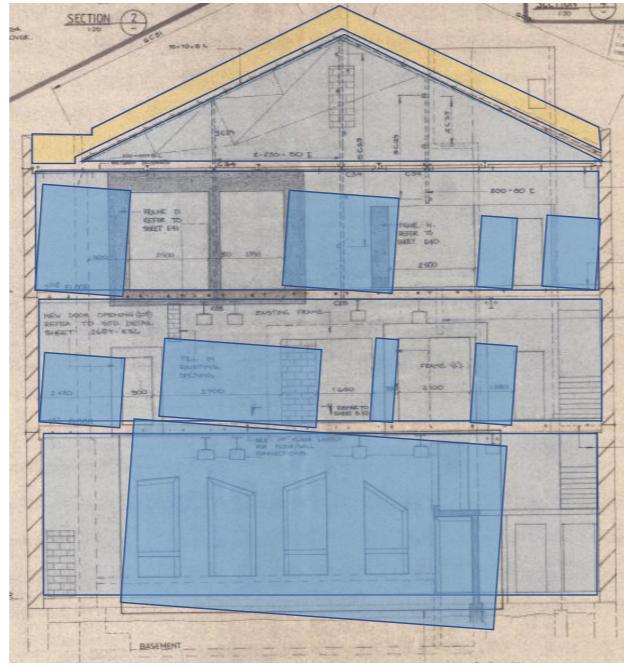
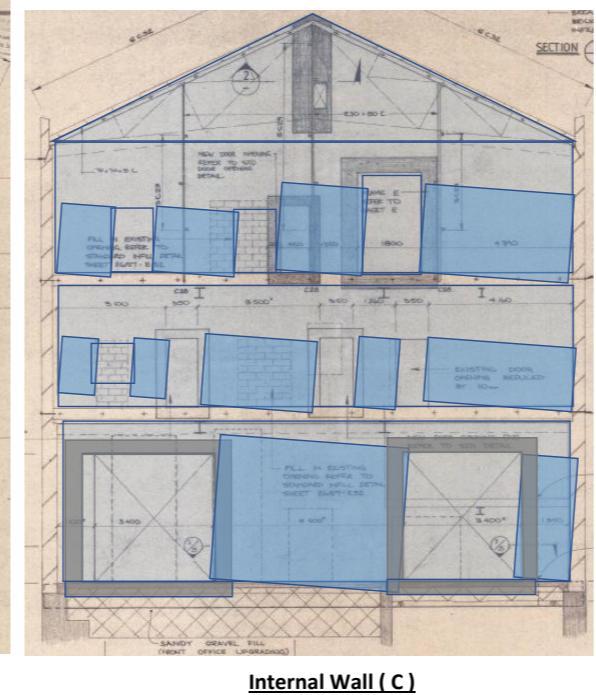
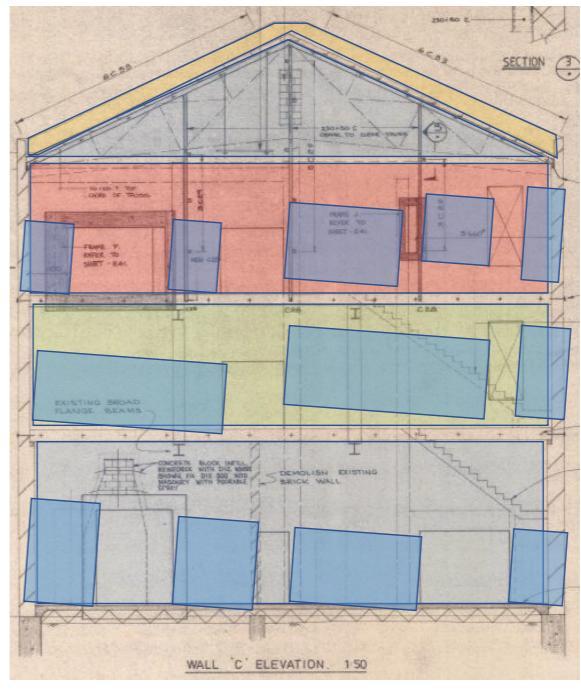
Southland Times Existing Wall Seismic Rating (%NBS (IL2))

In the DSA we derived the Figure 16 and 17 sketches to illustrate the relative deficiencies of the building components to the Façade (Typical Transverse wall) and the West elevations (Typical Longitudinal wall) only. To enable the full extent of the 100%NBS (IL2) remedial works to be identified this technique has been used to incorporate all of the wall elevations both externally and internally. See page 2 for these outputs and an illustration of the Out of Plane and In-plane remedial works locations to the walls of the building.

It can be seen that the structural elements of concern relate to: Wall capacities Out of Plane (OOP), Wall Capacities In plane (IP), Roof and Floor diaphragm strengths and Diaphragm fixings to the walls.

The detailing required to strengthen the respective elements to the 100%NBS (IL2) capacity have then been detailed in the drawings appended to this report comprising Drawing No's 1711-2266, S1-00 to S1-02 dated 22/01/2019, Rev C1.
