Appendix 7: Structural Assessment – BECA

Initial Seismic Assessment Report - 57-81 Dee Street, Invercargill

We have now completed an Initial Seismic Assessment (ISA) of the buildings situated at 57-81 Dee Street, Invercargill including the buildings situated at 7 and 11 Don Street, Invercargill using the Initial Evaluation Procedure (IEP) as described in Part B of the guidance document *The Seismic Assessment of Existing Buildings - Technical Guidelines for Engineering Assessments*, dated July 2017 (*Technical Guidelines*). The assessment was carried out after completing a site visit, an internal and external walk over visual non-intrusive inspection and a review of the available plan drawings.

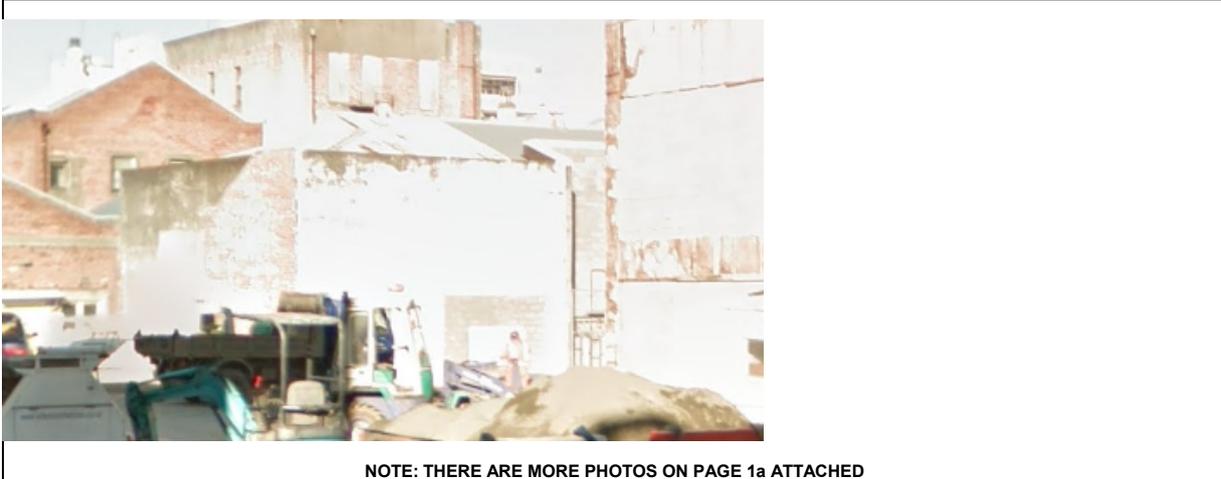
1.1 Photos (attach sufficient to describe building)

Constructed in circa 1969.
 Used as retail (currently vacant).
 Plan area of building is approximately 250 m2
 Two storey rear extension of original Deka building.
 Structural system
 The gravity load resisting system comprises steel portal frames.
 The seismic load resisting system comprises concrete shear walls in the transverse (east-west) direction and steel portal frames in the longitudinal direction (north-south) direction.
 The first floor is composed of a concrete suspended slab, fixed into the surrounding concrete walls.

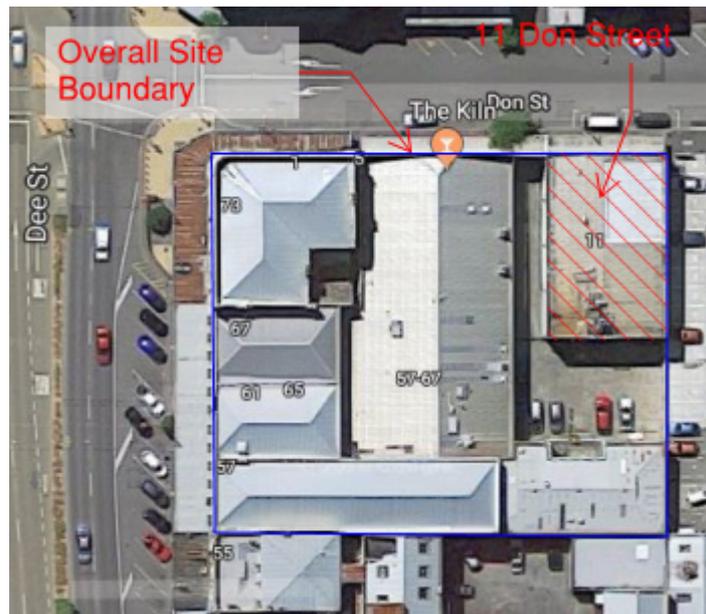
11 Don Street is a two storey reinforced concrete frame building with concrete block infill panels. The building has a full reinforced concrete basement over building footprint with reinforced concrete beams, columns and floor construction at ground floor and first floor. The roof appears to be light weight construction on either structural steel or timber roof framing.

This building is well constructed and is in good condition.

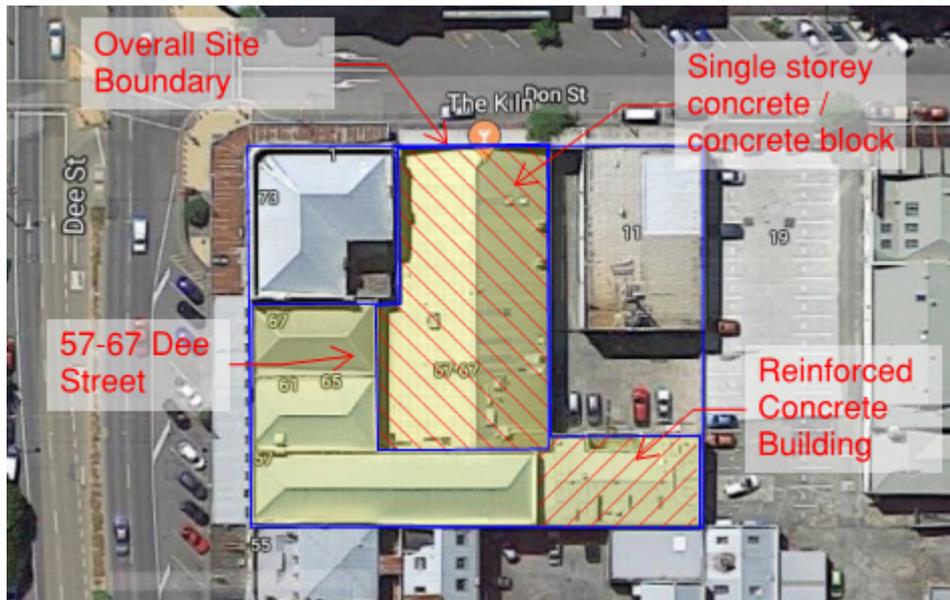
57-67 Dee Street

The remainder of this building is the “old DEKA” building from 57-67 Dee Street. This building is a two storey predominantly unreinforced masonry (URM) with significant alternations from the original building fabric for the past retail usage. There is a partial basement over the footprint of the building (refer attached drawing 5320381-EW-SK001). The basement is constructed of concrete with the URM walls from ground floor to roof. The internal floors are timber with structural steel/timber gravity beams for both the ground floor and the first floor with a timber framed roof over and light weight cladding. We expect that some of the remaining URM construction in this section of the building is part remnant of the original Langlands block buildings. The Langlands block buildings were a continuous URM construction along Dee Street from Esk to Don Street.

These conglomeration of buildings are in varying condition with the reinforced concrete and concrete block building sections appearing to be in relatively good condition.

The two storey URM building and partial basement condition is typically for the age of the building. The basement is not fully water tight and the upper sections of the building have been cut about to effect usage to the ground floor bar areas. There was no specific distress noted to the URM elements of this building. We would typically consider the mortar in this age of building to be relatively soft and the brick strength to be moderate.

It is noted that portions of these buildings are URM and as such are considered to be earthquake prone. In the event of demolition the contractor shall take adequate precautions during demolition to ensure that demolition is undertaken in a controlled fashion, and any additional precautions for compliance with Health and Safety are in place.

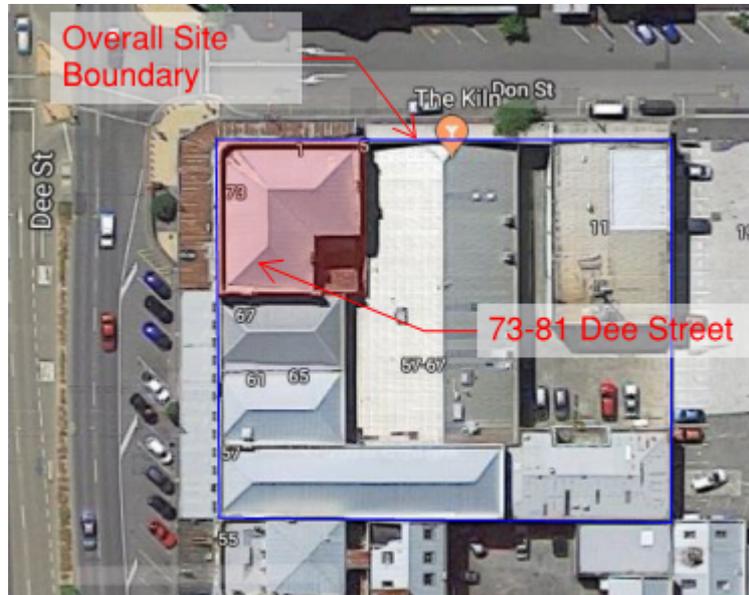
The building is a three storey unreinforced masonry building with typically double and triple brick structural load bearing walls with internal timber floors at ground, first and second floor levels. The roof is timber framed with light weight cladding

The building has a partial basement over the footprint of a relatively low depth (approximately 2.2m below ground floor level) constructed on concrete. It is specifically noted that there is a services recess formed in both the Dee Street and Don Street frontages of the basement. There are exposed services in these recesses and we are not aware of any future requirement to access these services.

The condition of the “Langford building” is typical for the age of building. There is some distress noted in the external façade with cracks evident through the external plaster work and URM construction at window spandrel beams, parapet level and at several other locations. The internal floors are in good condition with the floor joist being recessed into the load bearing brick walls. This provides a gravity connection only with lateral load transfer unpredictable from this type of connection.

The basement is not water tight and is of a very low stud height (1.8m). There does not appear to be significant area of degradation in the basement area which would suggest any settlement issues of the structure.
