6.14.3 On Site Observations: Zookeepers Café (50 Tay Street)

The extant building at 50 Tay Street was constructed in 1916 and is currently occupied by Zookeepers Café. Major alterations were undertaken on the interior and façade in the 1950s and several minor renovations have been undertaken since then. The following description of the building follows from the site visit conducted by Dr Dawn Cropper and Dr Naomi Woods on 18 April 2018.

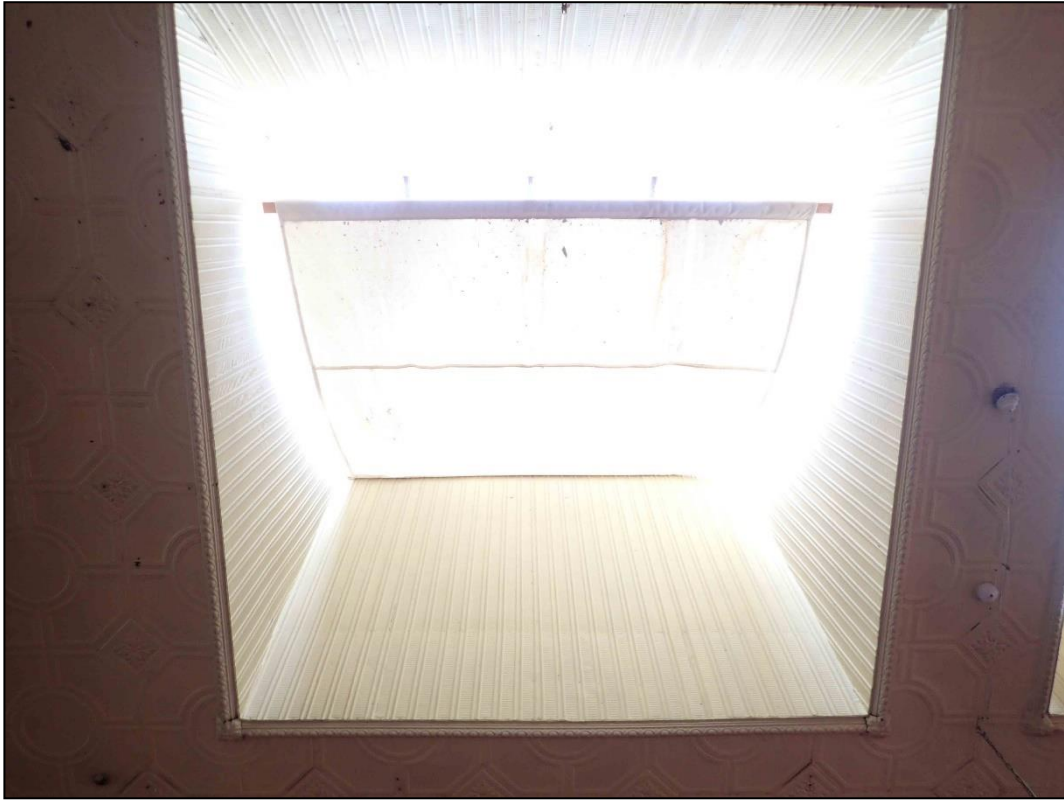
Figure 6-376. Skylight lined with pressed tin in ceiling of 48 Tay Street.

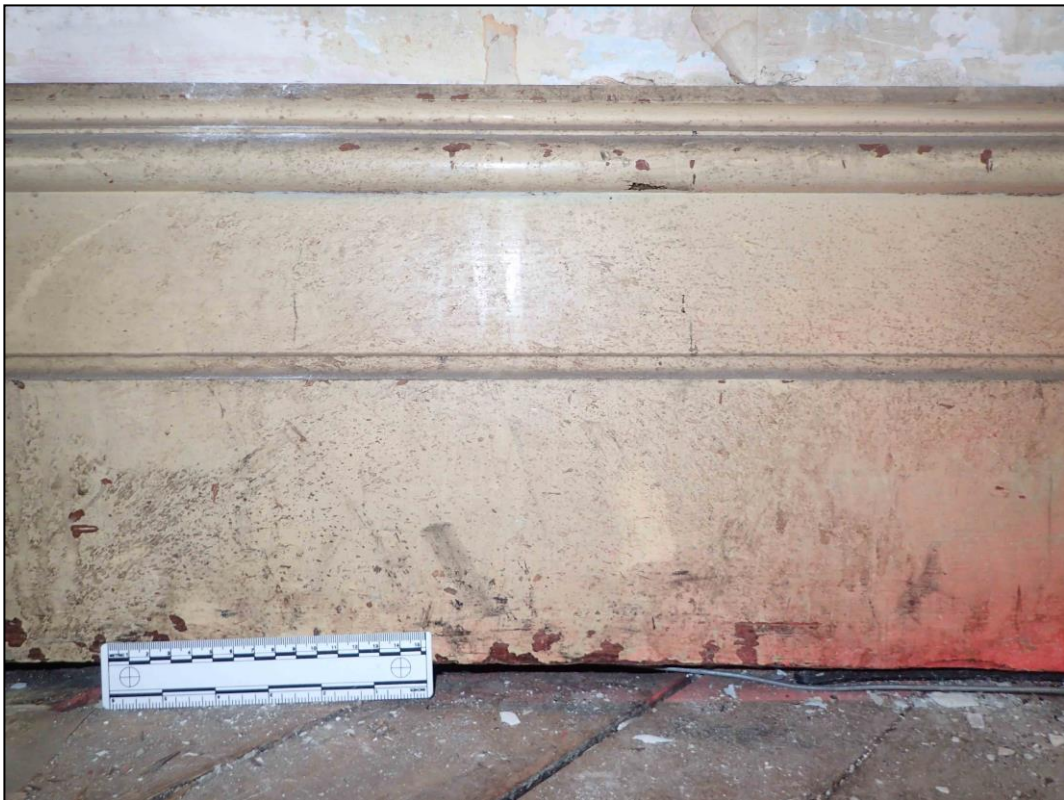
Figure 6-377. Moulded skirting on south wall of Room 3.

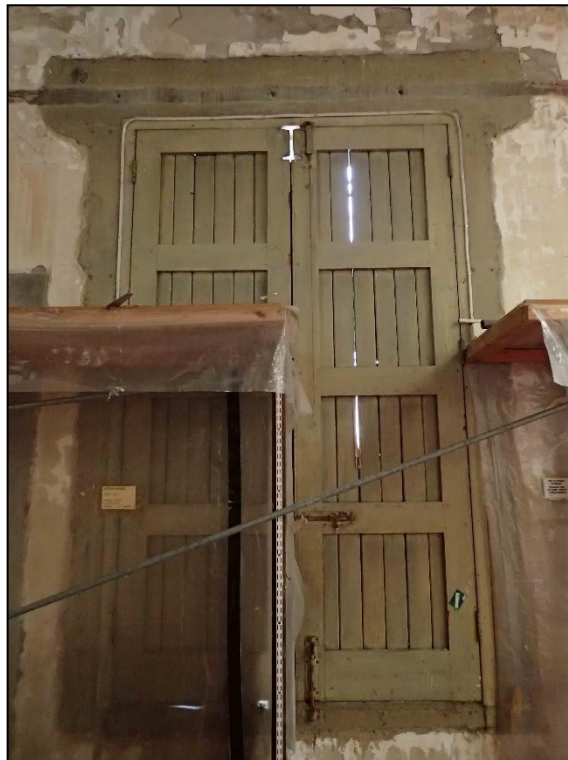
Figure 6-379. Loading door in east wall of Room 3.

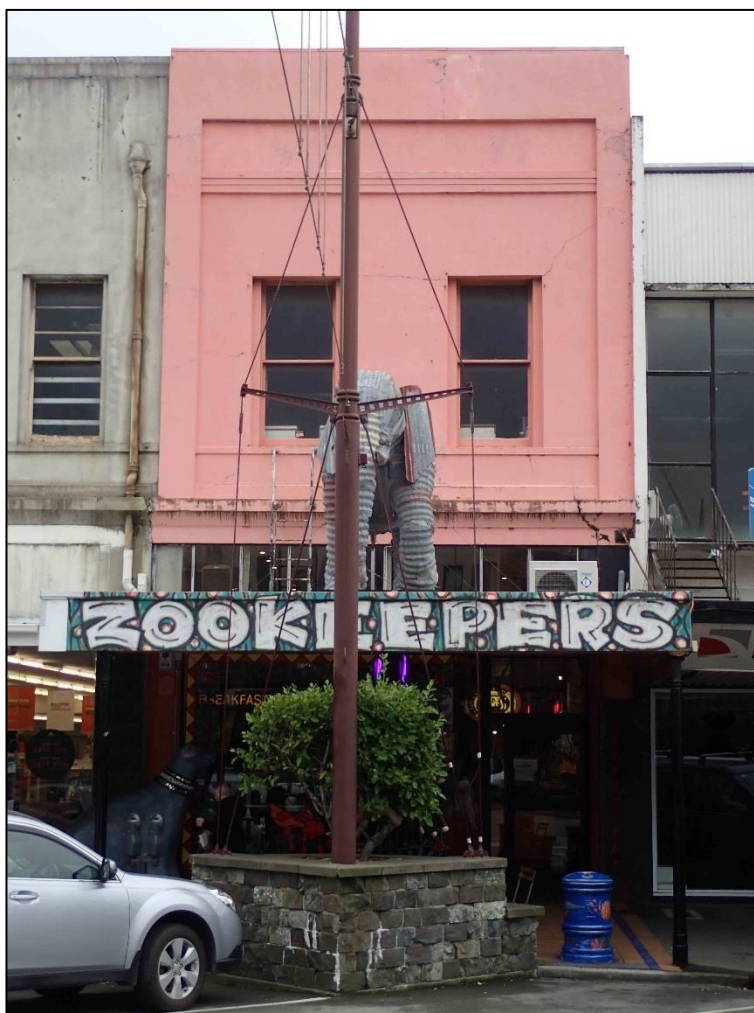
Figure 6-380. Tay Street façade of 50 Tay Street.

The Tay Street façade of 50 Tay Street has no visible heritage features. It is a plain rendered façade with minimal detailing and a modern ground floor glass shop front (Figure 6-367). The verandah, all of which was replaced in 1952, is supported by cast iron posts and holds a corrugated iron elephant. The first floor has been painted pink.

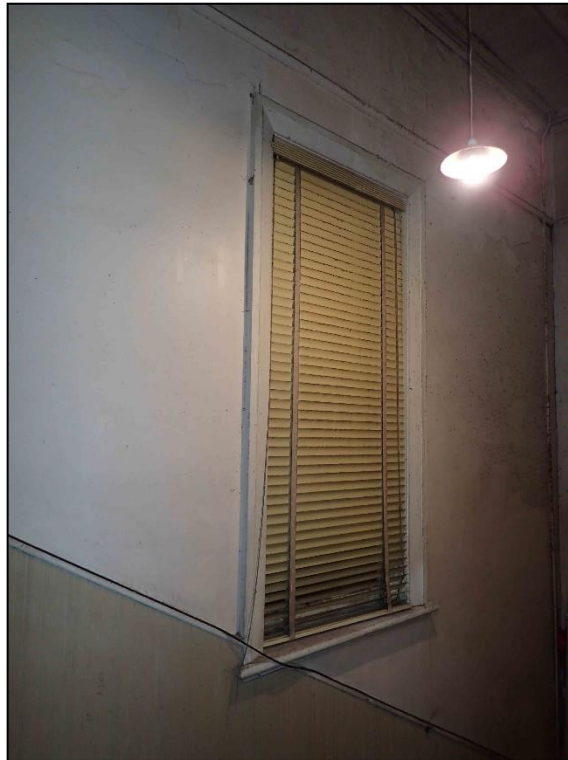
There are relatively few windows at 50 Tay Street, but most appear to be original. Two timber sash windows with bevelled architraves are present on the south wall of Room 9 and there are another two matching windows on the east elevation (Figure 6-381), although these now look directly at the wall of 54 Tay Street. Room 7 has two fixed windows, the eastern most of which has louvre panes at the top, and these have similar timber architraves to the other first floor examples (Figure 6-382), suggesting they too are original. The ground floor shopfront window is modern.

Figure 6-381. Window in east wall of Room 6.

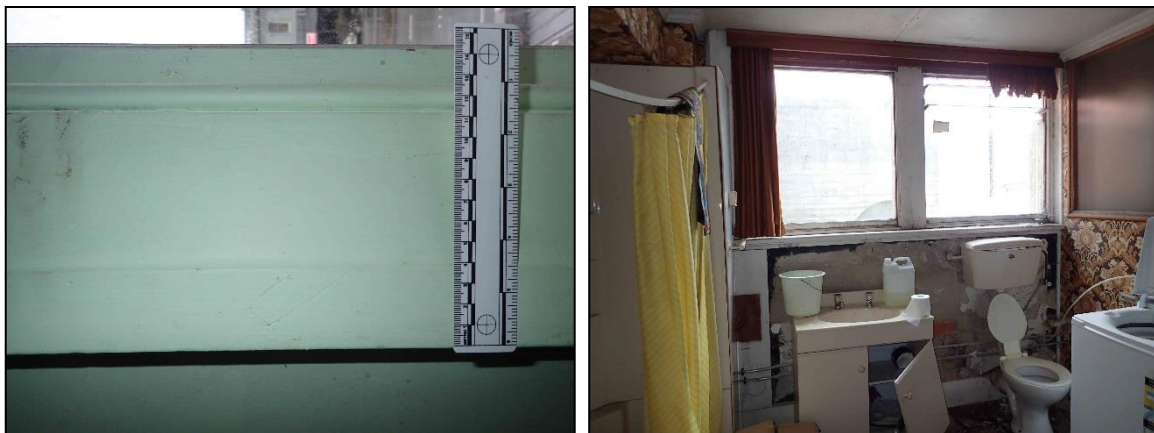
Figure 6-382. Left: detail of architrave on window in Room 9. Right: fixed windows with louvre panes in Room 7.

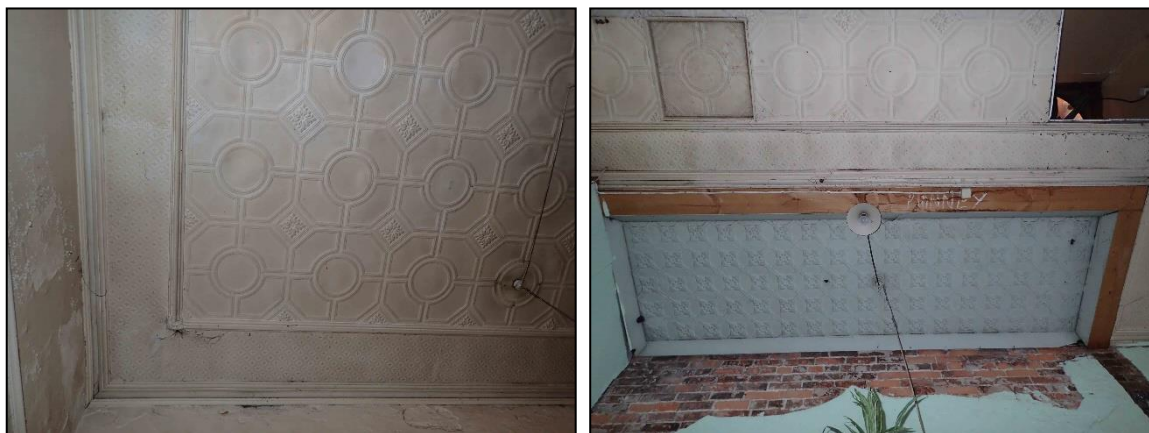
Figure 6-387. Pressed tin ceiling and moulded cornice in Room 9, with old stairwell ceiling (right).

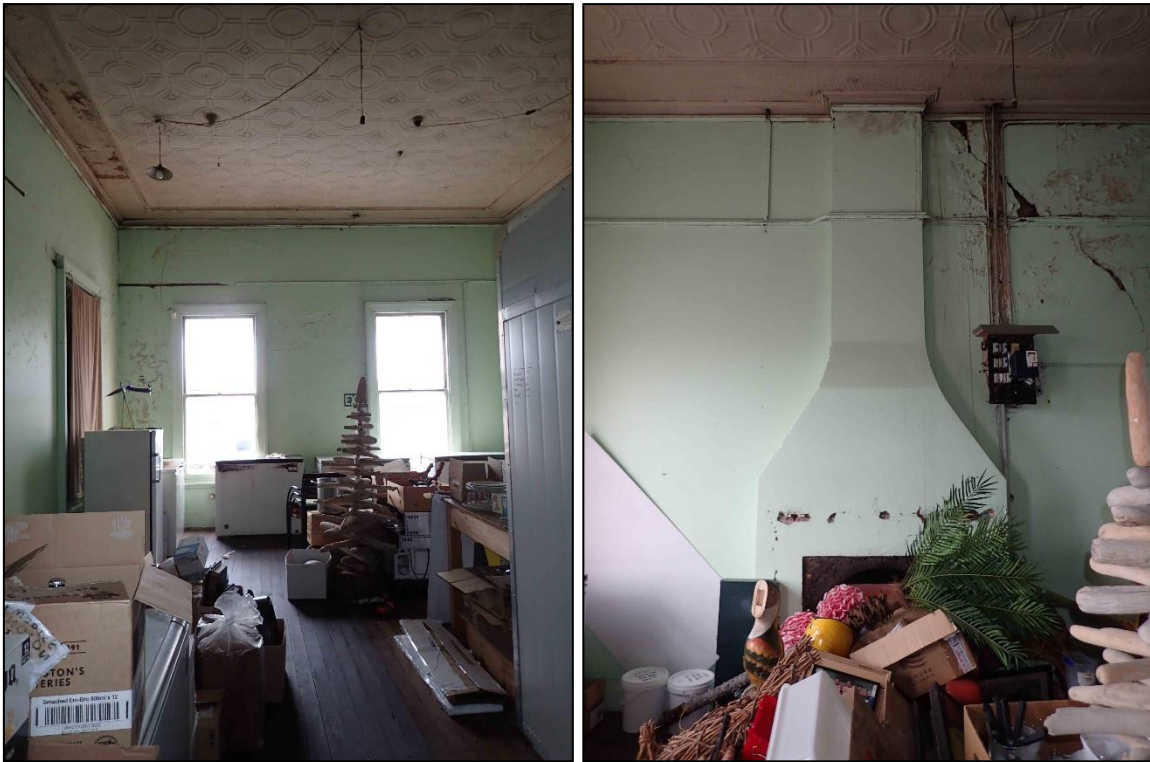
The floor is lined with tongue and groove floorboards that run north-south. Painted lime plaster covers the walls and an old fireplace is present on the west wall (Figure 6-388). There is also a large archway with a keystone in the west wall (Figure 6-389) that appears to have originally connected this and 48 Tay Street, although there is no evidence of said arch in the neighbouring building. This feature was unable to be investigated in more detail as it was obscured by a large refrigerator unit.

Figure 6-388. Left: Room 9 looking south. Right: old fireplace in Room 9, looking west.

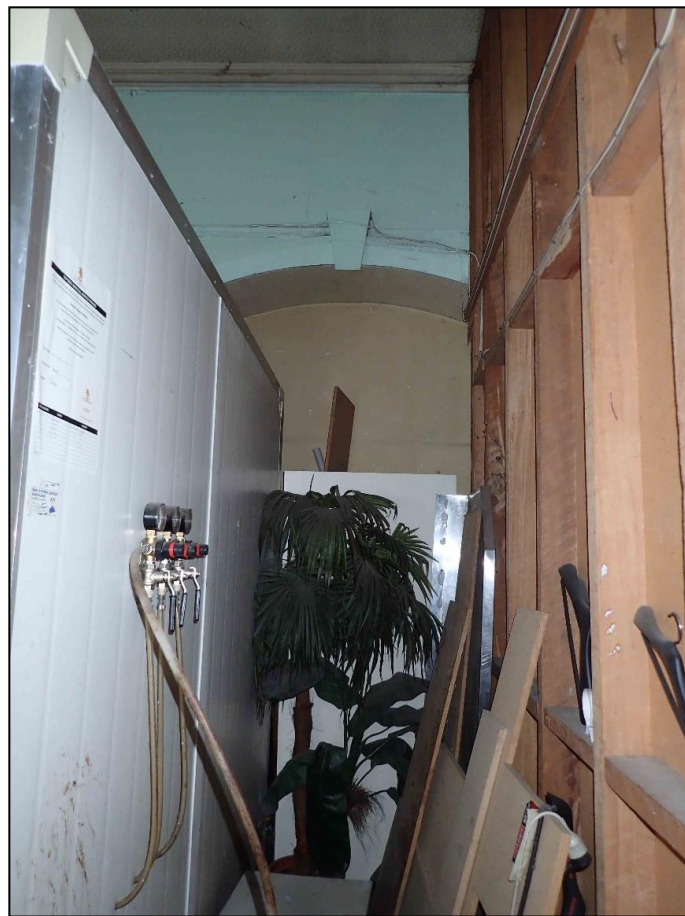
Figure 6-389. Archway in west wall of Room 9.

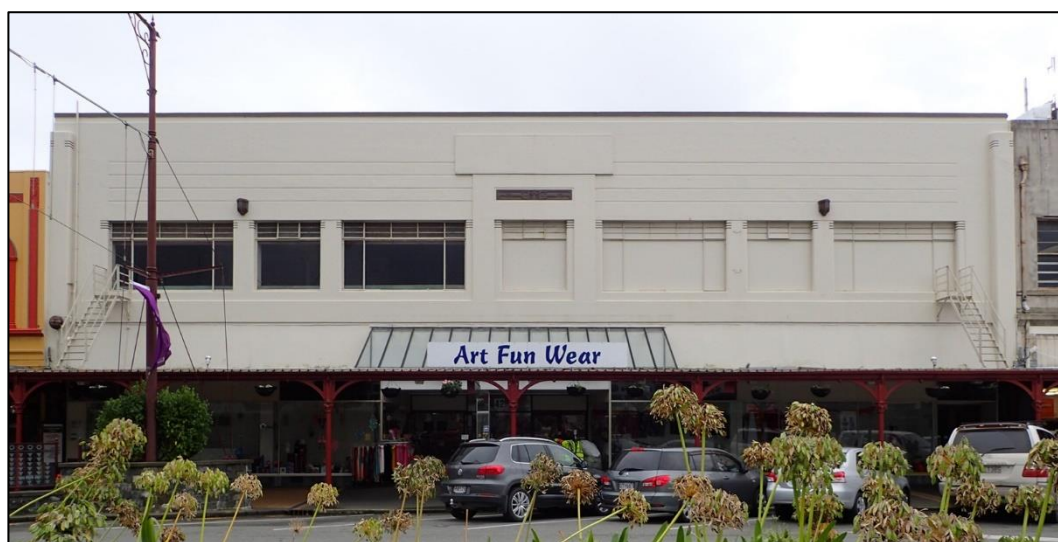
The south elevation of the Herbert Haynes and Co. Building faces Tay Street and has a combination of Victorian and Art Deco design elements (Figure 6-400). The ground floor of the façade has been modified numerous times but it retains some heritage features, including the 1893 verandah and multiple leadlight quarter lights (Figure 6-401 and Figure 6-402). This verandah is the only surviving pre-1900 example on Block II, and is supported by cast iron posts and support brackets. The first floor of the south elevation was remodelled in the Art Deco style during the 1934 alterations. Seven steel-framed windows are arranged symmetrically across this level and all have quarter lights with horizontal grilles. The centre window and the three to the east have been blocked but their frames remain *in situ*. A simple band of reeding extends almost the full width of the building above the first floor windows but is interrupted by simple moulding around the central window. A plain parapet wall sits atop the façade and the entire upper level have been rendered in concrete.

Figure 6-400. The Tay Street frontage of the Herbert Haynes and Co. Building.

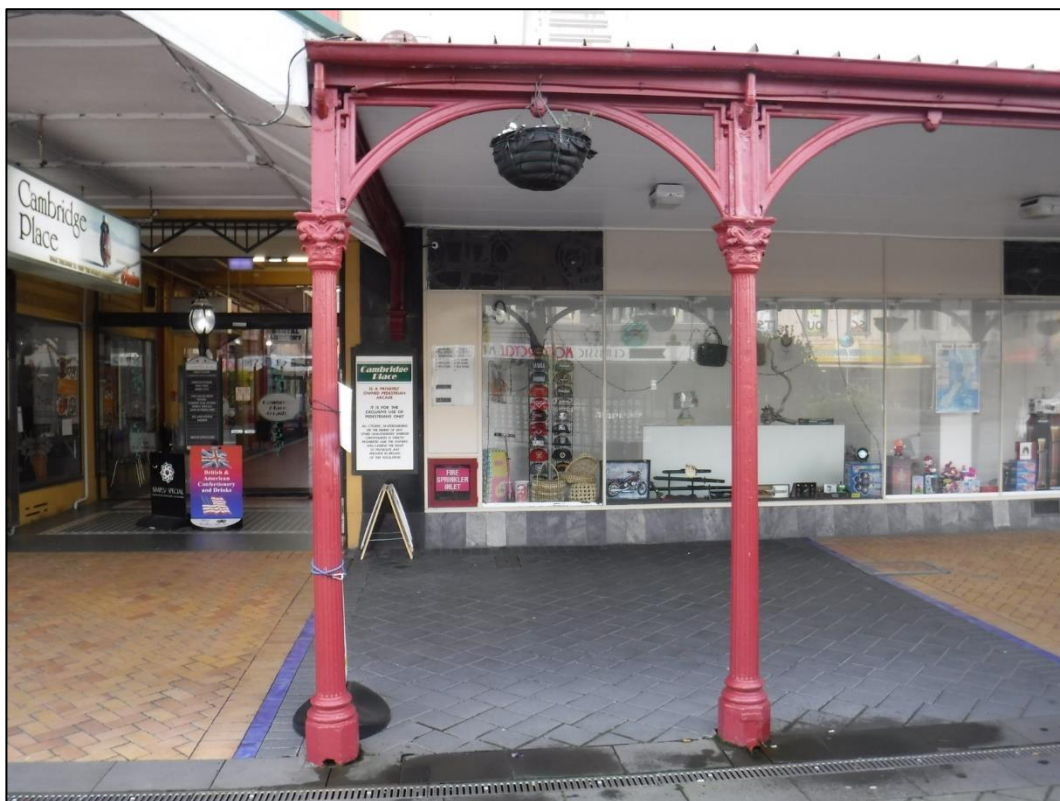
Figure 6-401. 1893 verandah posts, west end of the south elevation.

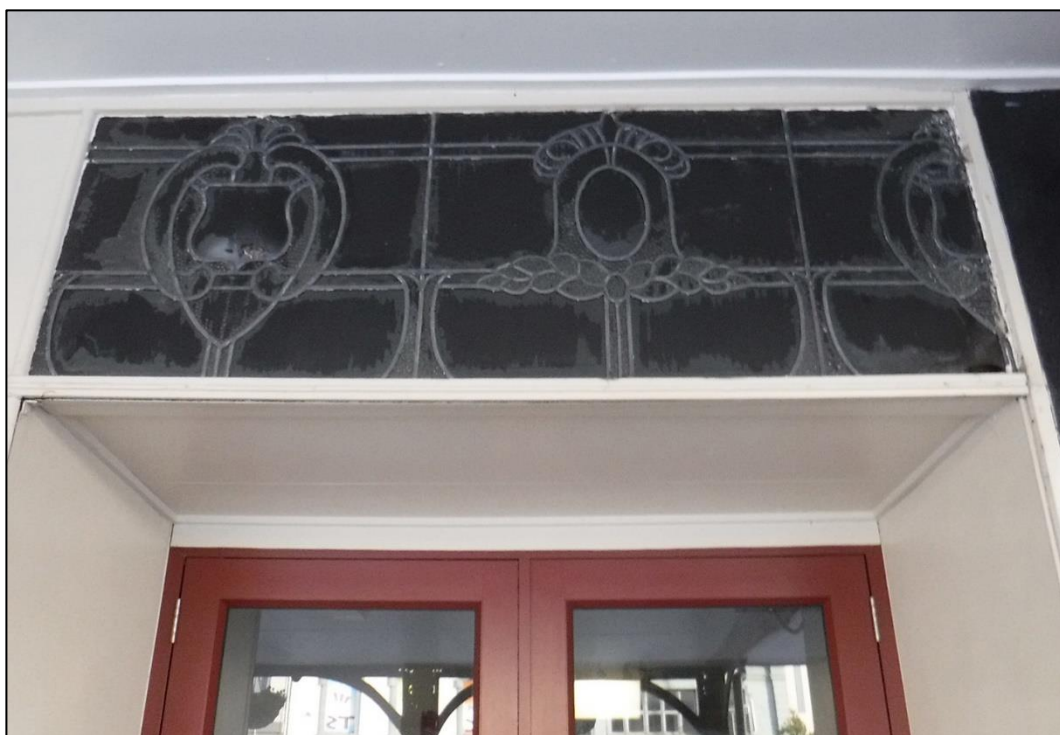
Figure 6-402. Lead light quarter light windows, east end of the south elevation of the Herbert Haynes and Co. Building.

The windows in the ground floor of the south elevation of the Herbert Haynes and Co. Building are large fixed panes with leadlight quarter lights that date from 1923 or later (Figure 6-402). The other windows are fixed with steel or aluminium frames and appear to date to 1934 or later (**Error! Reference source not found.** and Figure 6-404). There is a modified sash window in the west elevation of the first floor that may relate to an earlier building phase (Figure 6-404).

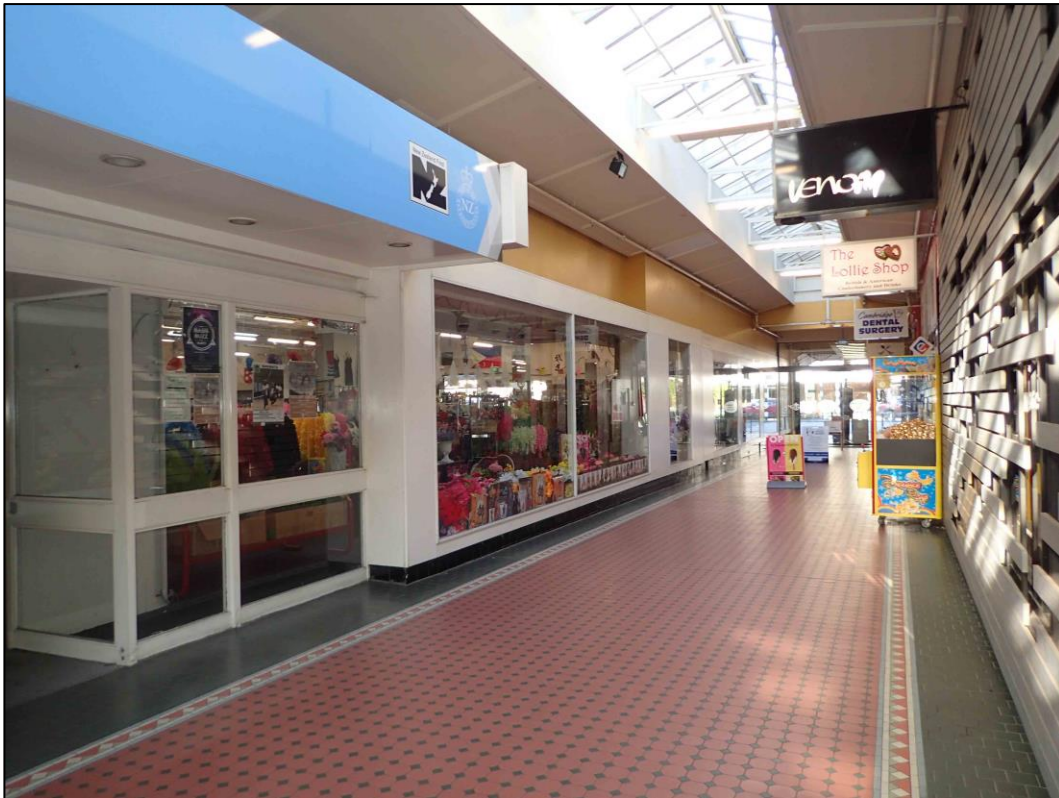
The east elevation of the Herbert Haynes and Co. Building is not visible due to the proximity of the neighbouring buildings. Part of the west elevation of the ground floor is visible from the interior of the southwest of the Cambridge Arcade but retains no visible heritage fabric (Figure 6-403). The west elevation of the first floor is visible from the carpark to the north of the building and from the first floor of buildings opposite (Figure 6-404 and Figure 6-405). The west elevation of the first floor appears to date to the 1934 alterations and has no decorative

Figure 6-403. West elevation of the Herbert Haynes and Co. Building, looking southeast from within the Cambridge Arcade.

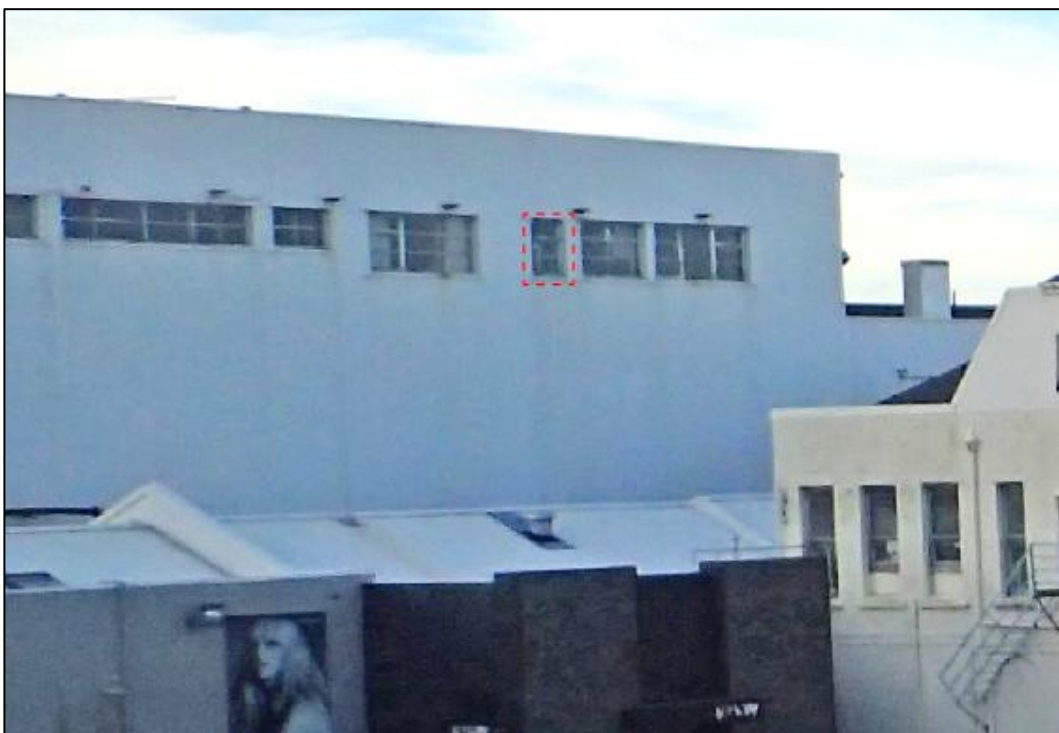
elements (Figure 6-404). One modified sash window on this elevation appears to predate the others. The north elevation of the first floor of the Herbert Haynes and Co. Building is visible from the car park to the north of the building (Figure 6-405). The north elevation of the first floor appears to date to the 1943 alterations (Figure 6-405).

Figure 6-404. The west elevation of the Herbert Haynes and Co. Building as seen from the first floor of a building on the north side of the carpark, looking southeast. The modified sash window is outlined in red.

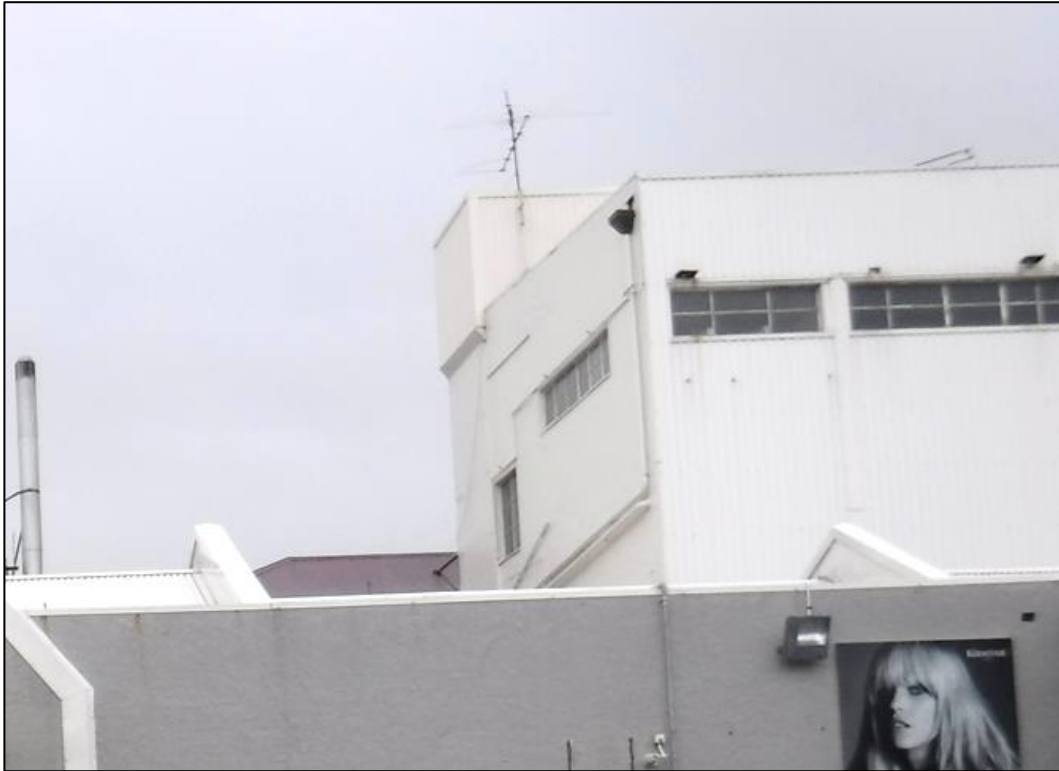
Figure 6-405. The north elevation of the first floor of the Herbert Haynes and Co. Building as seen from the carpark looking east. Part of the west elevation is also visible

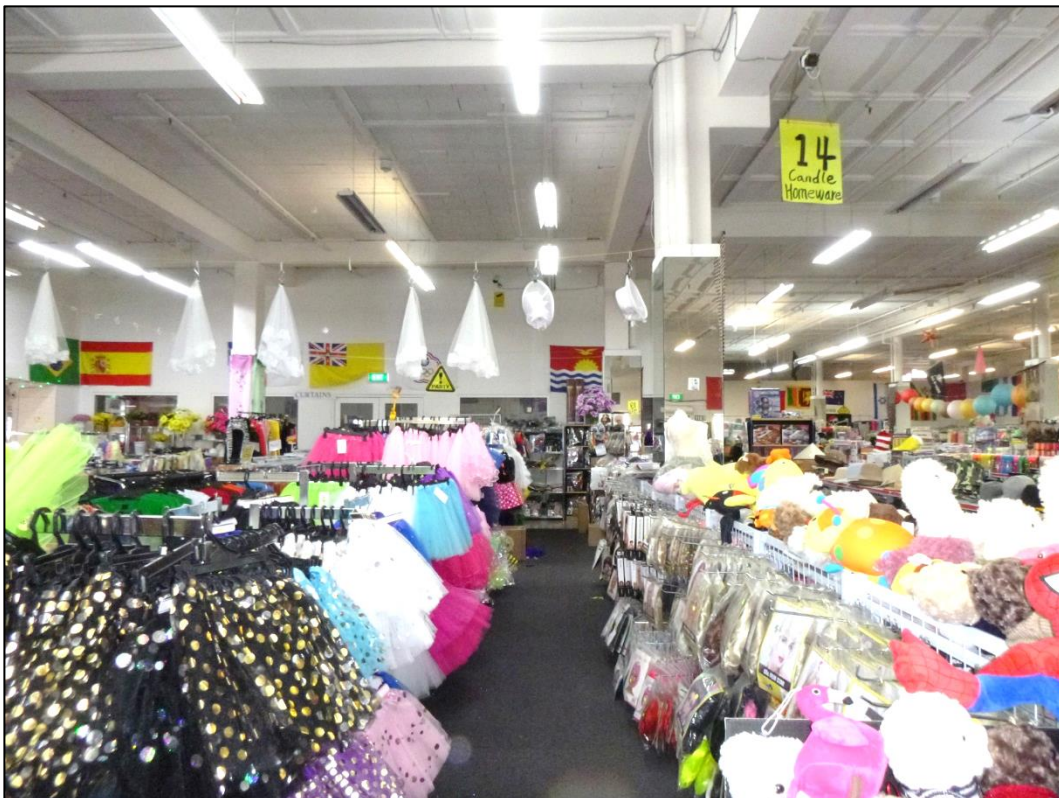
The ground floor of the Herbert Haynes and Co. Building is currently a large single room retail space (Figure 6-406, Figure 6-407 and Figure 6-408). The only remaining visible heritage features or fabric are the cast iron ceiling supports and the board and batten ceiling (Figure 6-409). The floor is covered in modern carpet. It is possible to differentiate the different sections of the original building by a change in ceiling pattern and the location of a large structural beam that runs north-south.

Figure 6-408. Room 1, the Herbert Haynes and Co. Building, looking north. Note the differences in the ceilings between the two sections of the original building.

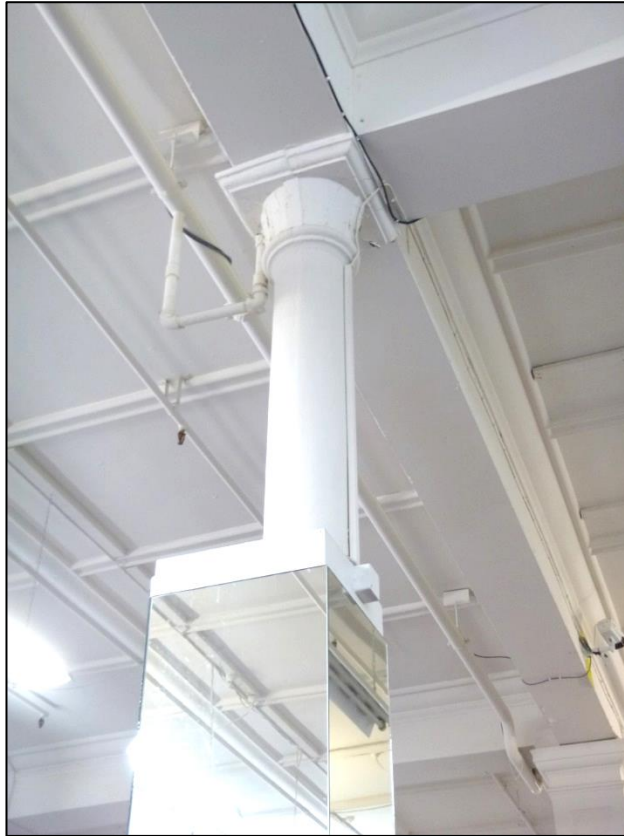
Figure 6-409. Example of a cast iron ceiling post in Room 1.

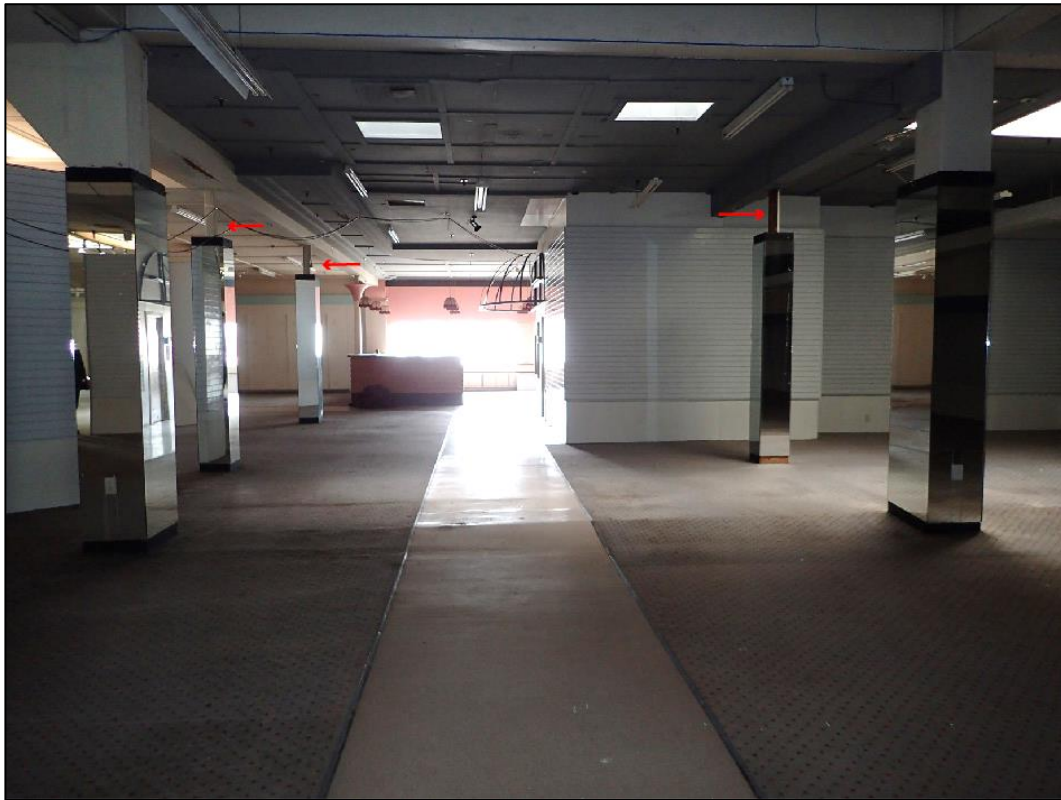
Like the ground floor, the first floor of the Herbert Haynes and Co. Building is currently a large open retail space (Figure 6-410, Figure 6-411 and Figure 6-412). Again, there is minimal visible heritage fabric or features, aside from some cast iron ceiling posts and a modified sash window toward the north end of the west wall (Figure 6-411 and Figure 6-413). The current layout and linings date to the 1991 refurbishment for Farmers.

Figure 6-411. Looking south in Room 2 of the Herbert Haynes and Co. Building. The red arrows indicate cast iron ceiling posts.

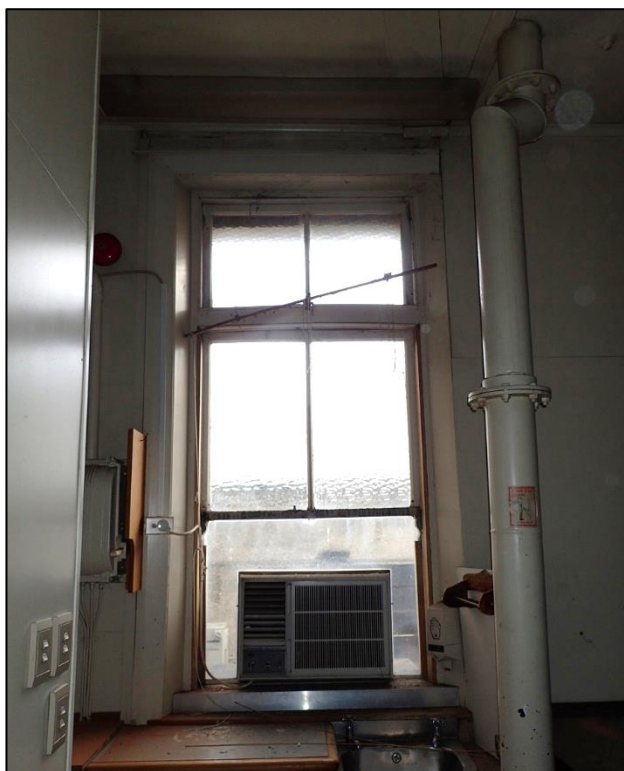
Figure 6-413. This modified sash window in the west wall of Room 2 appears to be an original feature.

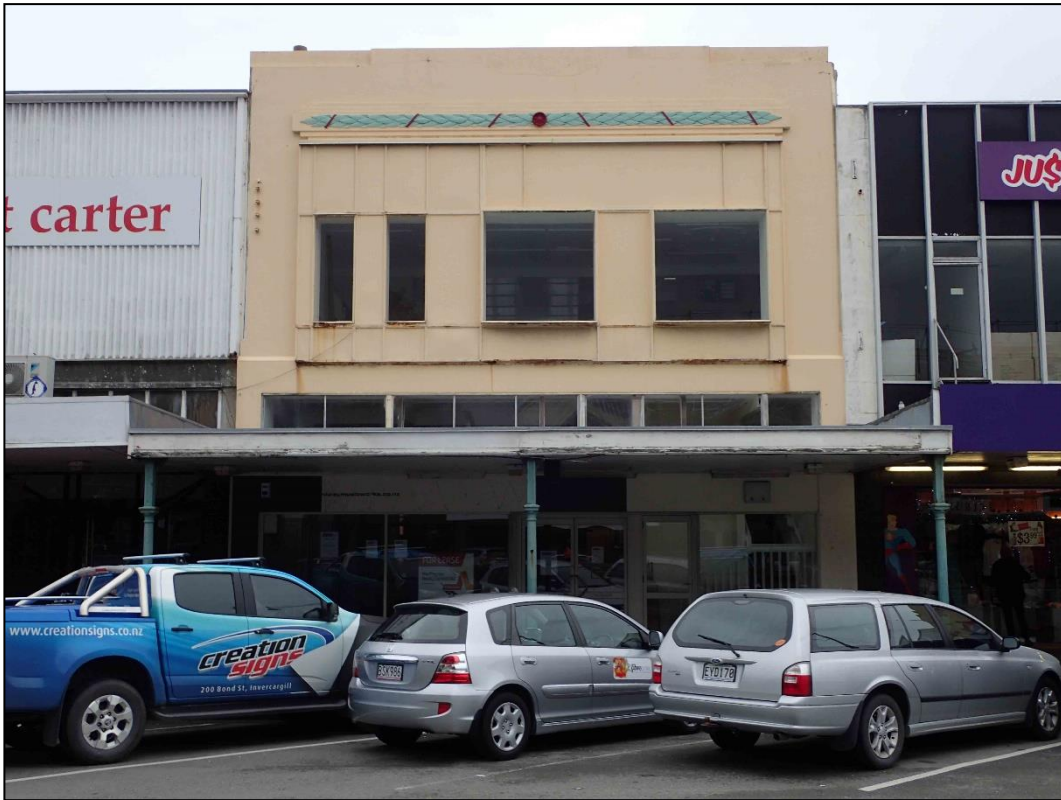
The Tay Street façade is in a simple Art Deco design that has remained relatively unchanged since this part of the building was constructed (Figure 6-426). A horizontal band of decorative moulding sits above two large and two

smaller fixed first-floor windows. Another row of small fixed windows runs along the top of the verandah, which is supported by cast iron posts. The ground floor shop fronts have modern glass doors and large windows.

Figure 6-426. Tay Street façade of Annie Ibbotson's Building.

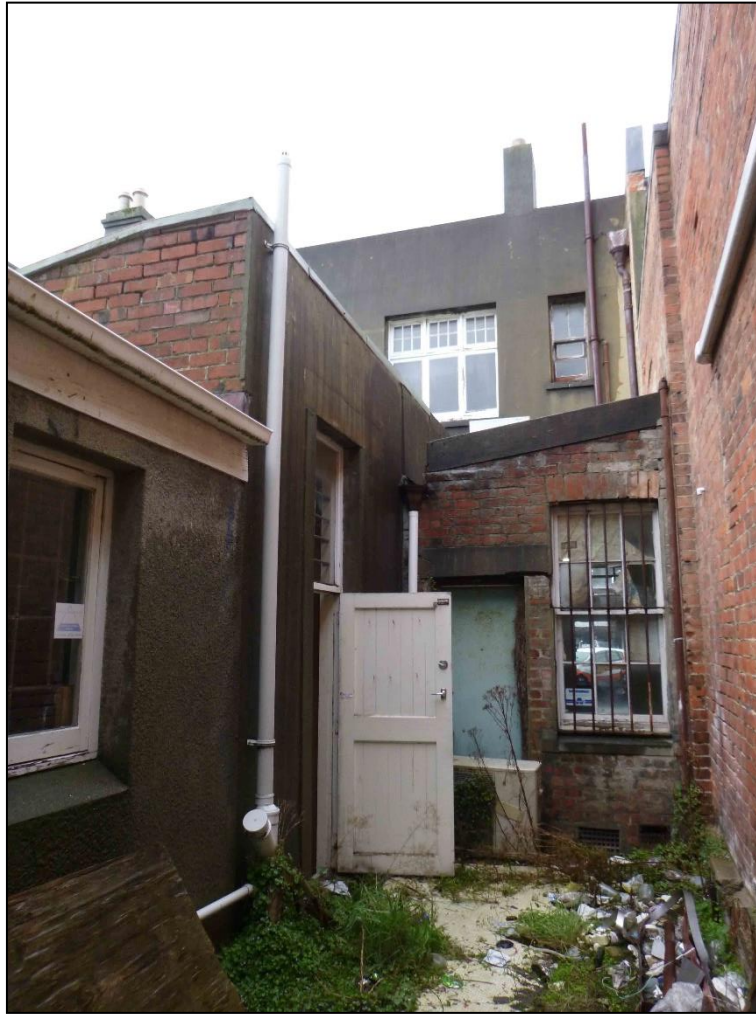
The east elevation of Annie Ibbotson's Building is entirely hidden by the neighbouring property (36 Tay Street). Only a small portion of the west elevation is visible, and this is limited to the rear single-storey portion. The visible section is rendered brick and has a timber casement window and a ledge door with transom light (Figure 6-427). The south elevation is also rendered brick on the first floor, but the brick remains exposed on the lower floor sections (Figure 6-427). The first-floor elevation on this side has no decoration but has typical 1930s windows. The west section of the ground floor south elevation (the exterior of Room 10) has a timber sash window and a doorway with a brick lintel, while the east portion has now windows or doors. Cast iron grills of sub-floor vents are visible on the south elevation.

Figure 6-427. South and west elevations of Annie Ibbotson's Building.

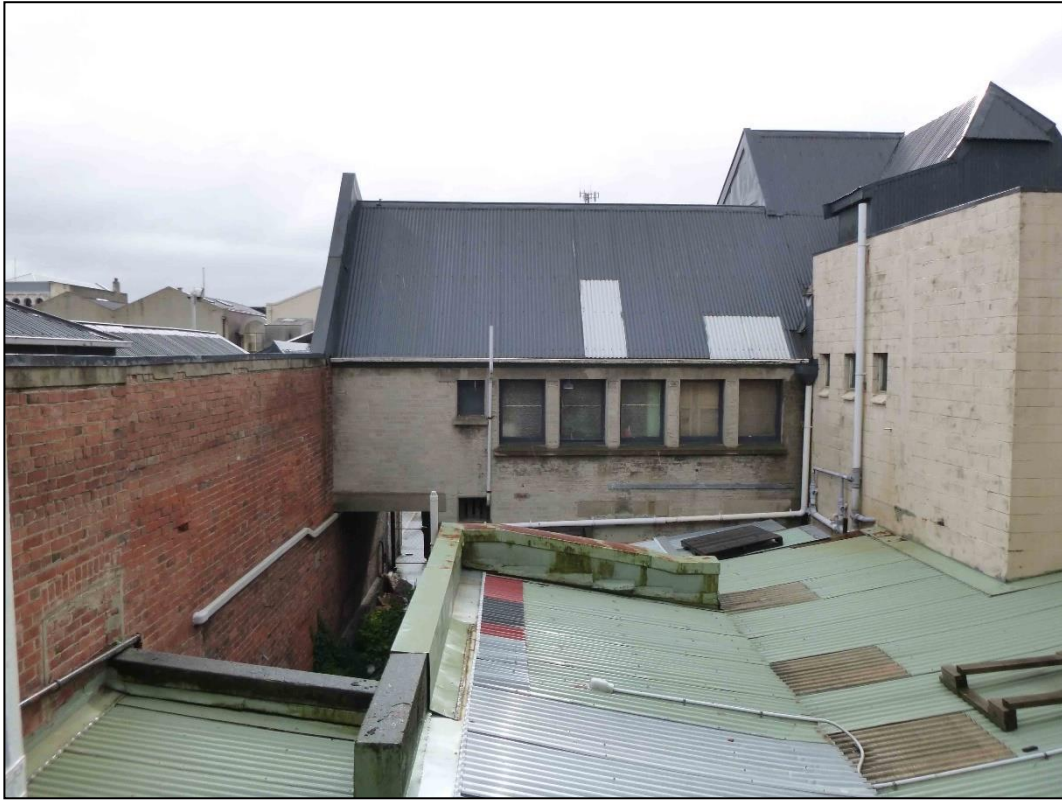
The roof of the front portion of Annie Ibbotson's Building is not visible from the street, however aerial photography indicates that it has a central ridge with a gable at the south end and a hip at the north. The roof over the rear portion is made up of three mono-pitch rooves, two of which slope down to the east and the other to the west (Figure 6-428). All are clad in corrugated iron and have short parapets.

Figure 6-428. View from the first floor of Annie Ibbotson's Building with rear section of roof (green) in the foreground.

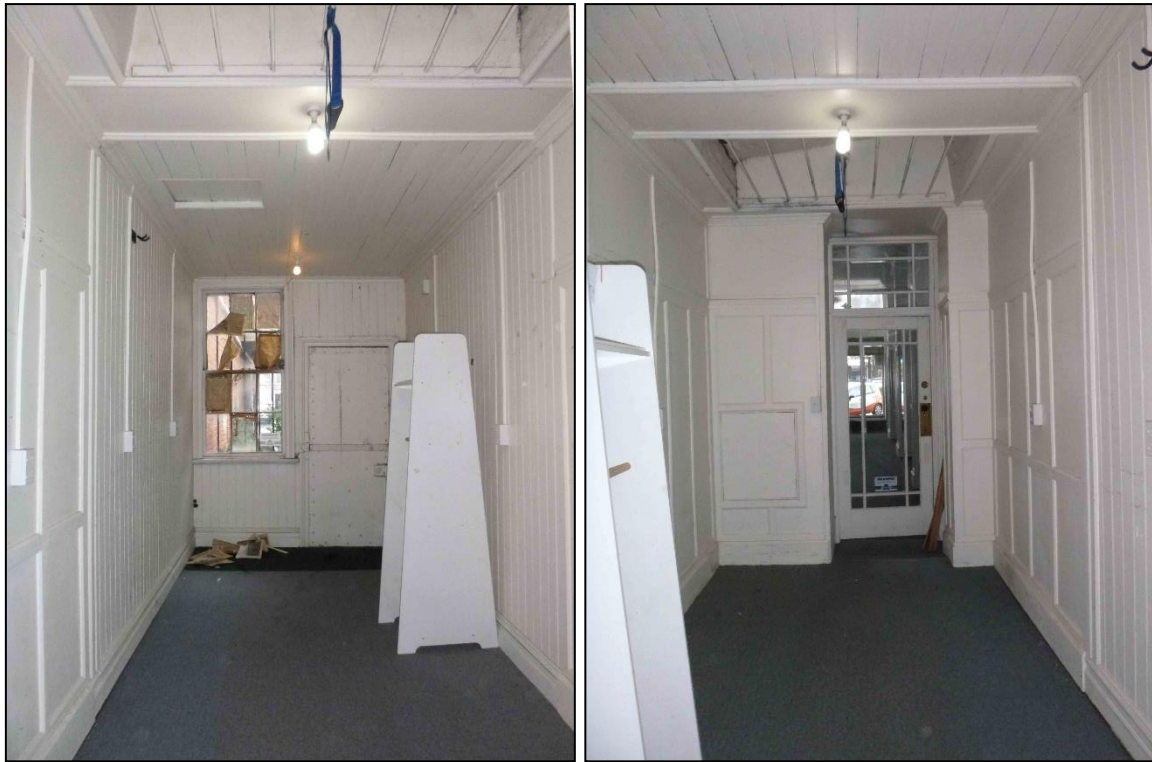
A variety of windows can be found at Annie Ibbotson's Building. On the south elevation, all the windows are fixed and all on the ground floor have been replaced since the building's construction. There is another row of small fixed windows just below ceiling height on the north wall of the main shop floor (Room 1). Room 10 has a timber sash window (six-over-six) on the north wall (Figure 6-429), suggesting this part of the building is older than the rest. This window also has traditional moulded architraves. At the south end of this room there is a glass-panelled door with a transom light (Figure 6-429). The ground floor toilet (Room 8) has a single-pane timber awning window in the west wall.

Figure 6-429. Room 10 of Annie Ibbotson's Building looking north (left) and south (right).

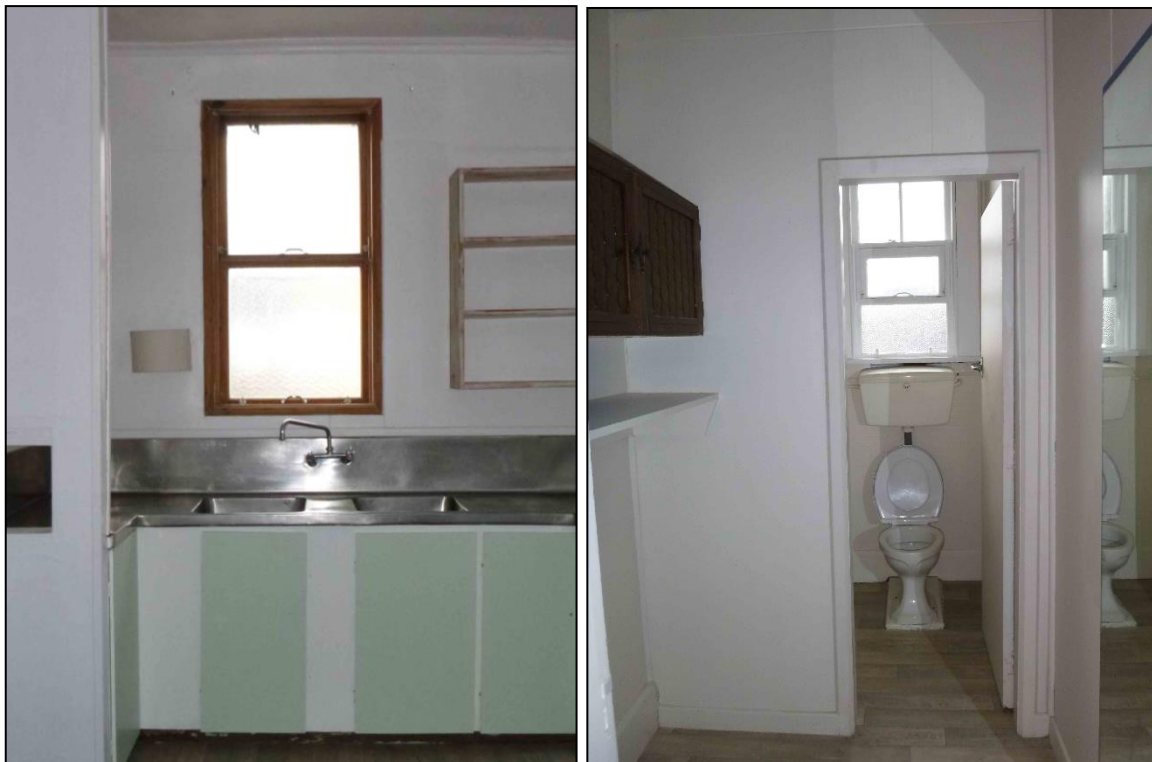
Another timber sash window is present in the north wall of Room 13; however, this example is one-over-one and does not have moulded architraves, and the sash window in the north wall of Room 14 has been altered so that only one small pane acts as an awning window (Figure 6-430). These sash windows may have been recycled during the construction of the 1933 building. Two sets of folding windows sit in the north wall of Room 12 (Figure 6-431).

Figure 6-430. Sash window in north wall of Room 13 (left), and altered sash window in north wall of Room 14 (right).

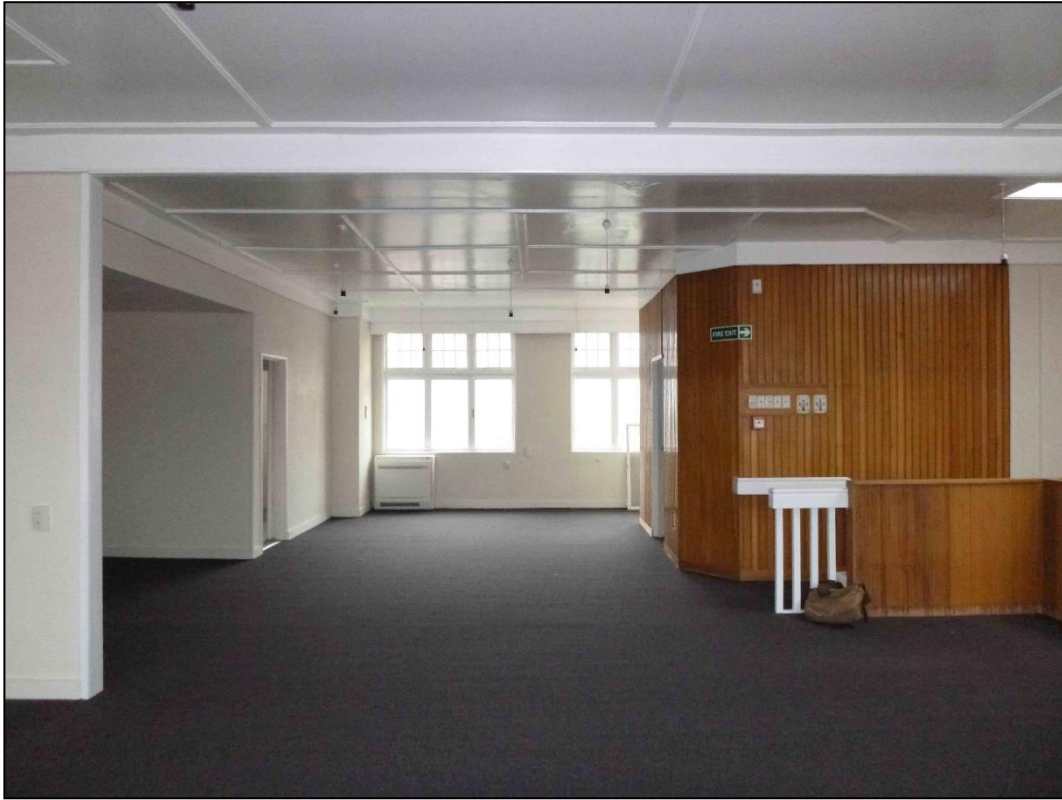
Figure 6-431. Room 12 looking north, showing folding windows.

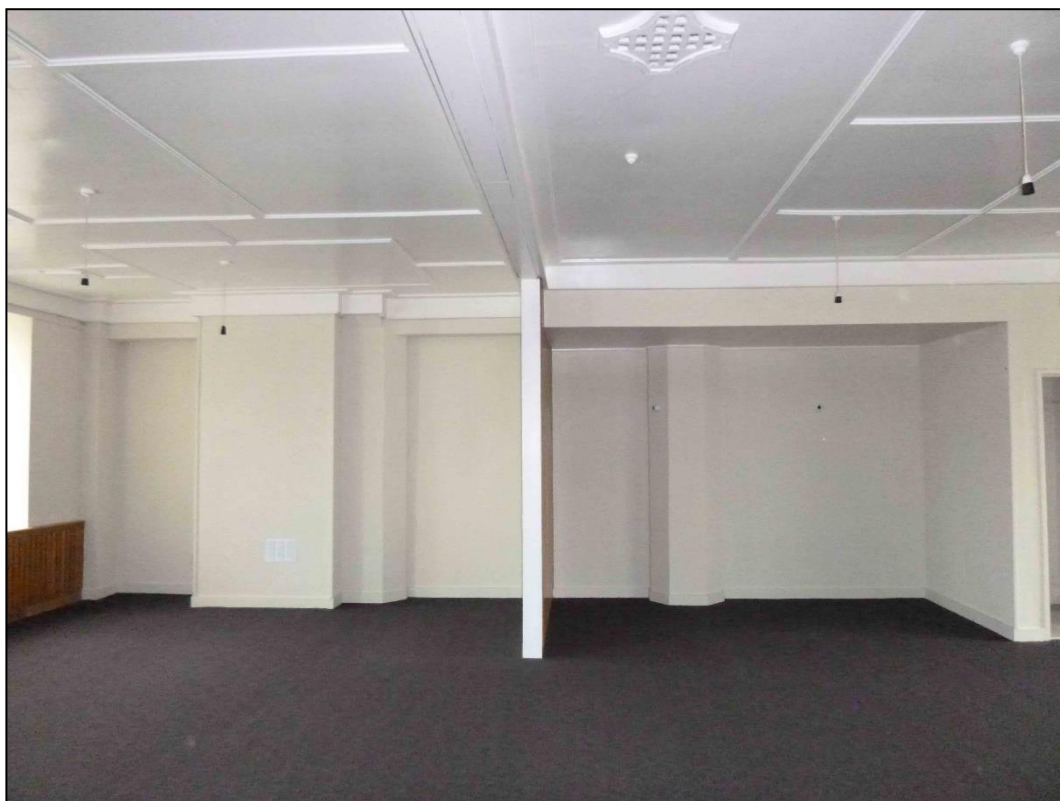
The first floor has been renovated multiple times since its construction, however it still retains some original 1930s features. The layout is currently one large open space with a smaller kitchen and bathroom/toilet accessed off this (Figure 6-432). The kitchen and bathroom fittings are modern, as are the carpets throughout. The walls are hard or softboard with timber battens, and this design is mirrored on the ceiling. An Art Deco ceiling ventilator and ceiling rose are present in Room 12, and there is a blocked-up fireplace in the southwest corner (Figure 6-434).

Figure 6-434. Room 12 of Annie Ibbotson's Building, looking west, with blocked fireplace to the left of the image and ventilator at the top.
