6.14.3 On Site Observations: Zookeepers Café (50 Tay Street)

The extant building at 50 Tay Street was constructed in 1916 and is currently occupied by Zookeepers Café. Major alterations were undertaken on the interior and façade in the 1950s and several minor renovations have been undertaken since then. The following description of the building follows from the site visit conducted by Dr Dawn Cropper and Dr Naomi Woods on 18 April 2018.

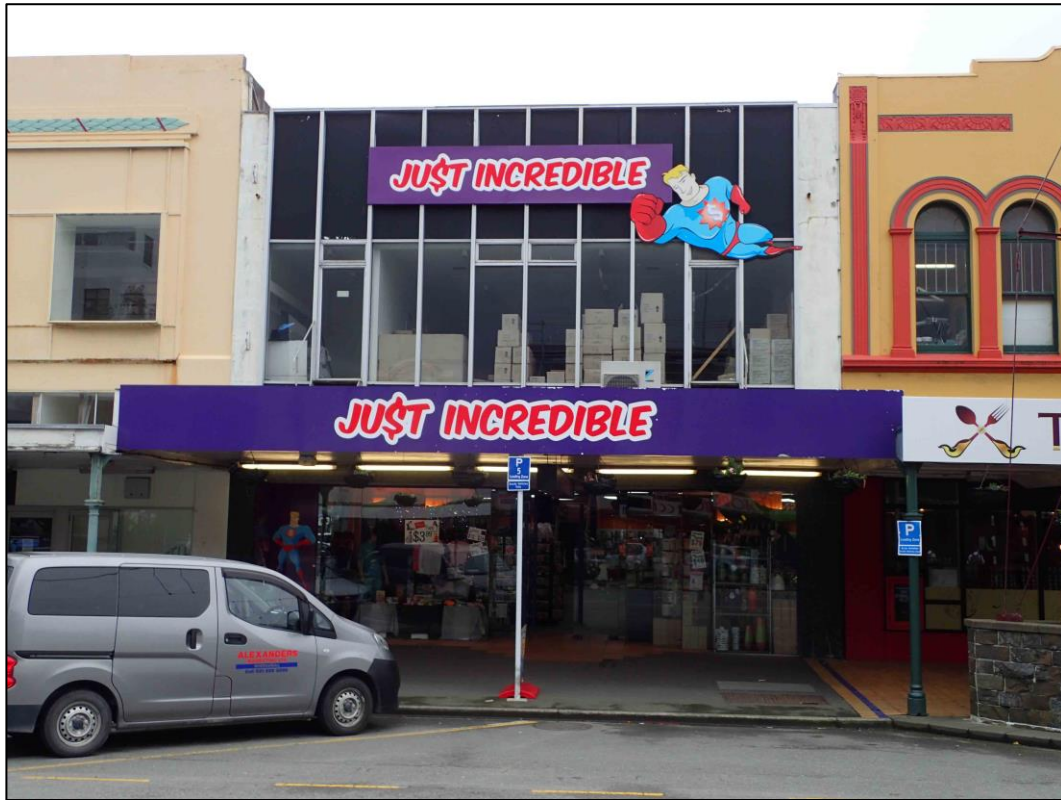
Carter's Building occupies an L-shaped portion of TS 17 with a frontage to Tay Street. No known pre-1900 buildings survive on this part of the site; however, the northeast corner of the building can be seen to have a different and separate roof structure to the remainder and may pre-date the other parts of the structure. Blocked windows and a door are visible on the north elevation and three timber sash windows with lugs are present on the first floor (Figure 6-436). Windows that match these are also present on the 1910 Muir addition, so it is possible the east portion was part of this building or was altered to match it.

Figure 6-435. Tay Street façade of Carter's Building.

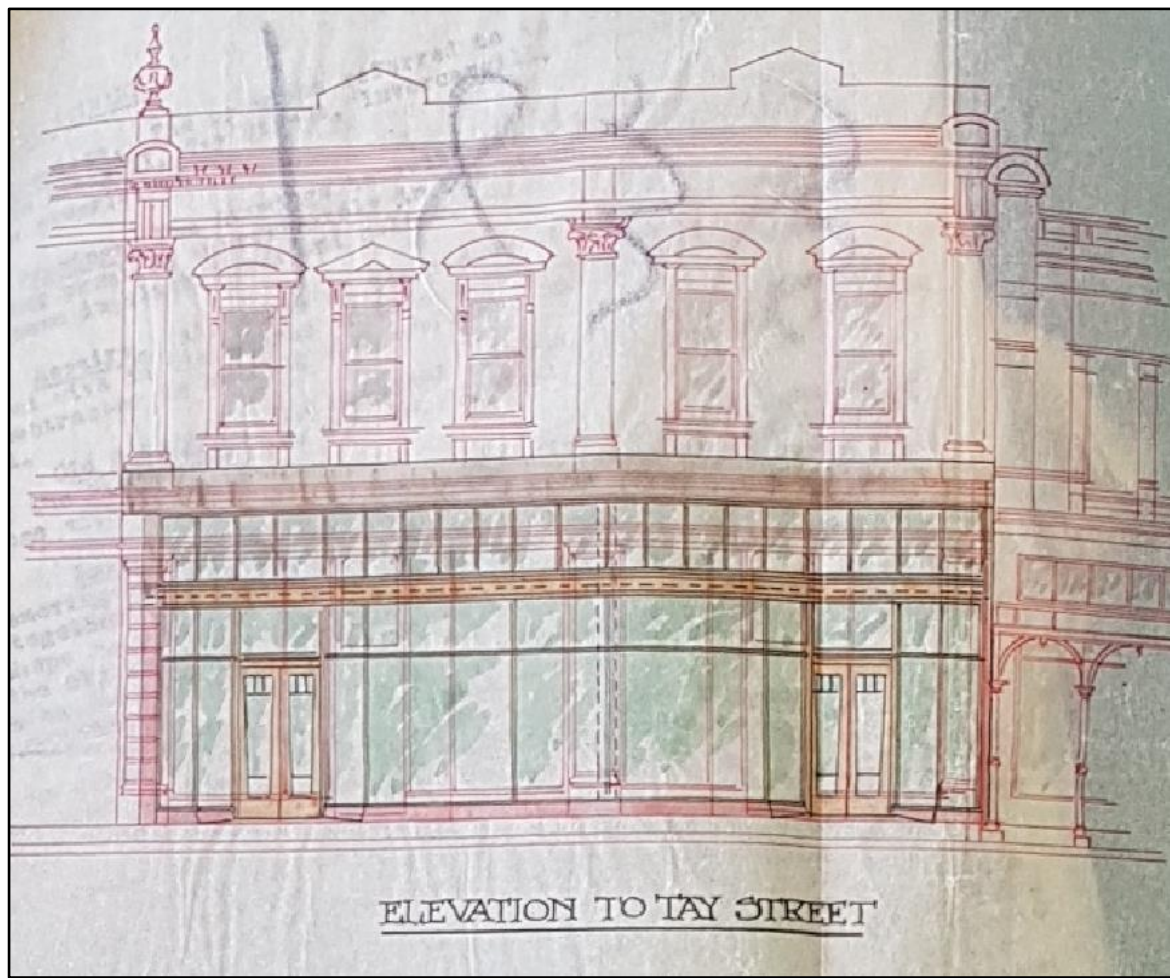
Figure 6-443. Detail from 1933 plan of W. H. Boyes premises at 22 Tay Street, showing the alterations to the street façade (Wilson, 1923a).

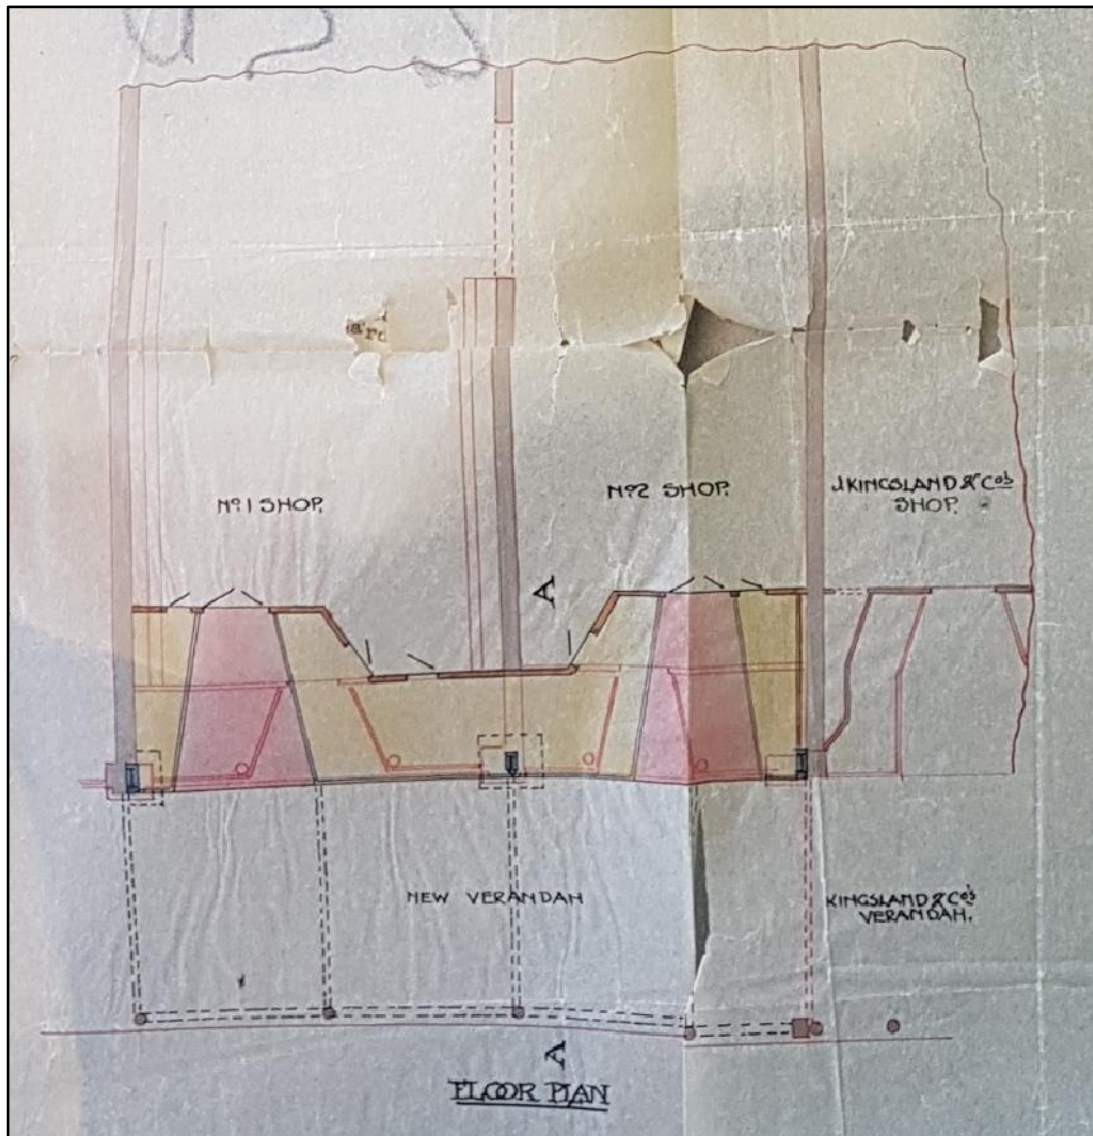
Figure 6-444. Detail from 1933 plan of W. H. Boyes premises at 22 Tay Street, showing the alterations floor plan of the two shops, and the addition of a new verandah (Wilson, 1923a).

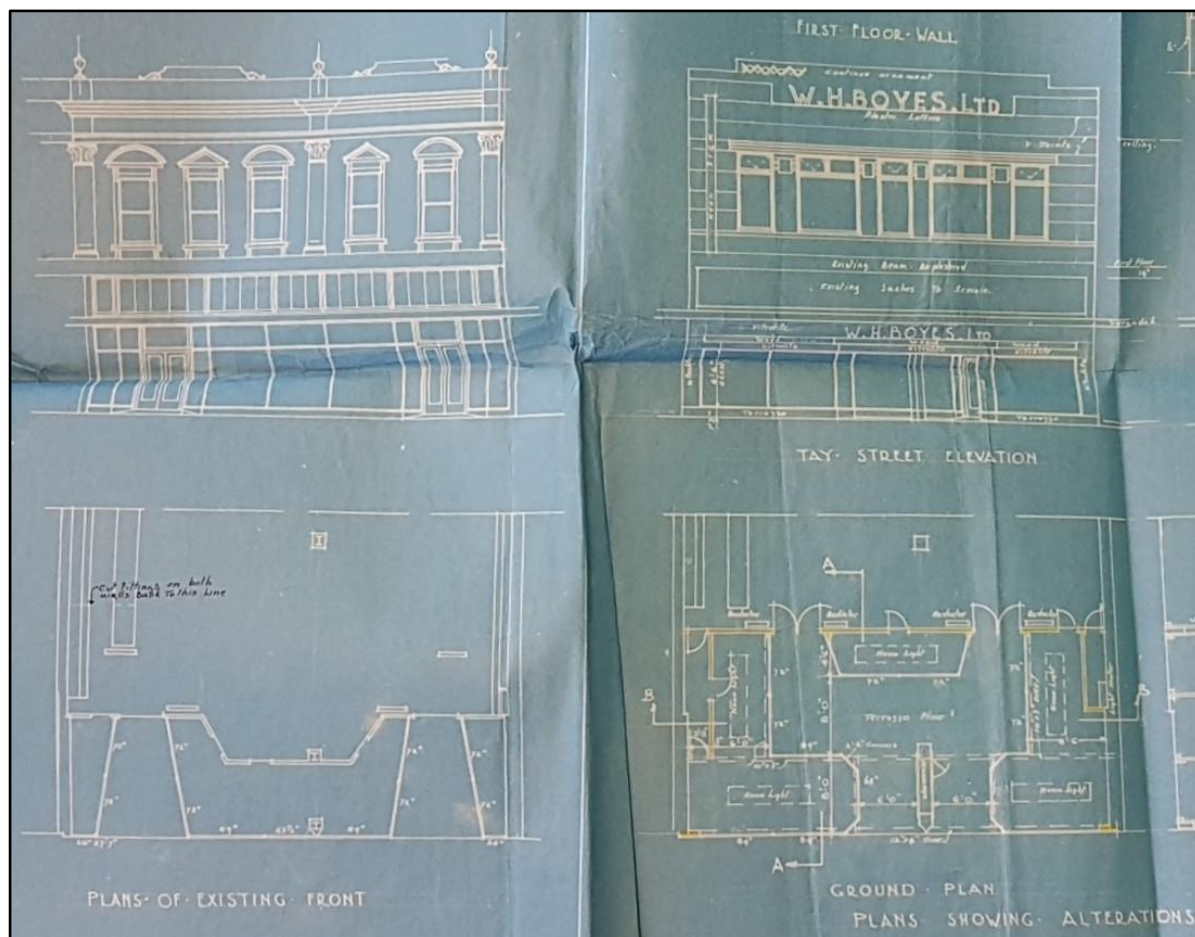
Figure 6-445. Detail from 1943 plan of W. H. Boyes premises at 22 Tay Street, showing the alterations to the shop's street façade, and alterations to the floor plan (E. Smith, 1943).

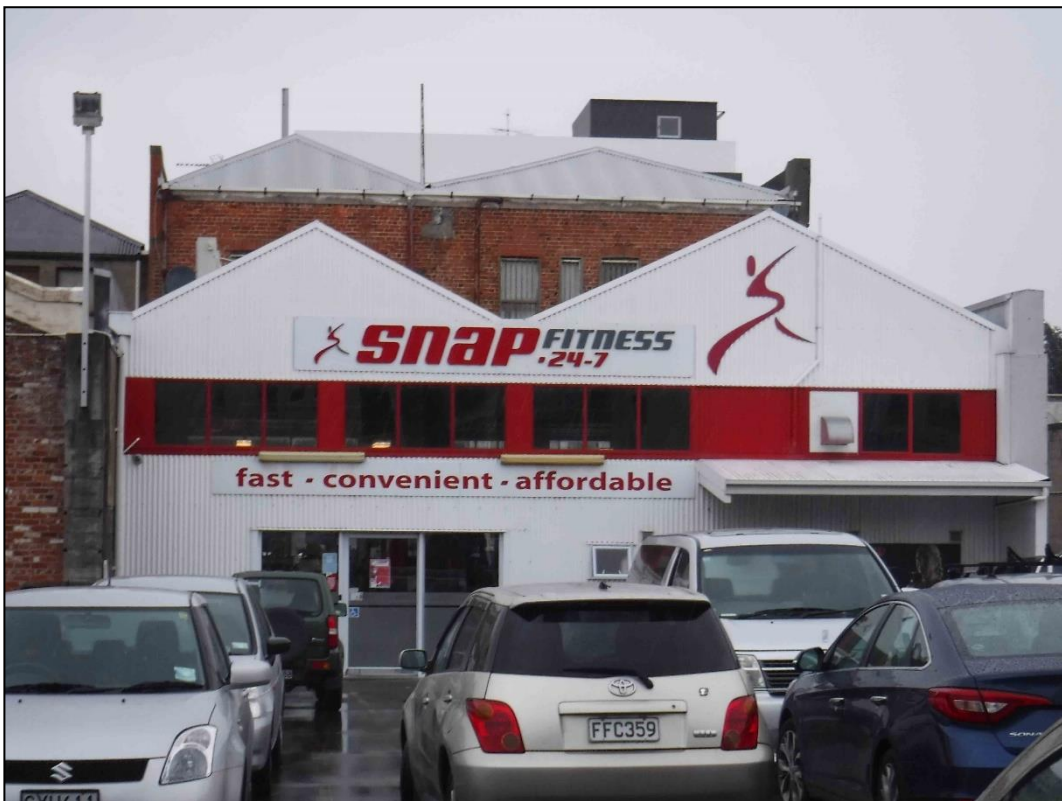
Figure 6-450. North elevation of Peters' Building.

The north elevation is dominated by the rear of the twentieth century extension which is clad in corrugated iron (Figure 6-450). An automatic sliding door and multiple steel-framed fixed and casement windows are present, as is a blocked goods entrance on the western end. The first floor of the front section of Peters' Building is also visible on this elevation and has exposed brick with multiple two-pane sash windows with timber frames.

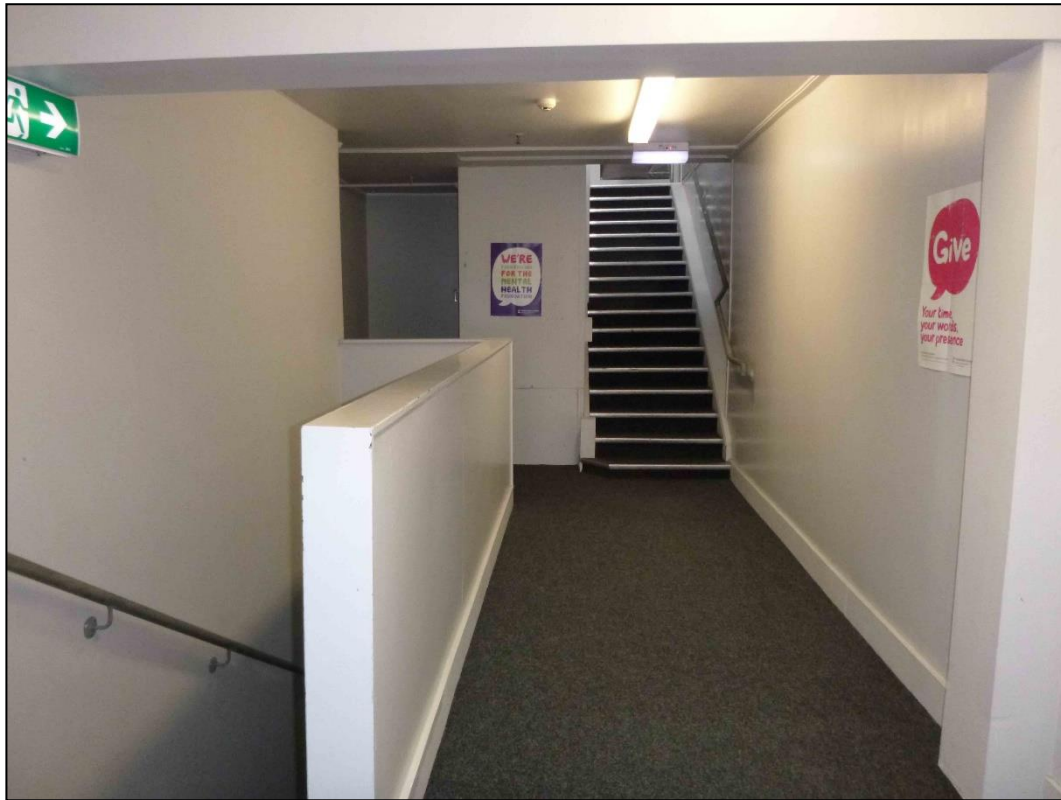
Figure 6-454. Mezzanine landing (Room 6) at Peters' Building, looking north.

Only the landing of the mezzanine was accessible during the site visit (Room 6; Figure 6-454) but the floor plans suggests that there are two rooms to the north of this space (Figure 6-451). No heritage fabric was visible on this level, and modern wall linings and floor coverings (carpet) were used throughout.

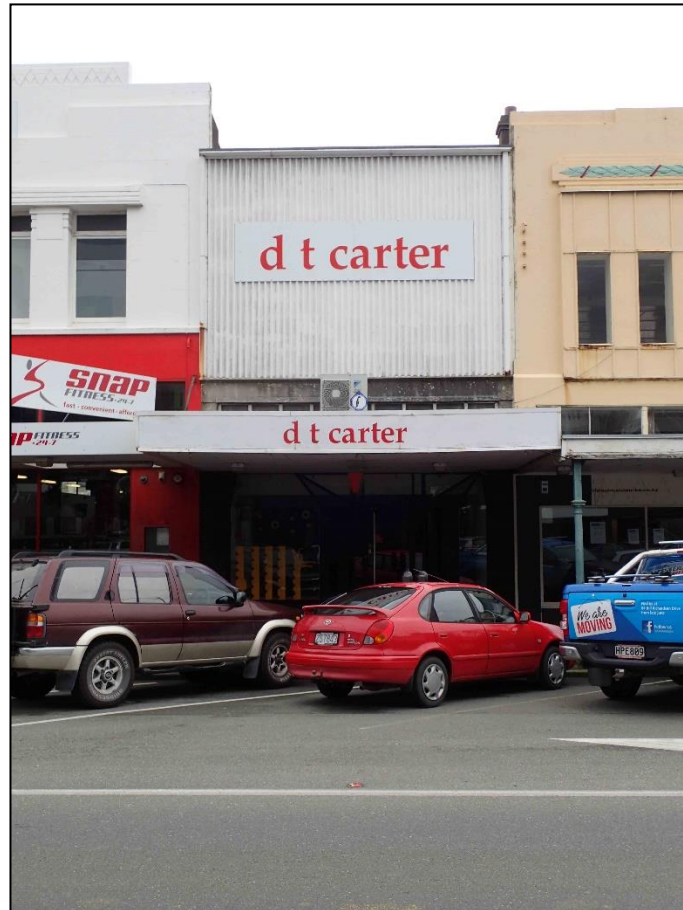
Figure 6-458. Street façade of Kingsland's Shop.

The Tay Street façade has no visible heritage fabric (Figure 6-458). Alterations in 1960 included the removal of most of the original detailing and covering the upper portion of the façade with galvanised corrugated iron and the installation of a suspended verandah. The ground floor shop front has also been repeatedly altered and currently consists of an inset glass door flanked by two shop display windows with floor-to-ceiling glass panes.

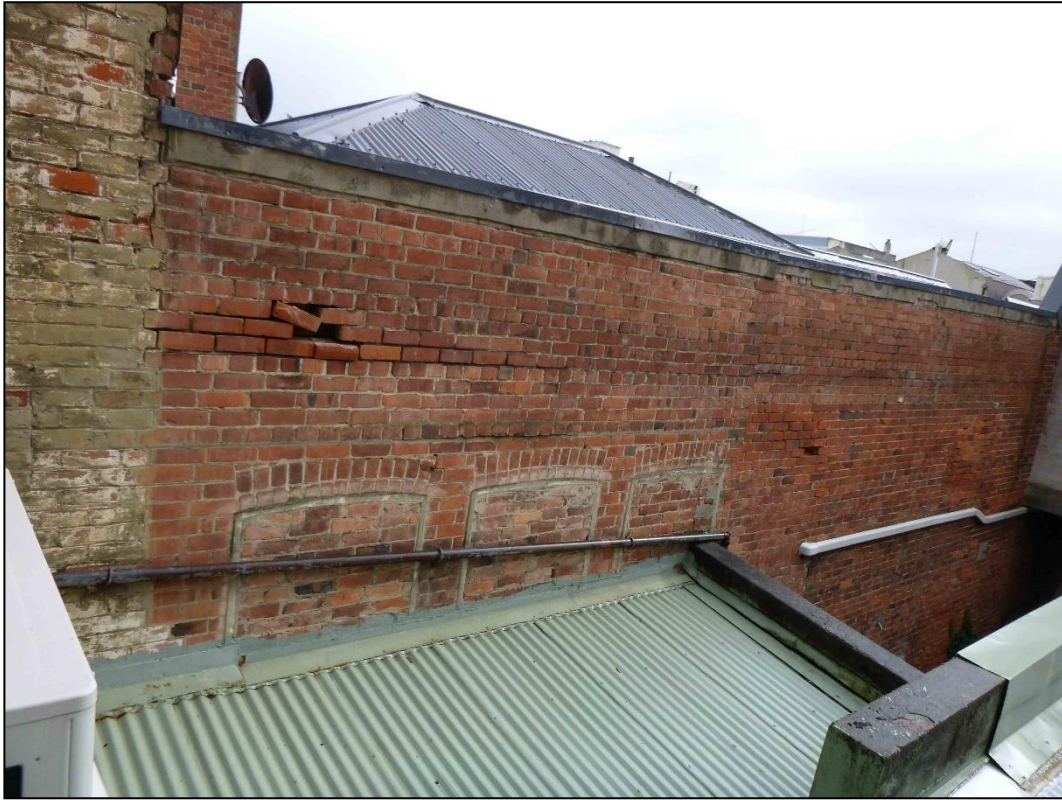
Figure 6-459. East elevation of Kingsland's Shop, looking northwest.

The west elevation is entirely hidden by the neighbouring Peters' Building. The east elevation is also partially obscured by Annie Ibbotson's Building however part of the front portion and the entire rear portion is visible (Figure 6-459). The brickwork varies along the length of this elevation between running bond and English garden wall bond and there are multiple blocked up arched windows and doors (Figure 6-460). On the north elevation the brickwork is English garden wall bond and there are no windows or doors (Figure 6-461). The concrete party wall between this and Snap fitness is also clearly visible on this elevation.

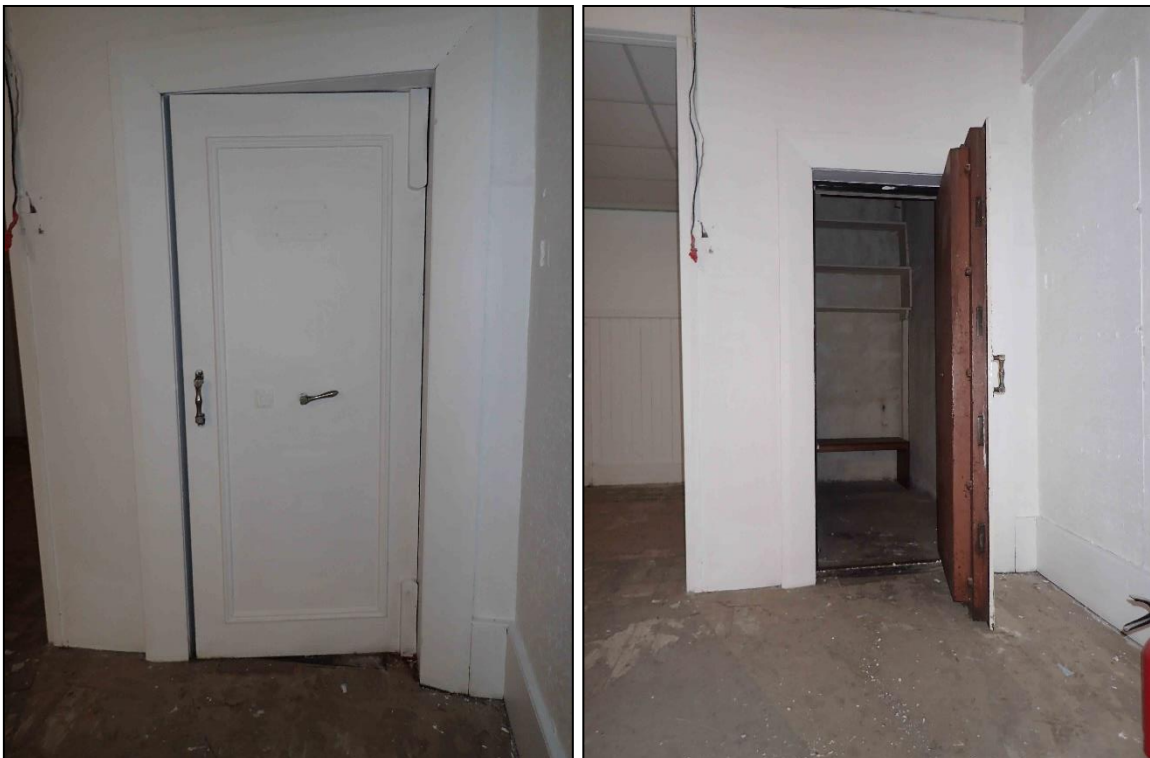
Figure 6-466. Strong room at Kingsland's Shop (Room 2).

A strong room (Room 2; Figure 6-466) is located at the back of Room 1 and has a maker's plate that reads "F. Whitfield & Co/ SAFE & DOOR MANUFACTURERS/ LONDON" (Figure 6-467). Frederic Whitfield came from a family of locksmiths and safe makers and took charge of the family business in the 1880s. The name changed to the Whitfield Safe and Lock Company by the start of the twentieth century (Beck, 2007), suggesting that this strong room was installed during those two decades.

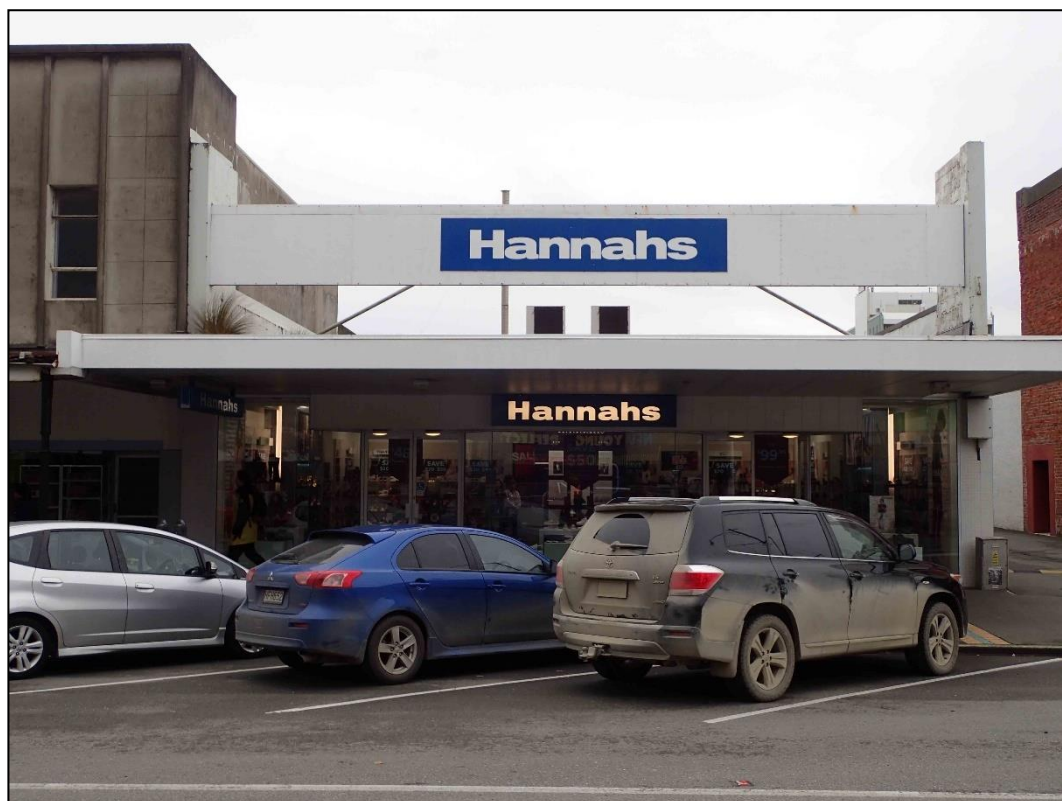
Figure 6-472. Tay Street façade of 16 Tay Street.

There is currently only one building on TS 19: the single storey Hannahs shop, constructed in 1969 (Figure 6-472). A site visit was conducted by Peter Mitchell on 18 April 2018, but the interior of the building was not inspected as it is entirely modern.

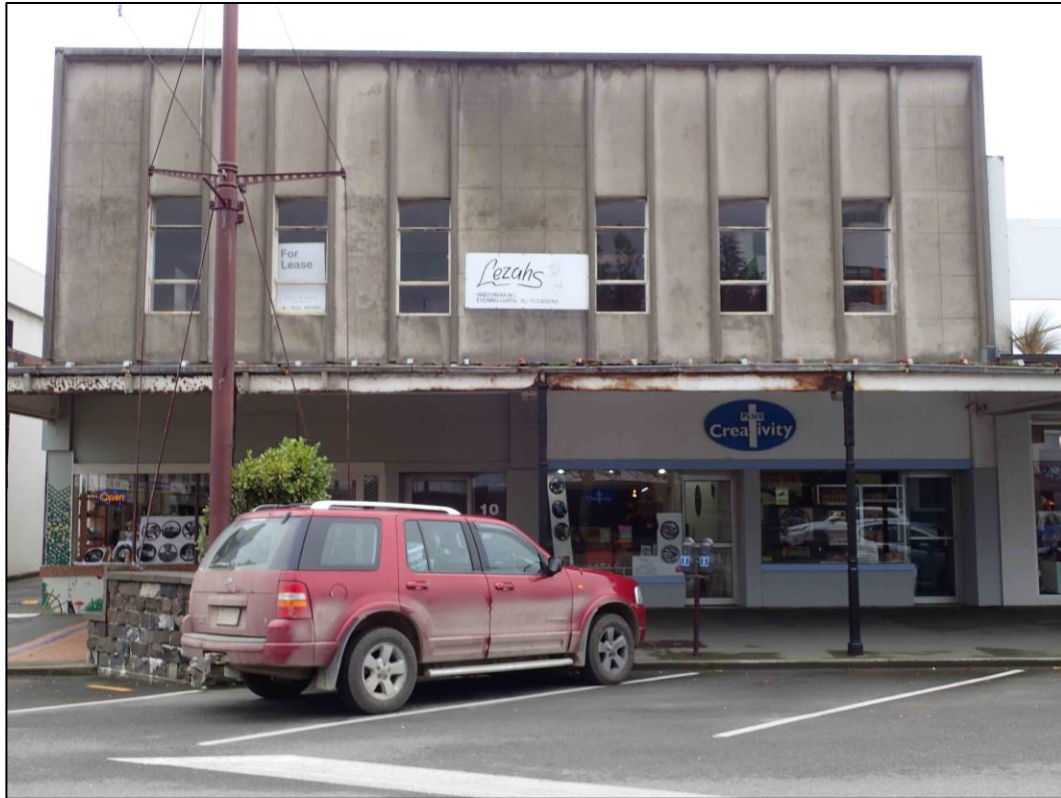
Figure 6-481. Tay Street façade of Watson's Building.

The Tay Street façade has no visible heritage fabric (Figure 6-481). Alterations in 1962 included the removal of most of the original detailing, rendering of the brickwork and the replacement of the original brick parapet with

the extant concrete example. Six steel casement windows line the first-floor façade and date to the 1962 alterations. The three ground floor shop fronts have also been repeatedly altered and each currently consists of an inset glass door and large display windows. A glass door that leads to the stairs to the first floor is positioned roughly on the centre of the Tay Street façade. A simple verandah extends the length of the building and is supported by iron posts.

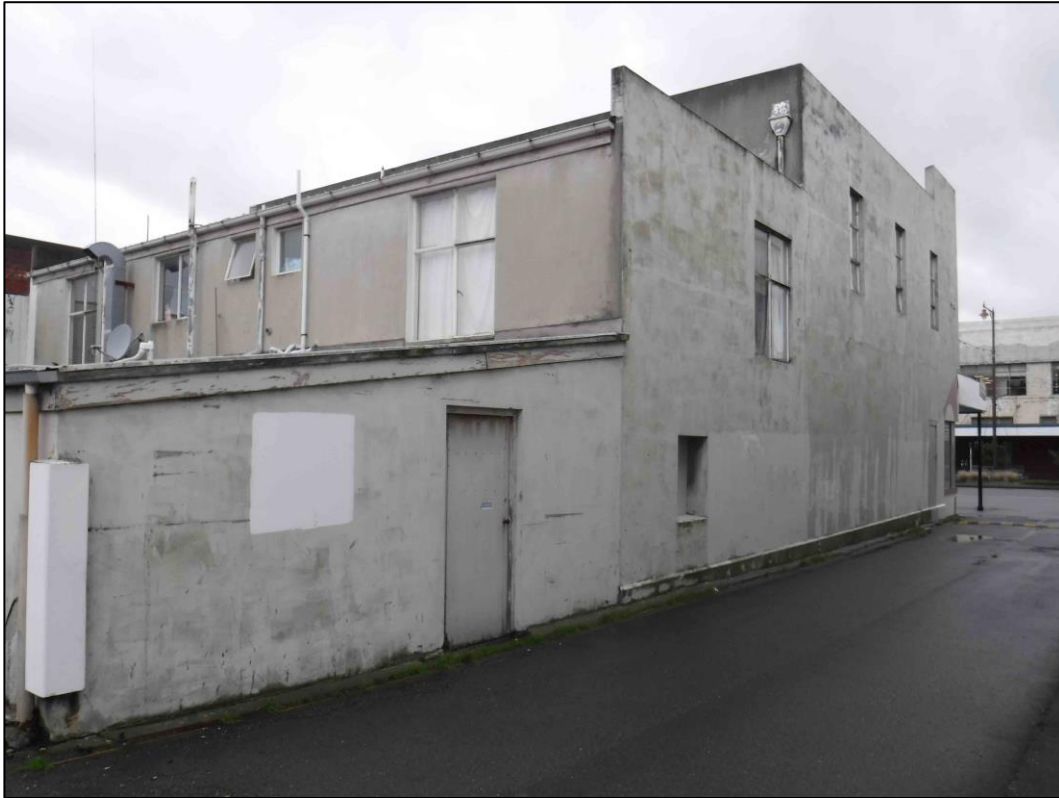
Figure 6-482. West elevation of Watson's Building, looking southeast.

The west elevation of Watson's Building is plain rendered brick and concrete with low parapets at the south end and on the mezzanine section (Figure 6-482). The east elevation is partly obscured by the neighbouring Hannah's Building but the parts that are visible are rendered like the west elevation. The north elevation of the original portion of the building has been mostly obscured by the mezzanine addition and the enclosed outbuildings, but it has no decoration and is also rendered brick and concrete (Figure 6-483). The three different levels are clearly visible on this elevation.

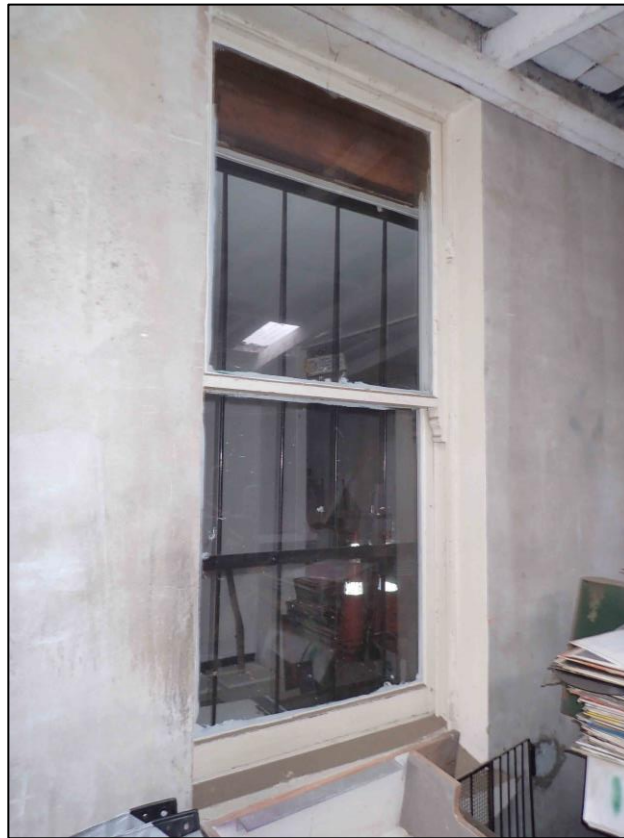
Figure 6-484. Original timber sash window with lugs in ground floor north elevation.

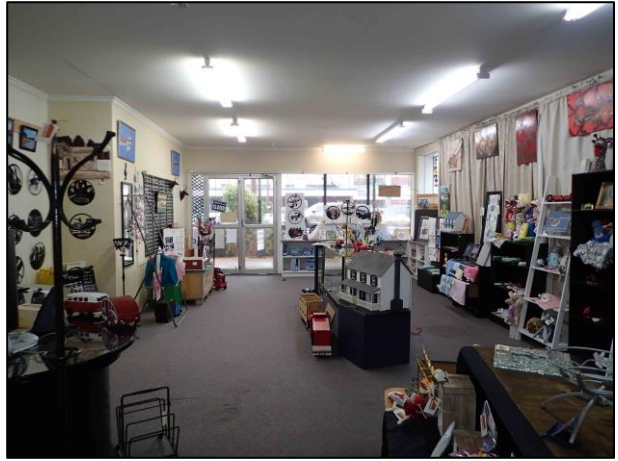
Figure 6-486. Room 1, looking north (left) and Room 11, looking south (right).

The ground floor of Watson's Building is divided into three shop spaces and an enclosed yard area at the rear (Figure 6-485), and all are currently occupied by a craft studio and shop (Figure 6-486). The interior of the building has been remodelled and as a result minimal heritage fabric is visible. Room 1 has a dado rail above which the wall is lined with painted pressed tin, although this appears to date to the early twentieth century due to its Art Nouveau style (Figure 6-487; left). Tongue and groove timber floorboards are exposed in half of Room 4 and may be original (Figure 6-487; right). A four-panel low lock rail door with moulded architraves is located in the east wall of Room 12 (Figure 6-488; left) and opens into a space that is now a cupboard (Room 13) but appears to have originally been the rear entry to the first floor. Exposed brickwork in the English Garden Wall bond is visible in this cupboard (Figure 6-488; right). Rooms 7, 8 and 9 were originally outbuildings but were partially enclosed during the 1960s renovations and now comprises storage areas and toilets (Figure 6-489). The stairwell leading up to the first floor has a mosaic tiled floor on the bottom level that may be original. The linings, mouldings and architraves have been updated elsewhere on this level.

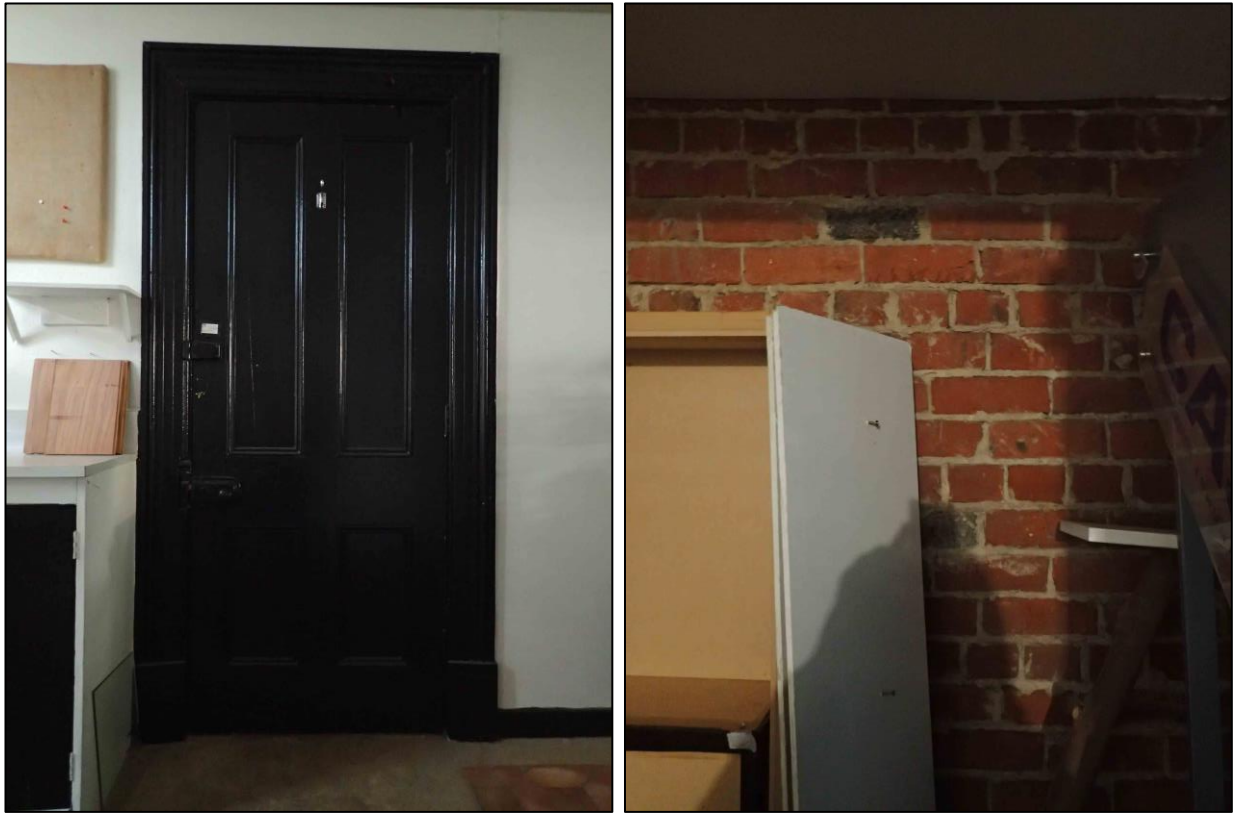
Figure 6-488. Left: original door in east wall of Room 12. Right: exposed brickwork on east wall of Room 13.

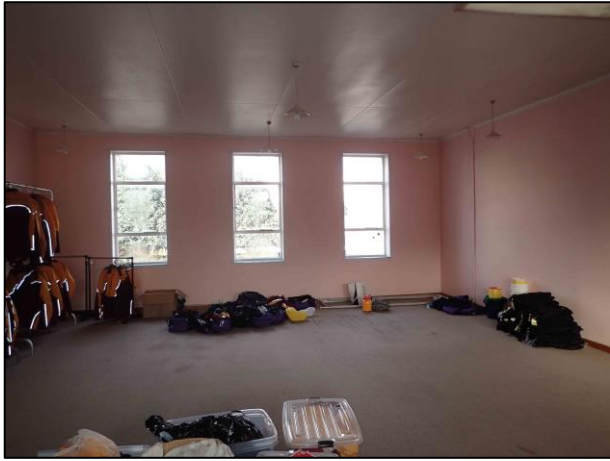
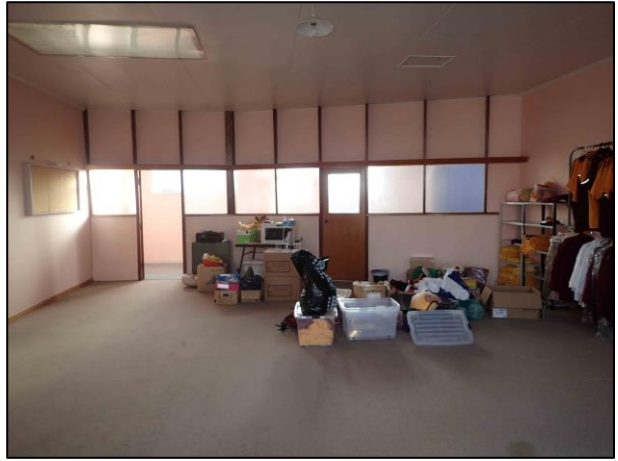
Figure 6-491. Room 16 looking south (left) and north (right).

The first floor is currently separated into two tenancies (Figure 6-490), one of which is occupied (Room 16; Figure 6-491). The west tenancy (Room 17; Figure 6-492) was unable to be accessed during the site visit, however the door and partition walls are glass, so the area was able to be viewed. No heritage fabric is visible in either space and each has softboard tile ceilings, softboard walls and modern carpet on the floors. Two toilet stalls (Room 18) are located at the north end of the first-floor landing (Room 15). The original roof structure is visible through an opening in the ceiling of Room 15 (Figure 6-493).

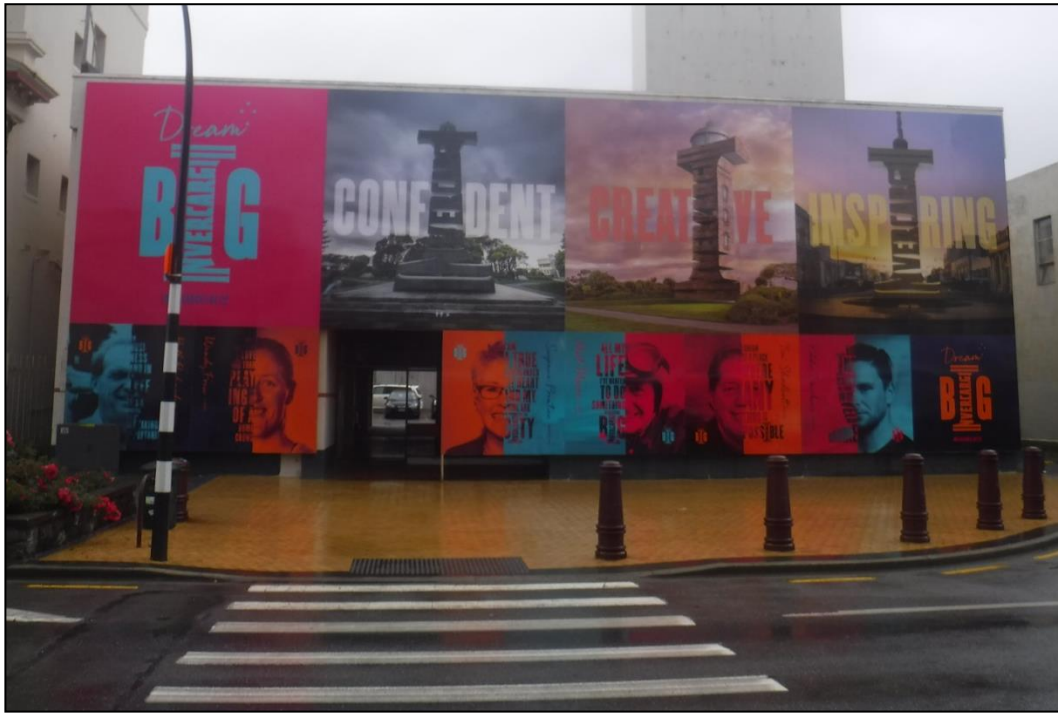
Figure 6-500. The south elevation of 4 Tay Street.

The south elevation of 4 Tay Street faces the street (Figure 6-500). The north elevation backs onto a car park accessed via various lanes and alleys. There are no pre-1900 features or fabric associated with the building at 4 Tay Street.

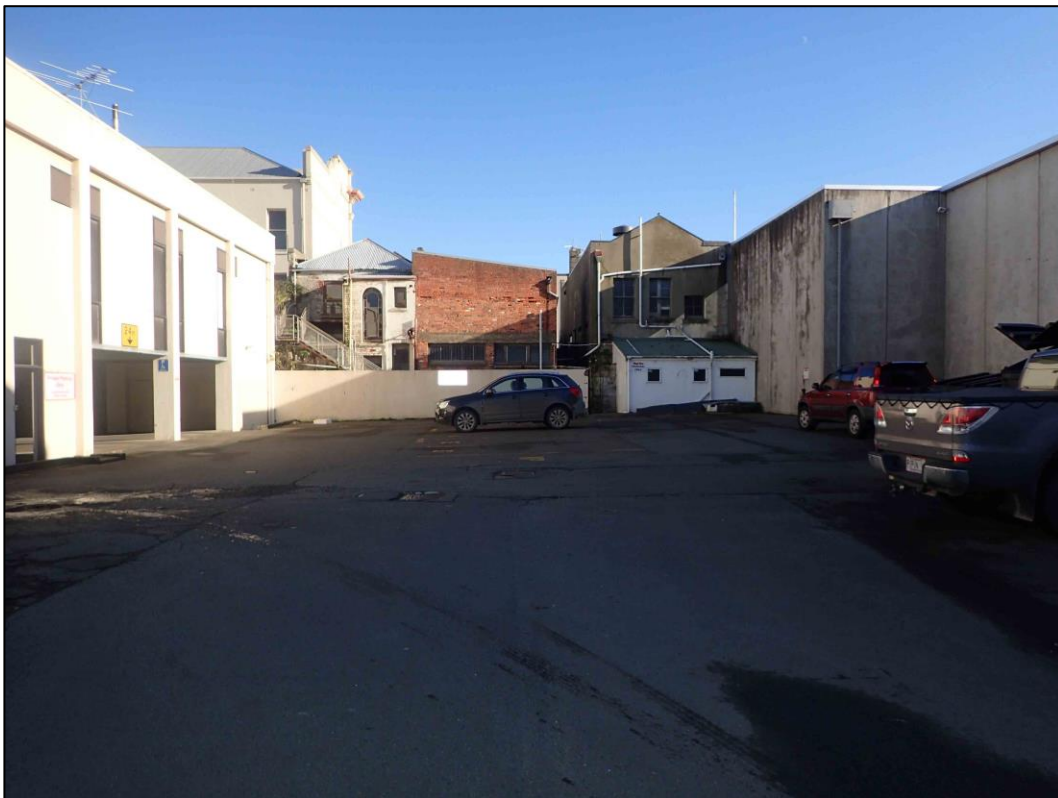
Figure 6-501. Lot 1 DP 4801 and Part Lot 2 14147 looking west.

The rear of TS 21 is occupied by two other land parcels. Lot 1 DP 4801 is currently an asphalt open-air car park while Lot 2 DP 14147 that extends onto the north of this section is occupied by the Reading Cinema complex (Figure 6-501). No archaeological or heritage features are visible on either land parcel.

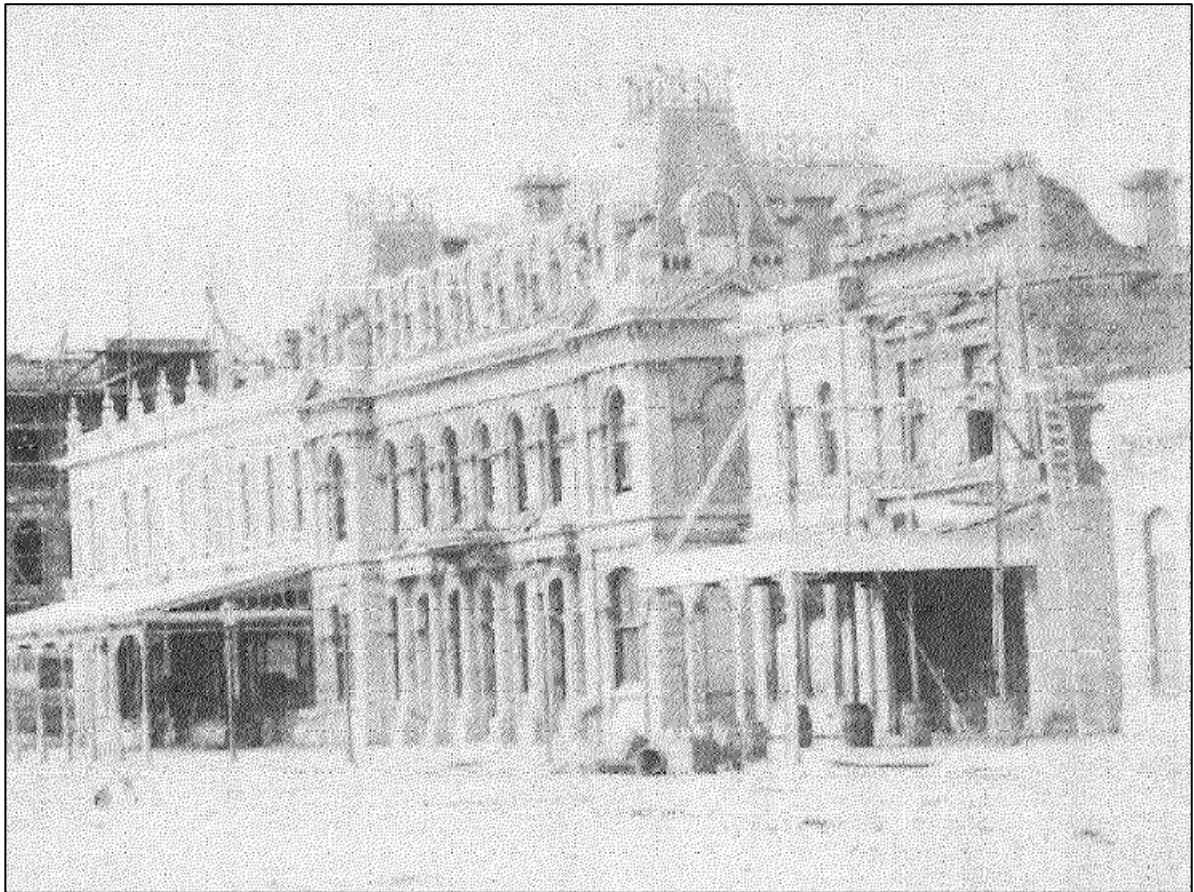
Figure 6-509. Detail of 1876 photograph of Dee Street showing the construction of a second storey on Lumsden's shop (right) (Anon., 1876).

Lumsden continued to his building and section of TS 22 until his death on 11 February 1904 (Southern Cross, 1904b). During his ownership he carried out several alterations, including the addition of a second storey in 1876 (Figure 6-509). The Nicholas Brothers (photographers who leased premises next door) complained in August 1876 that the new addition to Lumsden's building blocked the light into their studio, and made it impossible for them to take portrait photographs (Southland Times, 1876d). A photograph taken along Dee Street between 1879 and 1880, shows the additional storey added to Lumsden's building, with the distinctive clock now located in the centre of the building (Figure 6-510).

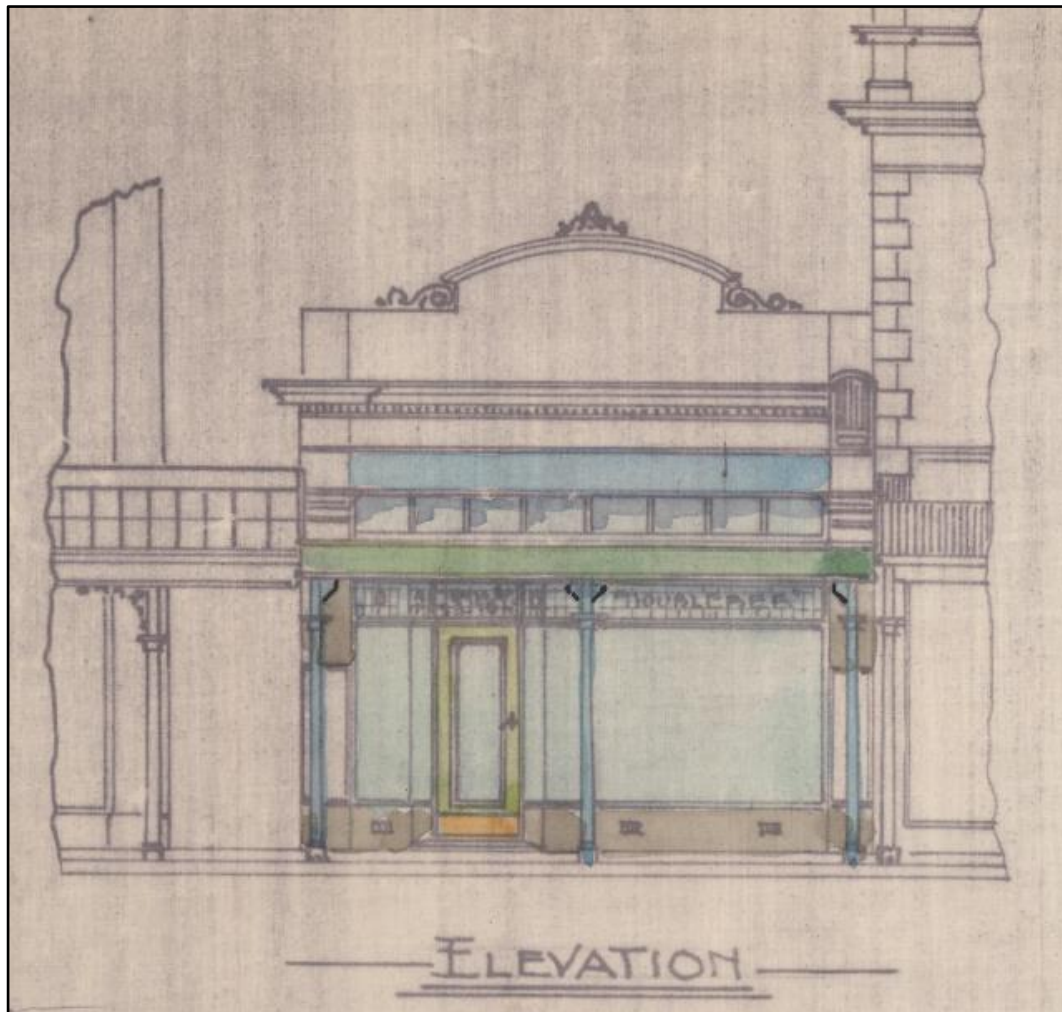
Figure 6-519. Detail from 1933 plan of building at 7 Dee Street, showing alteration to the store front (Brodrick & Royds, 1933).

The Brass Brother continued to run a clothier business in Barham's Building (H Wise & Co. 1924: 512). A photograph taken on the corner of Dee and Tay Street in 1926 shows the Brass Brothers in occupation of Ott's two-storey and Barham's single-story buildings (Figure 6-517). In 1933, the Brass Brothers carried out alterations to the store front of Barham's and Ott's Buildings (Figure 6-519 and Figure 6-520). The Brass Brothers formally purchased Ott's Building in 1952 and continued to own the property until 1963.

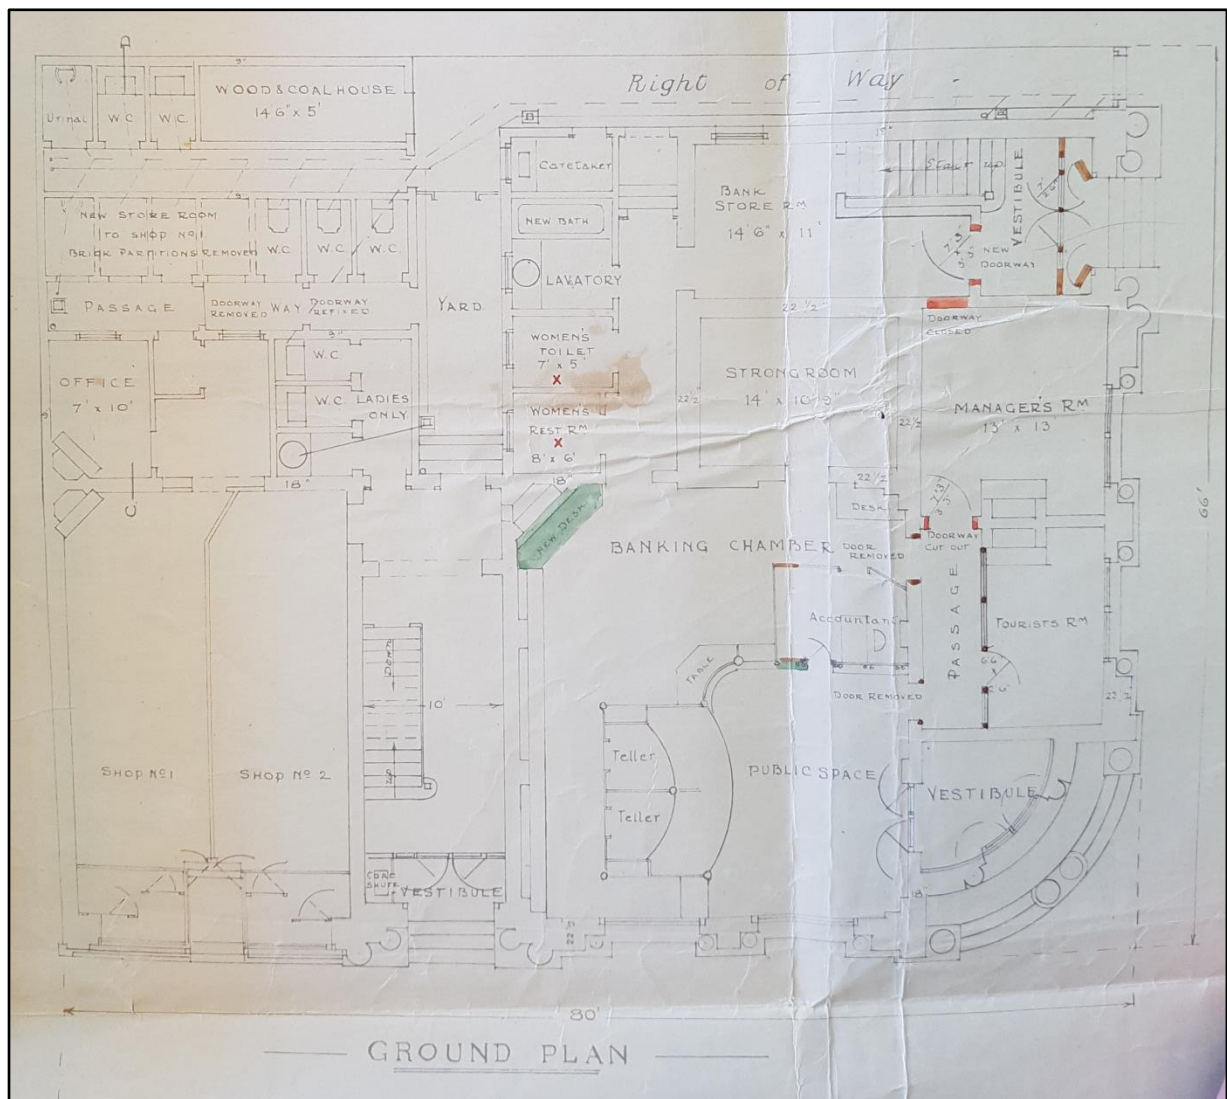
Figure 6-523. Detail from 1937 plan of the Bank of New South Wales, showing the ground floor plan of the building (Brodrick, 1937).

A floor plan of the interior of the BNSW was drawn up the building's original architect C J Broderick in 1937 (Figure 6-523). The layout of the building reflects the original description of the building's layout from 1904, suggesting that little internal alteration of the building had occurred by this time. In comparison, a floor plan of the building drawn by the architectural firm of Stephenson and Turner in 1968, shows a number of changes to the internal layout of the building (Figure 6-524). The most significant change evident is the removal of the vestibule entranceway on the corner of the building, and the addition of a large entrance and lobby off the Dee Street frontage, where the second store was previously located.

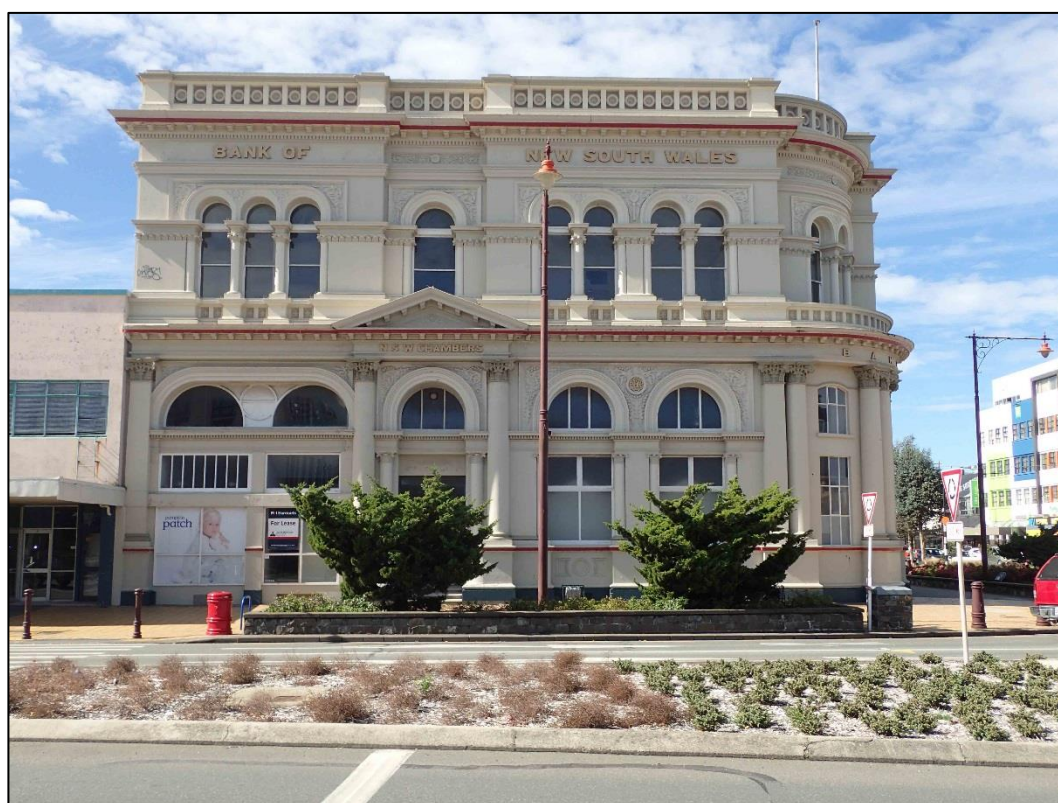
Figure 6-526. West elevation of the BNSW.

The BNSW is a prominent three storey corner building with façades to Tay and Dee Streets (Figure 6-526 and Figure 6-527). A true specimen of Renaissance Revival architecture, the façade incorporates both Italianate and Romanesque design elements and represents typical monumental architecture utilised by financial institutions to promote their ideologies of strength and permanence.

The north end of the west façade has a slightly different window arrangement from the remainder of the bank (Figure 6-526), and perhaps this was done to visually separate the bank from the retail space. Here, both arched windows are surrounded by a single moulded architrave (blind arch). The windows are different from those elsewhere in the building and have been replaced over time. This former retail space originally had a separate recessed entry and shopfront windows, as demonstrated by historical photos.
