6.14.3 On Site Observations: Zookeepers Café (50 Tay Street)

The extant building at 50 Tay Street was constructed in 1916 and is currently occupied by Zookeepers Café. Major alterations were undertaken on the interior and façade in the 1950s and several minor renovations have been undertaken since then. The following description of the building follows from the site visit conducted by Dr Dawn Cropper and Dr Naomi Woods on 18 April 2018.

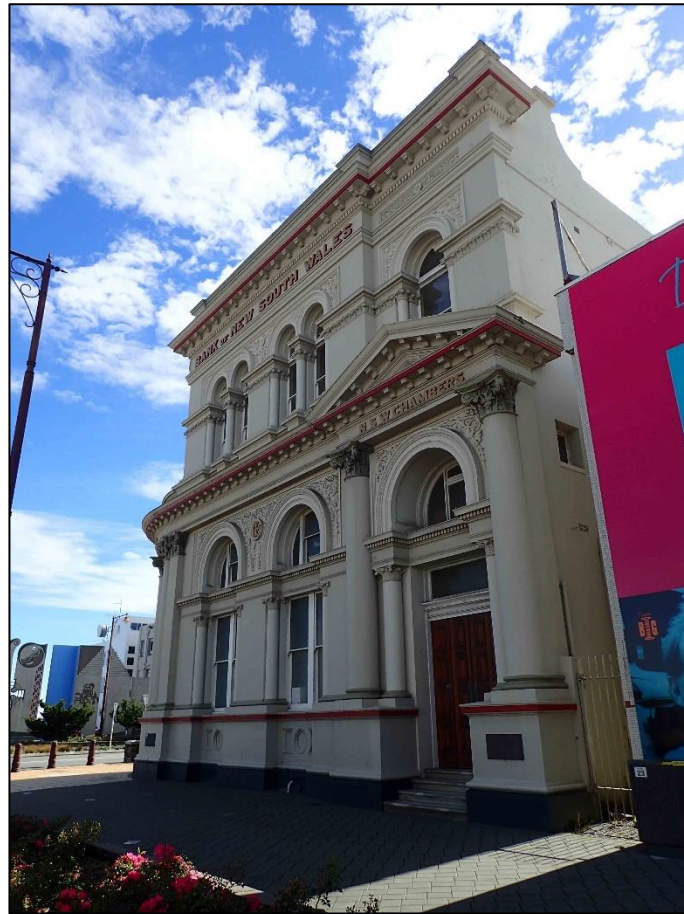
Figure 6-527. The south façade facing onto Tay Street.

The BNSW is a prominent three storey corner building with façades to Tay and Dee Streets (Figure 6-526 and Figure 6-527). A true specimen of Renaissance Revival architecture, the façade incorporates both Italianate and Romanesque design elements and represents typical monumental architecture utilised by financial institutions to promote their ideologies of strength and permanence.

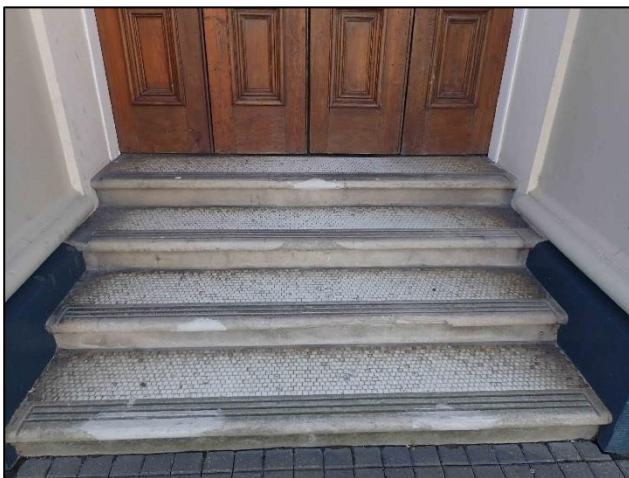
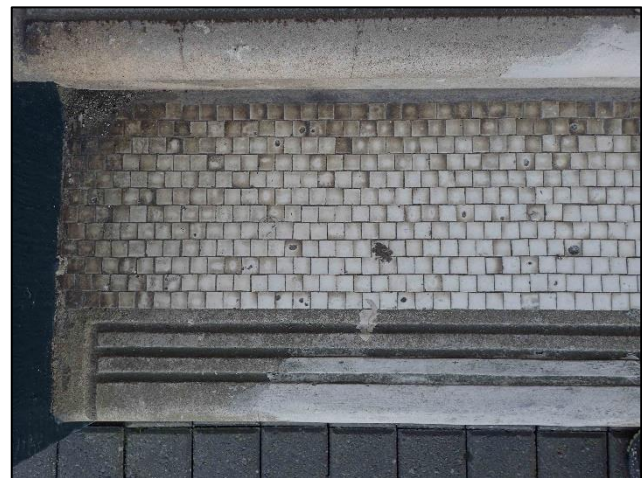
Figure 6-529. Detail of the stairs leading up to the south doorway.

Each entryway has heavy double timber doors, comprised of a set of eight-panelled bifold doors (Figure 6-528). Unlike any other building in the block, the ground floor is considerably higher than ground level, and each doorway features a staircase (Figure 6-529). The stairs are concrete formed *in situ*, and there are incised lines along the edge of each tread for drainage. The remainder of the treads are lined with mosaic tiles.

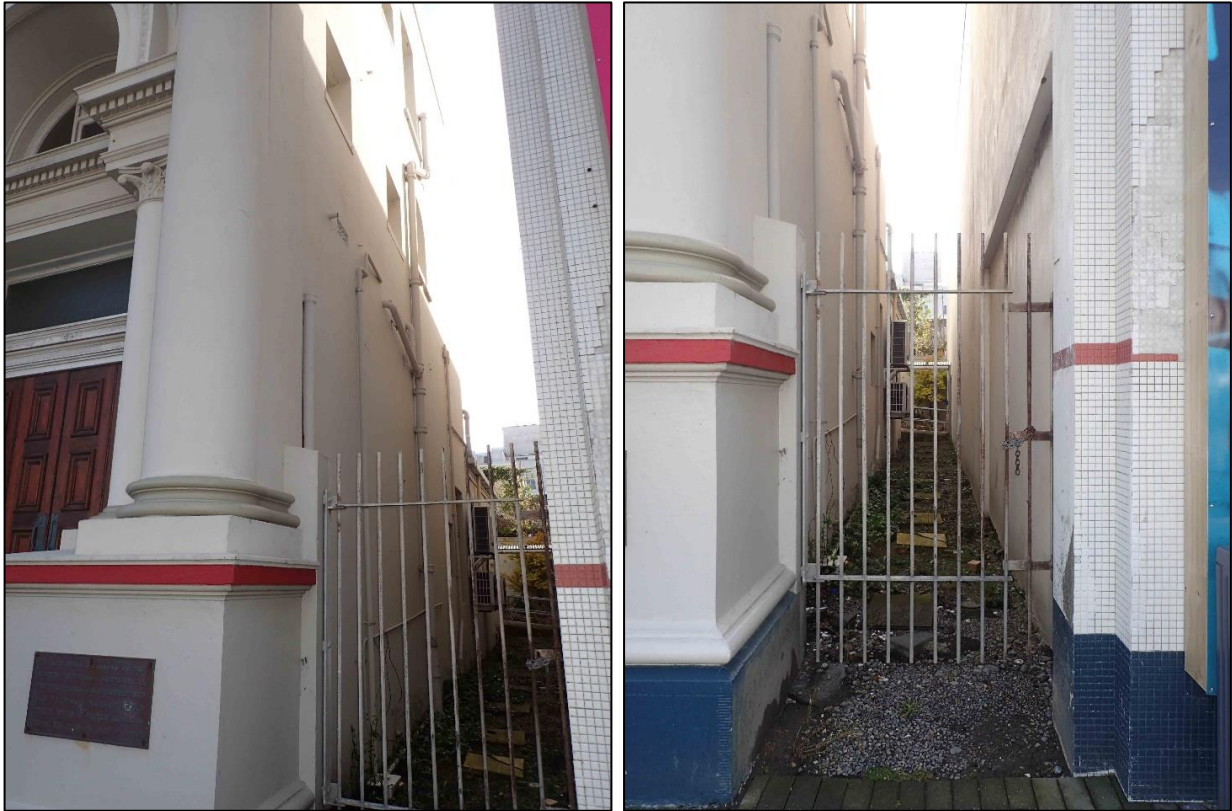
Figure 6-530. The east elevation of the BNSW.

The north and east elevations are a sharp contrast to the highly ornamented façade, consisting of a completely plain rendered wall punctuated by window openings and services (Figure 6-530 and Figure 6-531). There is an L-shaped single storey extension at the northeast corner of the building (Figure 6-531), which appears to incorporate at least two of the original lean-tos on the building. A covered access ramp from the former ANZ Building, now used as a carpark is visible in Figure 6-531, and there is a small open courtyard in the far northeast corner of the property.

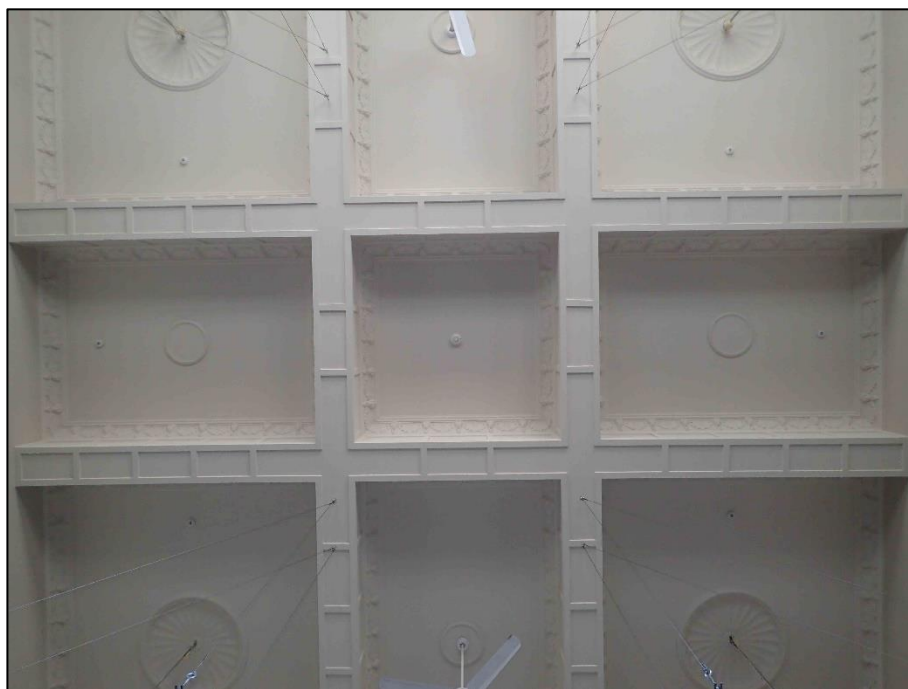
Figure 6-534. Coffered double-height ceiling.

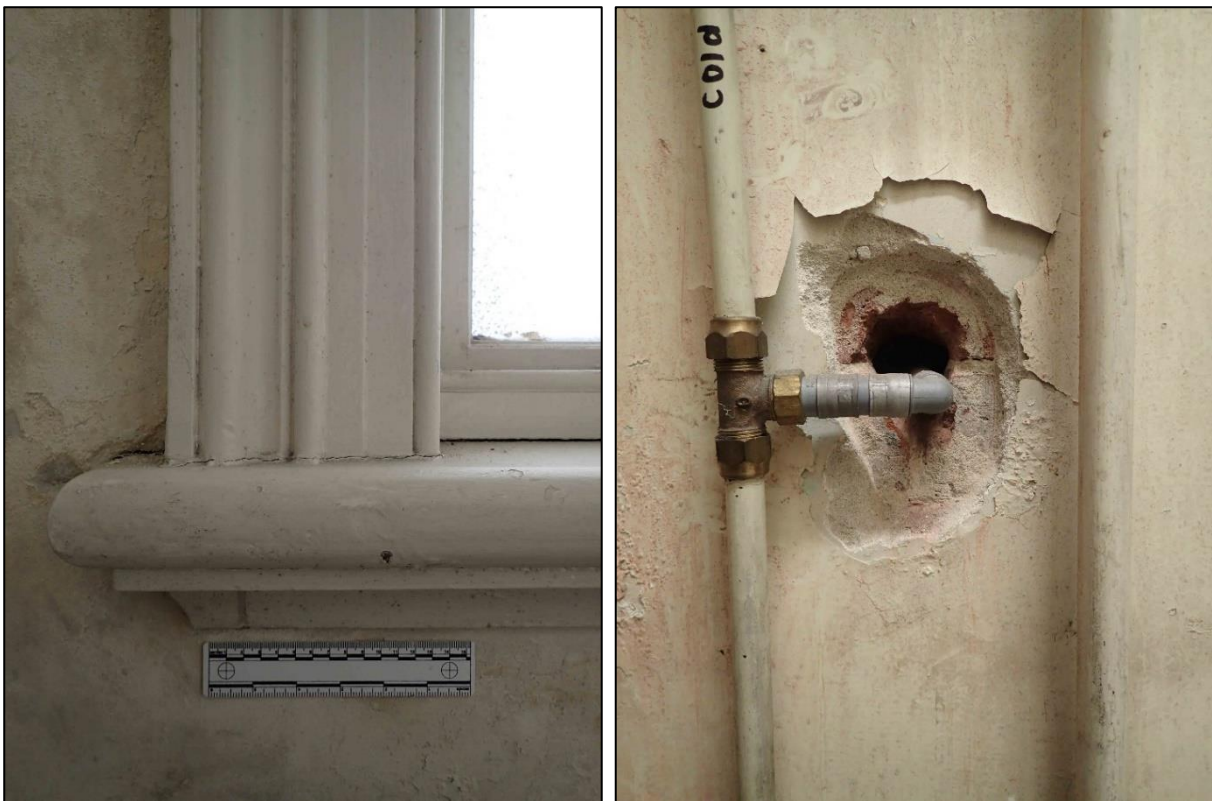
Figure 6-536. The original architraves, stool, and apron on the double-hung sash window in the ground floor toilet. Right: the thick plaster render over the brick walls exposed to accommodate the water supply.

The hallway on the east side has been recently updated and there are modern linings throughout. This hallway provides access to the toilets, services, and to the south lobby. An original sash window with moulded architraves is visible in the toilets (Figure 6-536). While the original skirting boards have been removed, the scar on the wall shows their considerable height. In a service cupboard beneath the stairs, some beaded tongue and groove match lining remains. In the rooms off the hall, the plastered brick wall is visible, and the layers of plaster are visible in Figure 6-536.

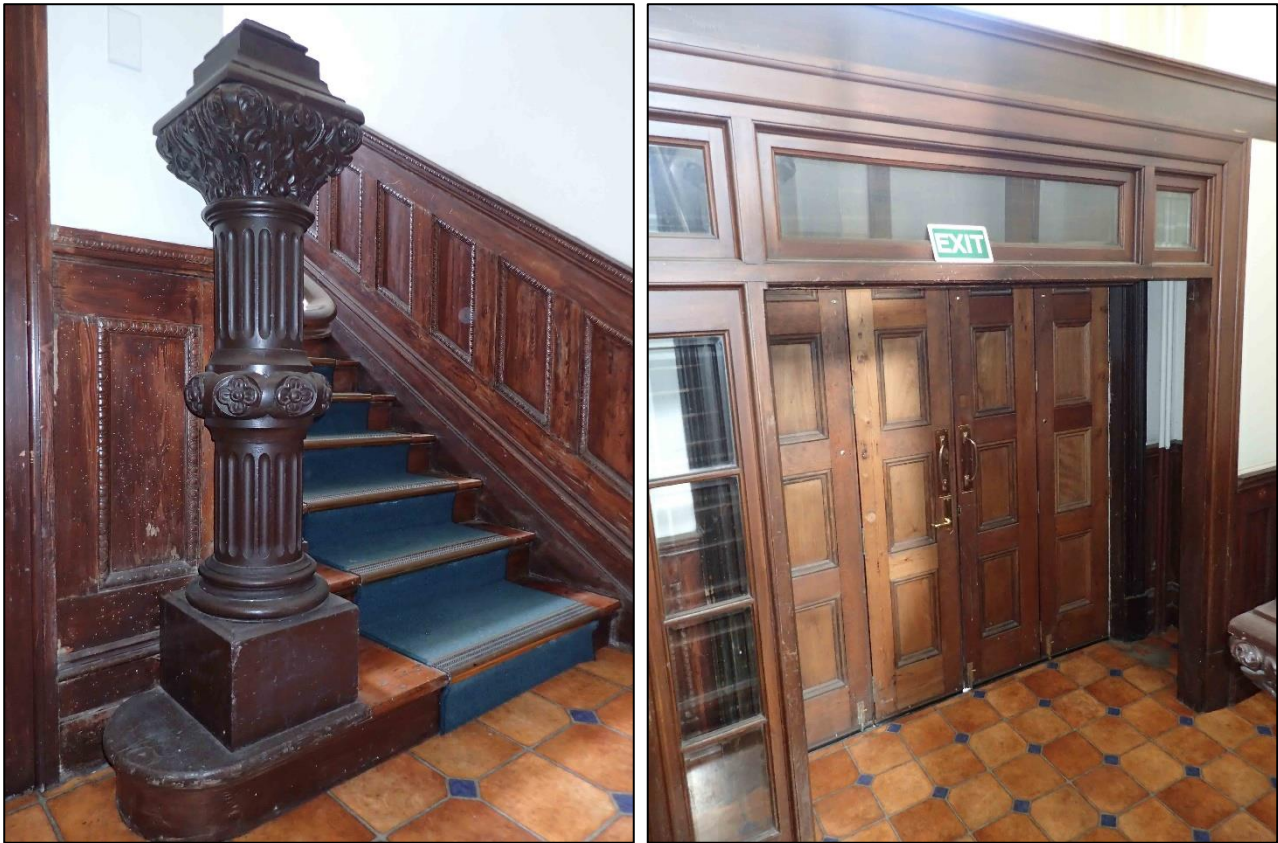
Figure 6-537. Left: the ornate balustrade and the timber dado in the south lobby. Right: the narrow partial height vestibule.

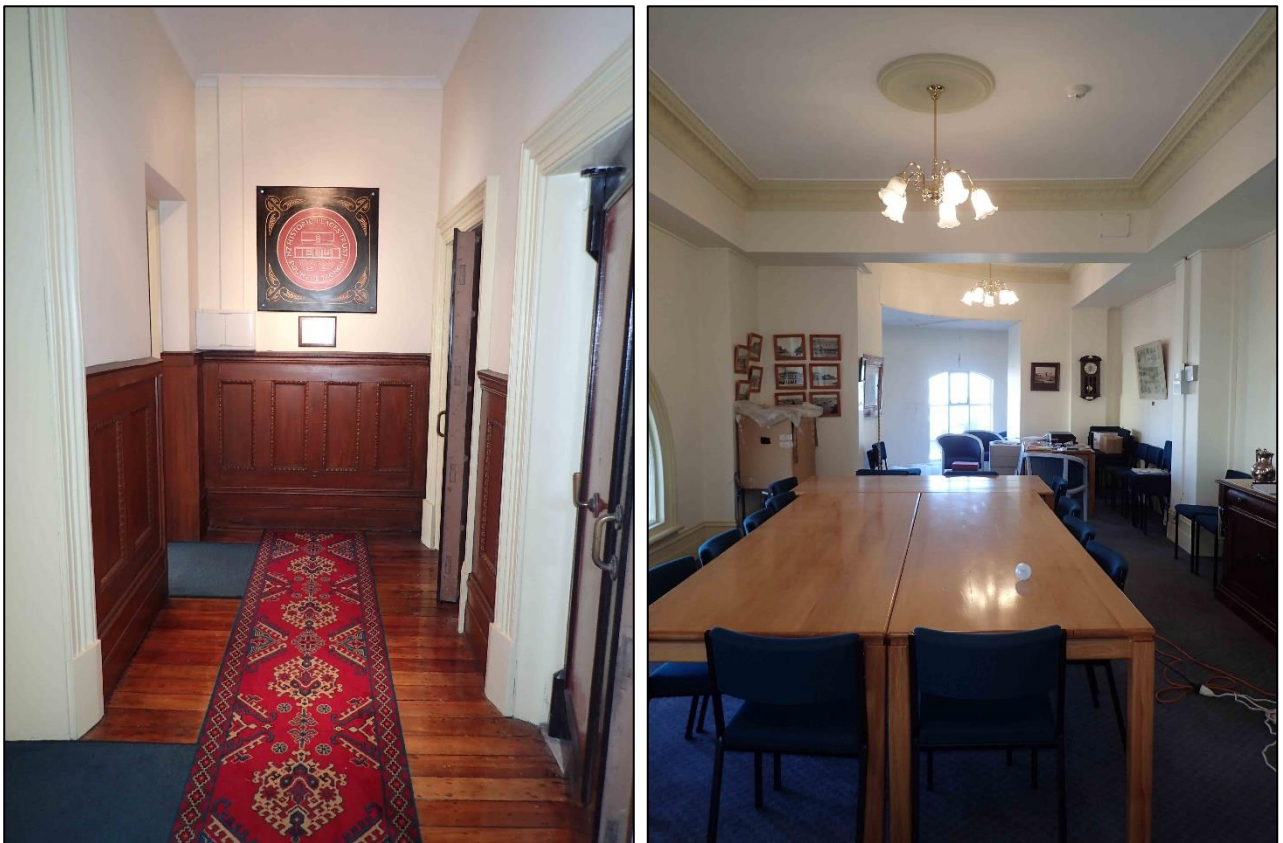
Figure 6-540. Left: the first-floor south hallway. Right: the large open-plan office on the south side of the first floor (Room 21).

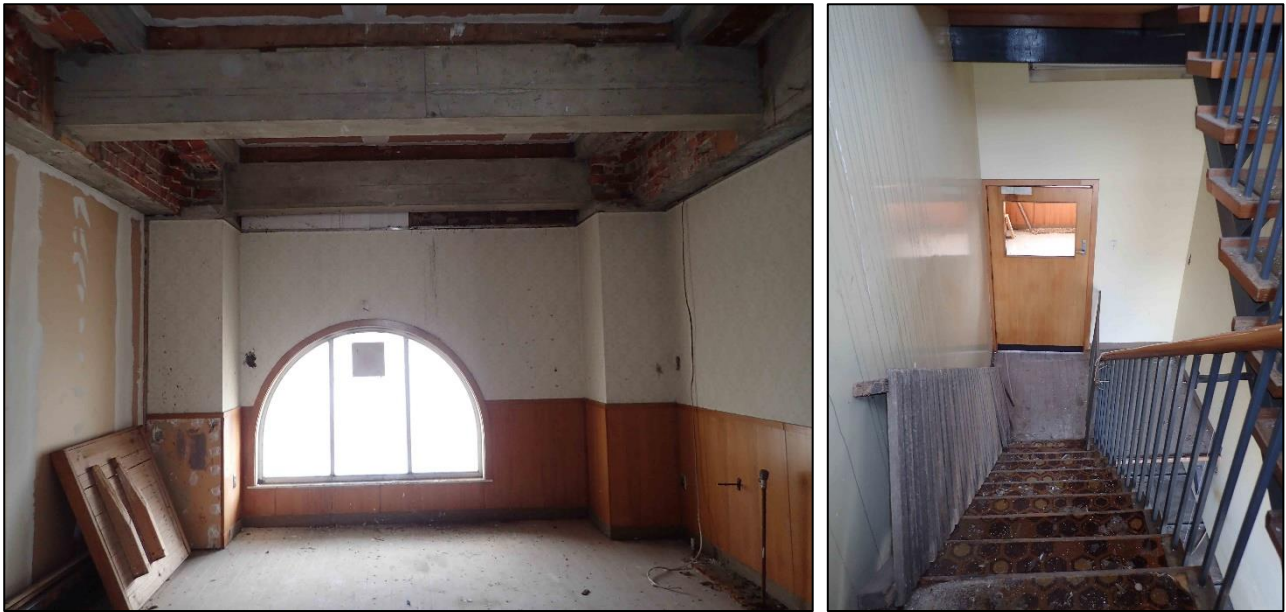
Figure 6-541. Left: view of Room 13, facing west. Right: looking down the western stairway to the first-floor landing.

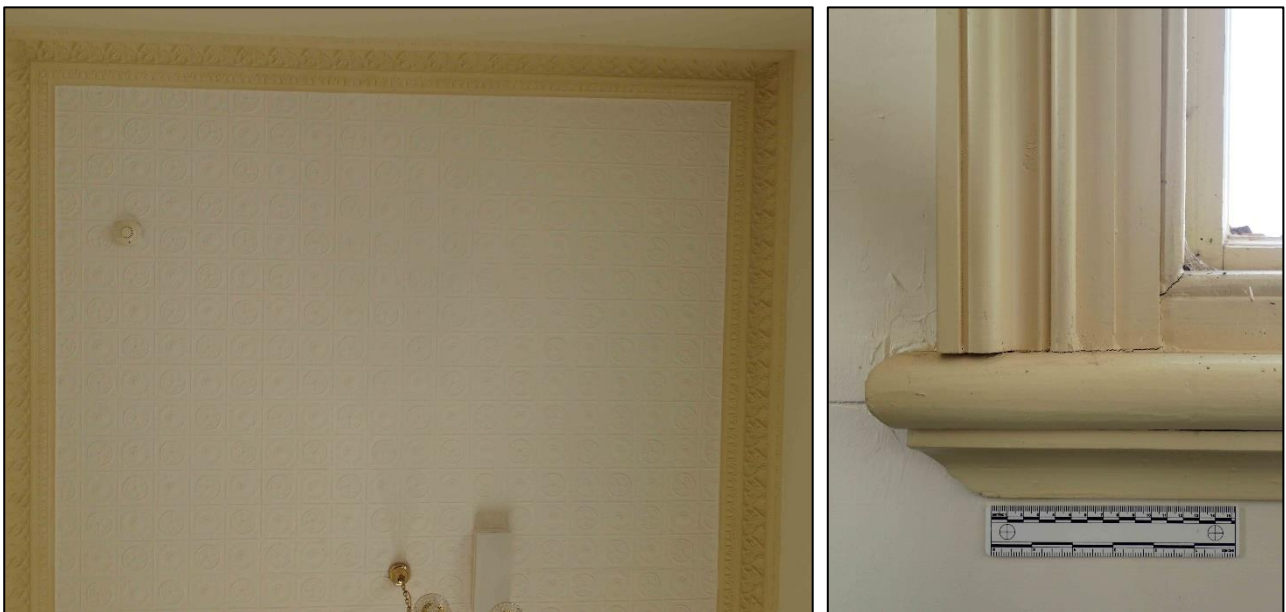
Figure 6-544. Left: the pressed timber ceiling of the second-floor landing. Right: the original stool and apron with a modern architrave.

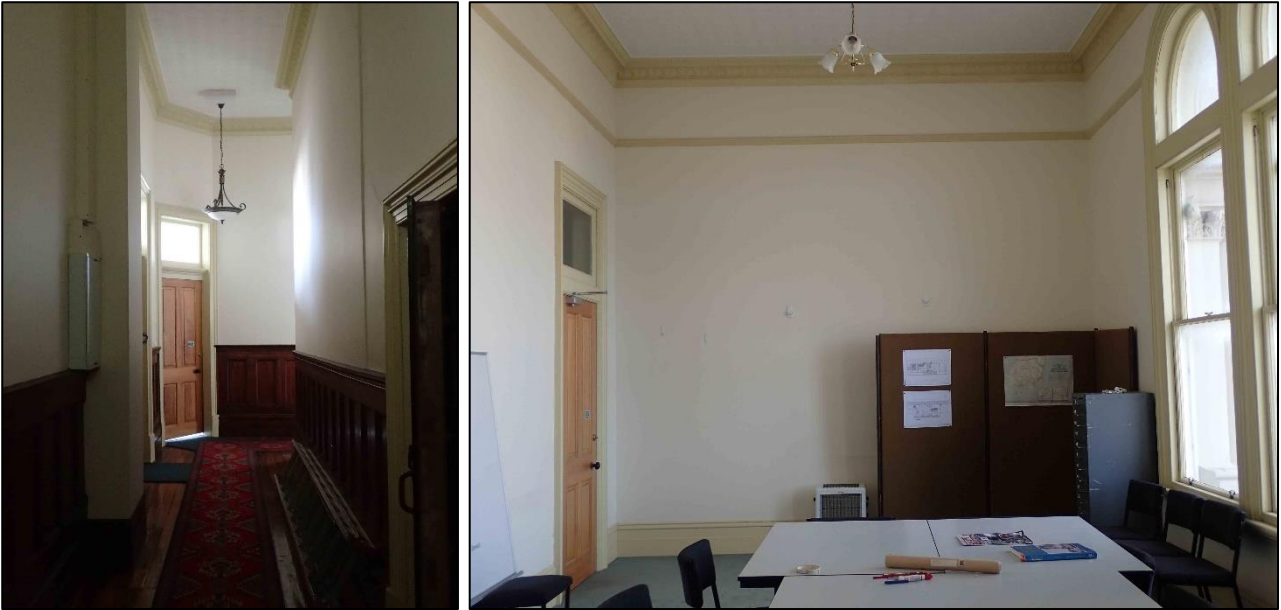
Figure 6-545. Left: the L-shaped hallway (Room 24). Right: an example of a finished room on the second floor (Room 25).

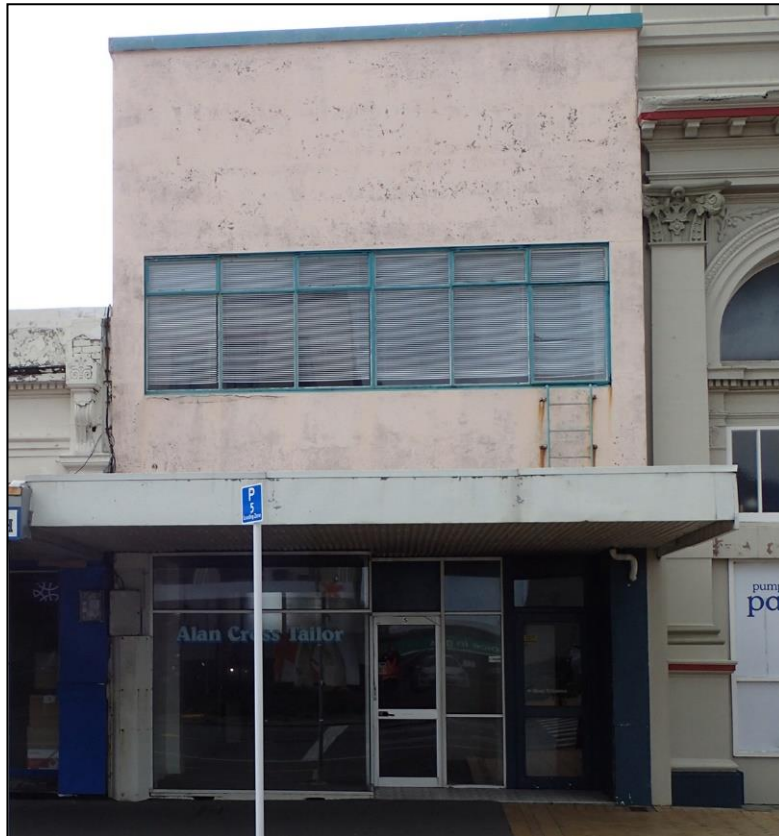
Figure 6-547. Dee Street façade of Ott's Building.

The west elevation of Ott's Building faces the street and retains no visible heritage fabric (Figure 6-547). The ground floor of the west elevation is heavily modified and consists of large fixed windows and two glass and steel doors. The door on the left (north) accesses the main ground floor retail area (Room 1) and the door on the right (south) accesses the stairway to the first floor (Room 4). A row of steel framed fixed windows with awning quarter lights stretch almost the full width of the first-floor façade and appear to date to an external modification undertaken during the twentieth century. All decoration has been removed from the façade and it has been rendered in concrete and a plain parapet lines the top. The supports have been removed from the verandah, probably at the same time as the façade and first floor windows were replaced. There is a steel fire escape at the south end of the first-floor façade that leads from a window on the verandah.

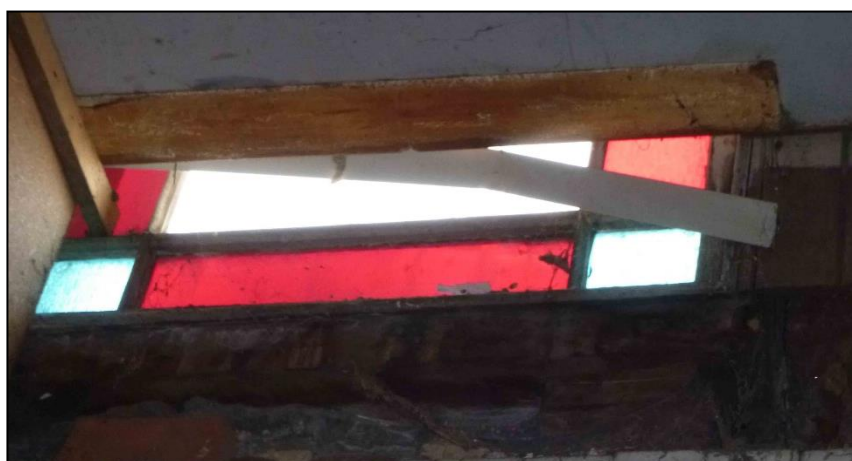
Figure 6-550. The bottom of the arched window in the east wall of Room 3.

The windows in the west elevation all appear to have been replaced at various times in the twentieth century. The windows in the east elevation appear to be mostly original, with the arched window with flashed glass panels being of note as it extends below the modern first-floor level (Figure 6-549 and Figure 6-550).

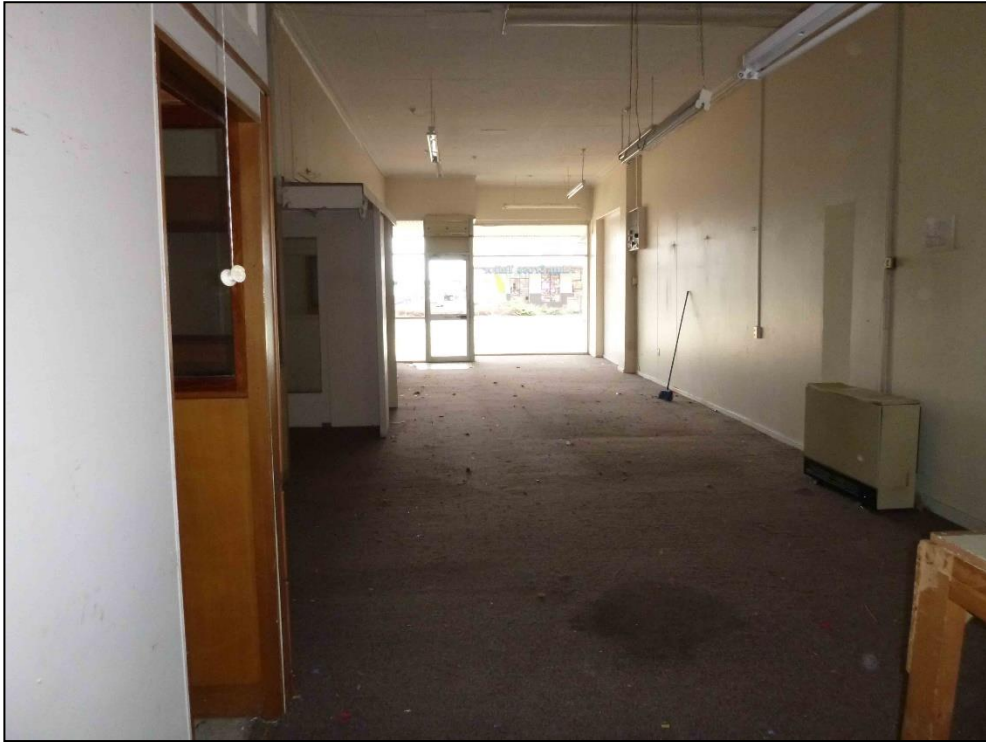
Figure 6-552. Looking west in Room 1.

The ground floor of Ott's Building is divided into four spaces (Figure 6-551, Figure 6-552, Figure 6-553 and Figure 6-554): a large open retail area (Room 1), a storage room (Room 2), toilets (Room 3) and a staircase to the first floor that is accessed from the street (Room 4). These room divisions, with the exception of the stairwell, appear to be modern and the ceiling has been raised (Figure 6-555). A small section of original beaded tongue and groove match lining is visible on the east wall of Room 3. The ground floor walls and ceiling are lined with plaster board and the floor is carpeted, most likely dating to the 1999 alterations. There is tongue and groove match lining in the rear of the ground floor. The floor in the rear of the building is concrete.

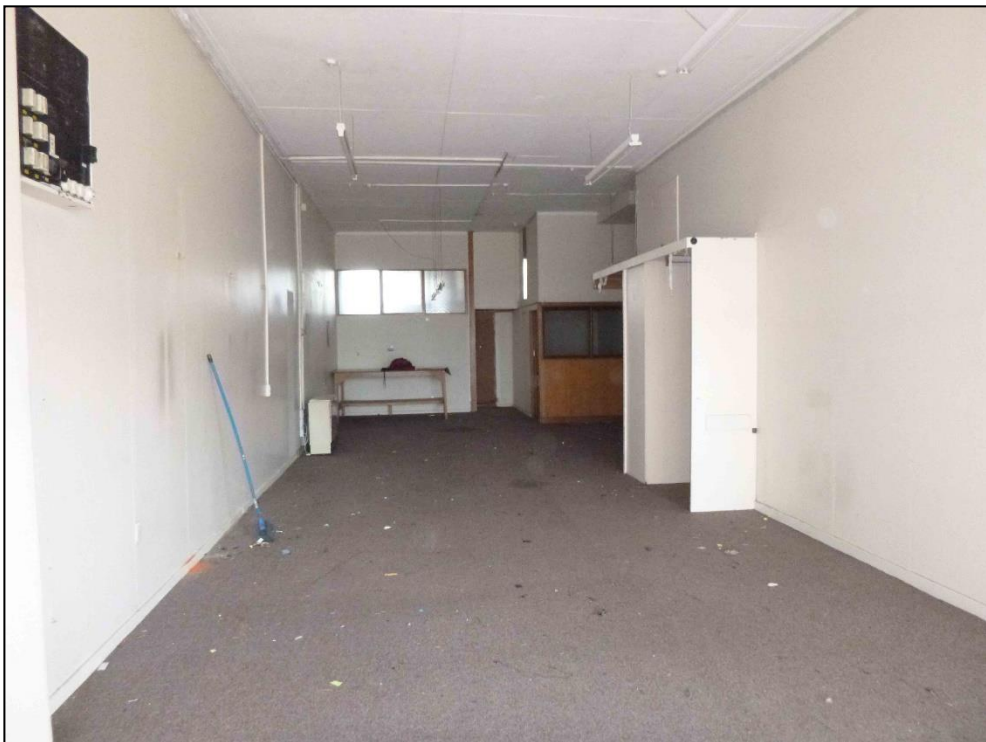
Figure 6-553. Looking east in Room 1.

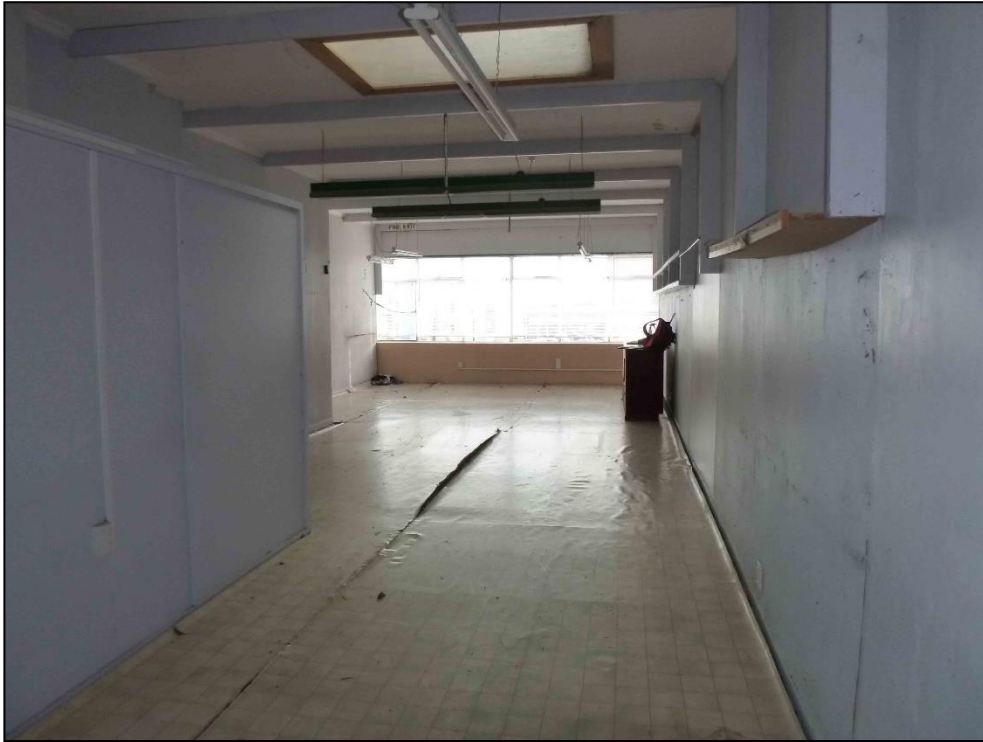
Figure 6-556. Looking west in Room 5.

The first floor of Ott's Building is divided into two main spaces (Figure 6-551): an open front area with fitting rooms and a modern toilet (Room 5) and a rear kitchen (Room 6). Apart from the arched window in the east wall there are no original features visible on the first floor (Figure 6-556, Figure 6-557 and Figure 6-558). The beaded tongue and groove match lining noted on the east wall of the ground floor may continue behind the hardboard wall lining of the first-floor portion of the east wall (Figure 6-555). The walls and ceiling in the front section of the first floor are lined with plaster board dating to the 1999 alterations. The floor is covered with vinyl.

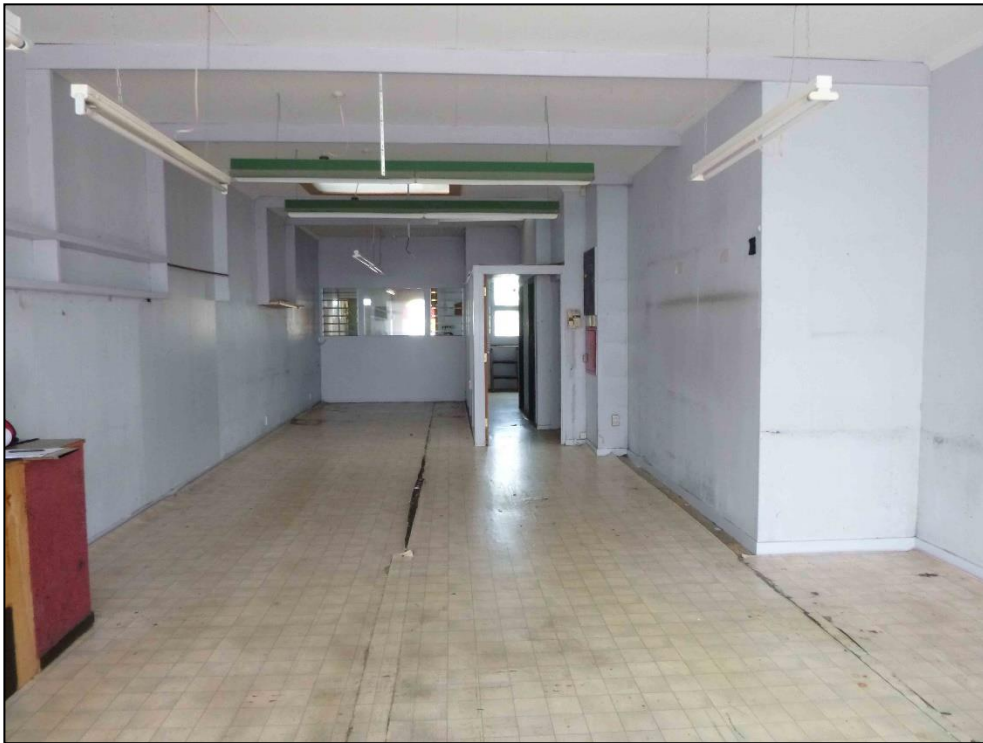
Figure 6-557. Looking east in Room 5.

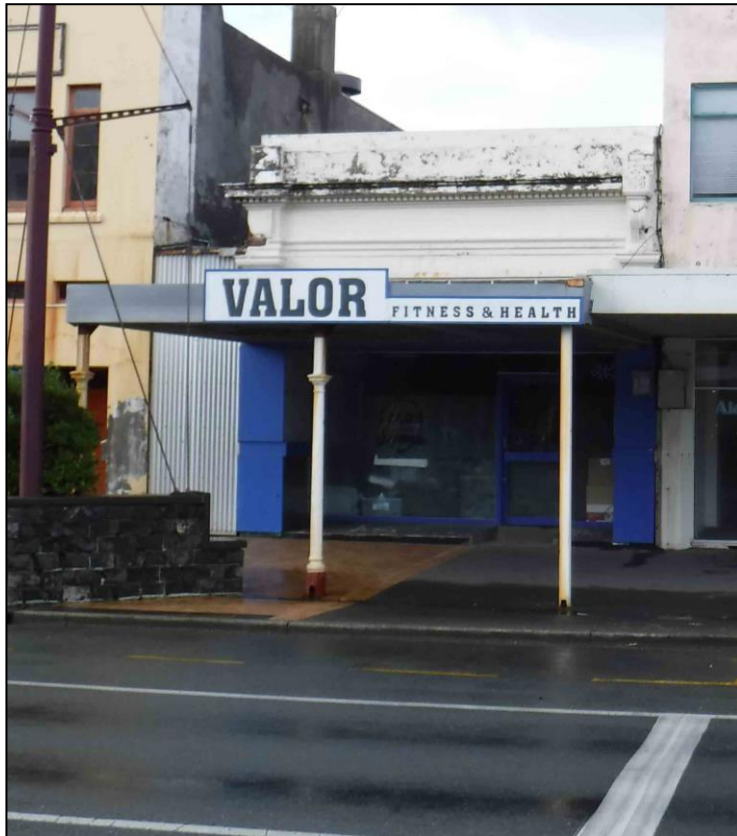
The Dee Street façade retains some heritage fabric but has been heavily modified (Figure 6-559). The shop front has two large fixed windows, with a door at the south end that accesses Room 1. There are four small fixed windows at the top of the ground floor of the west elevation. These and the verandah (supported by three iron posts) date from the 1933 façade alterations. A short rectangular parapet sits atop the façade and dates to the 1964 alterations when the previous, more elaborate design was simplified. Below this is a simple entablature that appears to retain most of its original fabric. The north end has been altered at some point in the late nineteenth century when the corner entrance was removed.

Figure 6-559. The Dee Street façade of Barham's Building.

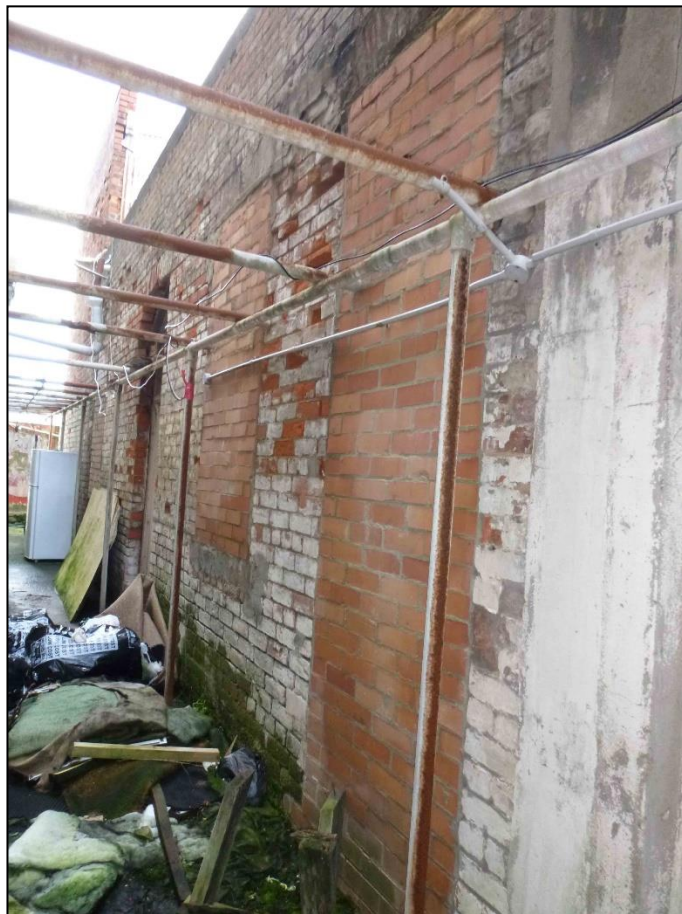
The south elevation of Barham's Building is not visible as it abuts the neighbouring structure (Ott's Building). The north elevation is visible from the alleyway at the north of the building and retains a considerable amount of heritage fabric. Exposed original English Garden Wall bond brickwork is visible along the whole length of this elevation and several windows and doors have been bricked up using modern bricks in a stretcher bond pattern (Figure 6-560). The west end of this elevation features rendered ornamentations around three arched windows that were bricked up during the 1964 alterations (Figure 6-561). This part of the building would have been visible from the street when the alleyway was open, and this is likely why it is relatively ornate. The east end of this elevation is two storeys and has no decoration. The east elevation of Barham's Building is plain exposed brick with a row of louvre windows at the top of the ground floor (Figure 6-562).

Figure 6-560. North elevation of Barham's Building, looking southeast, showing exposed brickwork and blocked openings.

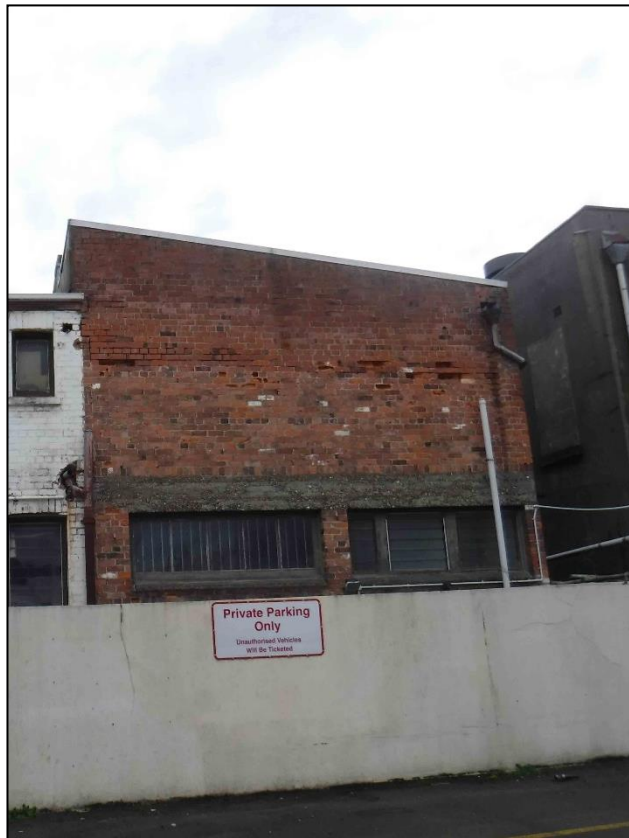
Figure 6-562. The east elevation of Barham's Building.

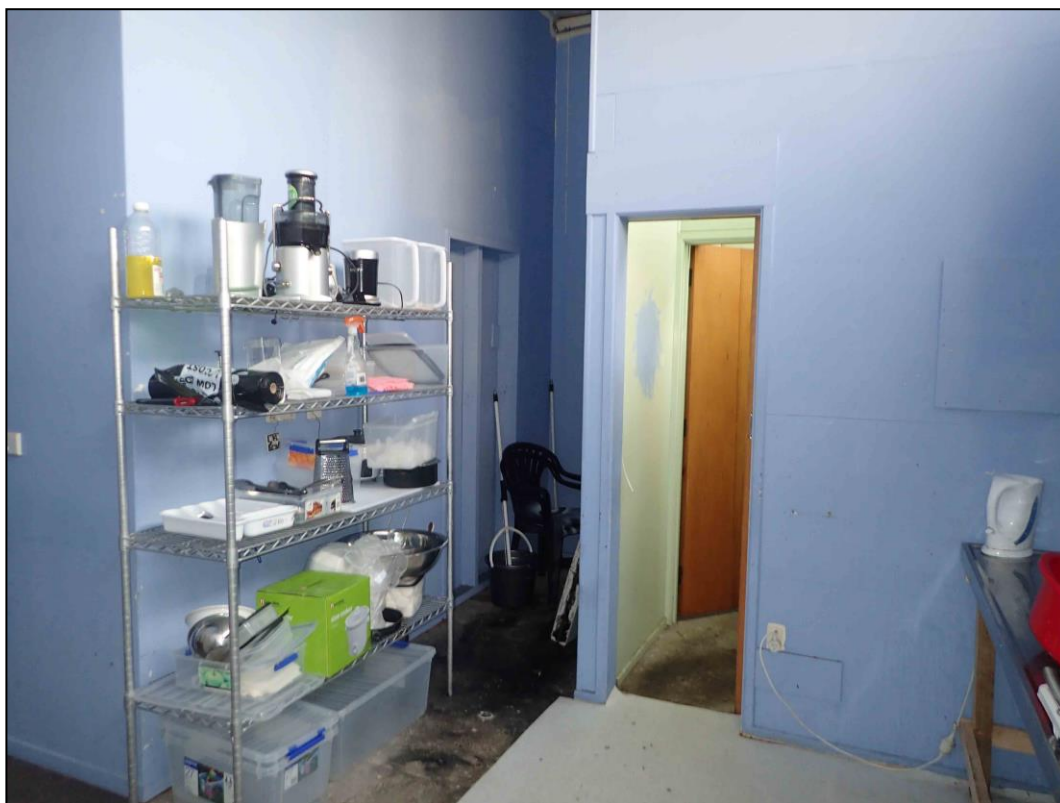
No heritage fabric was visible on the ground floor. The space is currently divided into a large front room (Room 1; Figure 6-563) and a rear kitchen and toilet area (Rooms 2 and 3; Figure 6-565). A modern stairway in the southeast corner leads to the first-floor addition (Figure 6-564). The wall, ceiling and floor linings in each room are modern. Carpet has been laid over part of the poured concrete floor that was installed in the 1960s.

Figure 6-565. Room 2, Barham's Building, looking northwest.

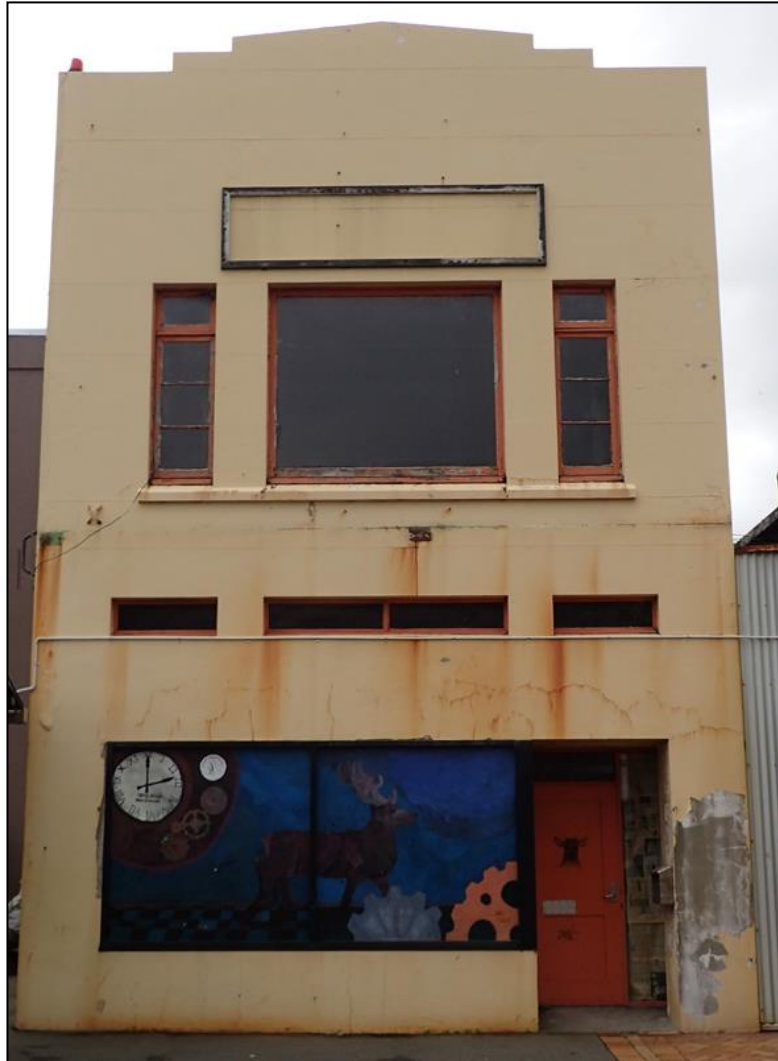
The Dee Street façade of Lumsden's Building has been repeatedly modified and retains no visible heritage fabric or features (Figure 6-566). The ground floor of the west elevation has two large modern fixed windows, with a door at the south end that accesses Room 1. Four small fixed windows at the top of the ground floor date from the 1942 façade alterations. The first floor of the west elevation features a large central window flanked by two multi-pane casement windows with awning quarterlights. Again, these date from the 1942 alterations. There is a panel above the central window that was installed by the last business to operate from the building (Thai Dee), and the façade is topped with a simple stepped parapet. The entire façade has been rendered in concrete.

Figure 6-566. The Dee Street façade of Lumsden's Building.

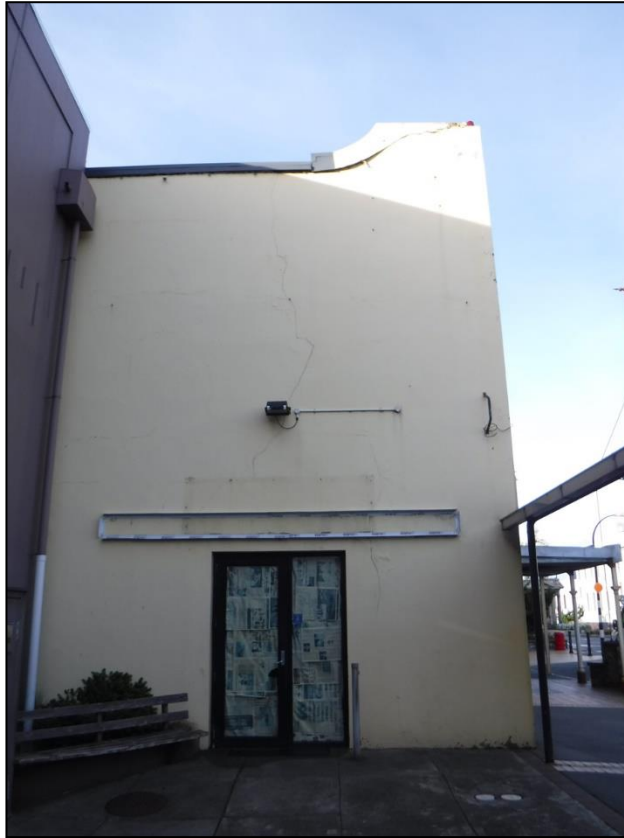
Most of the north elevation of Lumsden's Building is obscured by the south elevation of the cinema complex to the immediate north. A section of the north elevation is visible from Dee Street (Figure 6-567). A door in the north elevation assesses Room 1. The south elevation is clad in concrete render and features six filled in windows (two on the ground floor and four on the first floor) and a filled in doorway on the ground floor (Figure 6-568). The join between the 1872 building and the 1876 first floor addition is visible on the south elevation.

Figure 6-567. The section of the north elevation of Lumsden's Building that is visible from Dee Street.

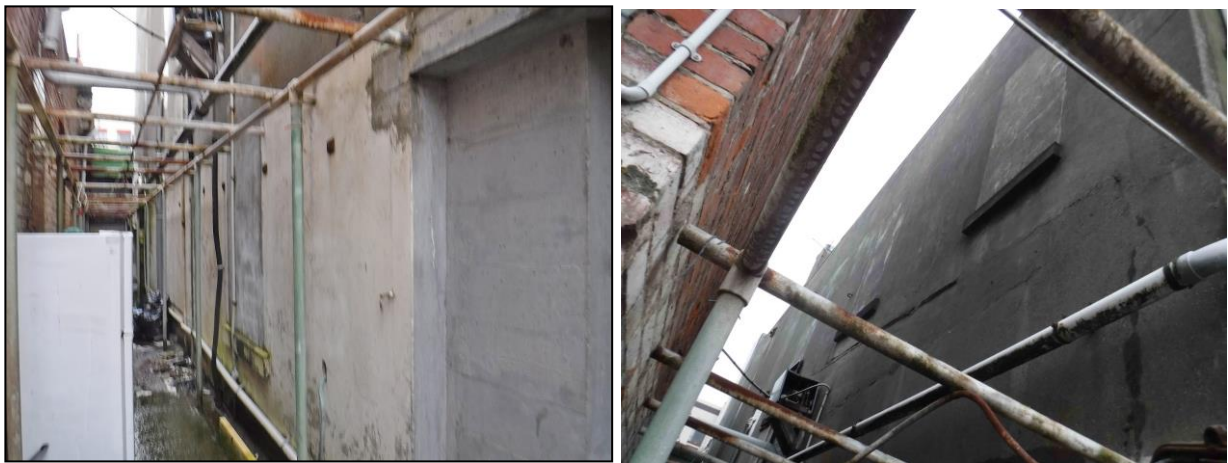
Figure 6-568. Left: the south elevation of the ground floor of Lumsden's Building. Note the filled in windows and doorway. Right: the first floor of the south elevation, looking northwest. Note the line that appears to define the 1876 first floor addition.

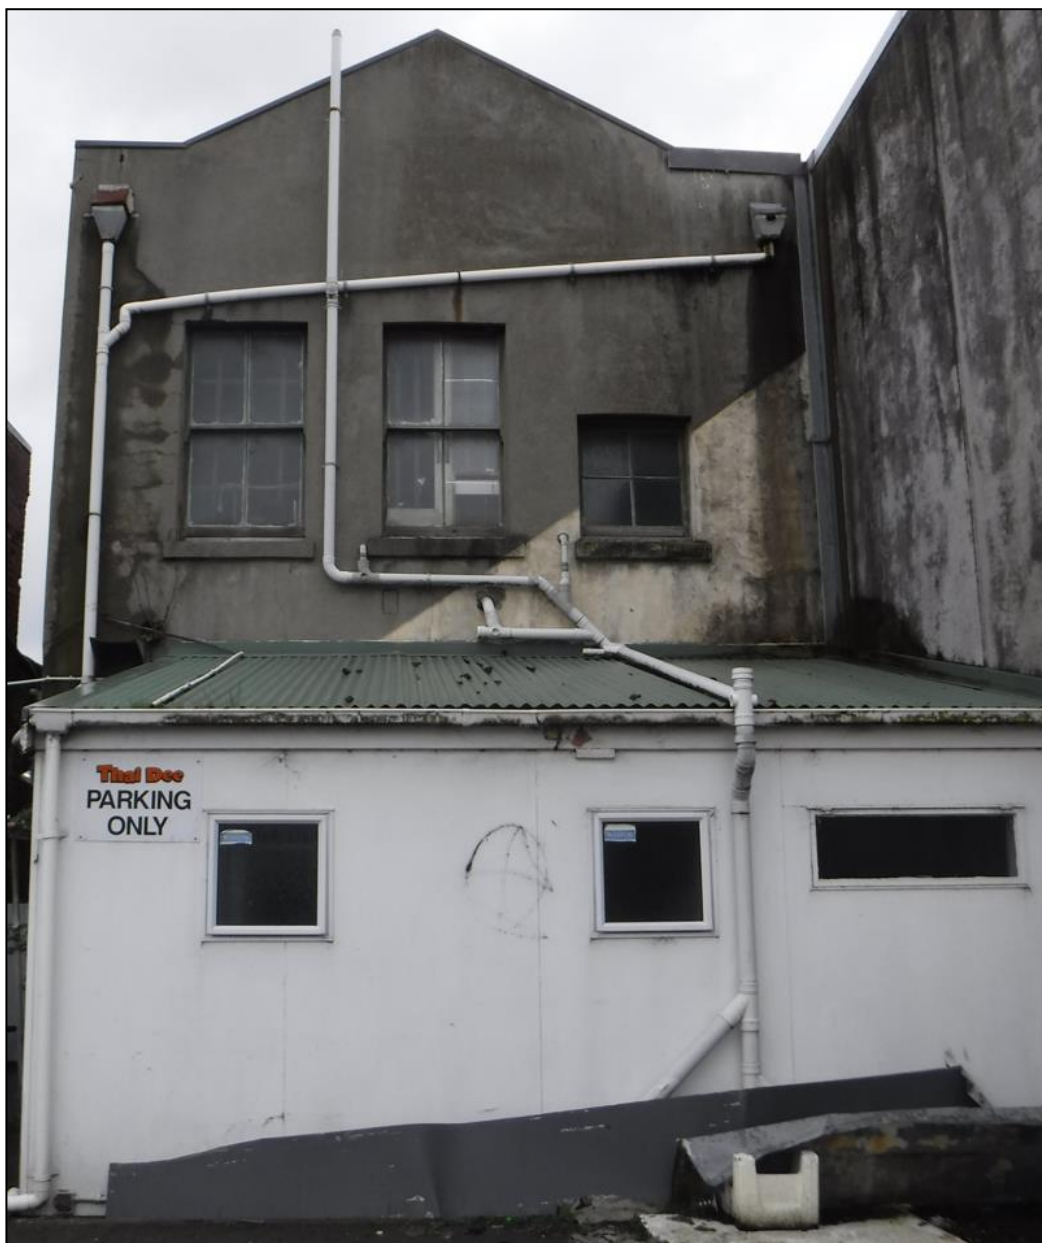
The first floor of the east elevation was added in 1876 and remodelled in 1942. A lean-to addition on the ground floor is a twentieth century feature (Figure 6-569). This obscures any potential original ground floor features or fabric. There are three windows in the first floor of the east elevation, two double hung lugged sash windows with two panes per sash, which opens into Rooms 4 and 5 and a fixed window which illuminates the stairwell (Room 3). These appear to date to the 1876 addition of the first floor.

Figure 6-569. The east elevation of Lumsden's Building.

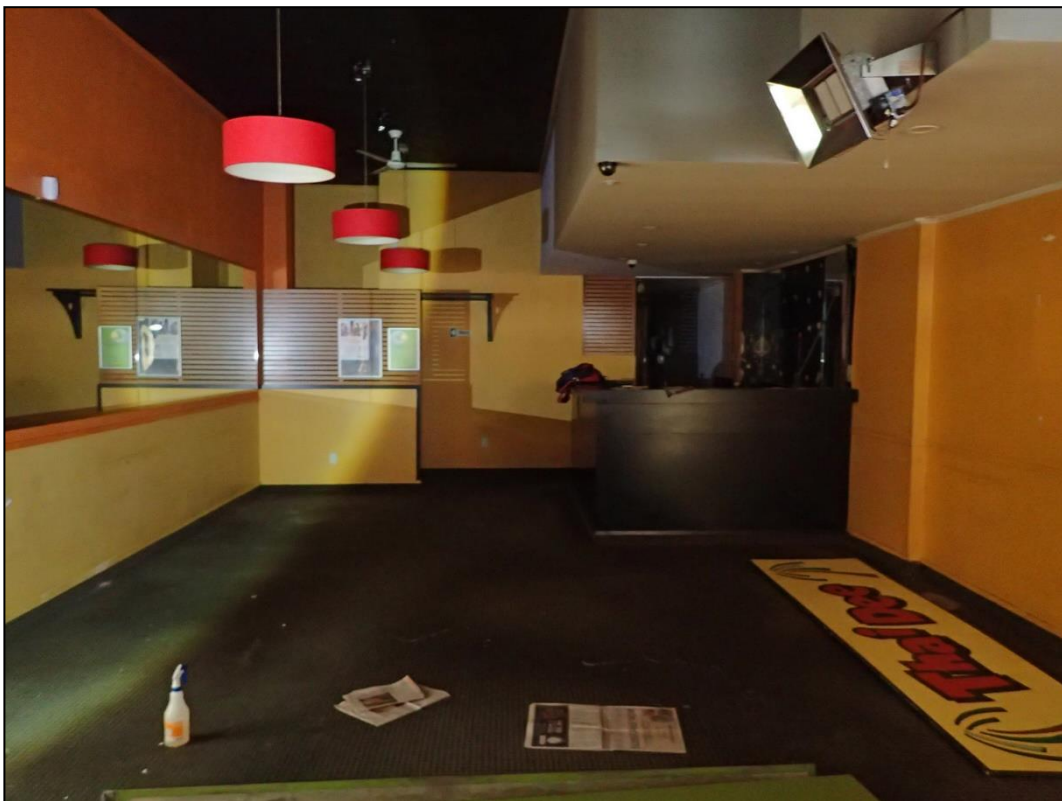
Figure 6-572. Room 1, Lumsden's Building, looking east.

The ground floor of Lumsden's building is divided into three spaces (Figure 6-570): a main restaurant seating and bar area (Room 1; Figure 6-571 and Figure 6-572), rear toilets (Room 2) and a kitchen (Room 3). A window in what was once the exterior wall of the east elevation has been filled in and is visible in Room 2 (Figure 6-573 and Figure 6-574). This wall is rendered in concrete (Figure 6-574). Further evidence of the original external east

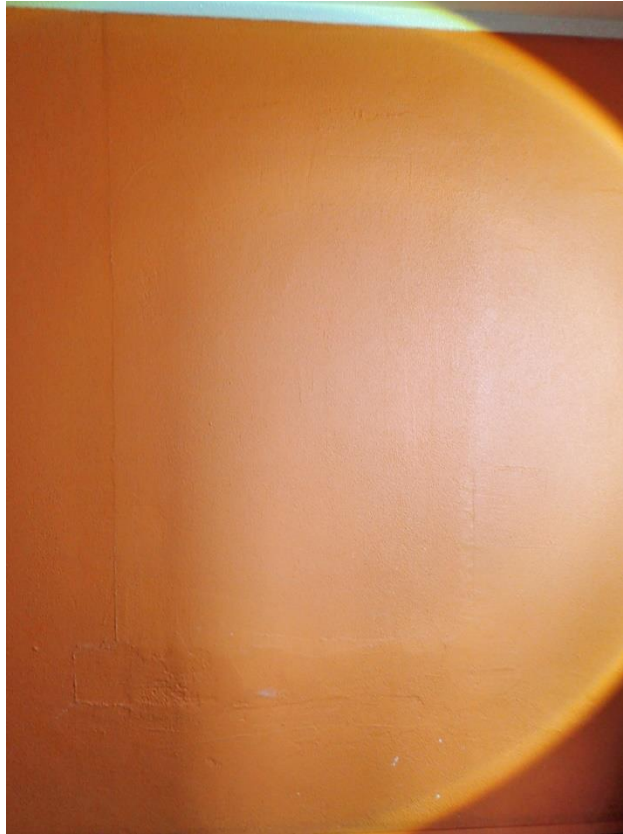
Figure 6-573. In-filled window in Room 2. This is the original exterior surface of the east elevation.
