6.14.3 On Site Observations: Zookeepers Café (50 Tay Street)

The extant building at 50 Tay Street was constructed in 1916 and is currently occupied by Zookeepers Café. Major alterations were undertaken on the interior and façade in the 1950s and several minor renovations have been undertaken since then. The following description of the building follows from the site visit conducted by Dr Dawn Cropper and Dr Naomi Woods on 18 April 2018.

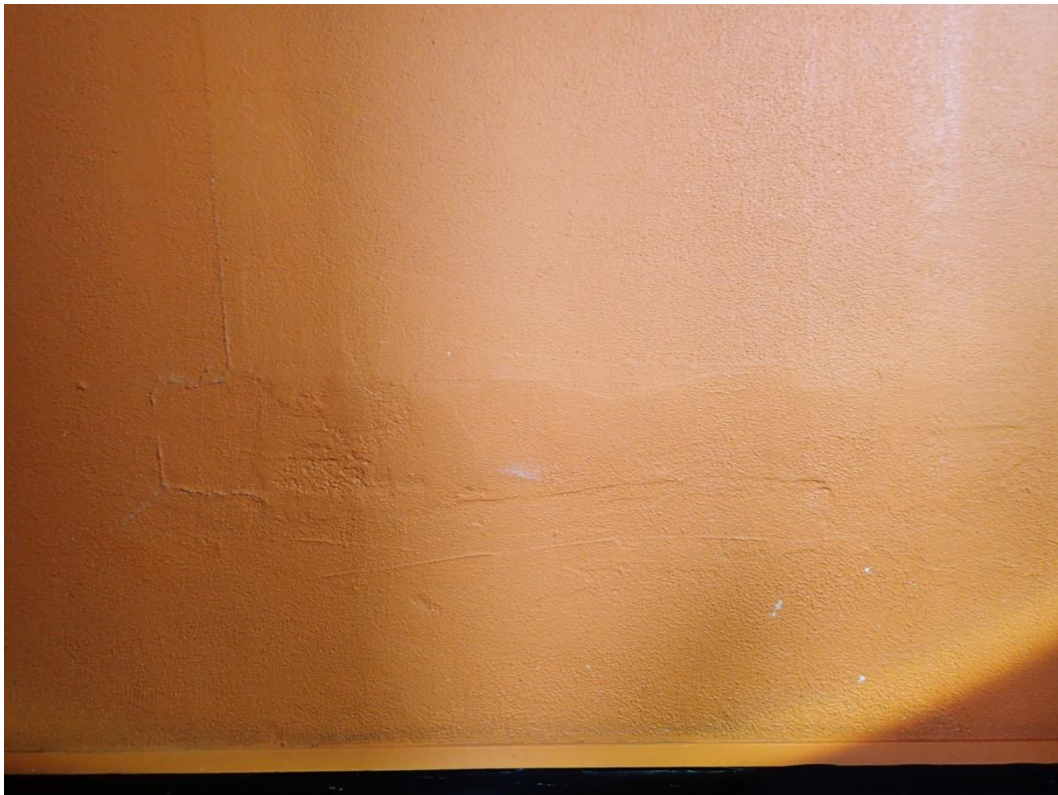
Figure 6-574. Scarring where the window sill has been removed from the original exterior of the east elevation.

The ground floor of Lumsden's building is divided into three spaces (Figure 6-570): a main restaurant seating and bar area (Room 1; Figure 6-571 and Figure 6-572), rear toilets (Room 2) and a kitchen (Room 3). A window in what was once the exterior wall of the east elevation has been filled in and is visible in Room 2 (Figure 6-573 and Figure 6-574). This wall is rendered in concrete (Figure 6-574). Further evidence of the original external east

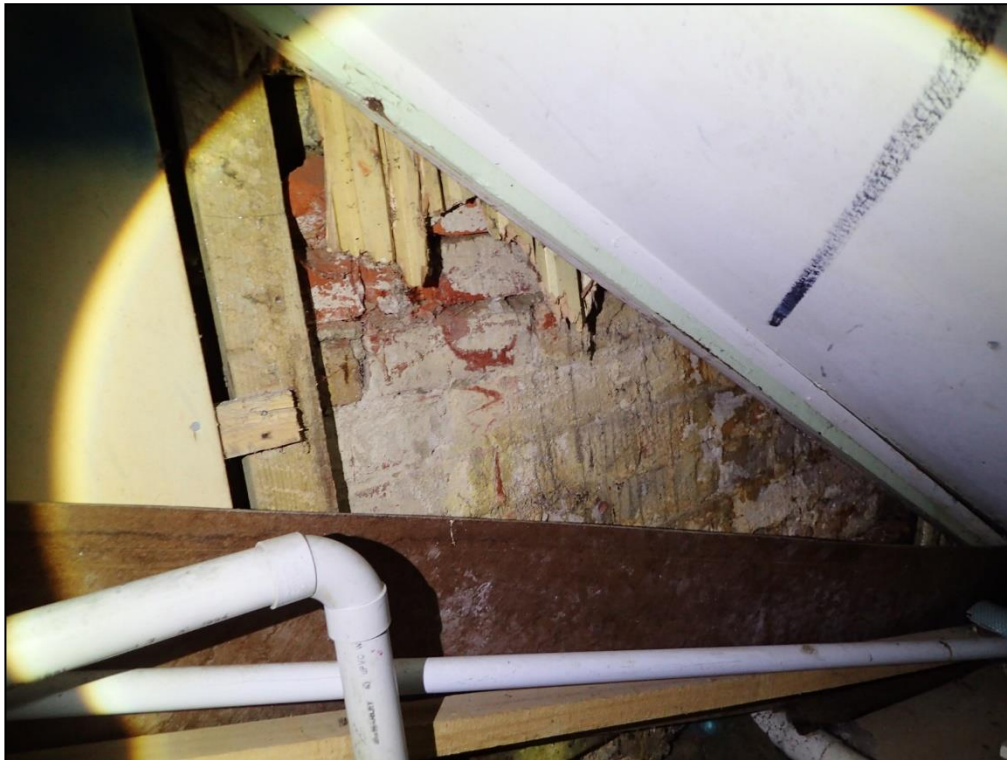
Figure 6-575. The original brick work of the internal surface of the east elevation. Looking east in the cupboard in Room 2.

elevation is visible in a cupboard under the stairs in Room 2, where the original brickwork can be seen (Figure 6-575). A steel fire-door in the south wall of the stairwell opens to the exterior (Figure 6-576). The wall and ceiling linings are plaster board and the floors lined with modern carpet, all of which appear to date to the 2001 alterations.

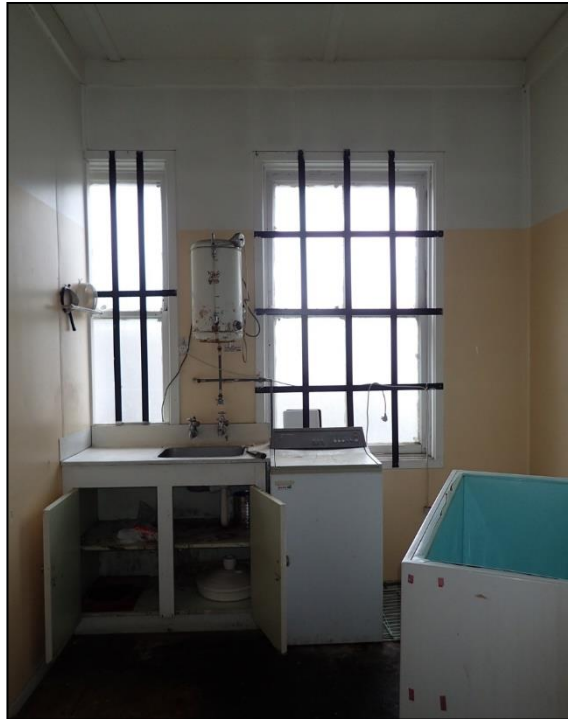
Figure 6-577. Looking east in Room 8 at the pre-1900 sash windows.

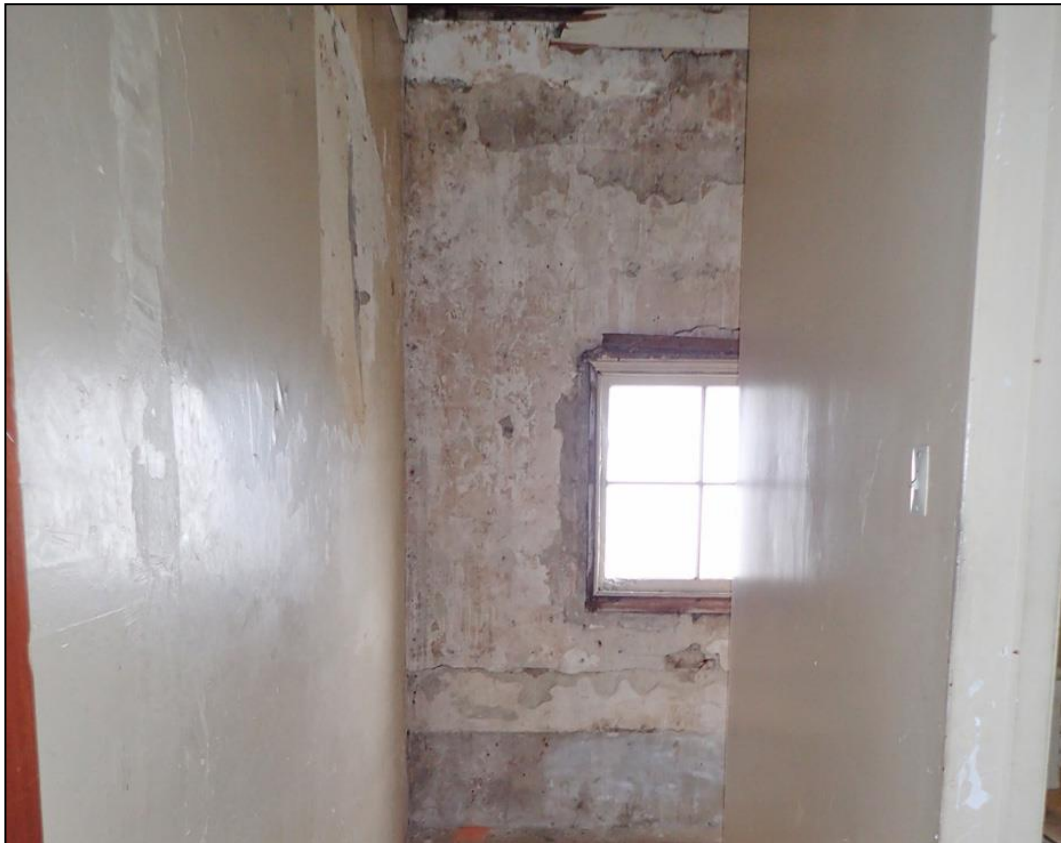
Figure 6-579. The fixed window in the east wall of Room 6 appears to be original to the 1876 build.

window in the east wall of Room 4 appears to be original to the 1876 addition of the first floor (Figure 6-579). An area of floorboards in Room 7 (the hall) are wider than those in other rooms (Figure 6-580 and Figure 6-581), and suggest at least part of the floor has been replaced at some point. Scarring on the ceiling and floorboards indicate where walls have been removed at various times (Figure 6-580). The wall and ceiling linings are a mix of hardboard, plaster board, concrete render and faux timber, dating to various periods of the building's occupation.

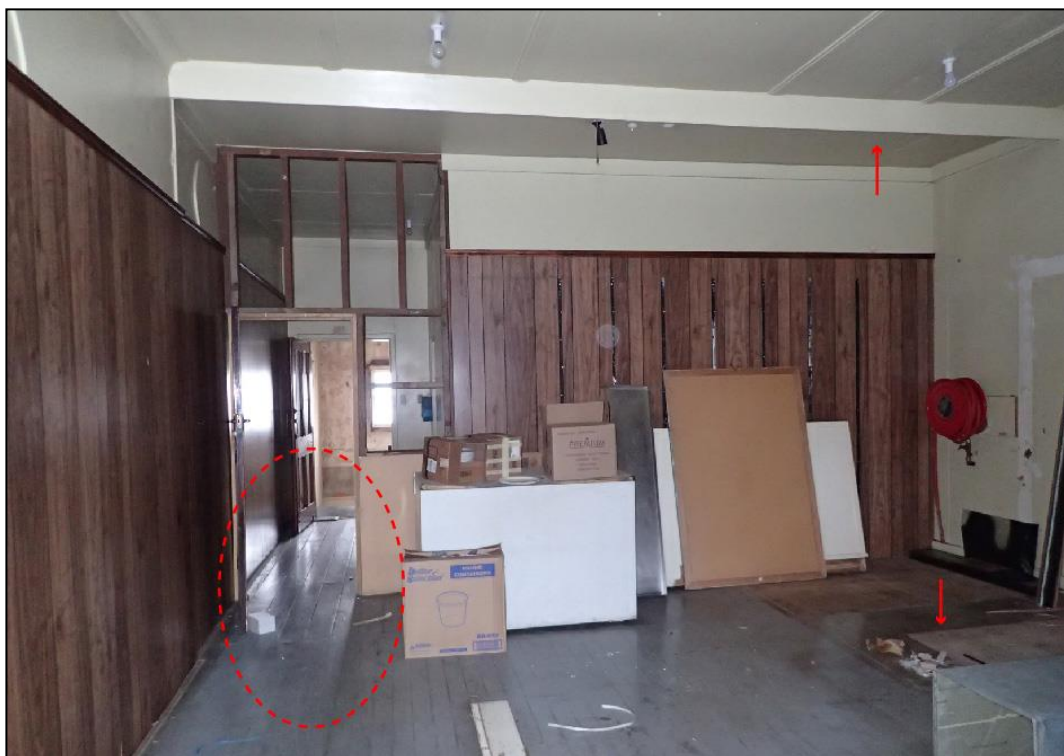
Figure 6-580. Looking east in Room 12 toward Room 10 with the change in floorboards circled in red. The arrows indicate scarring in areas where walls have been removed.

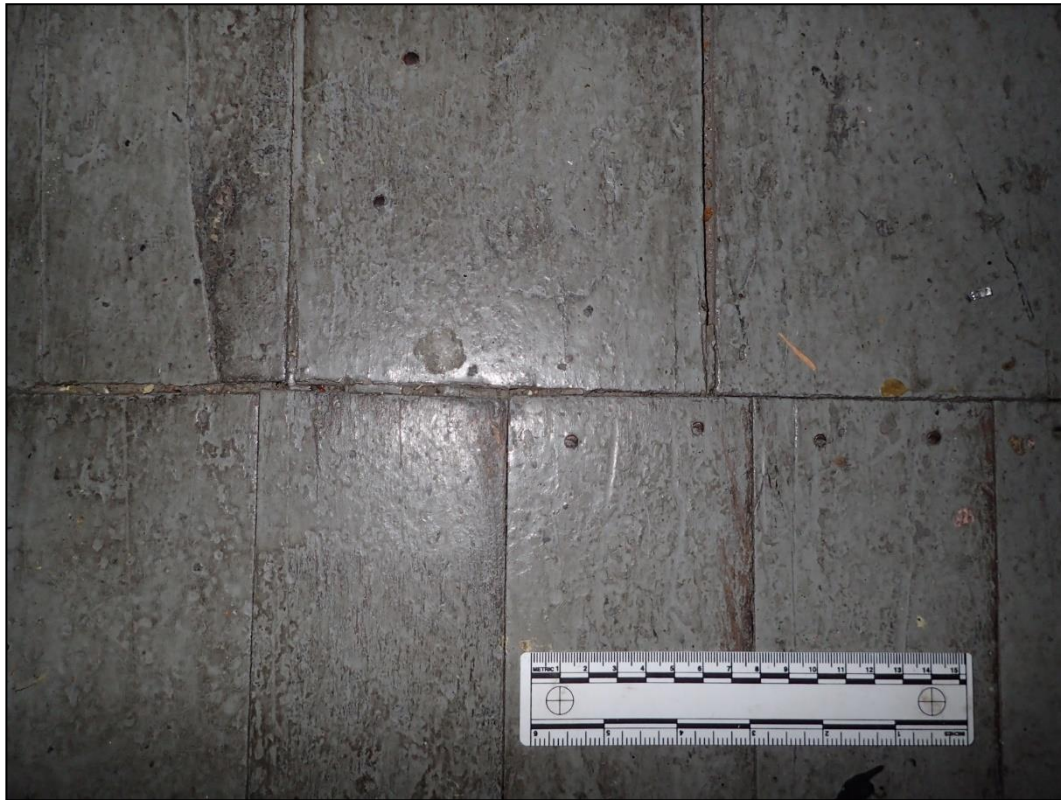
Figure 6-581. Detail of the change in floorboard size from Room 10 (top) to Room 12.
