# **Southland Museum & Art Gallery**

**Detailed Engineering Evaluation  
Quantitative Assessment Report  
Invercargill City Council**

## Detailed Engineering Evaluation Quantitative Assessment Report

Date: 29 November 2013  
Reference: 6-VI030.00 / 005gv  
Status: Final

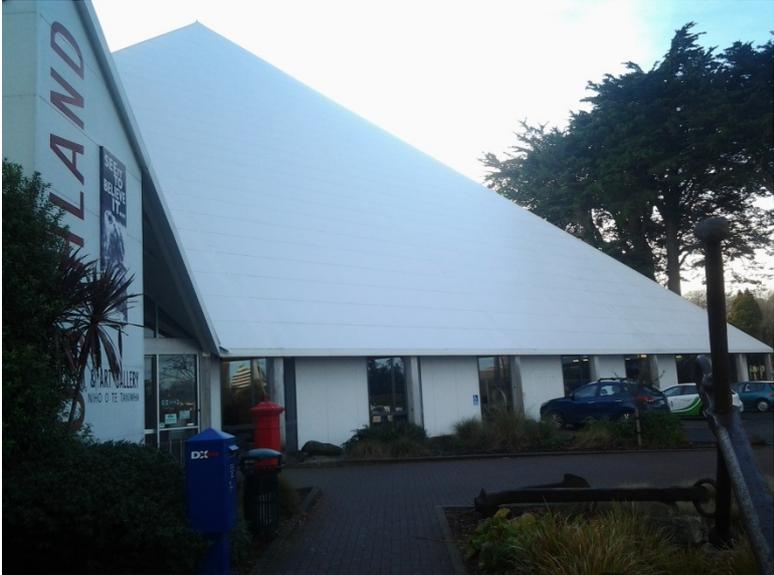
<b>Southland Museum</b>		
<b>No. / Location</b>	<b>Item description</b>	<b>Photo</b>
<b>General Photos</b>		
View from South	South elevation

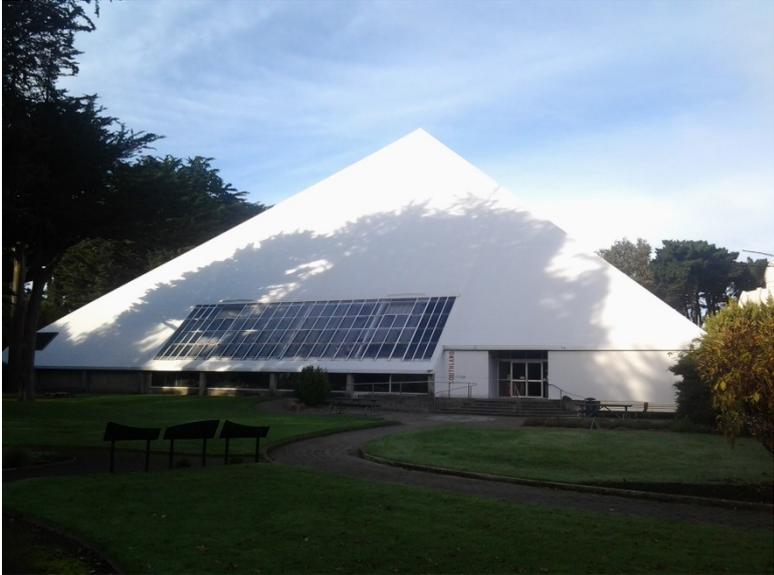
View from North	North elevation

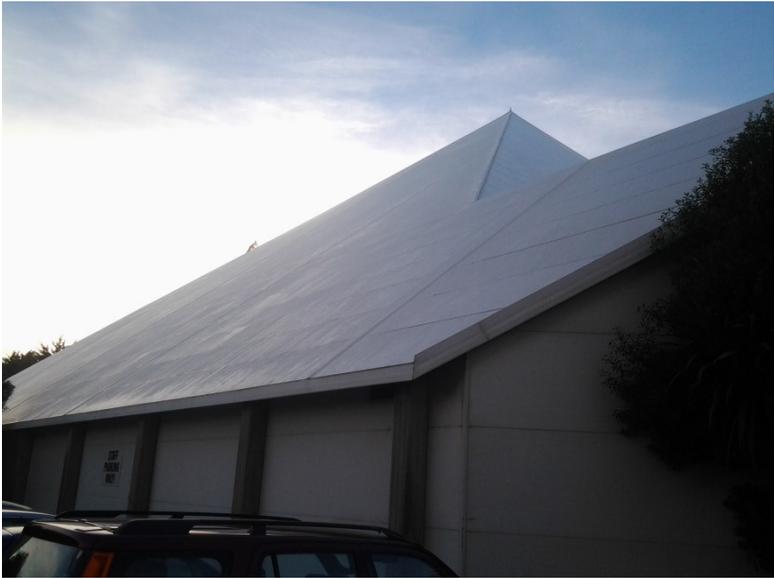
<p>View from Southwest</p>	<p>Southwest corner</p>

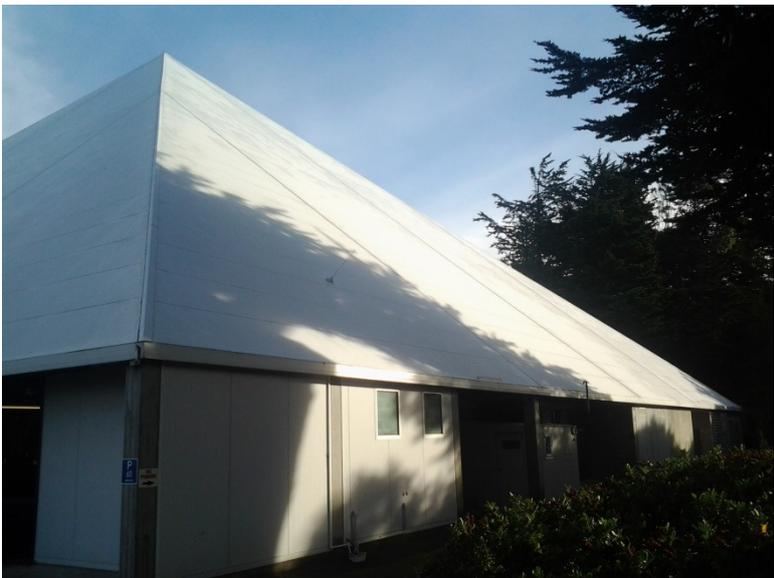
<p>View from Southeast</p>	<p>East elevation</p>

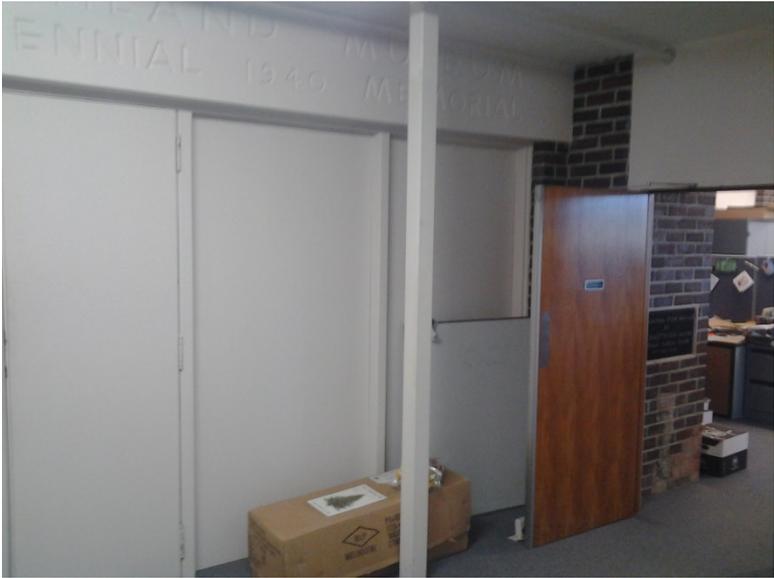
<p>Interior View from South</p>	<p>Original museum entrance</p>

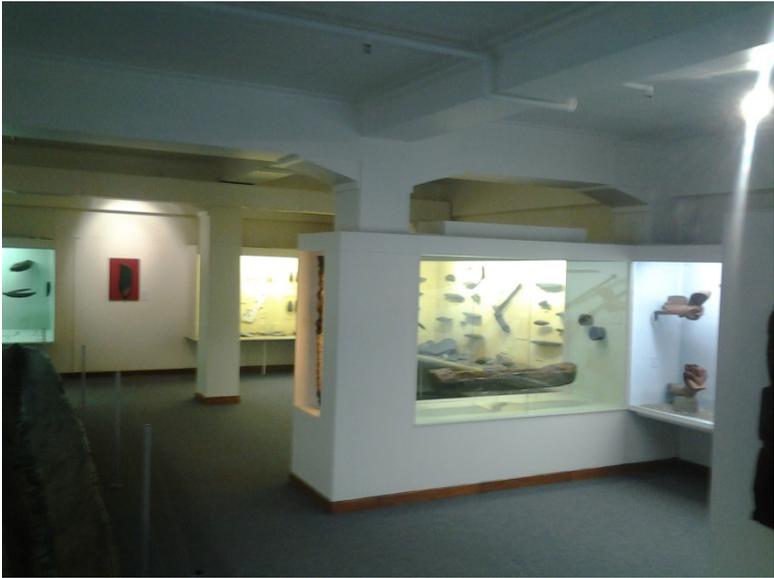
<p>Original Building</p>	<p>Interior view showing first storey concrete beams and columns.</p>

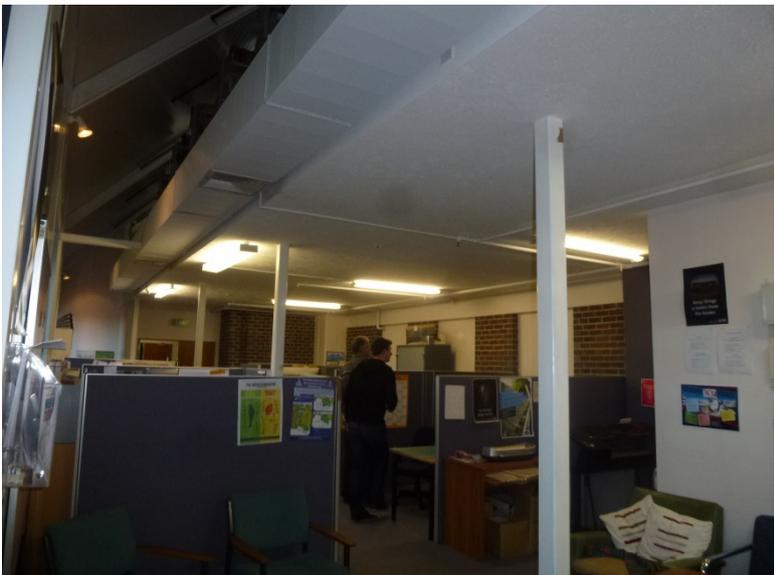
A photograph of a gallery interior. The ceiling features a grid of concrete beams. A white display case with glass panels is in the foreground, containing various items. In the background, there are more display cases and a red wall.
<p>View from South at ground level</p>	<p>Mezzanine structure at south side of original building. Original brick veneer seen in the background.</p>

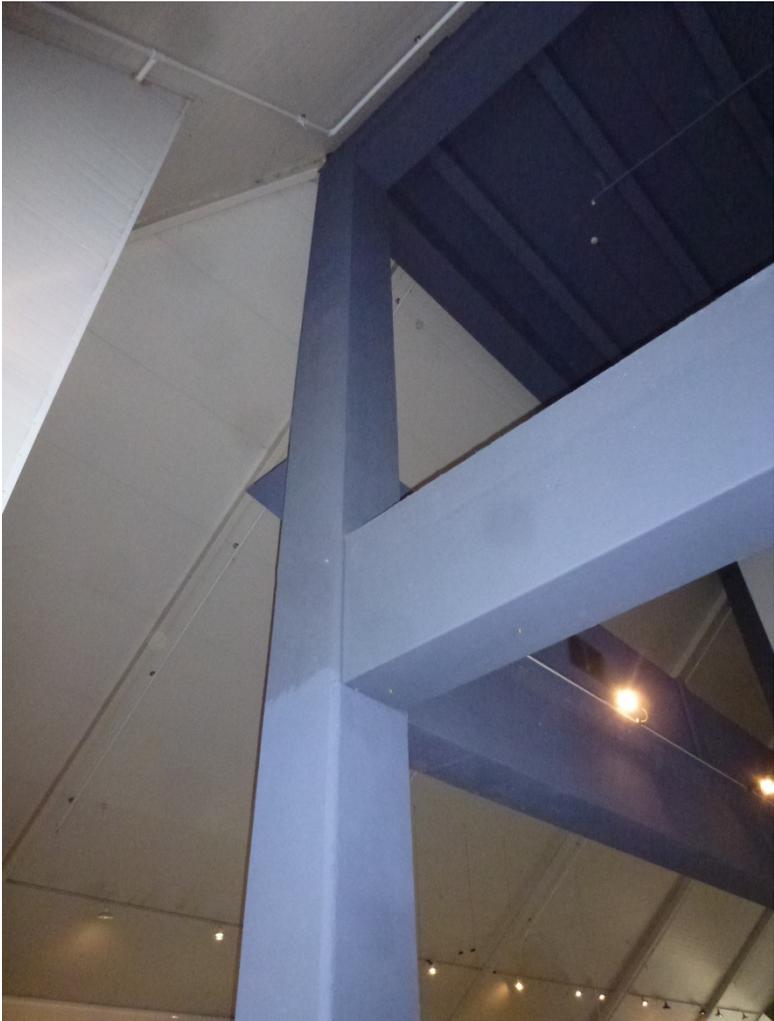
<p>View from southeast corner</p>	<p>Column at intersection of grids F and 2 of 1988 addition. Precast double-T structure of 1988 addition can be seen along with pyramid insulated panel roof.</p>

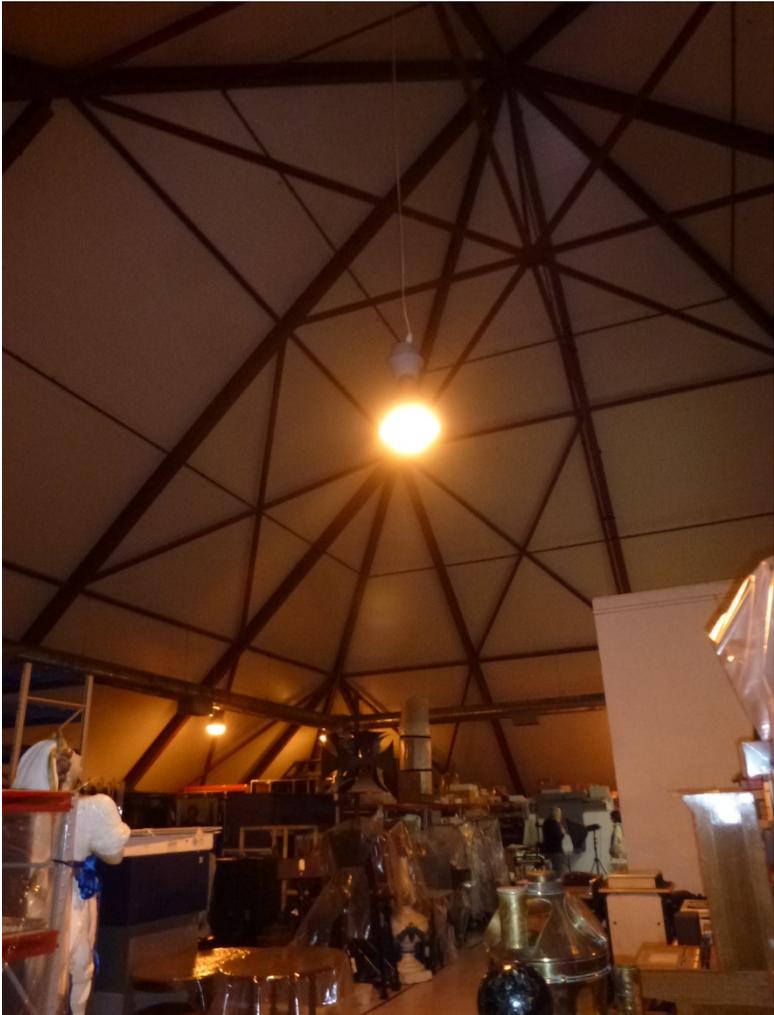
- a) Pounding with adjacent buildings
- b) Shear failure of short-span concrete beam at second floor
- c) Stiffness incompatibility between the steel structure of the pyramid and the concrete frame. Steel diagonals of the pyramid between GL8 and 9 connect to the 1<sup>st</sup> and 2<sup>nd</sup> floor of the concrete frame and act as braces between floors. The connections of these members are not adequate to resist the imposed forces
- d) Failure of bolts connecting the pyramid roof diagonals to the perimeter concrete columns
- e) Lack of bracing at the south side of the mezzanine to the south of the 1940 museum.

<p>Pyramid roof</p>	<p>Structural steel and roofing panels of pyramid roof.</p>

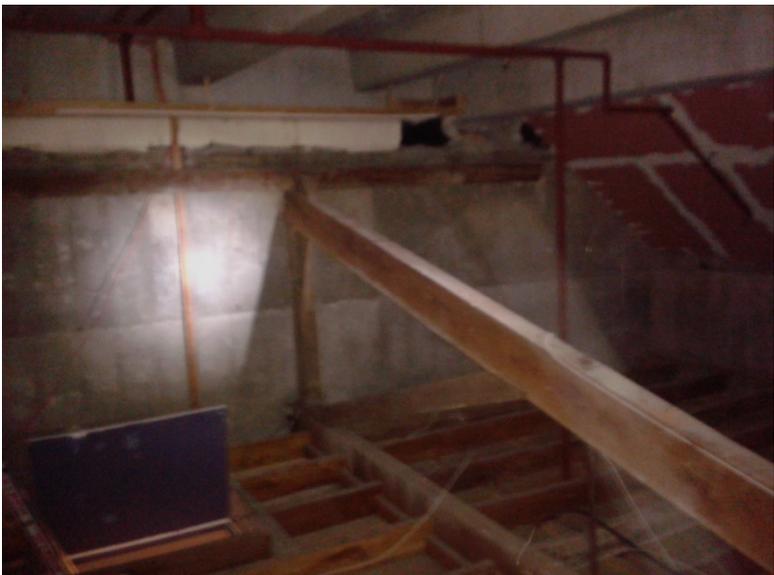
- a) Flexural failure of exterior concrete moment frame beams at the first story;
- b) Lack of roof diaphragm and connection to concrete walls;
- c) Pounding with adjacent buildings;
- d) Restraint of north stairwell within 1988 structure and lack of visible gap between the two structures in this location;
- e) Out-of-plane wall anchorage of concrete wall at roof level;
- f) Out-of-plane support of brick in-fill wall;
- g) Out-of-plane support of exterior brick veneer;

<p>Original Museum</p>	<p>Roof truss of original museum. Stahlton slab system of 1988 addition shown spanning above original roof</p>
