Government Life Building, 33 Dee St, Invercargill, 9810
DETAILED SEISMIC ASSESSMENT REPORT

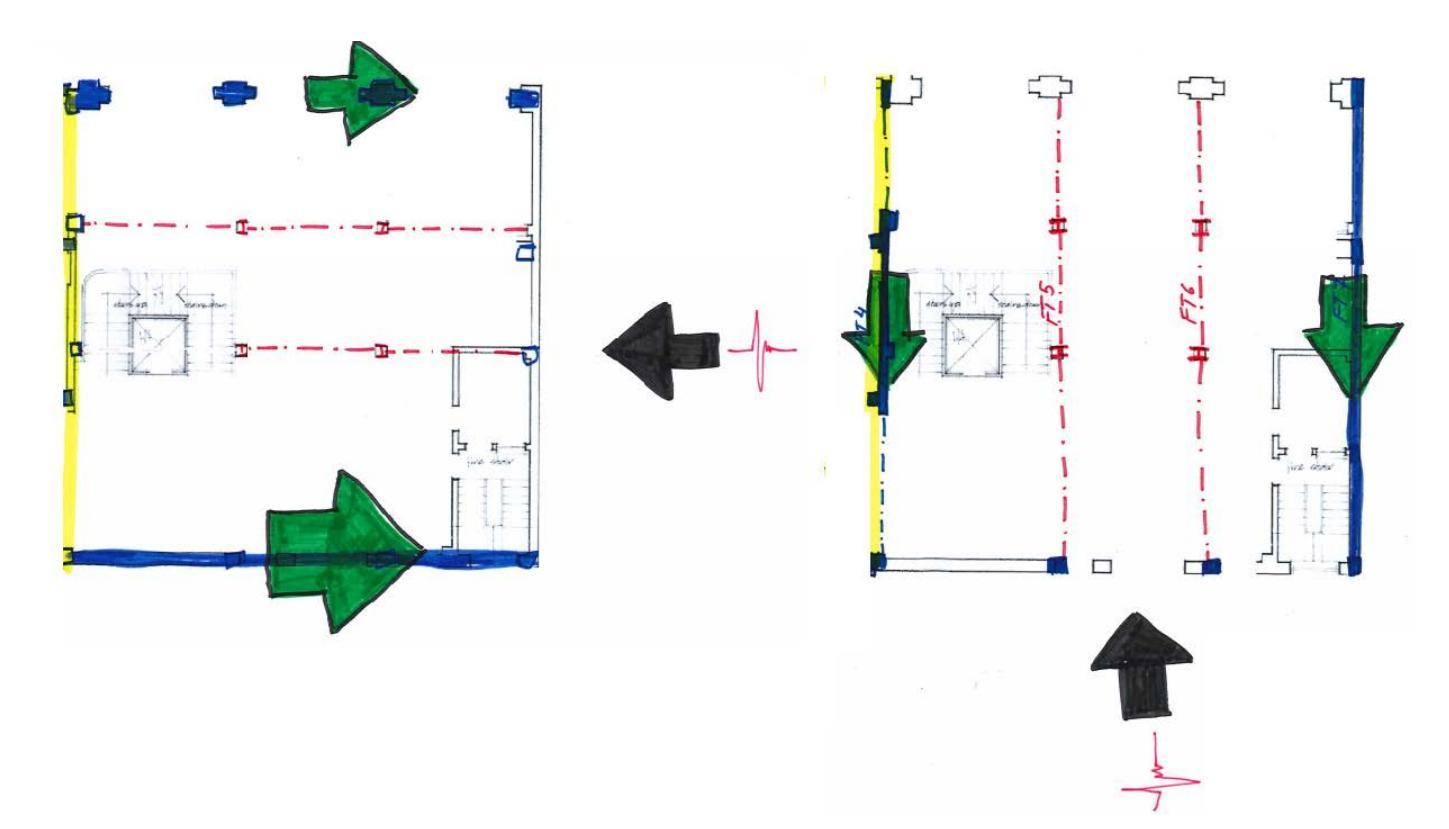
Figure 10 - Government Life East longitudinal lateral load resisting system (left) and transverse lateral load resisting system (right)

The lateral load resisting system comprises URM walls in the transverse direction and a URM wall and frame in the longitudinal direction. No diaphragm action can be relied on due to the lack of positive fixing between the timber floors and the URM elements. Lateral load will be transferred to the URM elements based on tributary width. The stiffer elements (URM walls) will likely attract a larger proportion of lateral load, as indicated in Figure 10. The contribution of the steel frames to the lateral load resisting system will be insignificant due to their flexible nature. This therefore induces eccentricity to the structure with the potential for failure. The URM walls are required to span out-of-plane between walls or frames but are limited by their fixing capacities.

This section of the building lacks a resilient lateral load path due to the lack of sufficient diaphragm action (stiffness and fixity) when out-of-plane loads are applied. This creates the potential for wall collapse out from the building.

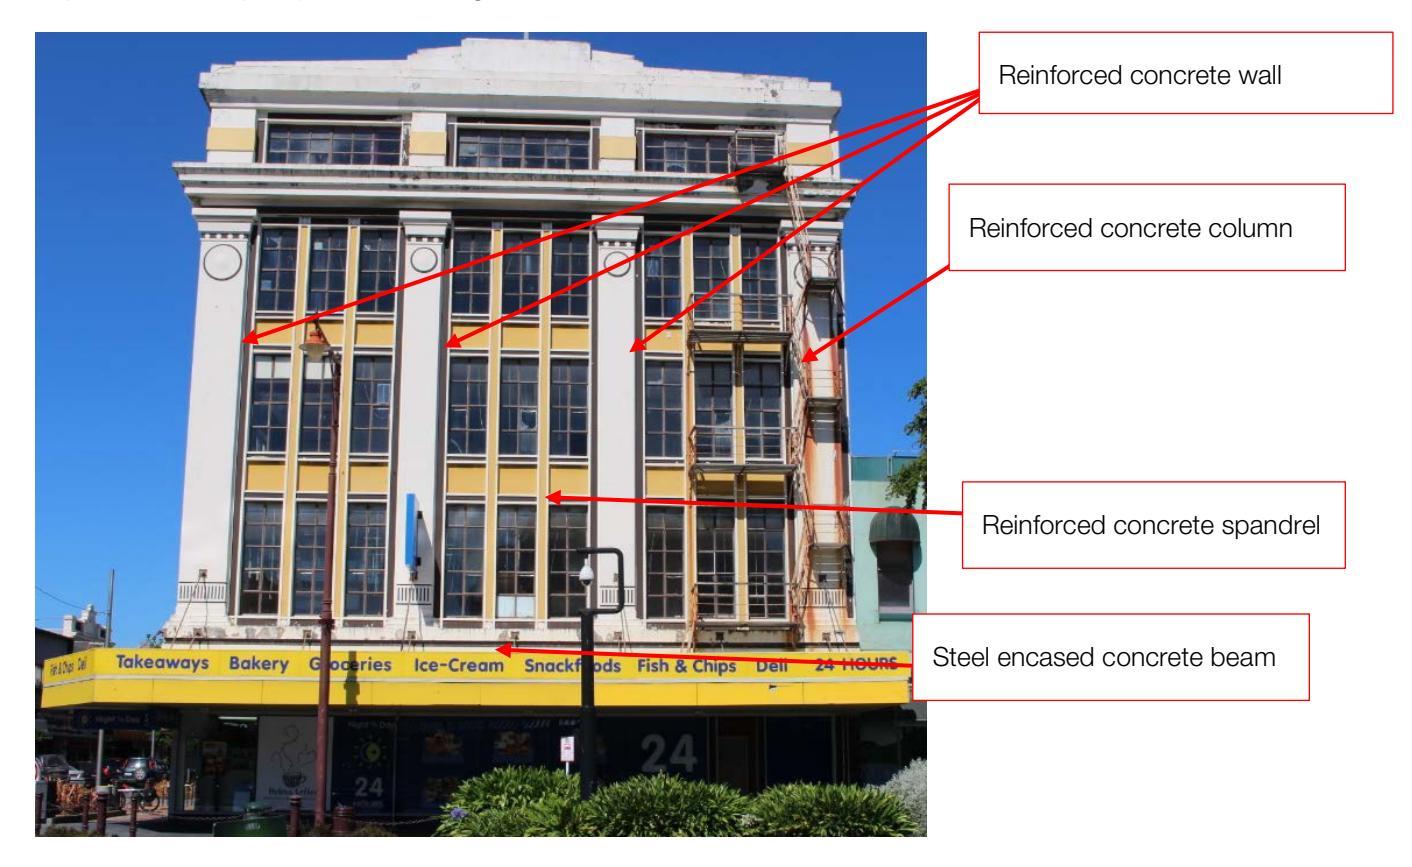
Figure 15 - External Dee Street Elevation

The frame along Dee St, Figure 15, comprises reinforced concrete wall, column and spandrel sections and a steel encased concrete beam above ground floor. Below ground floor the frame is constructed of steel columns and struts. The strength of this external frame under earthquake loading is limited by the flexural capacity of the reinforced concrete spandrels and the axial capacity of the out-of-plane 200PFC post at ground floor. Based on these specific component checks the frame capacity is 10-15%

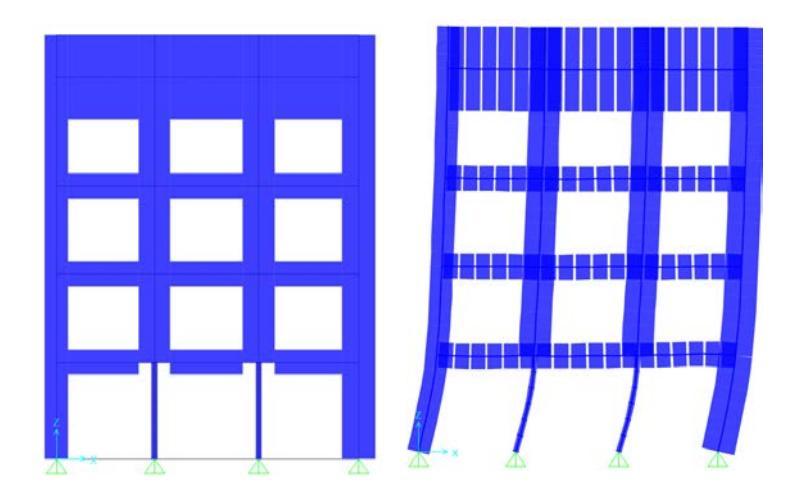
Figure 16 - Computer extract of URM frame (left) and displaced shape of URM frame (right)

The seismic load applied comprised half of the seismic weight of Government Life East based on the tributary width between lateral load resisting elements. The capacity of this frame under this level of loading was 10-15%NBS(IL2). The critical elements were the first-floor spandrels and the middle columns above first floor.

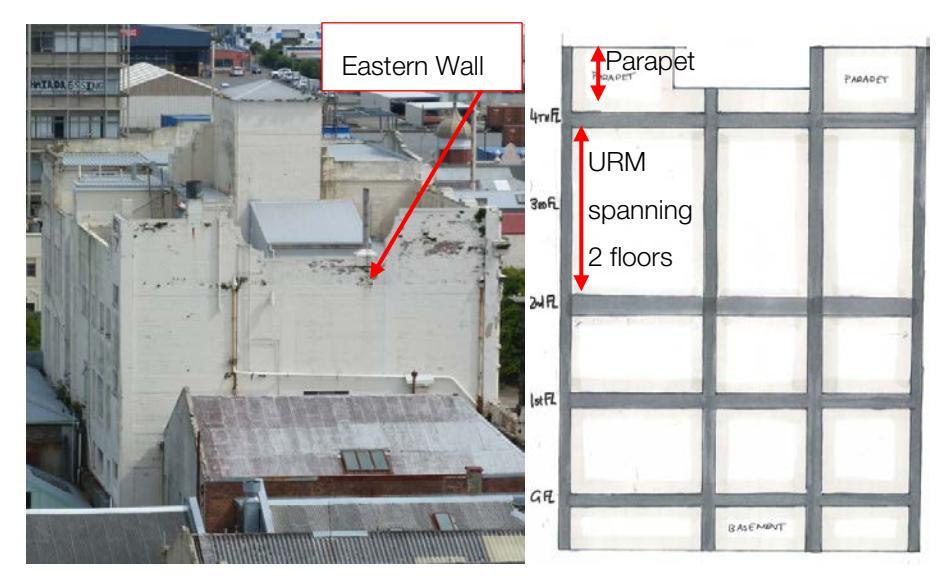
Figure 17 - Location of eastern URM wall (left), sketch of approximate configuration of eastern URM wall (right)

The eastern most wall is constructed of URM bounded by insitu concrete columns. The URM is required to span between two floors (between the 2nd and 4th floor), see Figure 17. This section of the wall was determined to be the most critical out-of-plane. The capacity of this wall over the full 2 storeys is approximately 15-20 %NBS(IL2).

The cantilever URM parapet above roof level was analysed also according to section C8 of the technical guidelines as a vertical spanning cantilever wall. The maximum height parapet cantilevers 3.0 m. The out-of-plane capacity of this parapet was calculated at approximately 15-20%NBS, see Figure 17.

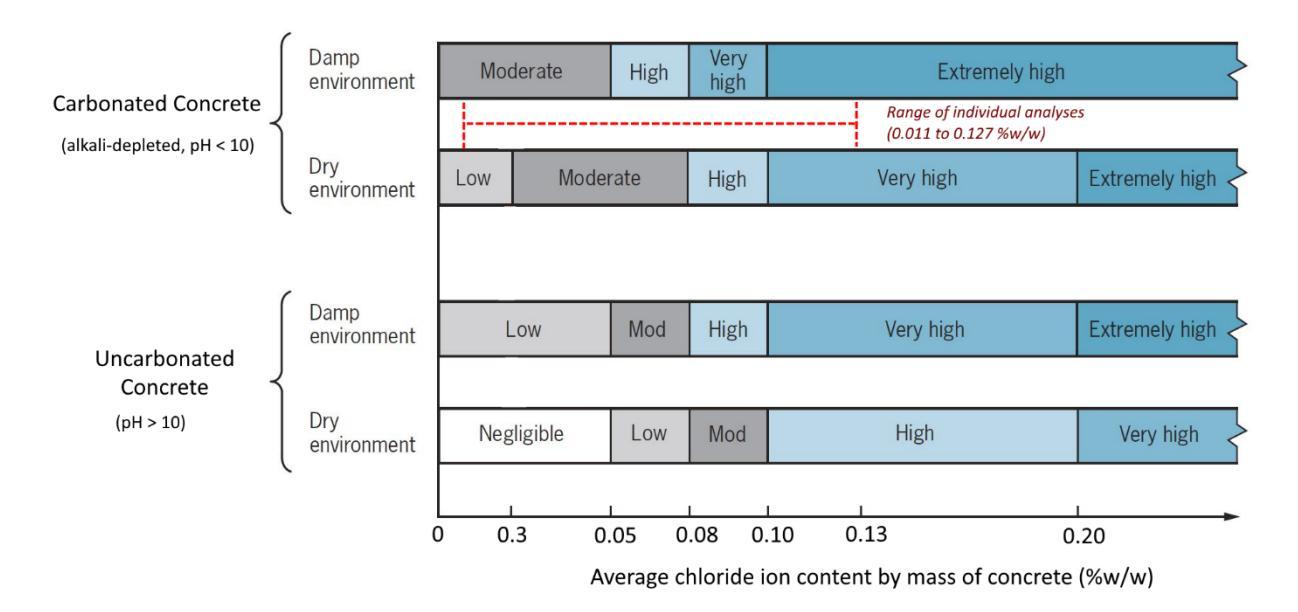
Because of this synergistic coupling between carbonation and cast-in chlorides, the current and future reinforcement corrosion risk for the sampled concrete is potentially moderate to high where the carbonation has reached the reinforcement, particularly if the environment is not protected and dry (Figure 2). Because of the nature of cast-in contamination, the corrosion risk is likely to somewhat variable across the structure, with localised hotspots reflecting the inhomogeneity of chloride distribution in the source aggregate.

Figure 2. Comparison of chloride contamination measured in cores with estimated risk of reinforcement corrosion under differing environmental conditions for typical quality older structural concrete.⁶

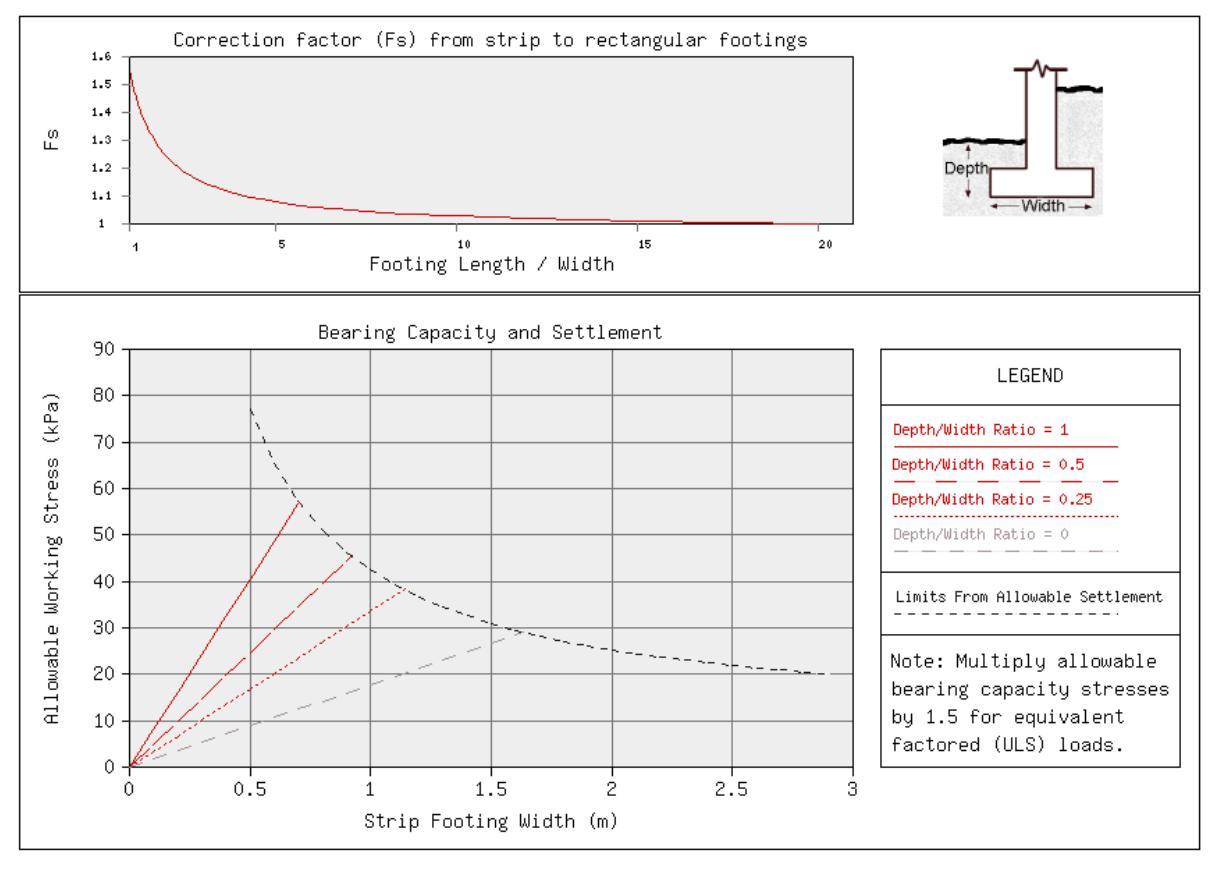
Figure 2: Typical Bearing for Shallow Footings on Alluvial Silt

From Figure 2 it can be seen an allowable working stress of approximately 40 kPa is recommended for a 500 mm wide by 500 mm deep strip footing founded within alluvial silt. This corresponds to a factored (ULS) bearing capacity of approximately 60 kPa and an

ultimate geotechnical bearing capacity of 120 kPa. Note the low allowable bearing for larger footings.

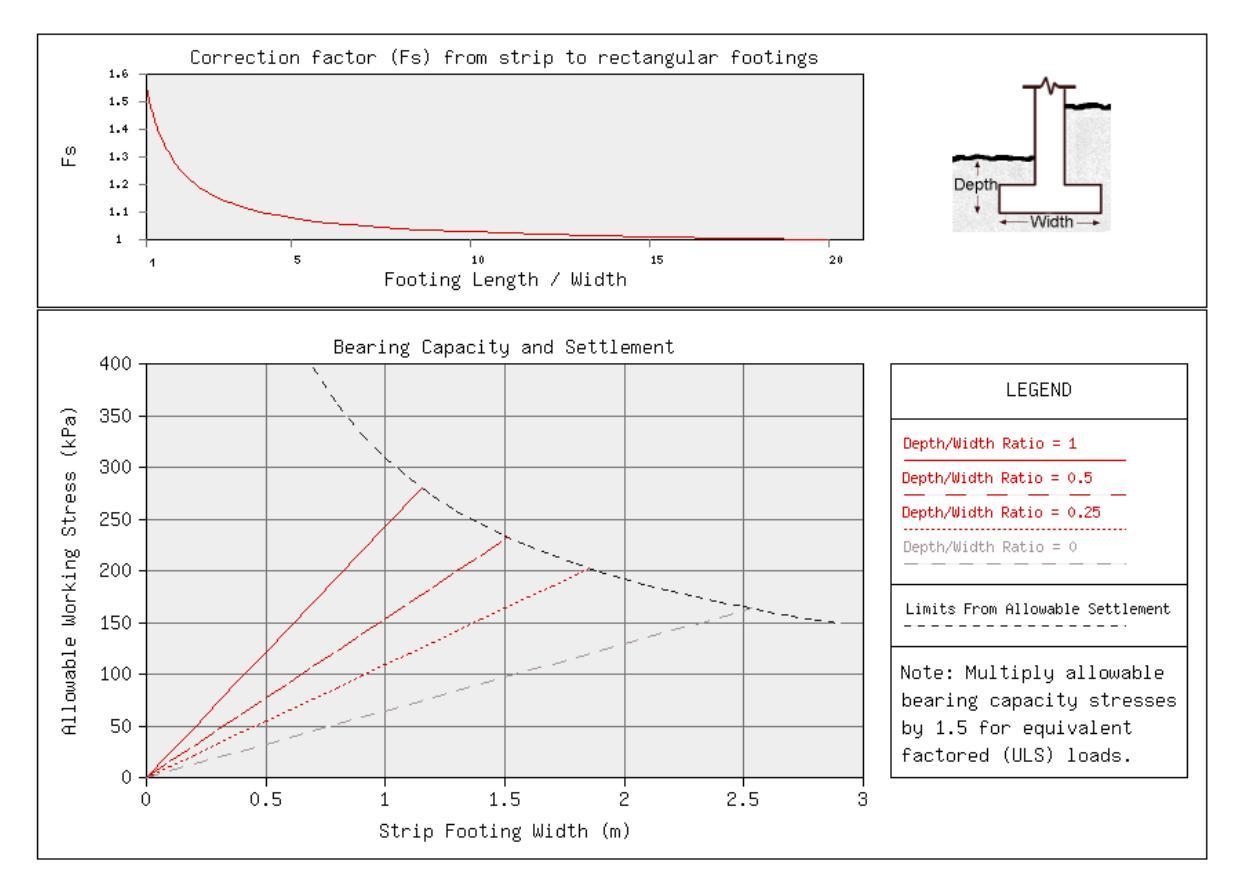
From Figure 3 it can be seen an allowable working stress of approximately 100 kPa is recommended for a 400 mm wide by 400 mm deep strip footing founded within alluvial gravel. This corresponds to a factored (ULS) bearing capacity of approximately 150 kPa and an ultimate geotechnical bearing capacity of 300 kPa.
