Southland Times Building, 67 Esk St, Invercargill, 9810

## DETAILED SEISMIC ASSESSMENT REPORT

Revision	Date	Description/Reason for Issue		
A	23/02/2018	Formal DSA Issue		
		Prepared by	Reviewed by	Approved by
		Name	Warren Holt	Andrew Marriott
		Signature

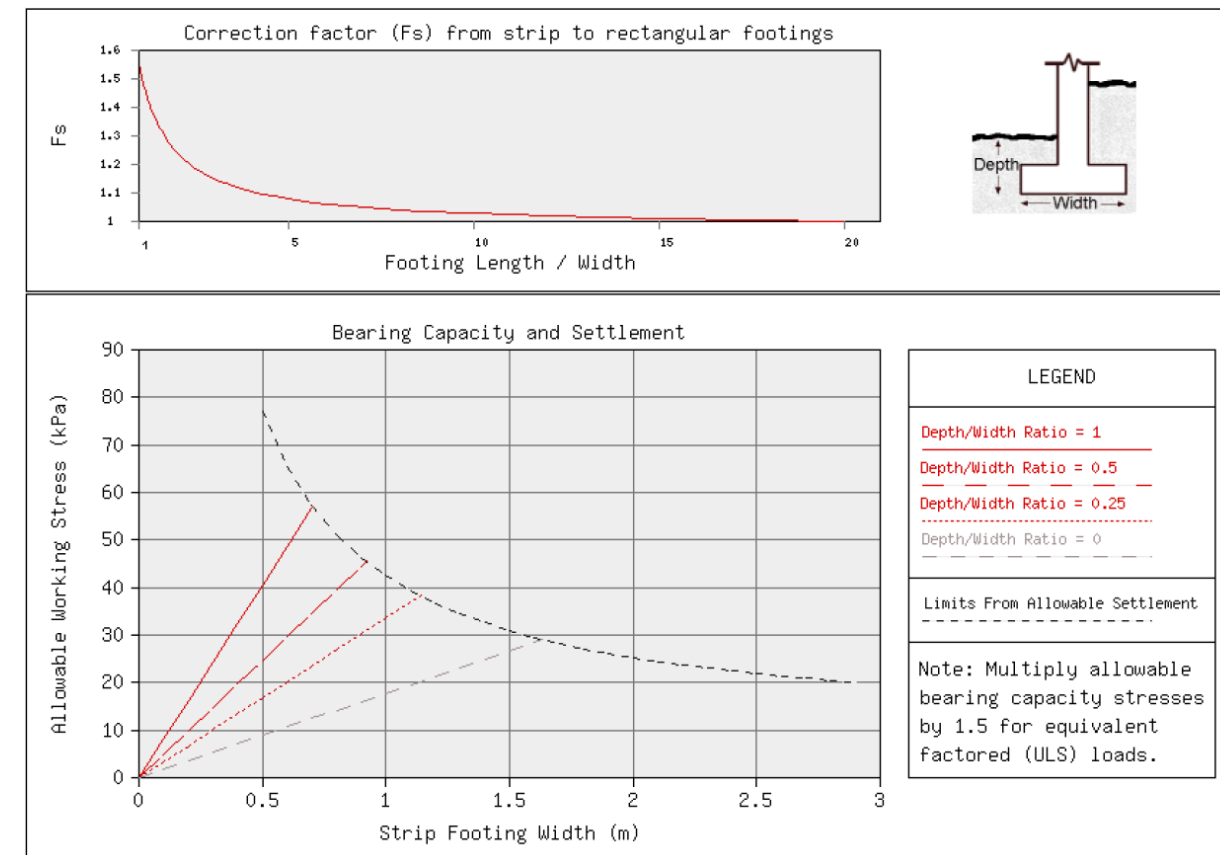
Strip footings (500 mm wide by 500 mm deep) within the alluvial silt are expected to have a geotechnical ultimate bearing capacity of 120 kPa. Footings (400 mm wide by 400 mm deep) upon the alluvial gravel are expected to have a higher geotechnical ultimate bearing capacity of 300 kPa. Figure and Figure outline these bearing capacities. Note low allowable bearing for larger footings.

Figure 12 – Typical bearing for shallow footings on alluvial silt (extract from Geosolve Report).

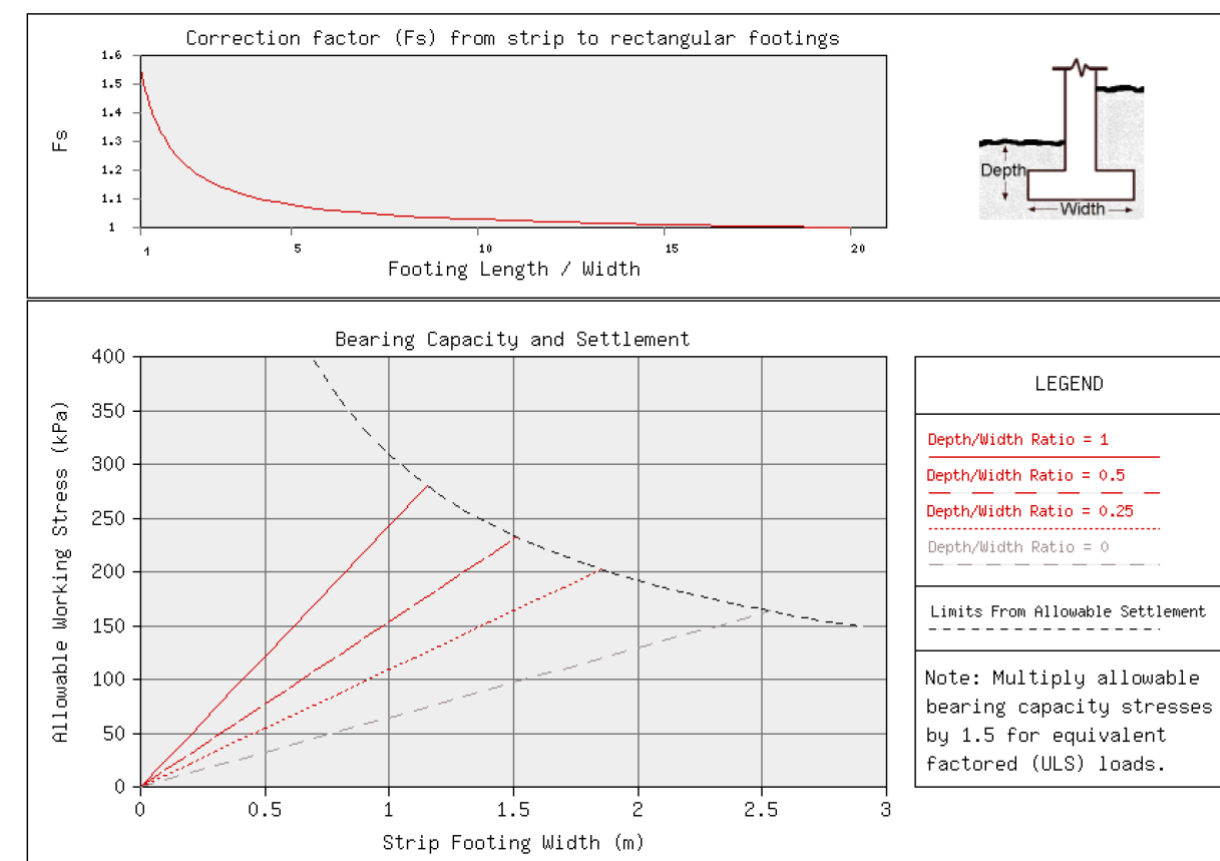
Figure 13- Recommended bearing for shallow footings on alluvial gravel (extract from Geosolve Report).

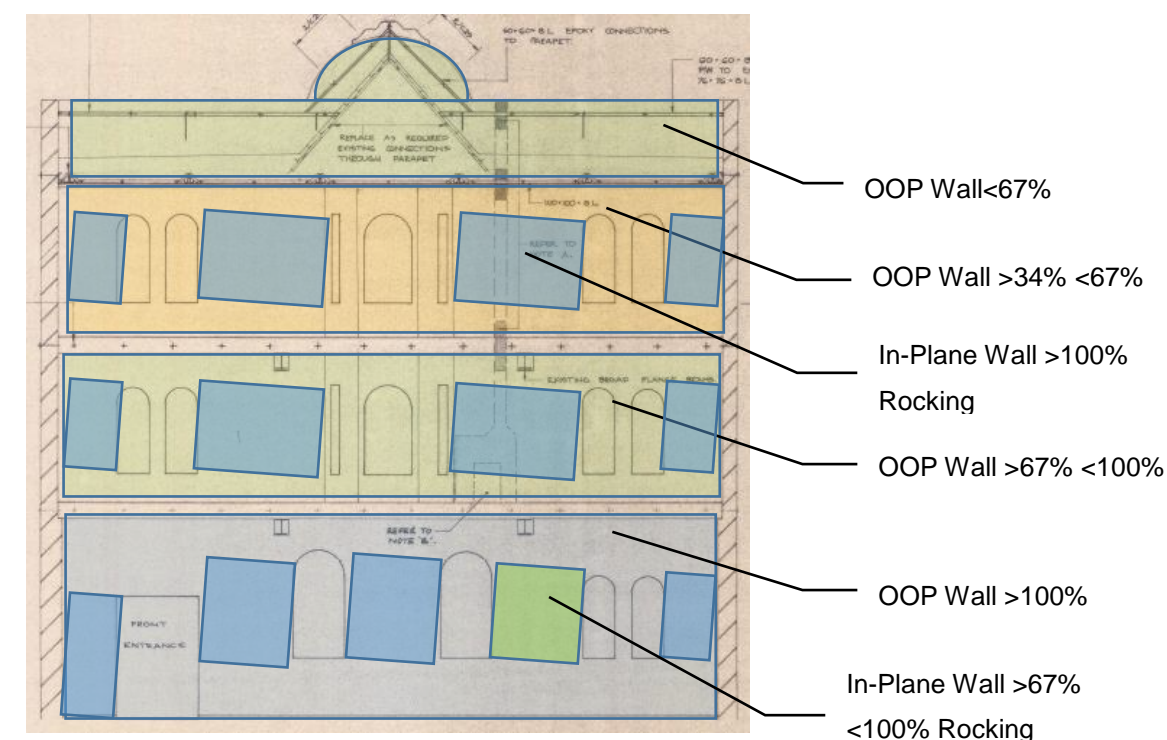
- Out-of-Plane Instability of face loaded URM walls and parapets – Section C8.8.5. The capacity of parapets with a base only restraint and the walls restrained by floors /ceiling diaphragms to their top and bottom are assessed under the virtual work based assessment recommendations utilising their head and base support conditions. The degree of horizontal deformation by the diaphragm as assessed above is utilised to determine the elements capacities. Axial loading has a positive effect on the capacities and as this

Figure 16 – Sketch of Front elevation URM element Outputs and Out of Plane Capacities

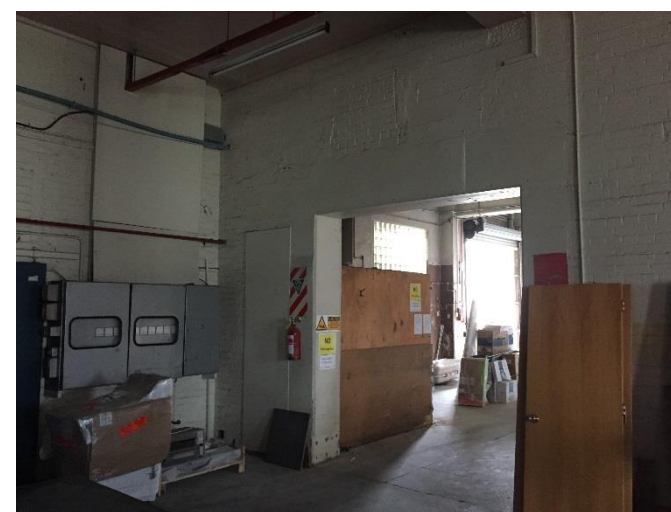
Structurally the main observation was the number of penetrations to the internal shear walls as a result of the historic refurbishments which have removed areas of URM shear walls and replaced them with reinforced concrete frames. The nature of the strengthening works to the 1986 refurbishments have in locations, been found to be below the level of provision typically used in today's seismic strengthening regimes and this may well be the result of more robust assessment procedures which have increased the seismic demands for strengthening works.

Figure 25 – South Elevation inset RC frame

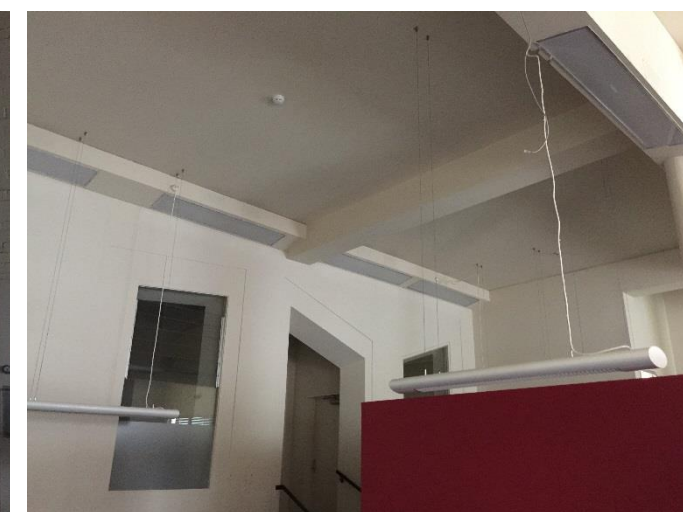
Figure 26 – Internal Grid B RC wall/frame

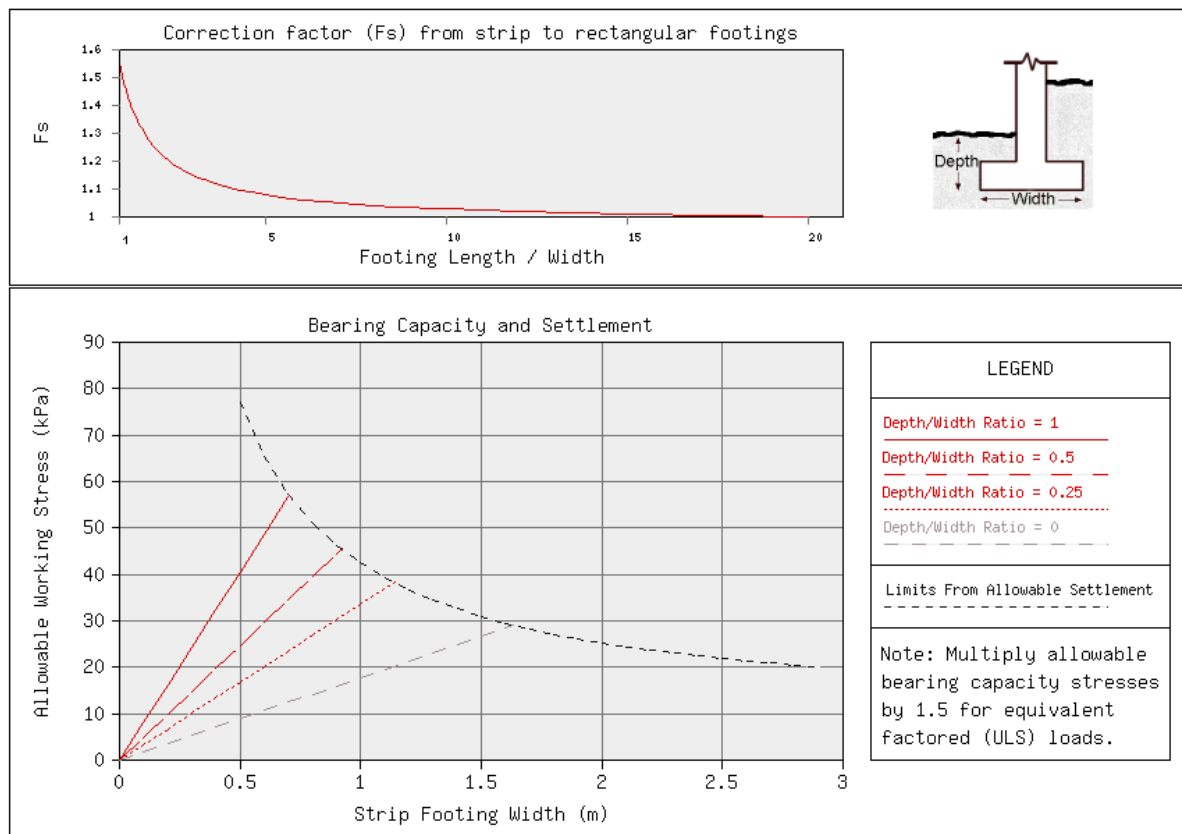
Figure 2: Typical Bearing for Shallow Footings on Alluvial Silt

From Figure 2 it can be seen an allowable working stress of approximately 40 kPa is recommended for a 500 mm wide by 500 mm deep strip footing founded within alluvial silt. This corresponds to a factored (ULS) bearing capacity of approximately 60 kPa and an

ultimate geotechnical bearing capacity of 120 kPa. Note the low allowable bearing for larger footings.

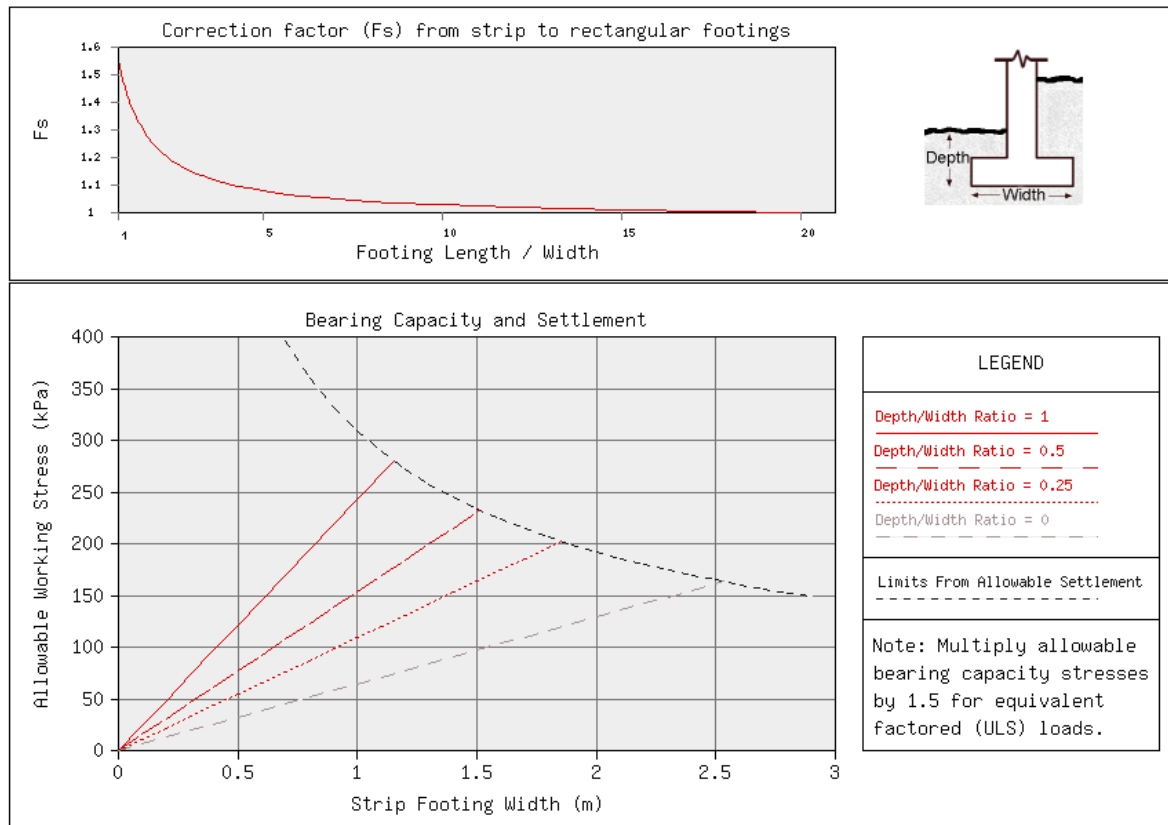
Figure 3: Recommended Bearing for Shallow Footings on Alluvial Gravel

From Figure 3 it can be seen an allowable working stress of approximately 100 kPa is recommended for a 400 mm wide by 400 mm deep strip footing founded within alluvial gravel. This corresponds to a factored (ULS) bearing capacity of approximately 150 kPa and an ultimate geotechnical bearing capacity of 300 kPa.
