**INITIAL SEISMIC ASSESSMENT REPORT (ISA PLUS)**

Former Frog 'n' Firkin

31 Dee Street, Invercargill

Date Issued: 9/04/2018

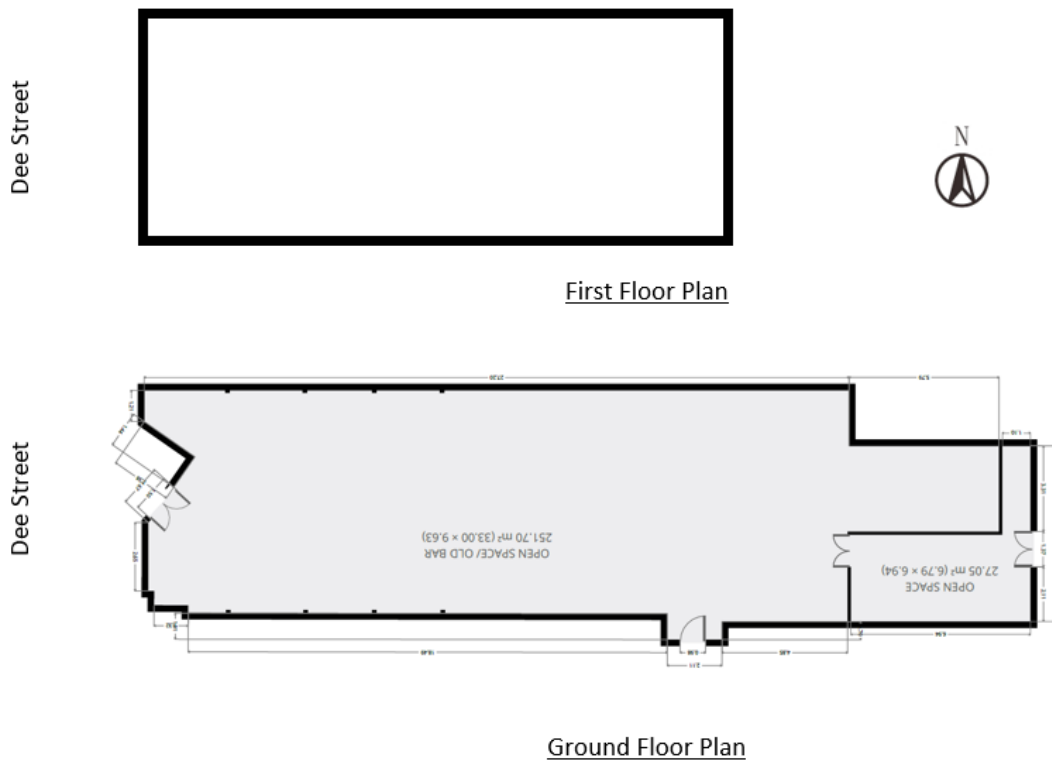
Figure 2 - Building floor plan

The two-storey building is rectangular in plan. The shopfront of the building is at the west end of the building facing Dee Street. The side walls are on the north and south sides of the building. As existing building drawings were not made available for this building, a scale model building plan was produced on site, as shown below in Figure 2.
