INITIAL SEISMIC ASSESSMENT REPORT (ISA PLUS)

Suzie's Tapas, Kim's Sunshine Sushi, Tasti Blitz, and Cargill Tea

12-16 Kelvin Street, Invercargill

Date Issued: 09/04/2018

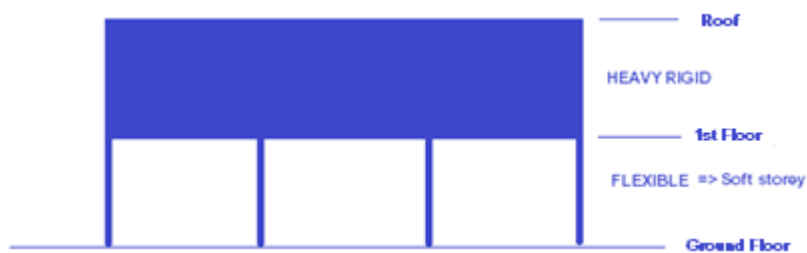
Figure 3 - Building elevation of soft storey structure example

In the transverse direction (north-south direction), there is also a soft storey critical structural weakness. A soft storey in a building occurs when a significantly more flexible building level supports a more rigid building level. This occurs at the shopfront, where a relatively heavy rigid first floor façade is supported by a “open” ground floor framing with no distinct lateral force resisting elements, see Figure 3.

It is estimated that the capacity of the building in the transverse direction is approximately 5-20%NBS (IL2).
