INITIAL SEISMIC ASSESSMENT REPORT (ISA PLUS)

Beauty and Beyond

18 Kelvin Street, Invercargill

BMC Reference: 1711-2266

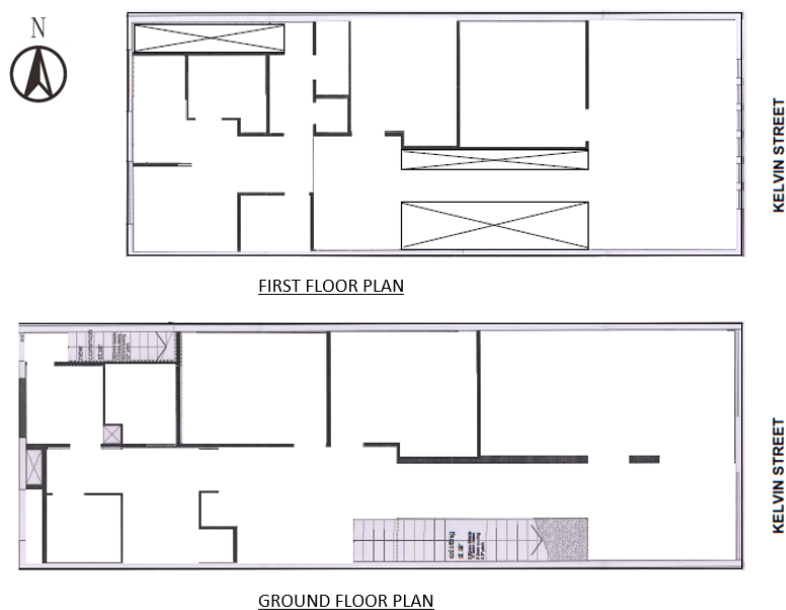
Figure 2 - Building floor plan at ground floor and first floor

The building plan is rectangular in plan with URM walls around the perimeter. The shopfront is at the east end of the building, facing Kelvin Street. The side walls are on the north and south sides of the building. A 2003 fitout floor plan drawing is shown below in Figure 2.

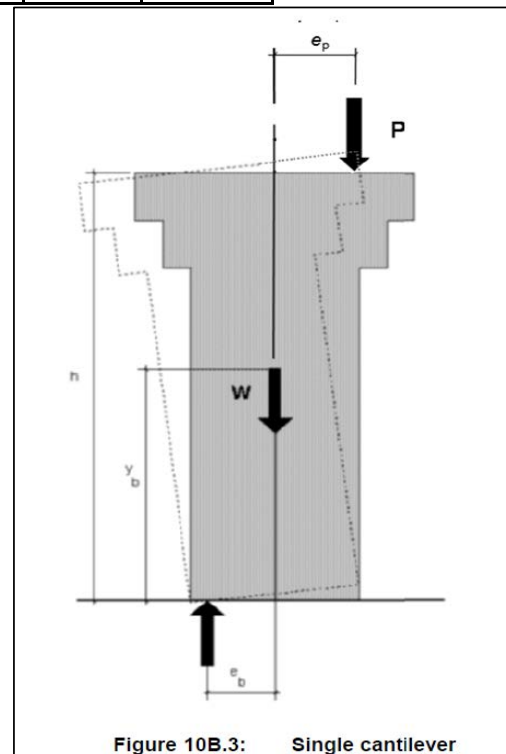
Figure 10B.3: Single cantilever

$C_{hc}(0.75)$	1.48	g
$C_p(0.75)$	1.10	g
