INITIAL SEISMIC ASSESSMENT REPORT (ISA PLUS)

42 Tay Street, Invercargill

Client Name: HWCP Management Ltd)

Date Issued: 9/04/2018

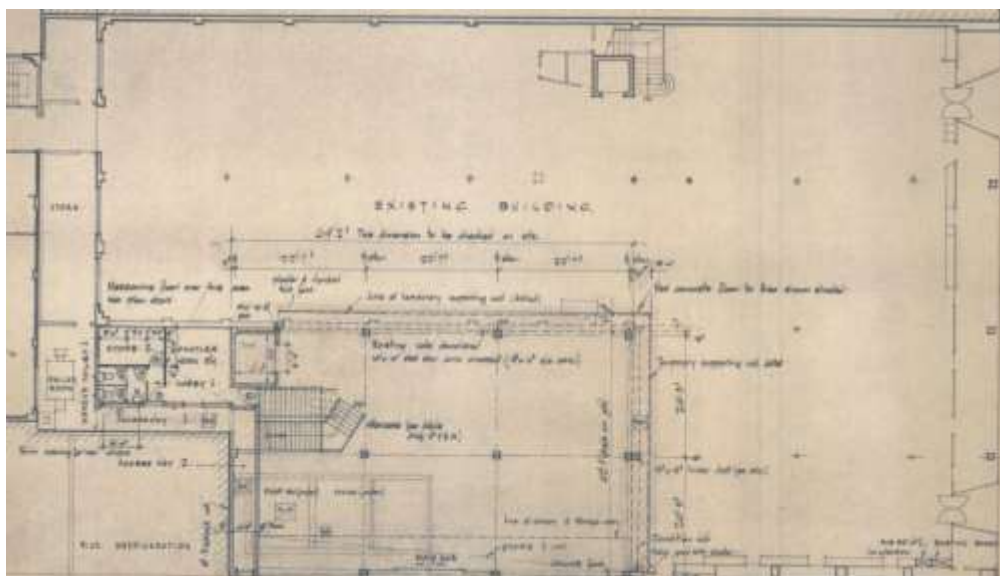
Figure 2: Building Ground Floor Plan from 1965 drawing by Smith Rice Lawrence & Mollison.

The first floor is timber joists supported on, potentially, steel beams spanning (N-S) between the cast iron columns to the roof valley lines above and to the 350mm wide (3 wythes) unreinforced masonry (URM) brick walls an the RC façade wall. The ground floor is a reinforced concrete ground bearing slab.
