INITIAL SEISMIC ASSESSMENT REPORT (ISA PLUS)

50 Tay Street, Invercargill

BMC Reference: 1711-2266

Date Issued: 9/04/2018

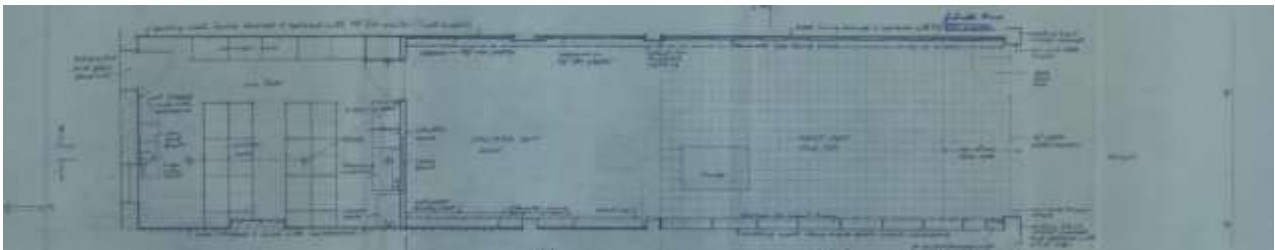
Figure 2: Building Ground Floor Plan from 1961 drawing by McAuthur & Boag Architects.

The first floor is timber joists supported on the 350mm wide (3 wythes) unreinforced masonry (URM) brick side walls. The ground floor is a reinforced concrete ground bearing slab.

Gravity loads are transferred to the foundations via URM walls, with loading from the timber first floor and / or timber roof trusses and purlins.
