Invercargill Central Redevelopment

Addendum to Woods, Cropper, Mearns, Mitchell,
McStay and Cawte 2018. Heritage Impact Assessment of
Block II, Town of Invercargill

Report Prepared for Bonisch Consultants
Author: Dr Naomi Woods and Dr Dawn Cropper
Reviewed by: Dr Hayden Cawte
Submitted: January 2019

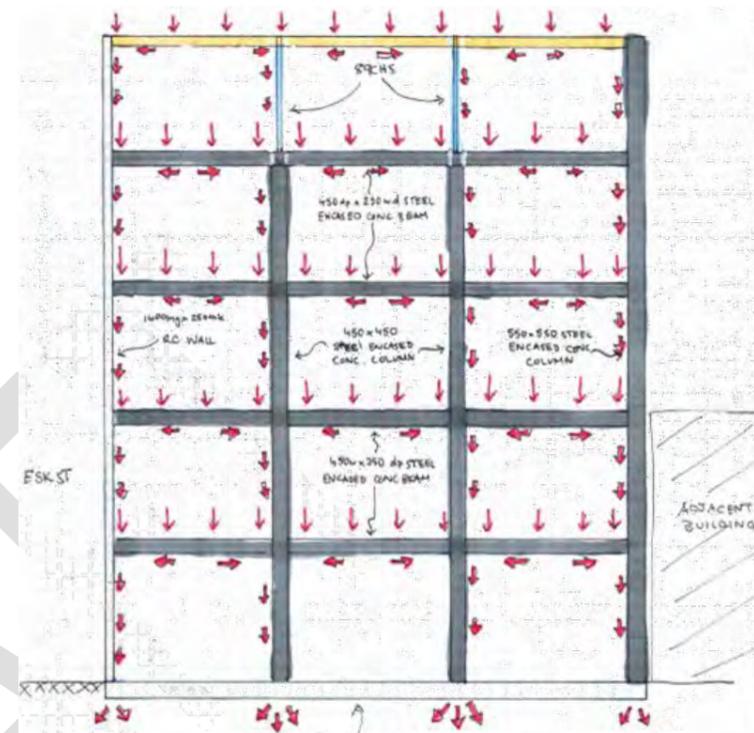
Figure 7 – Government Life West typical gravity load path

Due to the lack of documentation, assumptions have been made in regards to the foundation system. The foundation system is assumed to comprise reinforced concrete strip footing beneath columns and walls.

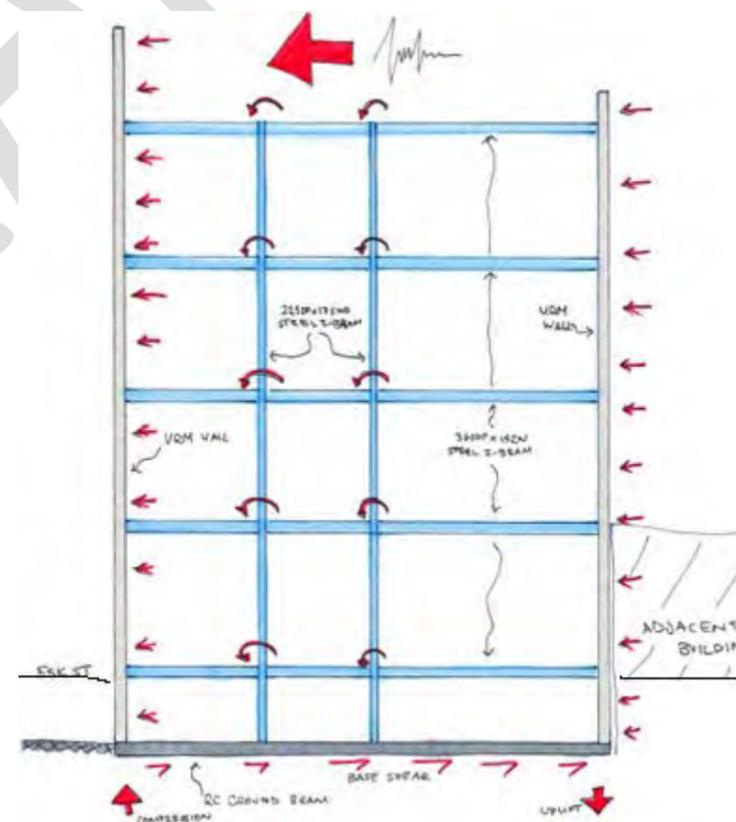
Figure 10 – Government Life East typical transverse lateral load path following first mode of failure

This section of the building lacks a resilient lateral load path due to the lack of flexible diaphragm action to support the URM walls.

The lateral load resisting system comprises timber flexible diaphragms without sufficient ties spanning to the URM shear walls with steel gravity support frames. Following the first mode of failure some lateral resistance will be provided by the steel frames. Lateral load is distributed on a tributary width basis at each floor level as there is no diaphragm action. The URM walls out-of-plane are required to span between walls or frames, but are limited by their fixing capacities.

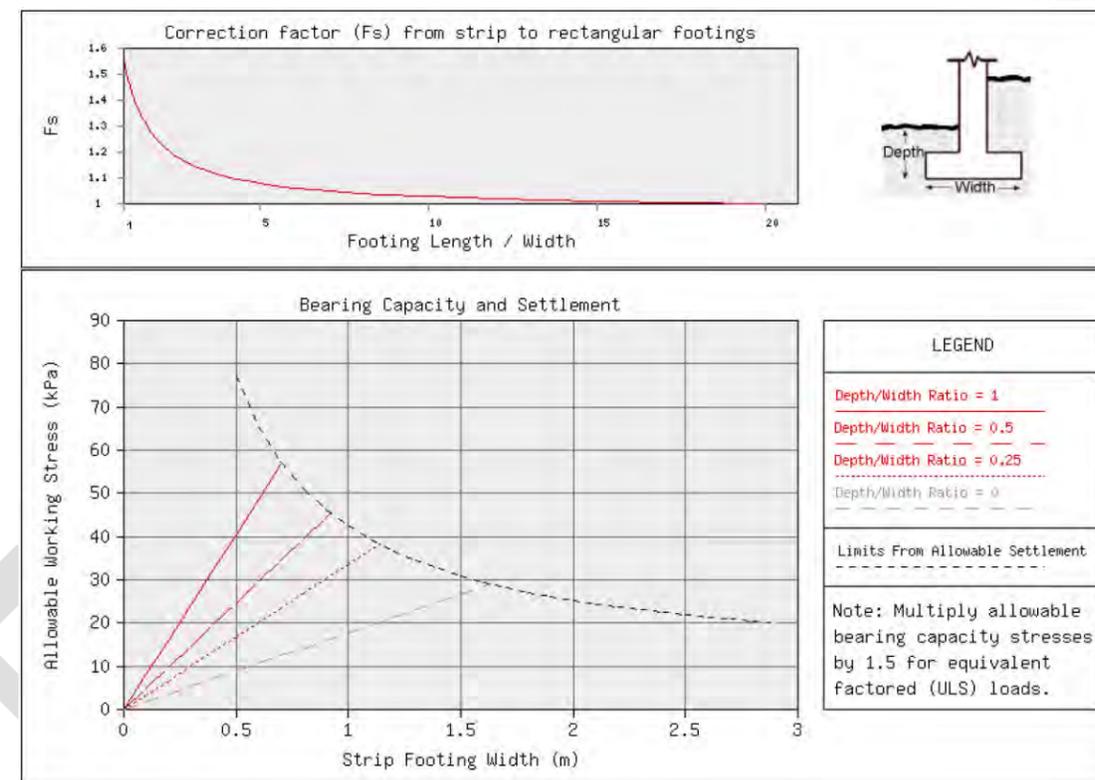
Figure 11 – Typical bearing for shallow footings on alluvial silt (excerpt from GeoSolve report)

Strip footings (500 mm wide by 500 mm deep) within the alluvial silt are expected to have a geotechnical ultimate bearing capacity of 120 kPa. Footings (400 mm wide by 400 mm deep) upon the alluvial gravel have an expected higher geotechnical ultimate bearing capacity of 300 kPa, see Figure 11 and Figure 12. Note low bearing for wider footings.

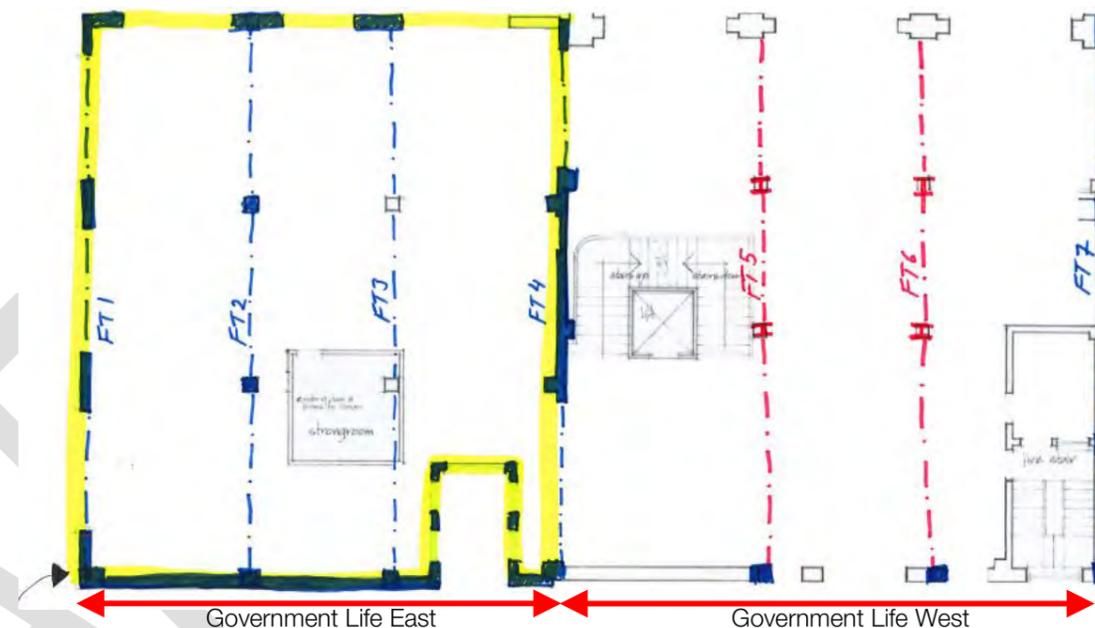
Figure 13 - Transverse lateral load resisting system

The primary transverse system of the existing Government Life West building consists of three concrete frames and one URM wall. Loads are distributed at each floor through rigid diaphragm action provided by the reinforced concrete floors. The concrete frames comprise a mixture steel encased concrete beams/ columns and reinforced concrete beams, columns and walls. Additional reinforced concrete wall elements, such as window mullions, have been excluded from the system as the lateral load capacity they provide is insignificant. The seismic weight and rigid diaphragm associated with this building section is outlined in yellow, in **Figure 13**.

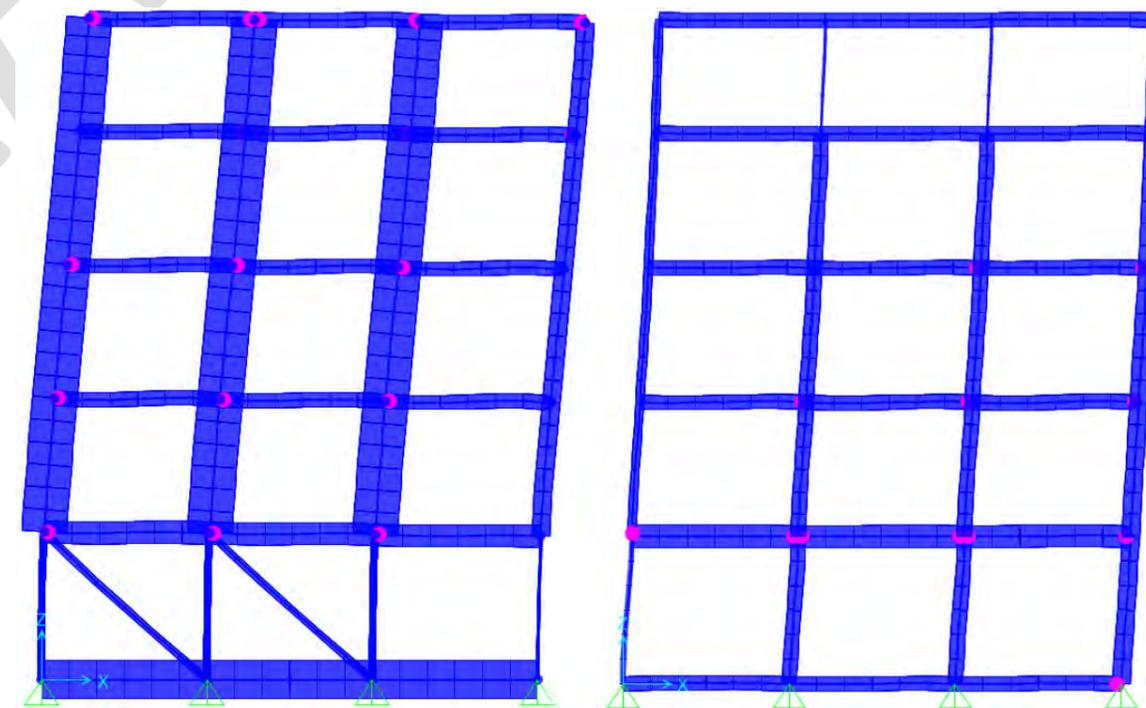
Figure 14 - SAP2000 pushover computer analysis (External frame left, internal frame right)

Two separate two-dimensional (2D) SAP2000 computer models were constructed to investigate the behaviour of each frame type in the transverse lateral load resisting system. The lateral seismic forces are assumed to be distributed over the building height in accordance with Section 6 of NZS 1170.5:2004 and the corresponding internal forces and building displacements are determined using a linear elastic static analysis. Computer model extracts of the 2D frame models' displacements are provided adjacently in Figure 14.

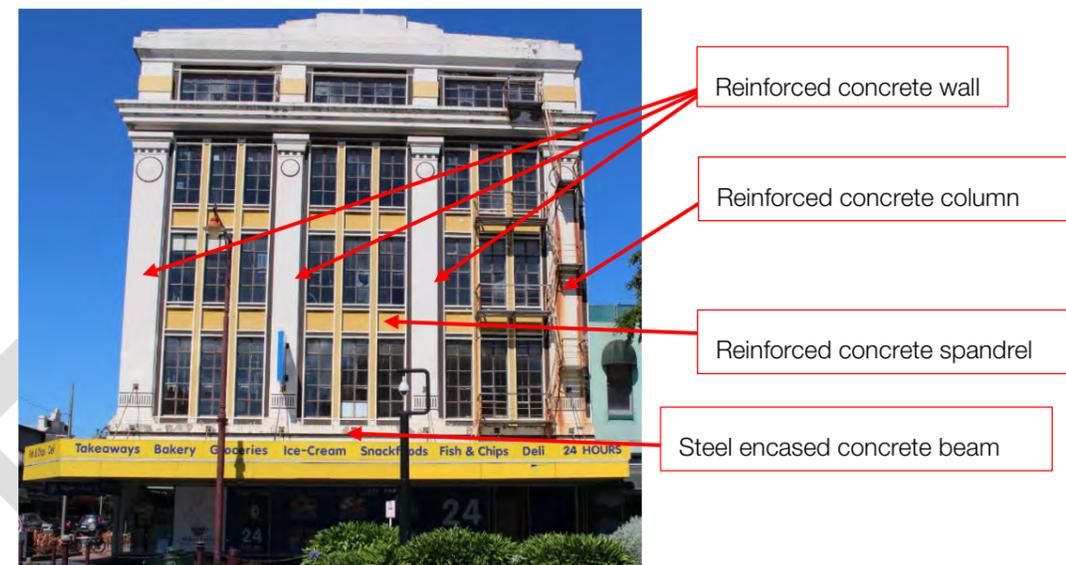
Figure 15 - External Dee Street Elevation

External Dee Street Frame

The frame along Dee St, Figure 15, comprises reinforced concrete wall, column and spandrel sections and a steel encased concrete beam above ground floor. Below ground floor the frame is constructed of steel columns and struts. The strength of this external frame under earthquake loading is limited by the flexural capacity of the reinforced concrete spandrels and the axial capacity of the out-of-plane 200PFC post at ground floor. Based on these specific component checks the frame capacity is 10-15%

The cantilever URM parapet above roof level was analysed also according to section C8 of the technical guidelines as a vertical spanning cantilever wall. The maximum height parapet cantilevers 3.0 m. The out-of-plane capacity of this parapet was calculated at approximately 15-20%NBS.

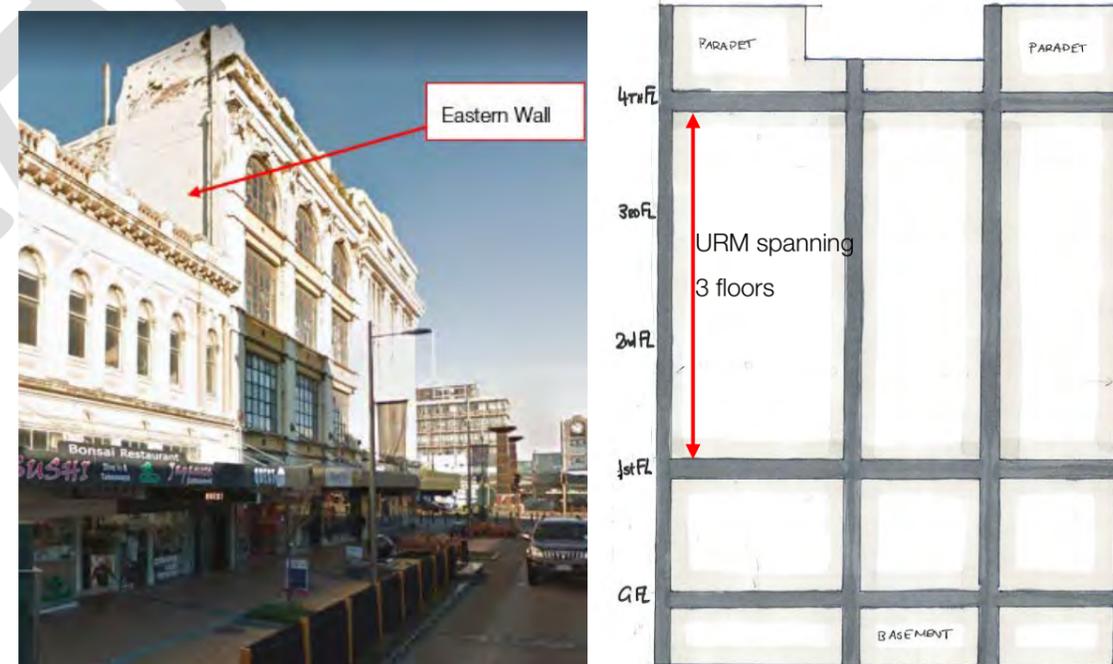
Figure 16 - Location of eastern URM wall (left), sketch of approximate configuration of eastern URM wall (right)

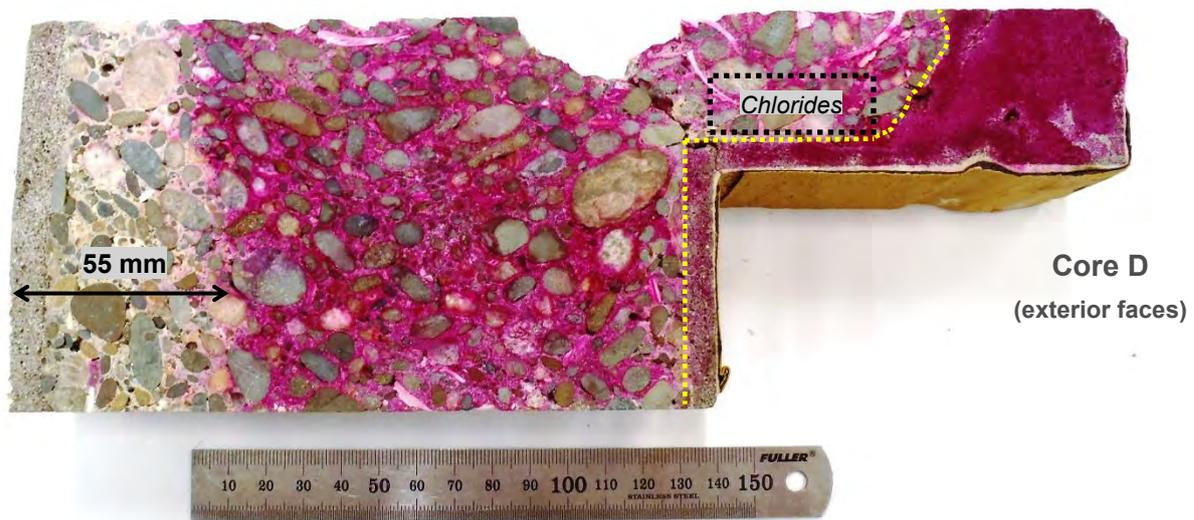
Figure 1. Longitudinal slices through the cores, photographed following application of the phenolphthalein reagent. The arrowed lines indicate the approximate maximum carbonation depth from each exposed end of the core. The approximate position from which the chloride sample was removed from the matching longitudinal slice is also indicated.

Figure 1 (continued).

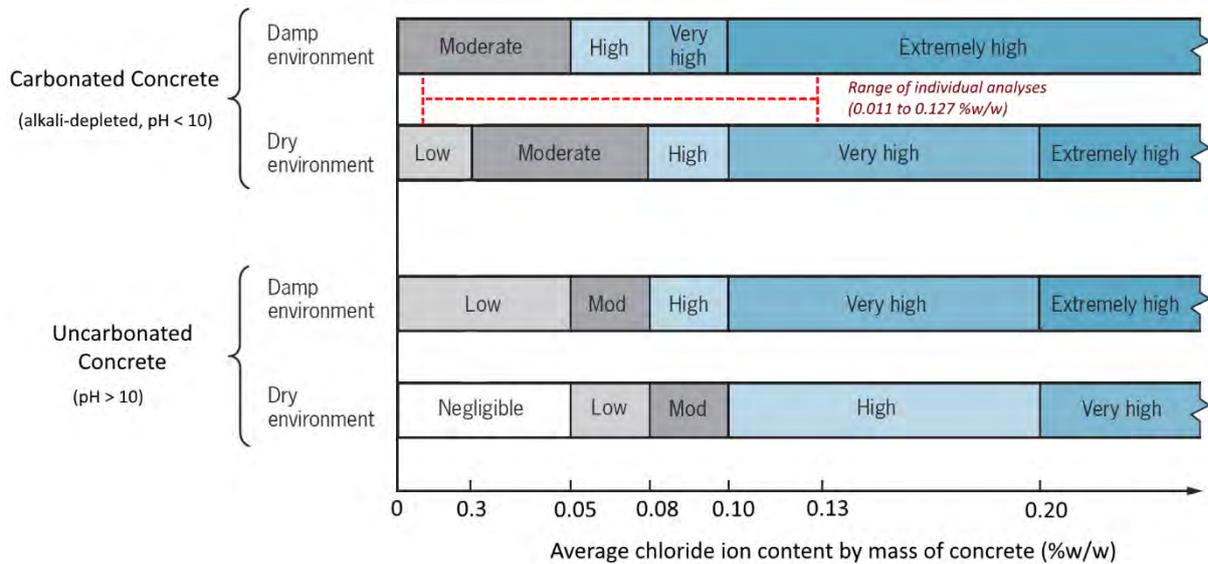
Because of this synergistic coupling between carbonation and cast-in chlorides, the current and future reinforcement corrosion risk for the sampled concrete is potentially moderate to high where the carbonation has reached the reinforcement, particularly if the environment is not protected and dry (Figure 2). Because of the nature of cast-in contamination, the corrosion risk is likely to somewhat variable across the structure, with localised hotspots reflecting the inhomogeneity of chloride distribution in the source aggregate.

Figure 2. Comparison of chloride contamination measured in cores with estimated risk of reinforcement corrosion under differing environmental conditions for typical quality older structural concrete.⁶

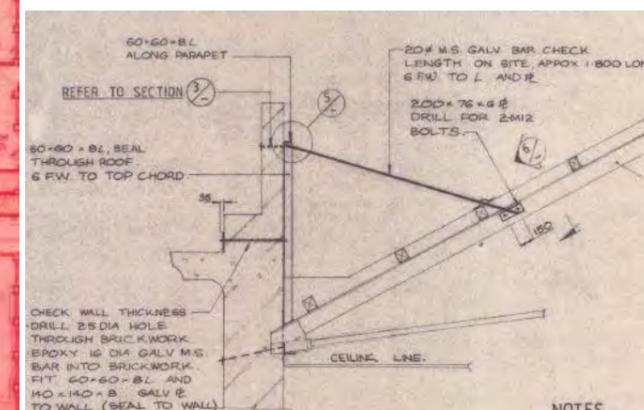
Figure 15: Façade parapet current restraint system

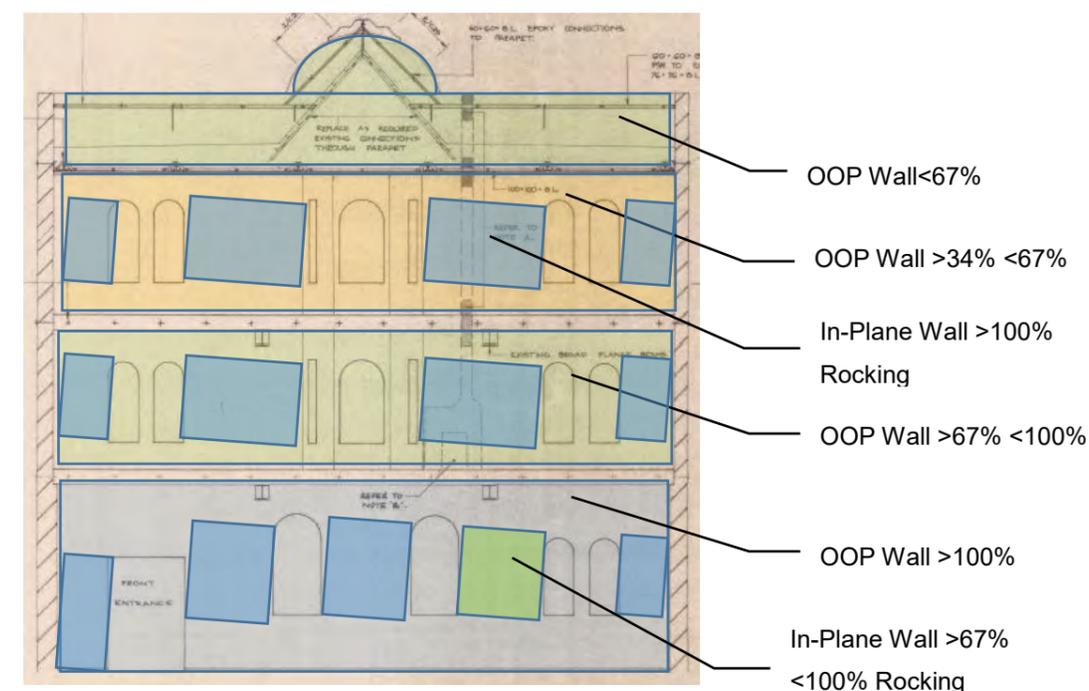
- Out-of-Plane Instability of face loaded URM walls and parapets – Section C8.8.5. The capacity of parapets with a base only restraint and the walls restrained by floors /ceiling diaphragms to their top and bottom are assessed under the virtual work based assessment recommendations utilising their head and base support conditions. The degree of horizontal deformation by the diaphragm as assessed above is utilised to determine the elements capacities. Axial loading has a positive effect on the capacities and as this

Figure 16 – Sketch of Front elevation URM element Outputs and Out of Plane Capacities

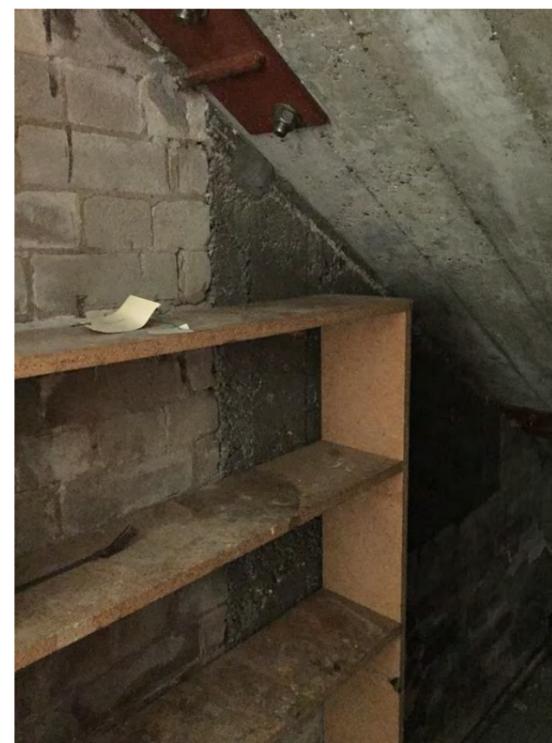
Figure 19 – Concrete Masonry Brickwork with RC window infill and RC stairs tied into West side wall.

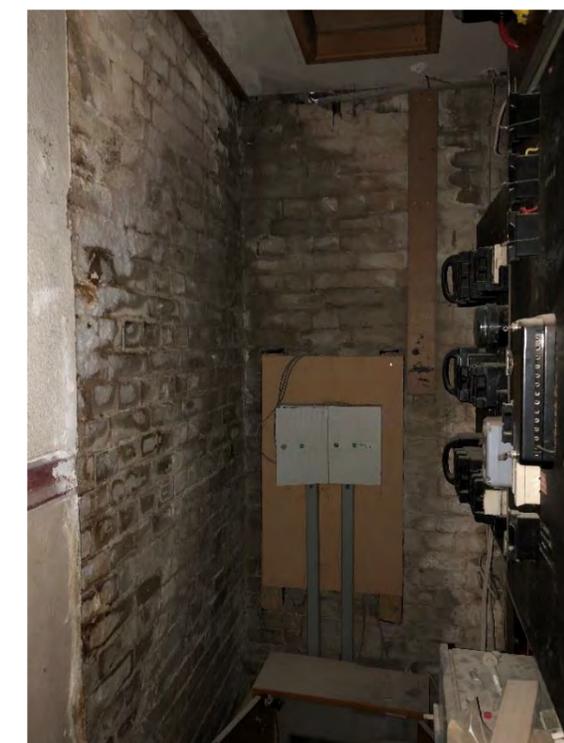
Figure 20 – Ground Floor North West corner evidence of efflorescence to the brickwork internal leaf.

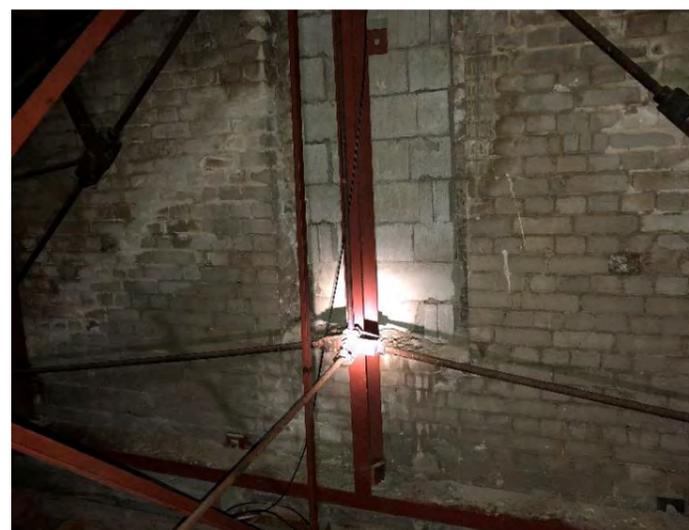
Figure 23 – East Gable front element strengthening girt has no effect on outwards movement as no fixing to wall and only at one location.

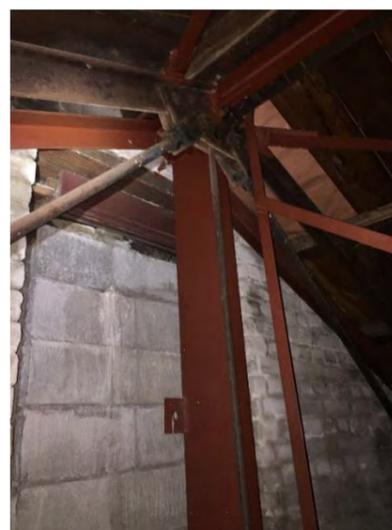
Figure 24 – West Gable front element strengthening girt has no effect on outwards movement as no fixing to wall and only at one location.

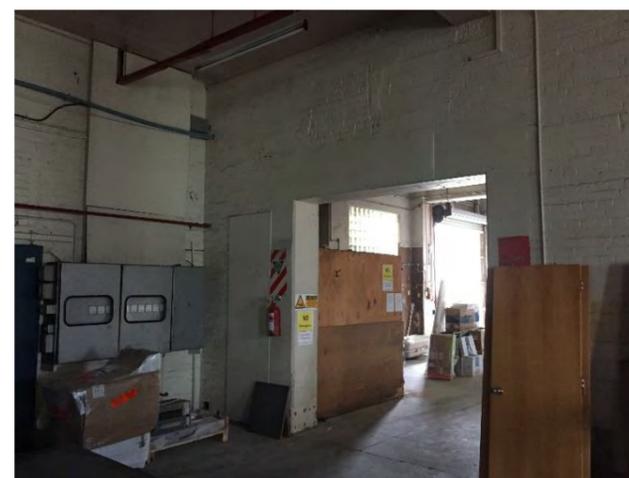
Structurally the main observation was the number of penetrations to the internal shear walls as a result of the historic refurbishments which have removed areas of URM shear walls and replaced them with reinforced concrete frames. The nature of the strengthening works to the 1986 refurbishments have in locations, been found to be below the level of provision typically used in today's seismic strengthening regimes and this may well be the result of more robust assessment procedures which have increased the seismic demands for strengthening works.

Figure 25 – South Elevation inset RC frame

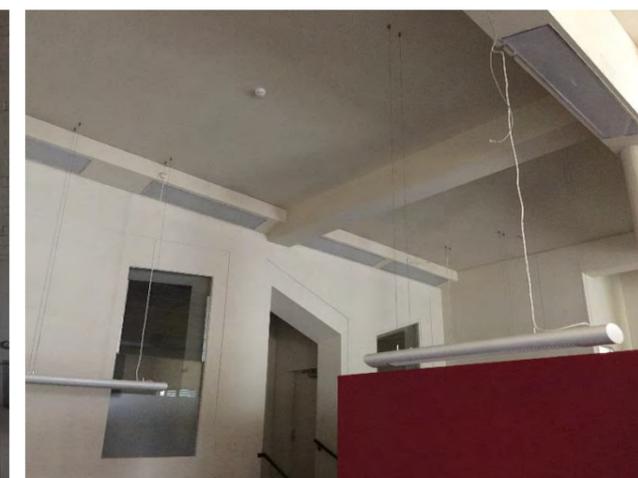
Figure 26 – Internal Grid B RC wall/frame

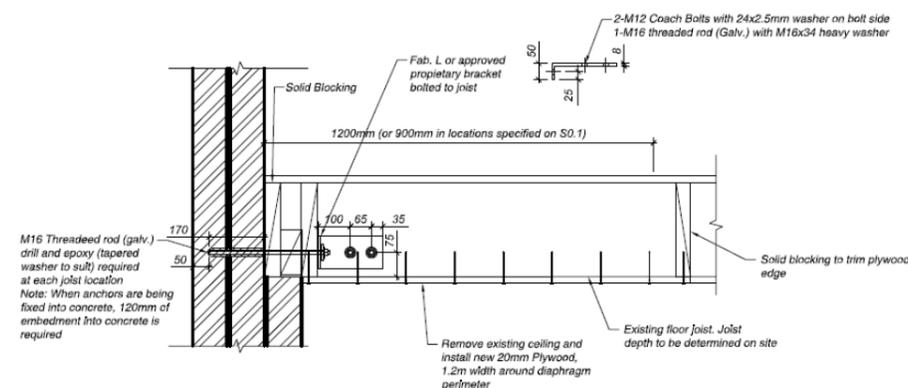
Figure 28 – Diaphragm to Wall typical remedial detail - Joist Perpendicular

There are a number of issues with regards the diaphragm / wall connections being inadequate, URM parapets and upper walls being of a low seismic capacity under out of plane loads all of which have placed the buildings rating within the “Earthquake Prone” Building Classification (‘Grade D’ building).

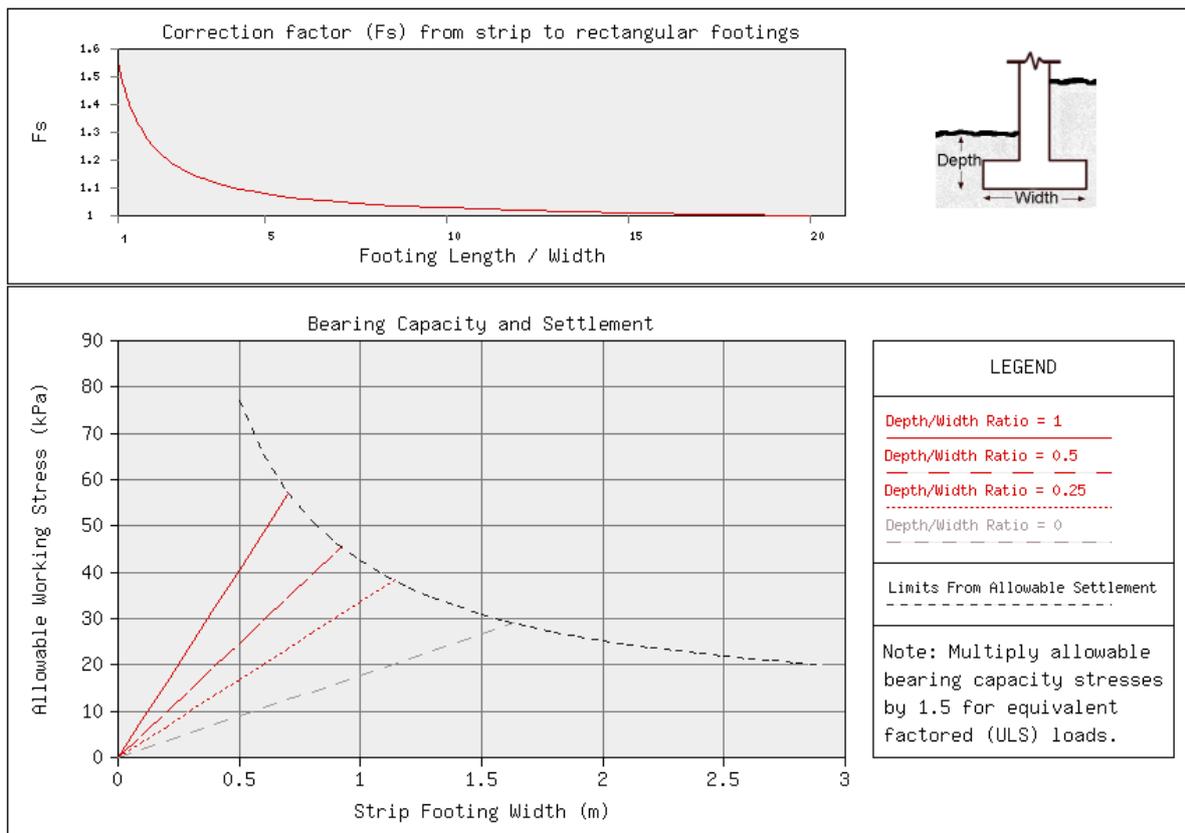
Figure 2: Typical Bearing for Shallow Footings on Alluvial Silt

Figure 2 below summarises typical working stresses for shallow footings, which bear upon alluvial silt. It should be noted the foundation working stresses presented on Figure 2 are governed by bearing capacity in the case of narrow footings and settlement in the case of wide footings.

From Figure 2 it can be seen an allowable working stress of approximately 40 kPa is recommended for a 500 mm wide by 500 mm deep strip footing founded within alluvial silt. This corresponds to a factored (ULS) bearing capacity of approximately 60 kPa and an

ultimate geotechnical bearing capacity of 120 kPa. Note the low allowable bearing for larger footings.

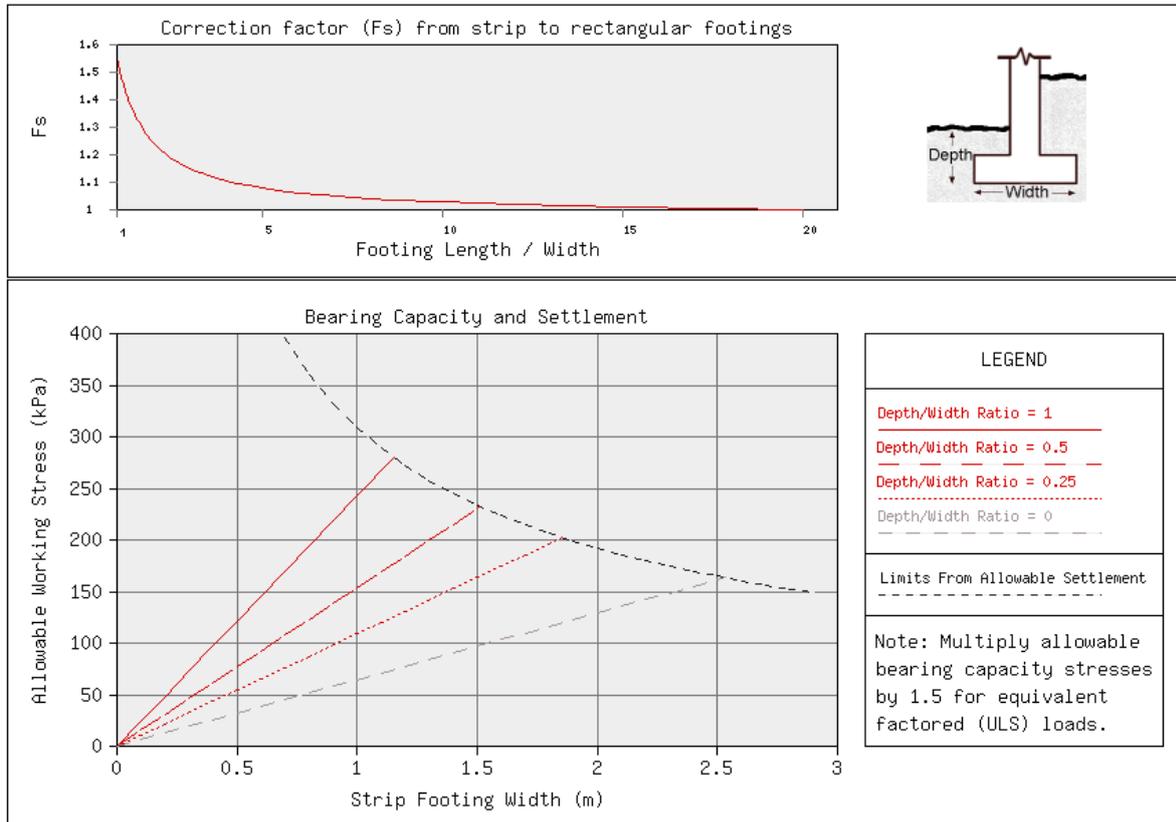
Figure 3: Recommended Bearing for Shallow Footings on Alluvial Gravel

Figure 3 summarises the recommended working stresses for shallow footings, which bear upon alluvial gravel. It should be noted the foundation working stresses presented on Figure 3 are governed by bearing capacity in the case of narrow footings and settlement in the case of wide footings.

From Figure 3 it can be seen an allowable working stress of approximately 100 kPa is recommended for a 400 mm wide by 400 mm deep strip footing founded within alluvial gravel. This corresponds to a factored (ULS) bearing capacity of approximately 150 kPa and an ultimate geotechnical bearing capacity of 300 kPa.
