November 16, 2021

Invercargill City Council  
Private Bag 90104  
INVERCARGILL

RE: SANDY POINT WATER SKI CLUB BUILDING & RAMP REPORT

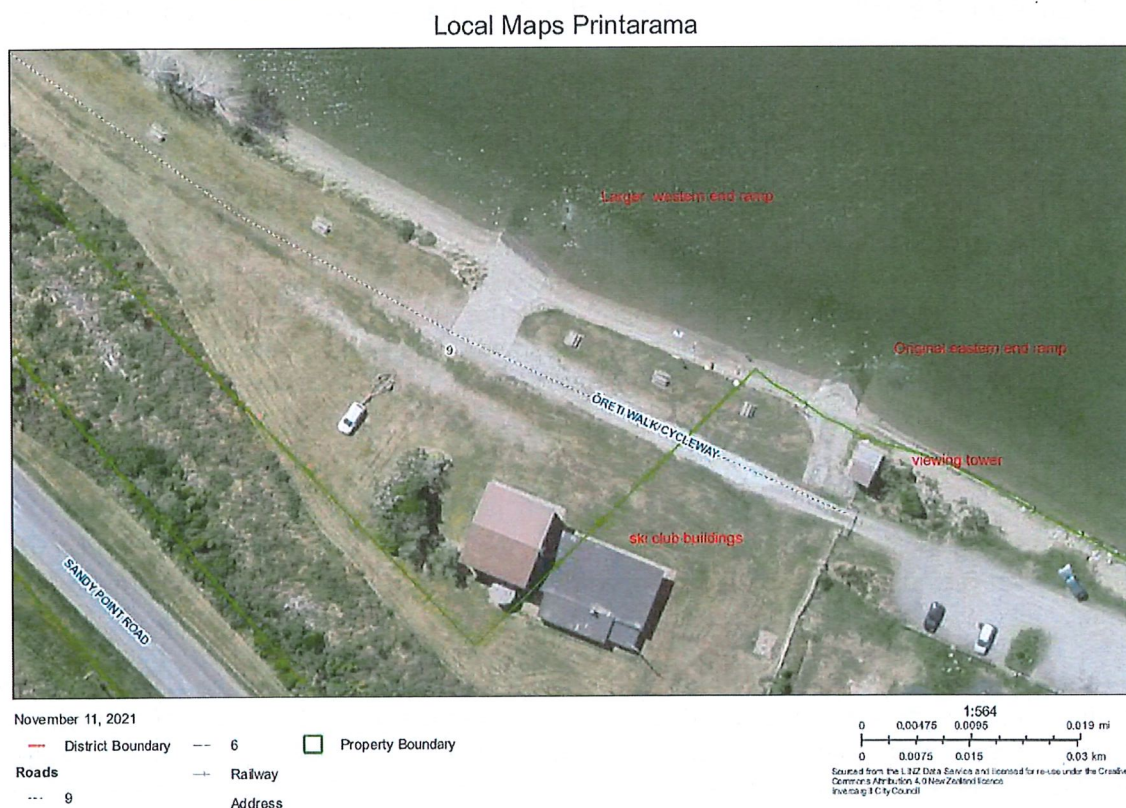
Fig. 1 site layout showing buildings and ramp locations

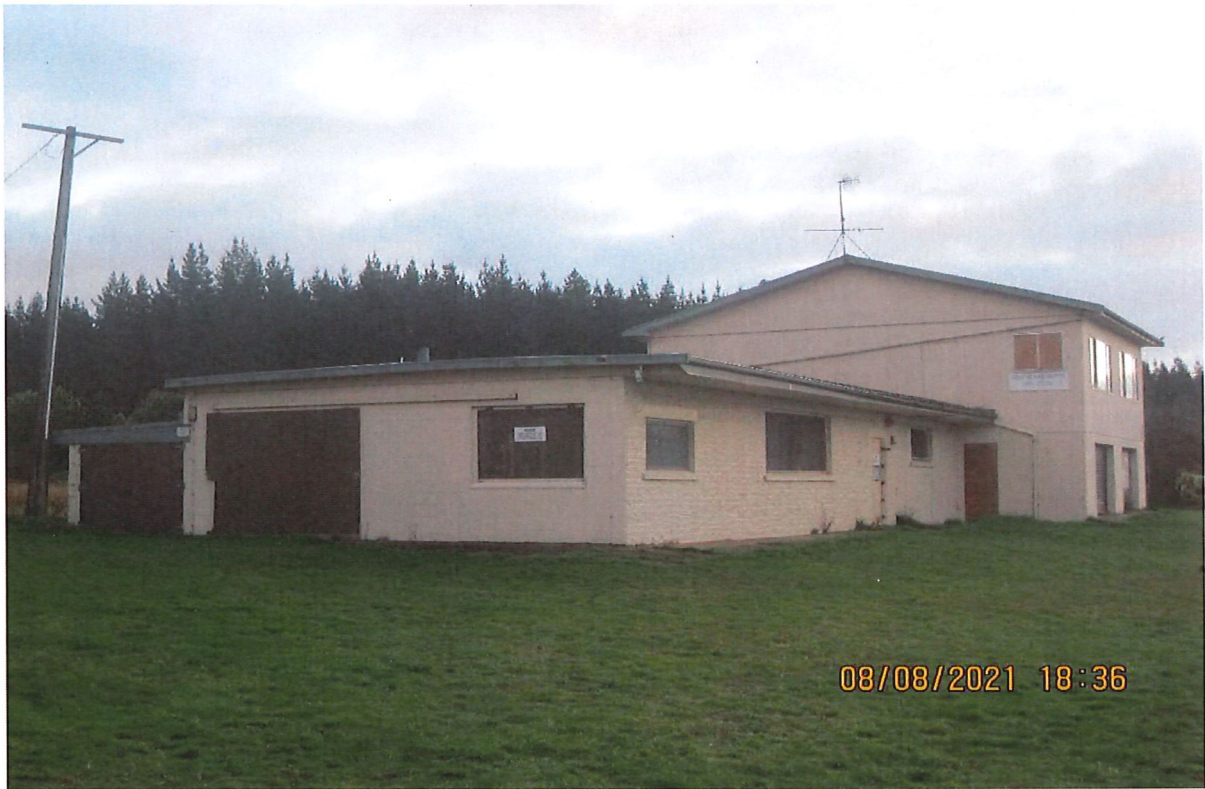
View of club rooms from NE corner

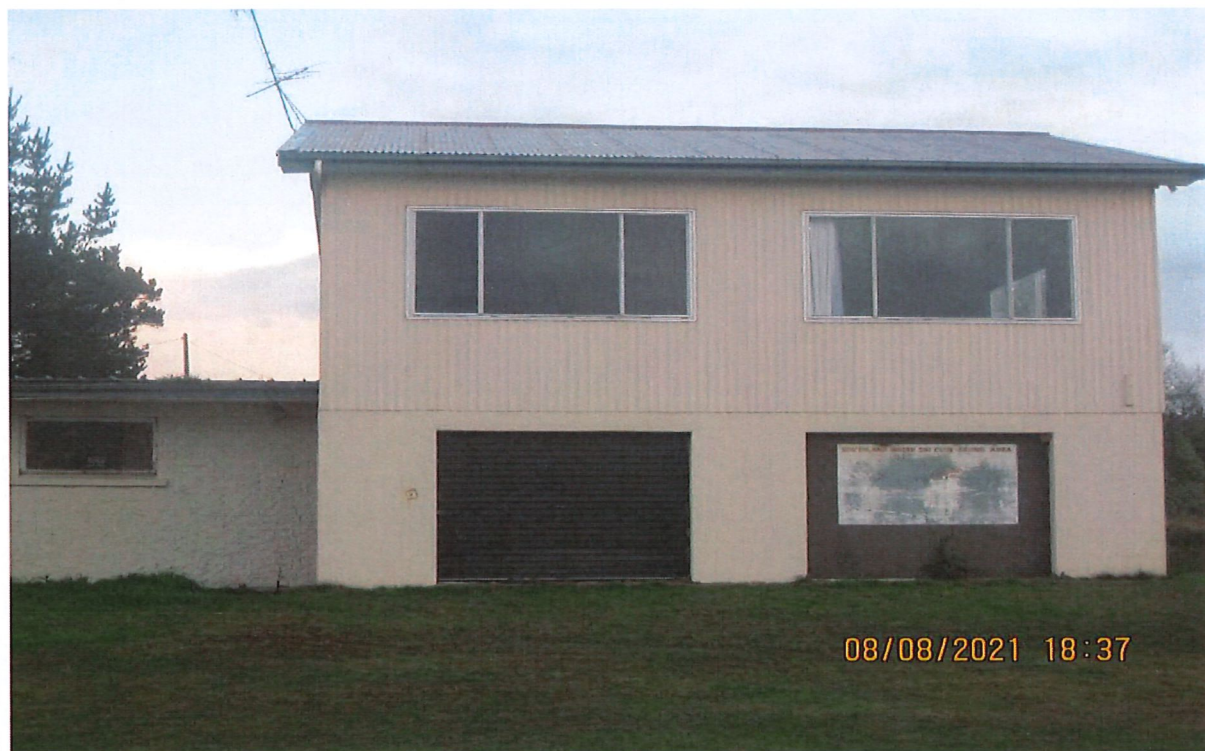
The two-storey portion of the building is in reasonable condition for its age and has reached the point of needing repainting and general tidy up. Some of the aluminium window glazing also needs attention as the sliding windows do not shut properly and the glazing gaskets to the glass require replacement.

View of two storey western end masonry block lower walls and fibre cement sheeting to upper level

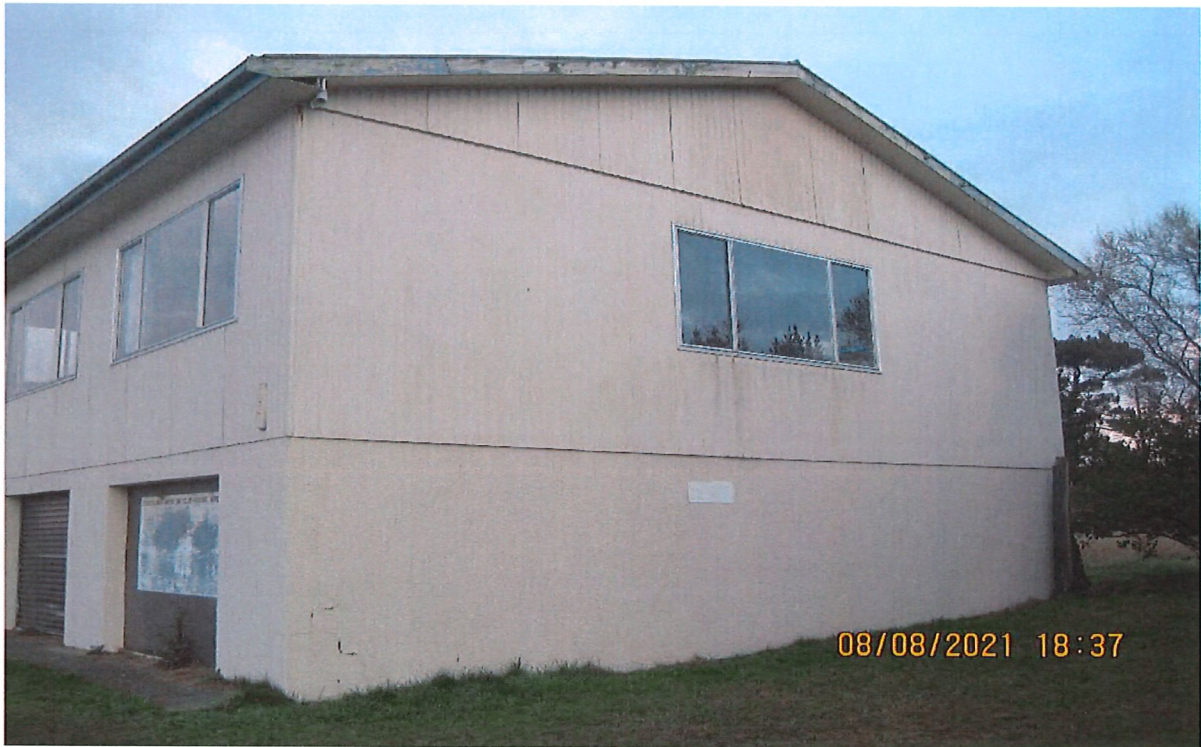
End view showing masonry block lower and fibre cement sheeting upper cladding.

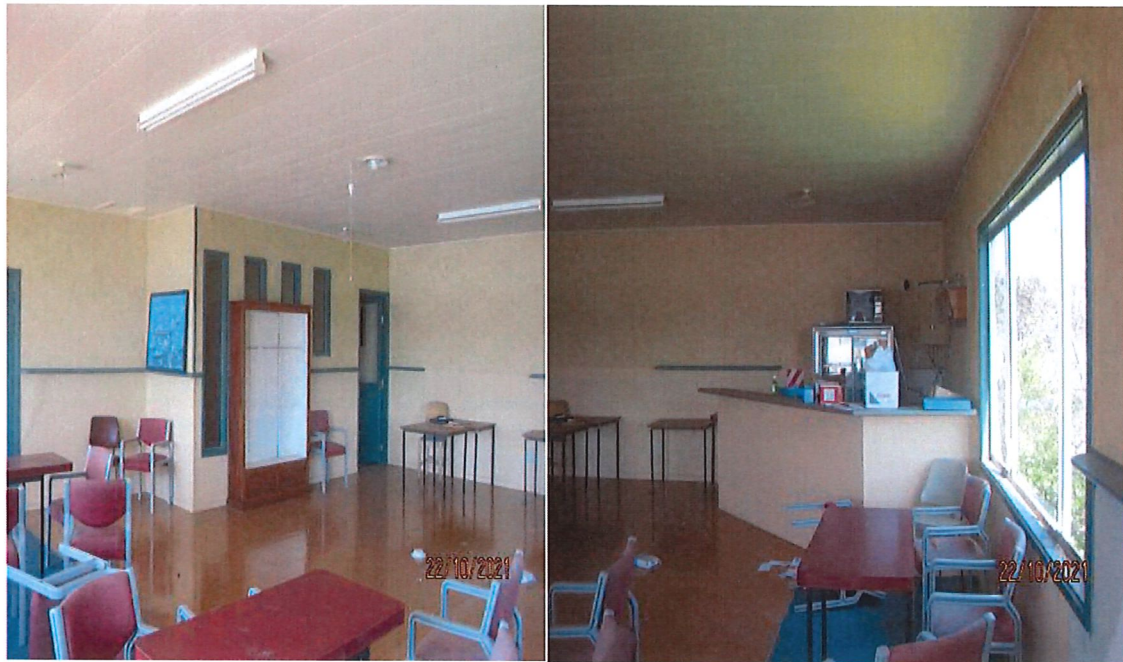
The ceiling of the upper lounge area comprises of soft board type ceiling tiles and is in good condition.

Upstairs lounge looking back towards the stair lobby

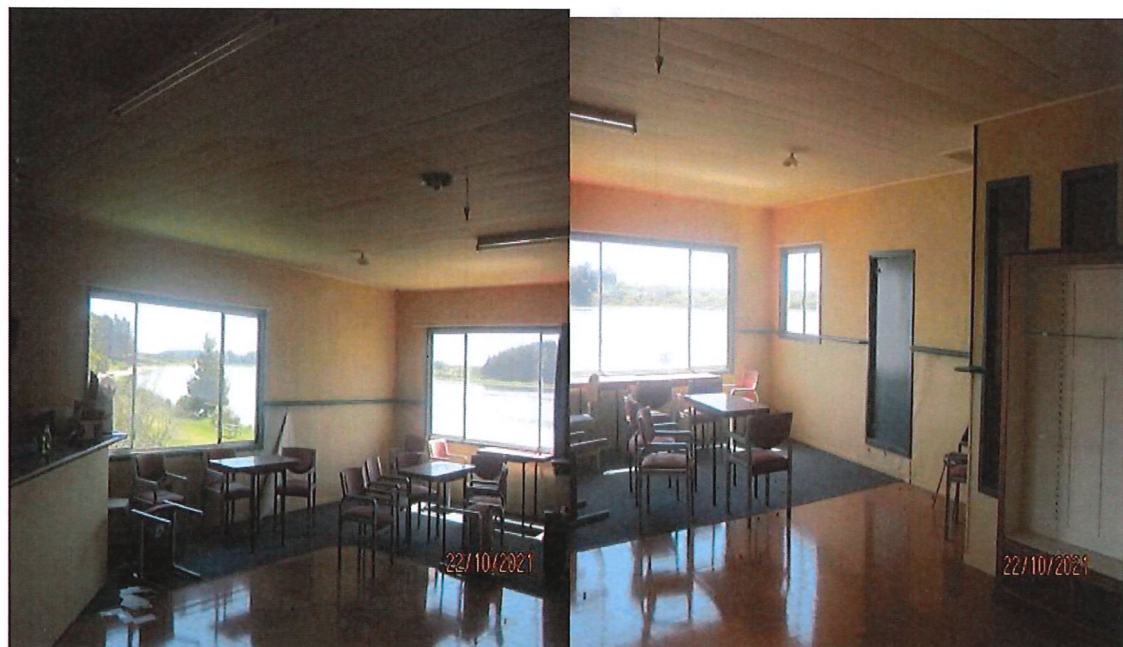
As mentioned previously the small egress door onto the adjacent roof of the single storey building is a timber door and is breaking down with exposure to the weather and moisture. Water is also entering at sill level and damaging the interior framing, linings' and trims in this area. The stud framing may be in poor condition and requiring replacement, however this could not be established conclusively without removal of the wall lining. From the exterior no form of head or jamb flashings could be observed.

View towards front river face with large windows and door out to roof on right of photo.

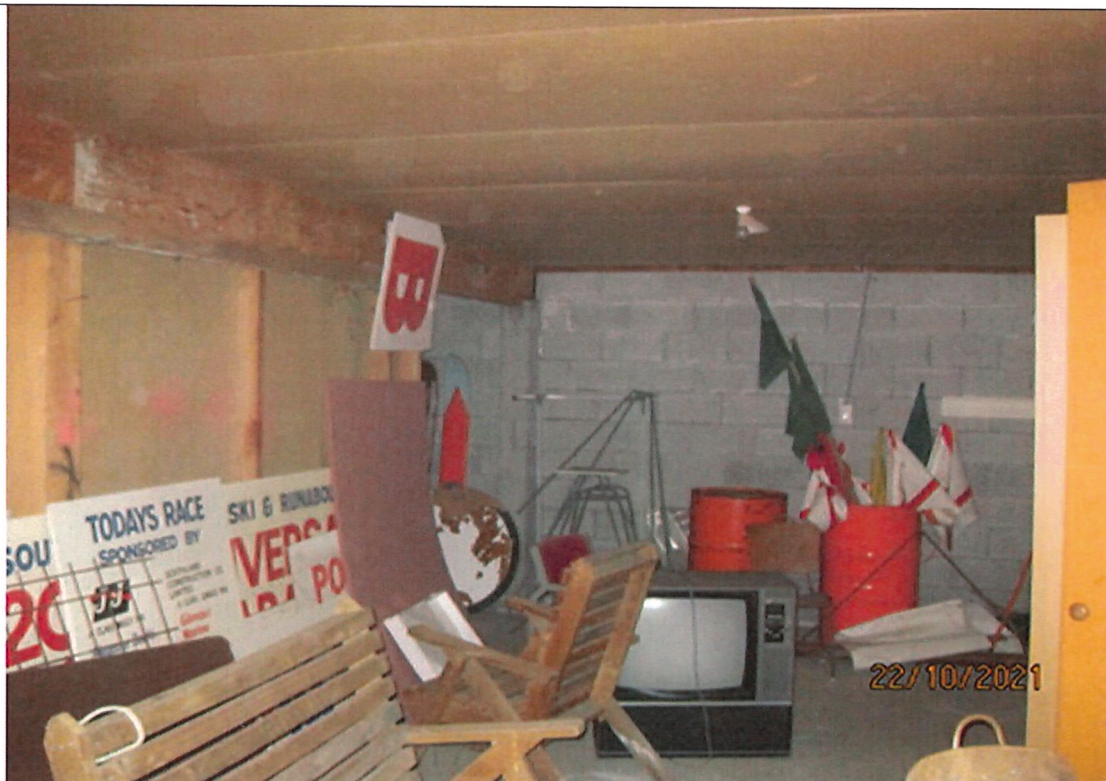
At the ground floor level, the masonry blockwork and first floor support beams are in good condition. The soffit lining of the first floor is part gib board, mainly to the rear and the other areas are MDF board. As such, there is little fire rating provided to the underside of the first floor. The timber support beams and the bottom plate for the floor joist support are not protected by any form of gib board fire lining either. The underside of the stairs has gib board full length. The space under the stairs has been utilised to provide the pump and pressure tank for the water supply drawn from the large storage tank outside.

Typical ground floor storage area, masonry block walls supporting the timber first floor structure

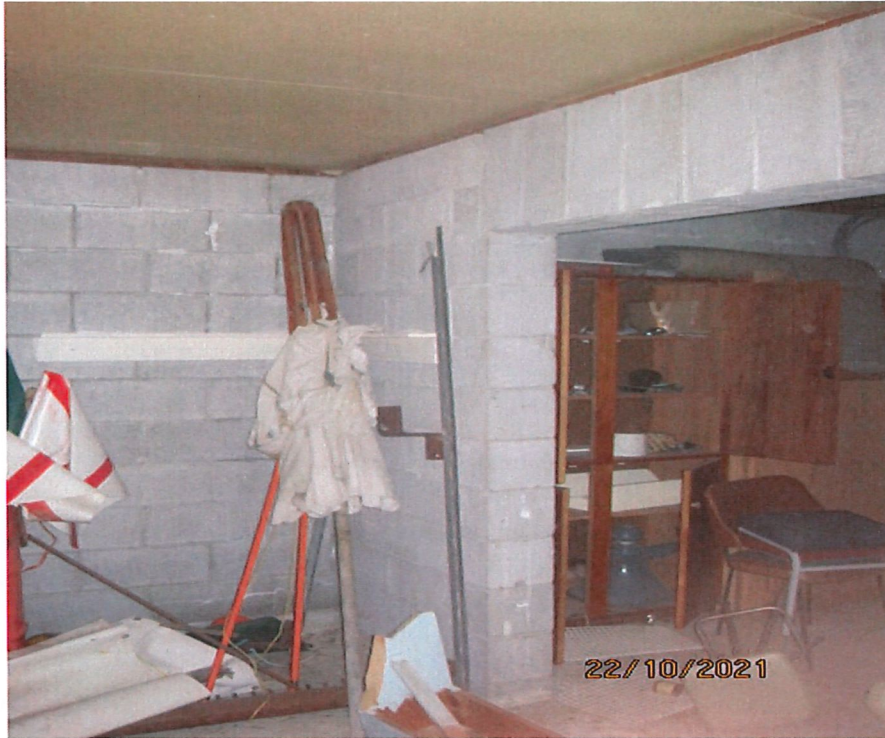
Concrete masonry support beam for first floor nearer the front part of the space.

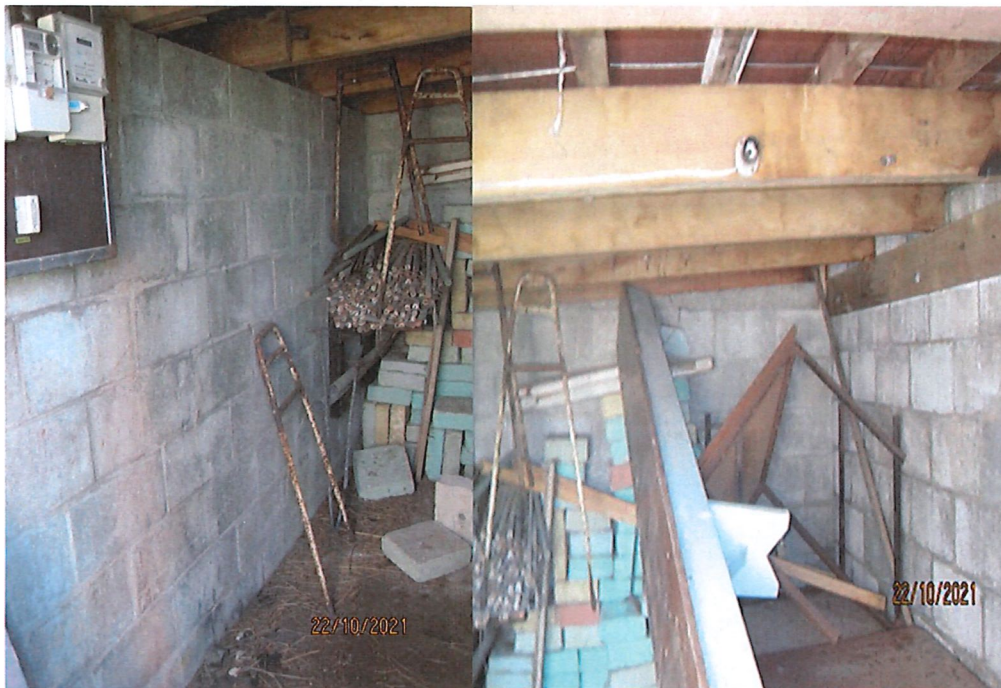
To the southeast corner of the building is a small lean-to storage area also using concrete masonry block walls with simple timber rafters over.

Interior view of small lean-to building to the SE corner showing typical condition of roof system and masonry block walls.

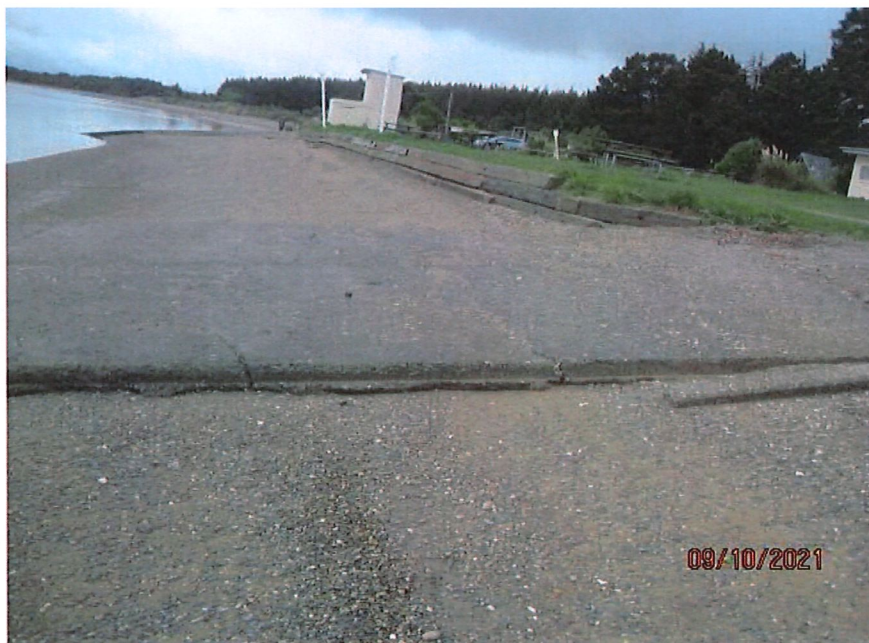
There are currently two ramps extending from approximately spring high tide level out to below low water. They are of differing ages and the older easterly located ramp beside the viewing tower is relatively narrow and steeper than the ramp located further to the west. Both ramps are constructed of poured insitu unreinforced concrete slabs founded on the gravelly sand of the shoreline. Refer to Fig 1 aerial photo for the locations.

Upstream side view of main ramp. Viewing tower and other ramp visible in the centre rear of the photo.
