# southland MUSEUM AND ART GALLERY

NIHO O TE TANIWHA

Options Report

November 2020

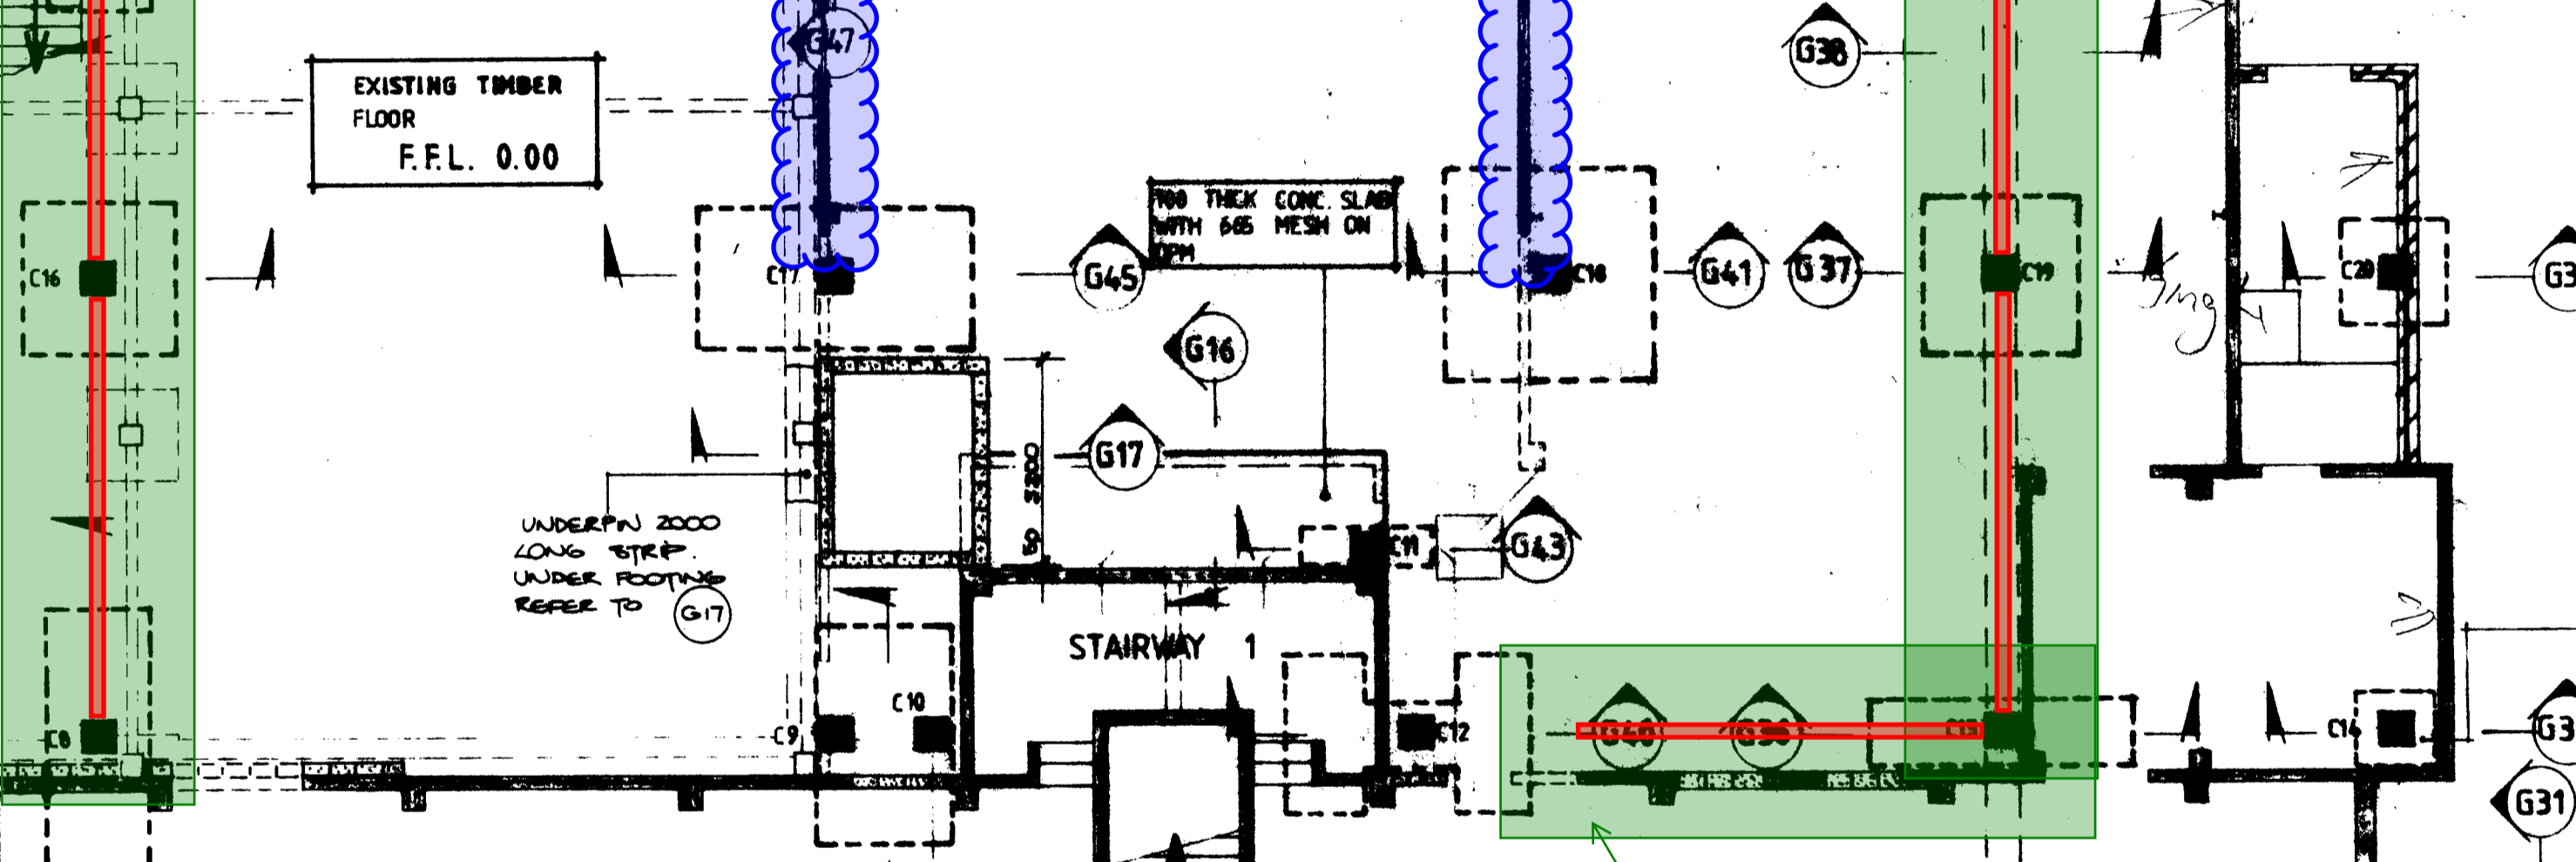
FOUNDATION PLAN (LEVEL 1)

Location of 250mm thick insitu concrete walls  
Wall reinforcing content - allow for 140kg/m<sup>3</sup>

0.6m deep insitu concrete foundation beams under new concrete walls. Typically extends 1m beyond the column at each end of the wall.  
For 34%NBS total beam width = 2m  
Allow for 70 kg/m<sup>3</sup> longitudinal reinforcing  
55 kg/m<sup>3</sup> stirrups

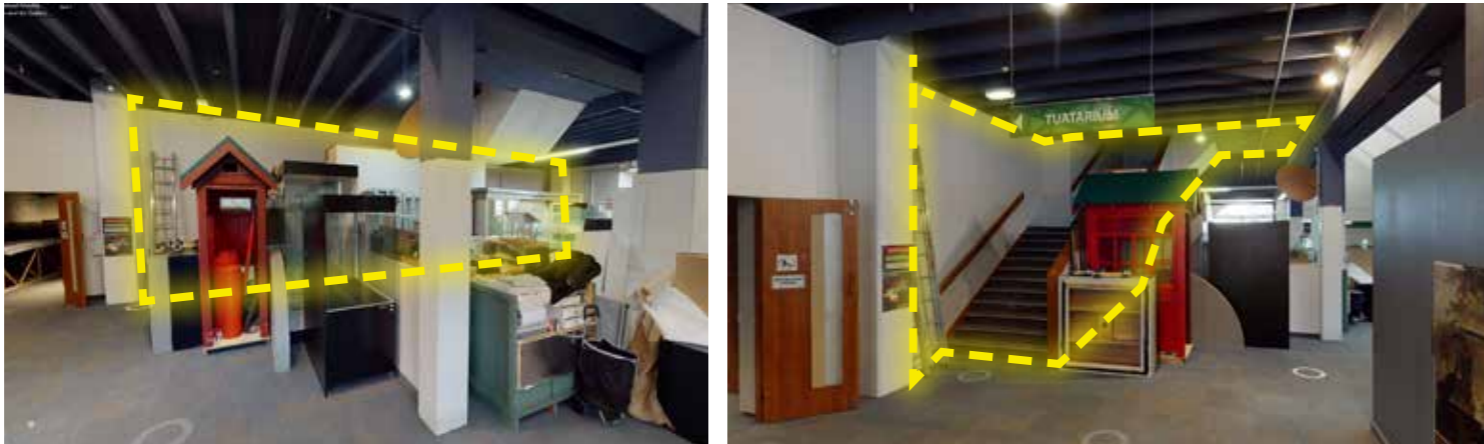
| Location | Scope of work | Description | Notes |
|--|--|--|--|
| GF- Structure / Fire / Accessibility<br><br>GRID 3 / C-E | RECEPTION STAIR<br> | New structural wall & foundation beam required.<br><br><b>Demolition:</b><br>- Remove existing stair.<br>- Cut out existing floor for new structural footing.<br><br><b>New Works:</b><br>- Form new structural flooring and wall to Structural engineers specification.<br>- Form new accessible compliant stair and balustrade with Fire rated lining to underside to fire engineers specification.<br>- reinstate floor coverings to new section of floor and new stair.<br>- Strap & line structural wall and paint. | Head room issue to be resolved at later design stage. |

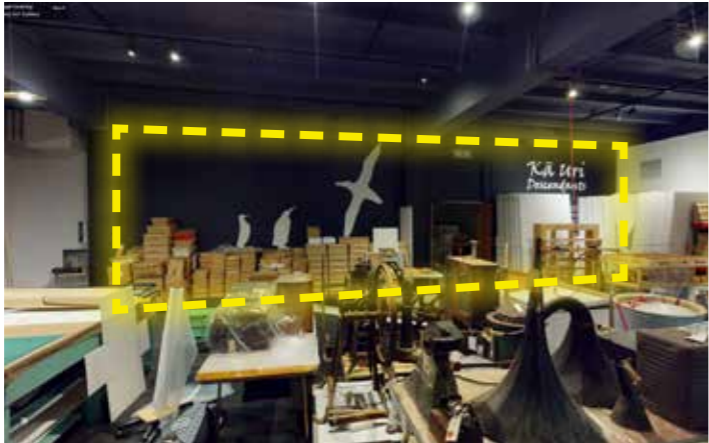
| Location | Scope of work | Description | Notes |
|--|--|--|--|
| GF - Structure<br><br>GRID 5 / B-D | GALLERY 2 WALL REMOVAL<br> | Remove existing wall due to structural weakness & safety hazard.<br><br><b>Demolition:</b><br>- Demolish existing full height wall on Grid 5 between grids B-D.<br><br><b>New Works:</b><br>- Patch existing floor covering where wall removed or flooring damaged during demolition<br>- Make good and paint soffit and columns. | |

Demolish existing full height wall. Patch existing floor covering where wall removed or flooring damaged during demolition. Make good and paint soffit and columns.

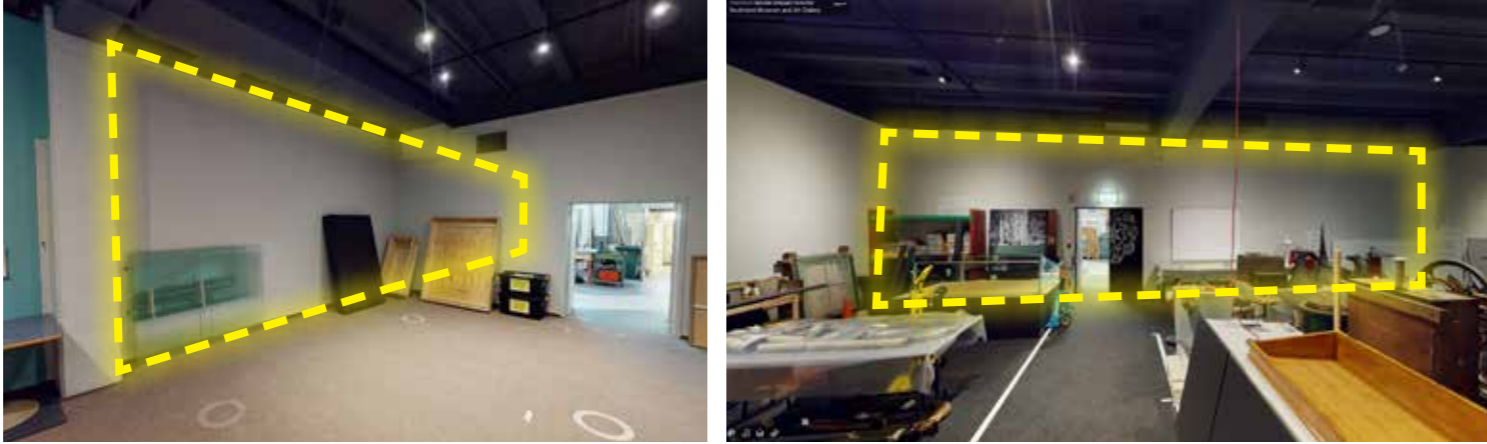
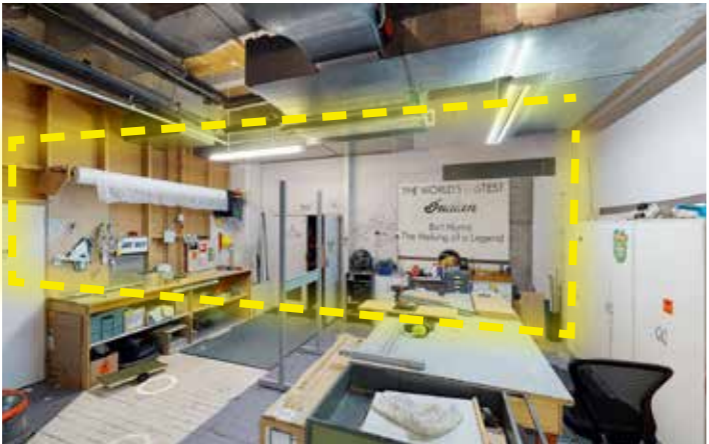
| Location | Scope of work | Description | Notes |
|--|--|--|--|
| GF - Structure<br><br>GRID 7 / B-D | EX CHILDREN GALLERY      GALLERY 2<br> | Remove existing wall due to structural weakness & safety hazard.<br><br><b>Demolition:</b><br>- Demolish existing full height wall on Grid 7 between grids B-D.<br><br><b>New Works:</b><br>- Replace wall with new full height PB lined timber partition w/ new double door to storage area.<br>Patch existing floor covering where wall removed or flooring damaged during demolition<br>- Make good and paint soffit and columns.<br>- Paint new wall both sides | |
| | Store room - structural wall removal & replacement<br> | | Review services connections - electrical, HVAC & Plumbing interface with existing wall removal. Make good where necessary. |

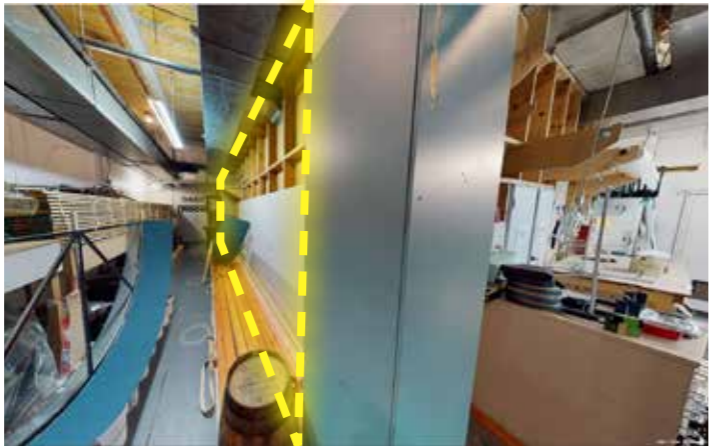
| Location | Scope of work | Description | Notes |
|--|--|---|--|
| GF- Structure<br>GRID 8 / C-E<br>NEW STRUCTURAL WALL AND FOOTING | RECEPTION STAIR<br> | New structural wall & foundation beam required.<br><br><b>Demolition:</b><br>- Cut out existing floor for new structural footing.<br>- Cut back existing partition<br><br><b>New Works:</b><br>- Form new structural flooring and wall to Structural engineers specification.<br>- Reinstate floor coverings to new section of floor<br>- Strap & line structural wall and paint.<br>- Re-instate | Retention of existing partition to be reviewed |

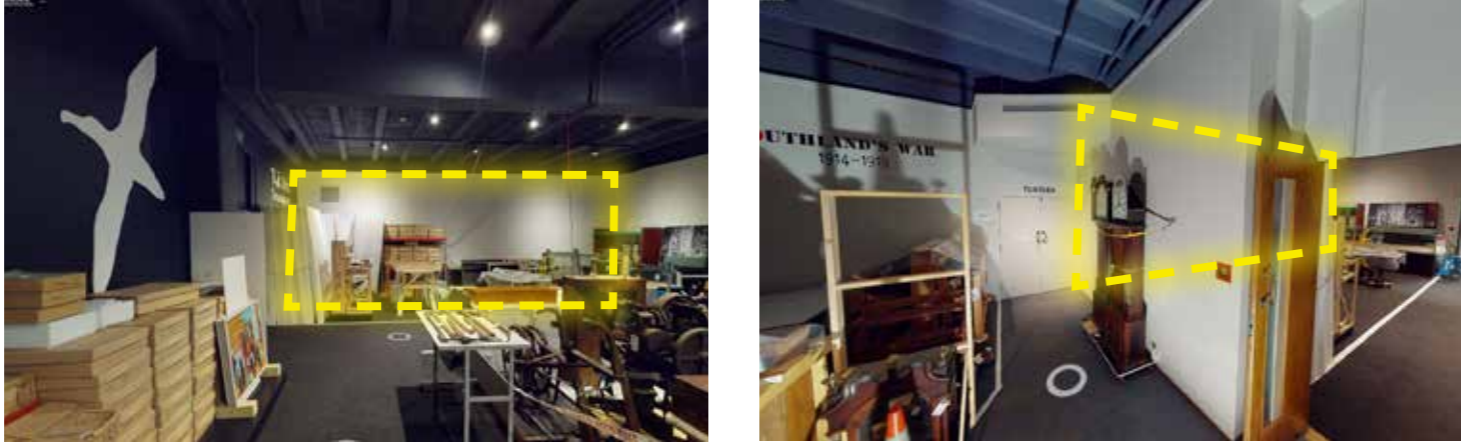
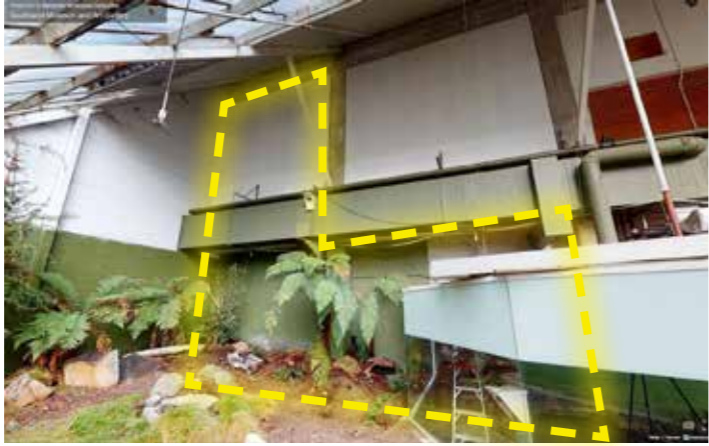
| Location | Scope of work | Description | Notes |
|--|--|---|--|
| GF - Structure<br>GRID B / 5-7 | GALLERY 2<br> | New structural wall & foundation beam required.<br><br><b>Demolition:</b><br>- Cut out existing floor for new structural footing.<br>- Cut back existing wall/ partition<br><br><b>New Works:</b><br>- Form new structural flooring and wall to Structural engineers specification.<br>- Reinstate floor coverings to new section of floor<br>- Strap & line structural wall and paint.<br>- Re-instate | |

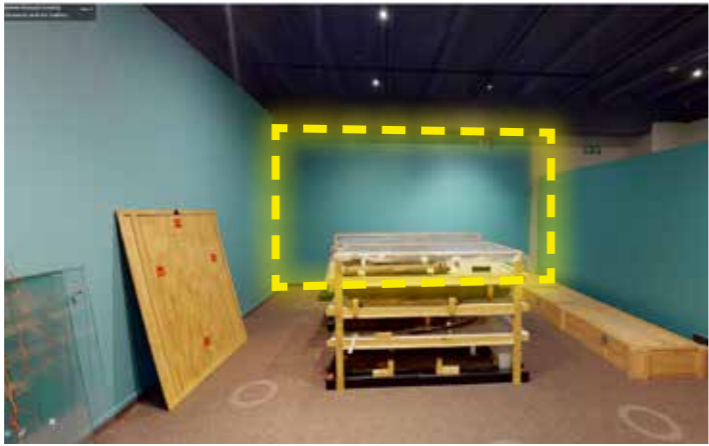
| Location | Scope of work | Description | Notes |
|--|--|---|--|
| GF - Structure<br>GRID E / 7-8 | EX. CHILDREN GALLERY<br> | New structural wall & foundation beam required.<br><br><b>Demolition:</b><br>- Cut out existing floor for new structural footing.<br>- Cut back existing wall/ partition<br><br><b>New Works:</b><br>- Form new structural flooring and wall to Structural engineers specification.<br>- Reinstate floor coverings to new section of floor<br>- Strap & line structural wall and paint.<br>- Re-instate | |

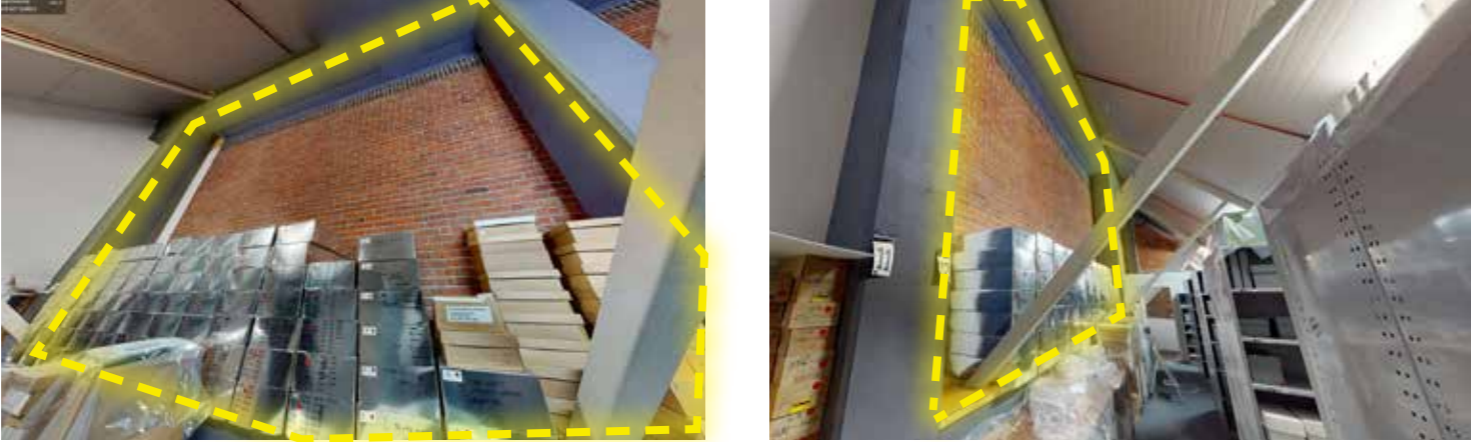
| Location | Scope of work | Description | Notes |
|--|---|---|---|
| LEVEL 1 - Structure<br>GRID F / 3-5<br>NEW STRUCTURAL WALL | ARCHIVE<br> | | |
