#### **Invercargill CBD Project**

Resource Consent Hearing Seismic Assessments March 2019

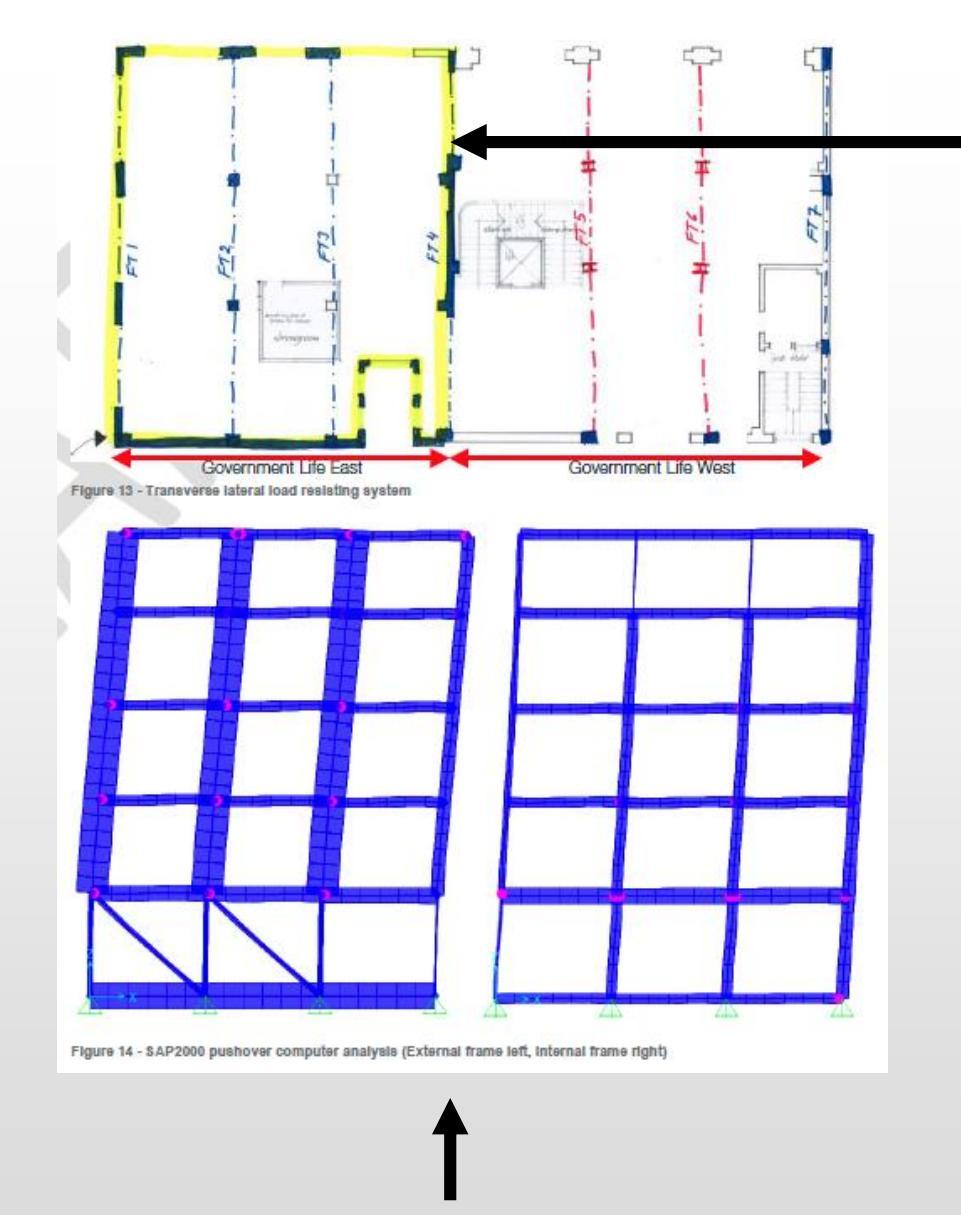
Computer Frame analysis showed CSW Flexural capacity of primary members & spalling concrete @ 10 - 45%NBS Structurally connected One relies on the other 'Siamese twins'

Concrete strengths 6 - 20 MPa = Poor (NBS 30-40MPa)

- **1.** Analysis determined seismic capacity **10 20%NBS**
- 2. Poor concrete strengths, low & unreliable durability
- 3. All Heritage features to the facades are concrete with spalling
- 4. Considered 'not able' to be repaired/strengthened
- 5. Untenanted for 35 years (except retail ground floor)
- 6. 5 storey, 2 x building forms, 90 yr old building, designed pre Napier EQ (modern buildings designed for 50yr life).

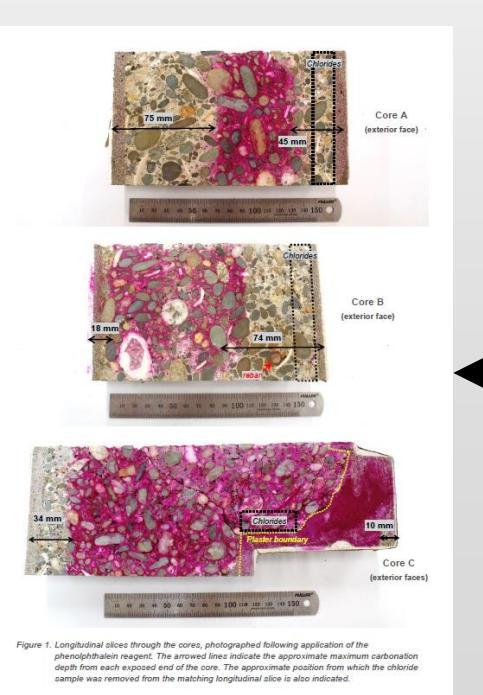
Durability Tests
Marine aggregate
Carbonated
Low covers
Low & variable
durability
