# RESOURCE MANAGEMENT ACT 1991 FOURTH SCHEDULE ASSESSMENT OF EFFECTS ON THE ENVIRONMENT

The Bluff Oyster and Food Festival Charitable Trust (**the Trust**) propose to expand and develop the site of the Bluff Oyster Festival held at 100-116 Gore Road, 12 and 14 Lee Street and 73 Barrow Street, Bluff. The Oyster Festival currently operates an open air venue at the south end of the site with large open faced shelters on the western boundary. The site can currently cater to a maximum capacity of 5000 people and with the festival selling out each year well before the festival date the Trust wants to expand the area available to the festival. They intend to do this by demolishing the buildings currently standing on the northern portion of 100-116 Gore. The expanded area will allow an additional 1000 guest to attend the festival. The Trust plans to erect a shelter, with terraced gardens and interpretive panels, illustrating and describing the sites past use from the early days of European settlement in the Bluff area.

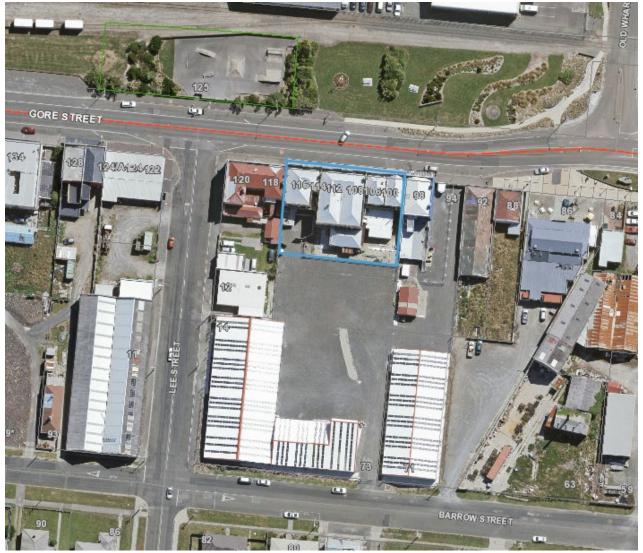
Figure 1: Site boundaries

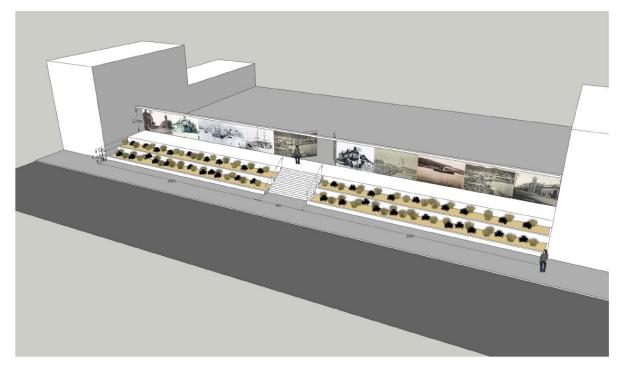
Figure 2: Illustrative Plans showing proposed Gore Street frontage.

The design incorporates a terrace garden rising up from Gore Street with interpretive panels along a 2.4m high wall at the rear of the gardens. These panels will tell the story of the Club Hotel and early Bluff history. The display is not intended to be static and will be updated intermittently with new photographs and stories.

McCulloch Architects have prepared design plans showing the intended end result for the Gore Street frontage with the main plan view provided below (Figure 2). A full set of the illustrative plans is provided in Appendix C.
