The Club Hotel, Bluff

A Heritage Impact and Archaeological Assessment

Report Prepared for: Bluff Oyster and
Food Festival Charitable Trust

Reviewed by: Dr Naomi Woods
Submitted: August 2018

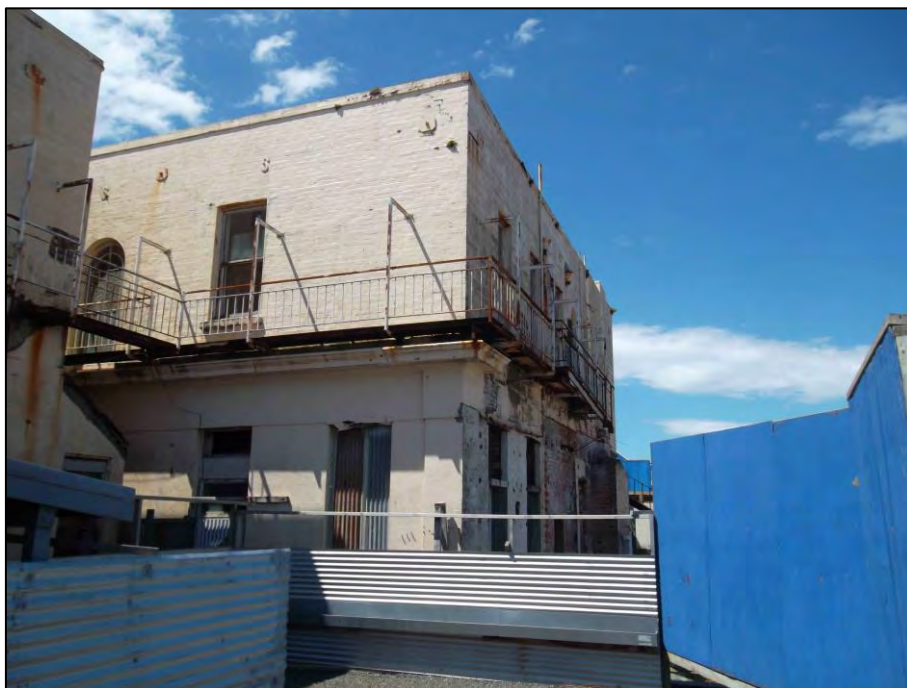
Approximately 10m of the west elevation is visible; however, photographing this section of the building was hampered by the position of the temporary enclosure around the festival toilets (Figure 7-14). On the ground floor are two doors, which have been blocked. The height of the doors suggests they would have had transom windows. On the first floor there is a sash window, a large arched window (visible from stairway), all of which are unadorned. A moulded cornice runs along the west elevation and it projects slightly around a pilaster at the south end of the building. This feature is likely part of the original 1884/1885 façade. A fire escape balcony runs along the length of the west elevation just above the cornice. The west elevation has a rendered finish on the ground floor up to the first-floor extension across to Scott's Private Hotel. Below this extension the brickwork is painted, as it is across the first floor.

Figure 7-14. Photographs showing the west elevation of the Club Hotel (photo facing northeast). Note the moulded cornice below the fire escape balcony.

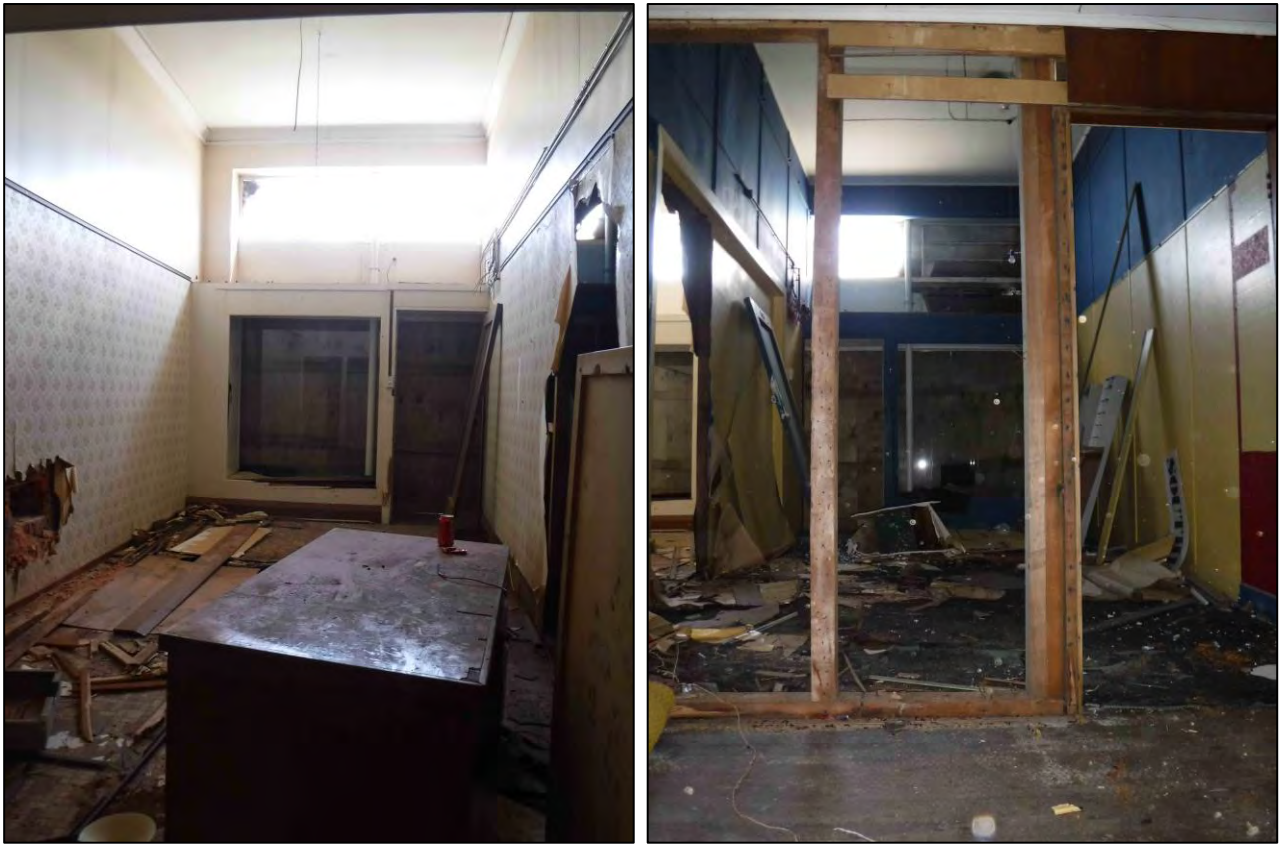
The ground floor of the Club Hotel consists of two shops (B01 and B02), the lobby (B04), the stairway to the first floor (B03), the bar (B05 and B07), and lounge (B06) (Figure 7-16). The two shops have modern linings atop earlier twentieth century linings that include tongue and groove floorboards and v-groove tongue and groove wall lining. Skirting boards from the 1930s are present in some areas, but there have been many late twentieth century replacements. The ceilings are lined with plasterboard, which has been partially removed in room B02 to expose a hardboard ceiling. The shopfront windows have been boarded over.

Figure 7-15. Photographs showing the shops on the west side of the ground floor of the Club Hotel (photos facing north).

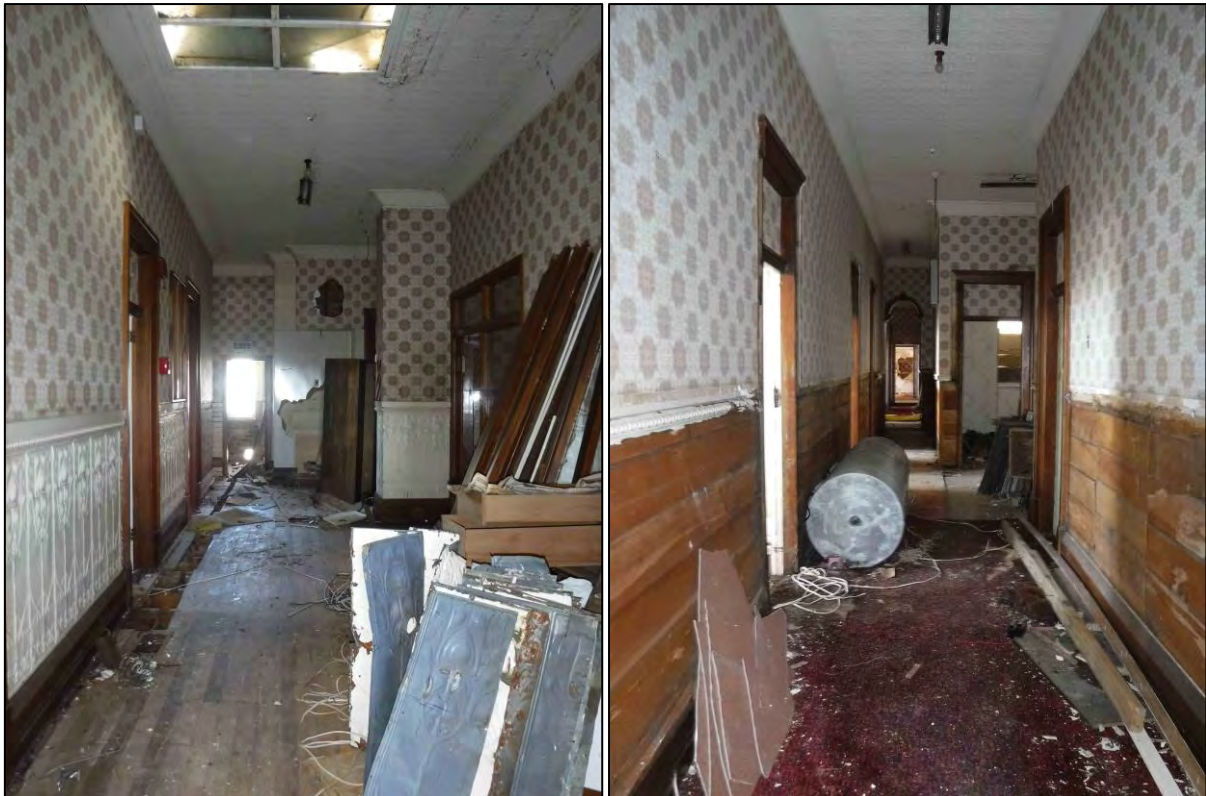
The first floor of the Club Hotel consists of ten bedrooms (B8-B10, B12-B13, B15-B17, B20-B22) and a toilet/shower block (B25-B28) off of a series of hallways (B11, B14, B18, and B24) (Figure 7-18). The larger bedrooms were situated on the north and east side of the building, with small bedrooms along the south side. Other facilities, such as a built-in cupboard and an ironing room also remain. (B19) The hallways feature a pressed metal dado with wallpaper above, and the ceiling is lined with pressed metal panels. The pressed metal dado was removed in some areas to reveal the sarking beneath.

Figure 7-18. Photo of the Club Hotel first floor hallways (left, looking south; right, looking east).

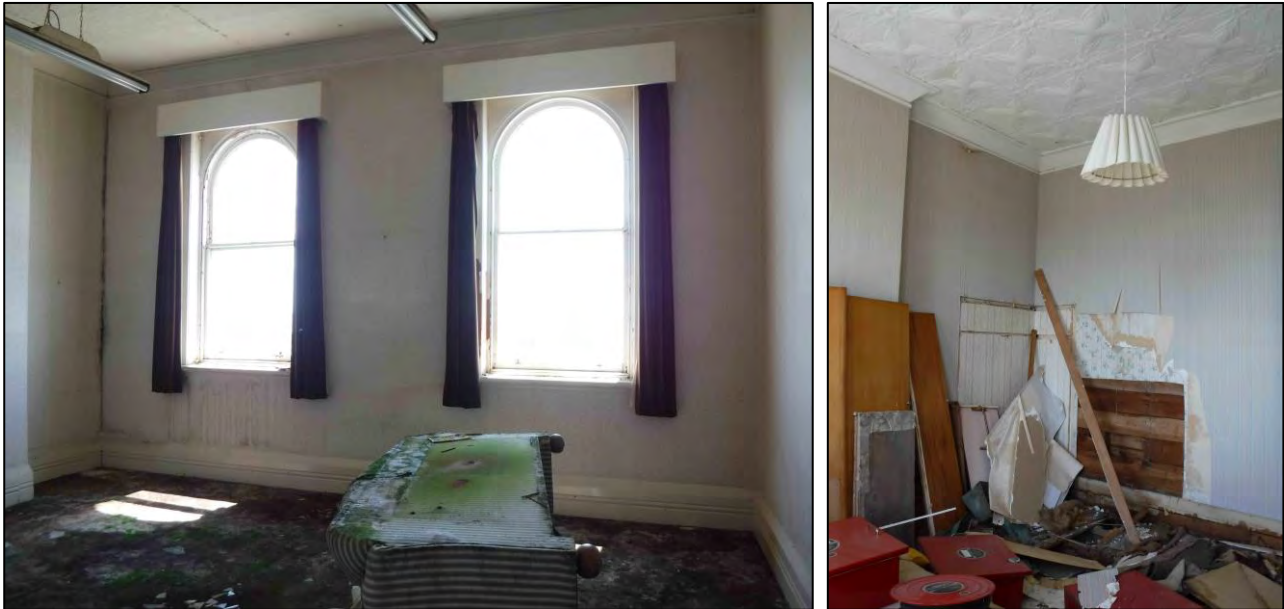
The bedrooms all share a similar décor, featuring modern carpet over timber floorboards, plasterboard on the walls, skirting boards from the 1938 alterations, and pressed metal ceiling and cornice (Figure 7-19, Figure 7-20). The doors leading to the hallway have transom windows, which have since been blocked. Some of the wall linings had been removed from the south wall of Room B10, revealing beneath the plasterboard several more layers of wallpaper over scrim and sarking. The fireplaces that once warmed these rooms have since been blocked and covered over with plasterboard.

Figure 7-19. Left: photograph of Room B8 showing the sash windows and skirting boards. Right: photograph of Room B10 showing the layers of wall linings. Note the pressed metal ceiling.

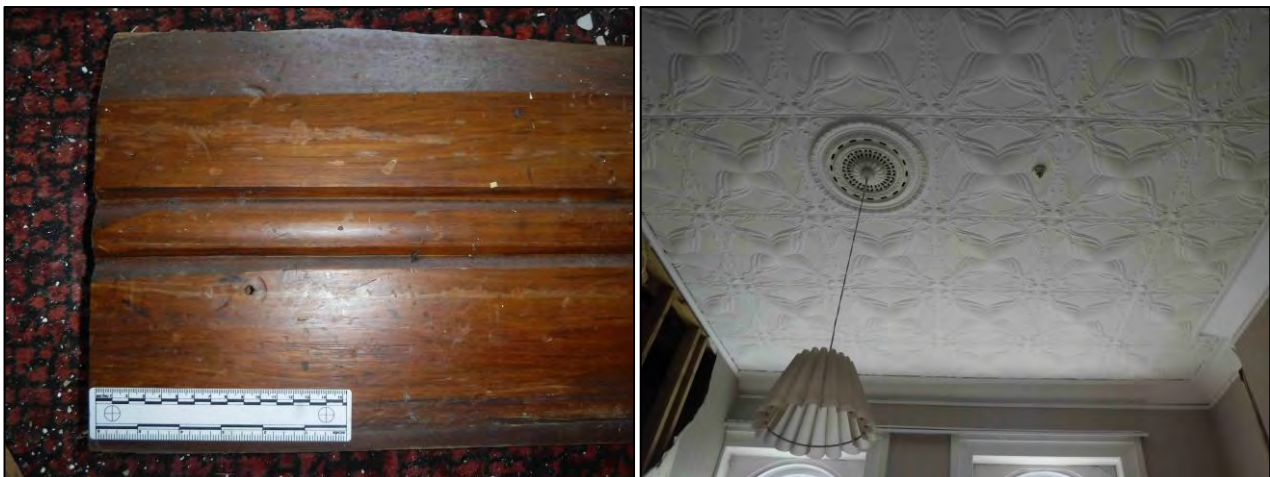
Figure 7-20. Left: detail of the skirting board from the front hallway (B11). Right: detail of the pressed metal ceiling in Room B10.

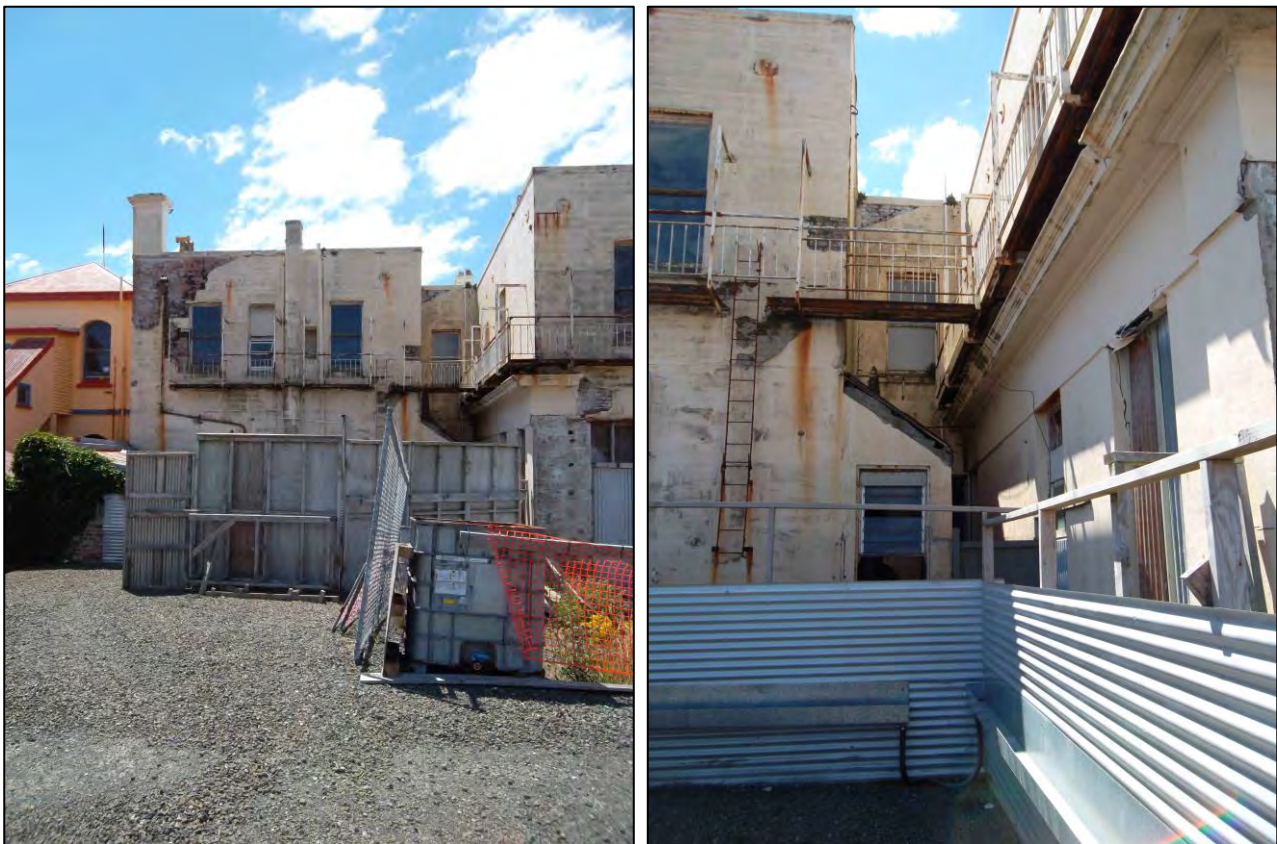
Like the other buildings in the Club Hotel block, the south elevation of Scott's Private Hotel is unadorned (Figure 7-21). On the ground floor are two doors, providing access to the back yard from each of the shops. There is a louvred window on the far east side of the building within the ground floor extension. On the first floor, there are three sash windows, a small fixed window, and a small chimney. There is a fire escape balcony along this elevation, which spans the right-of-way and joins the fire escape on the Club Hotel. The south elevation also includes a narrow first floor extension between the Club Hotel and Scott's Private Hotel. This elevation features a single double hung sash window.

Figure 7-21. Left: the south elevation of Scott's Private Hotel. Right: detail of the small ground floor addition.

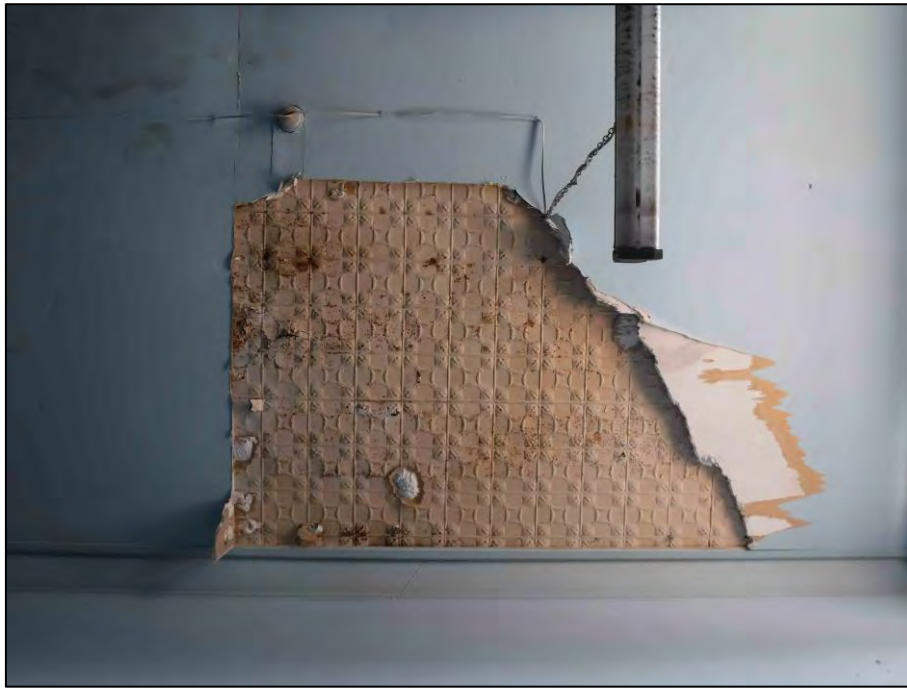
The interior layout of the ground floor consists of two commercial shops (west shop, Rooms A01-A02; east shop Rooms A06-A07) with a toilet block (Rooms A03-A04) to the rear of the building with shopfront windows that have since been boarded up. Both shops feature modern linings, many which have been removed to expose early twentieth century building fabric, including tongue and groove floorboards, v-groove tongue and groove wall linings, and pressed metal ceilings (Figure 7-23). Mid to late twentieth century partition walls are present in both shops. The linings on the west wall of the building have been partially removed exposing the brickwork beneath. The brickwork (English garden wall bond) is blackened, evidence of the previous fires that have affected the property (Figure 7-24). The west shop also features a corner fireplace (southwest corner), which has had the surround removed. The back door of this shop also has one of the few remaining doors, a four-panel door with a rim lock. The toilet block has modern linings and fittings throughout.

Figure 7-23. Pressed metal ceiling exposed beneath the plasterboard.

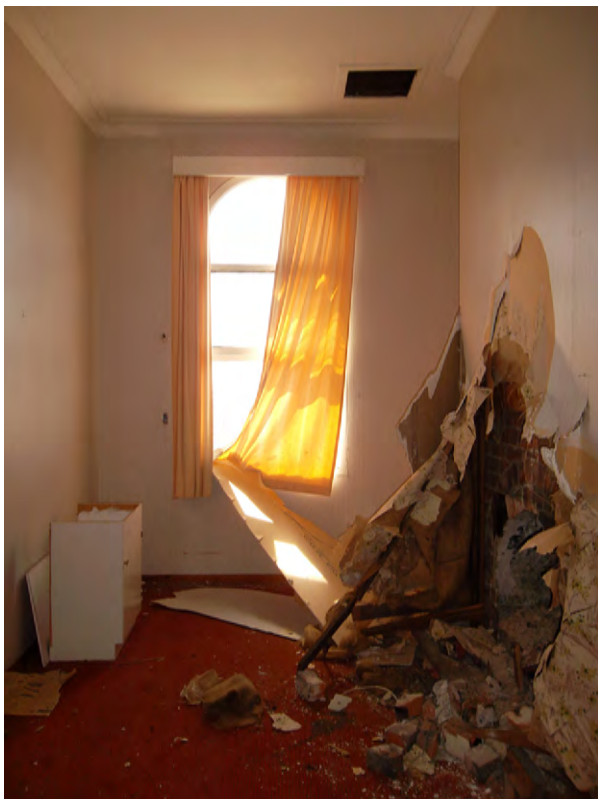
Room D03 looking north

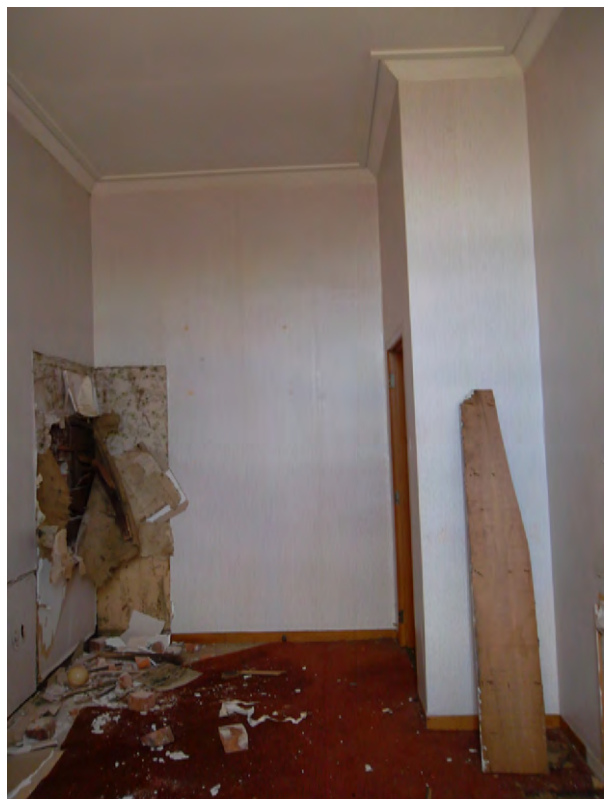
Room D03 looking south

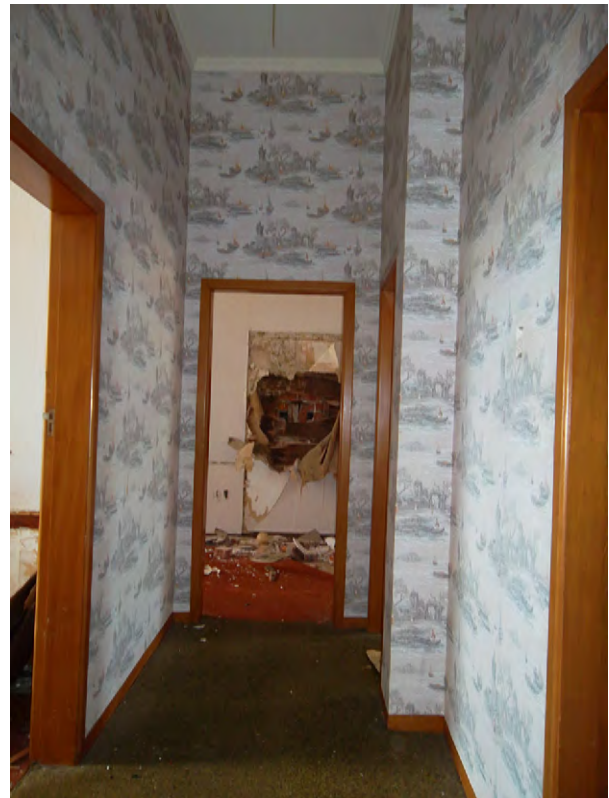
Room D04 looking east

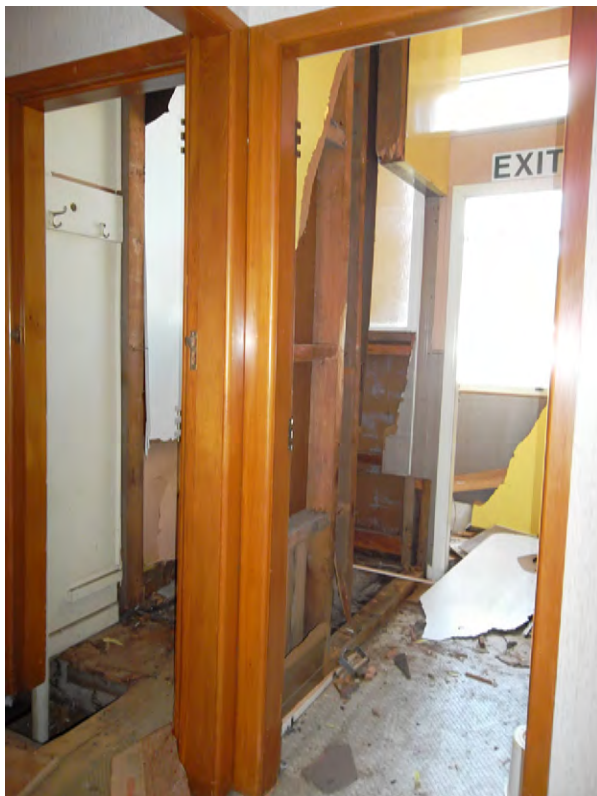
Room D05 looking south

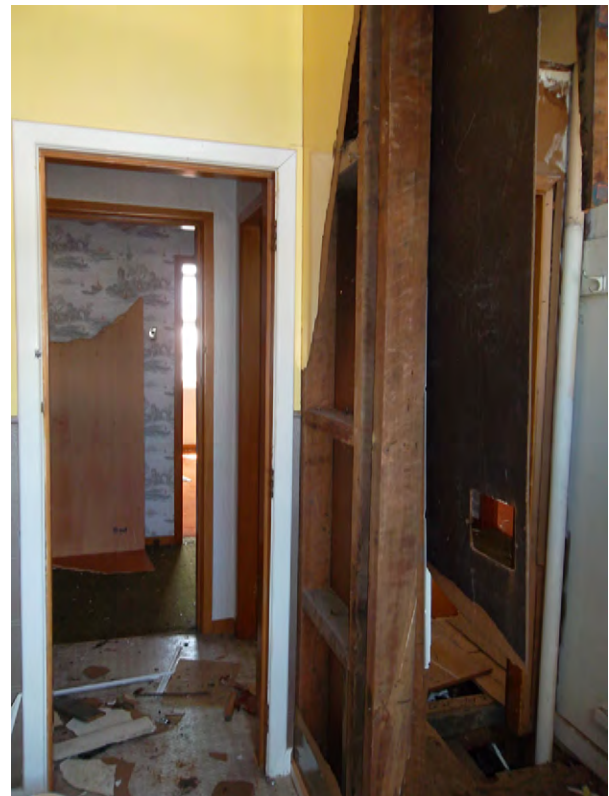
Room D05 looking west

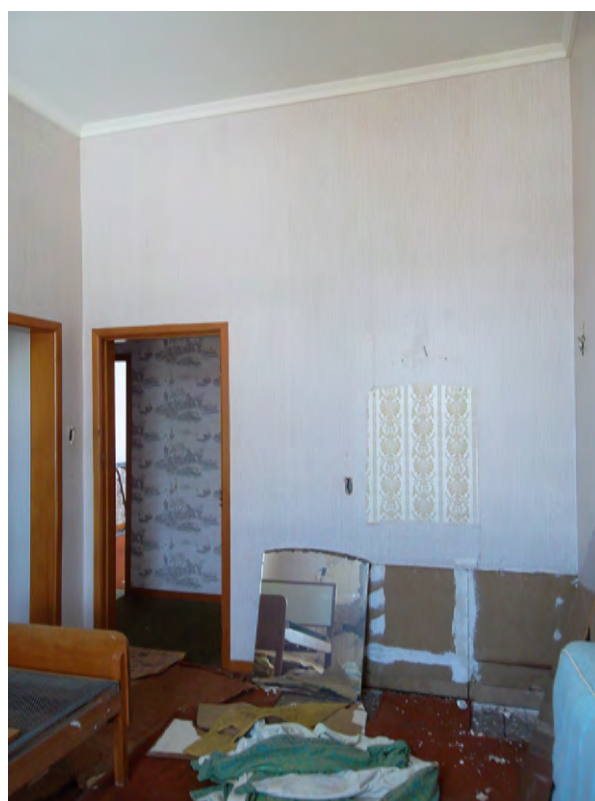
Room D06 looking west

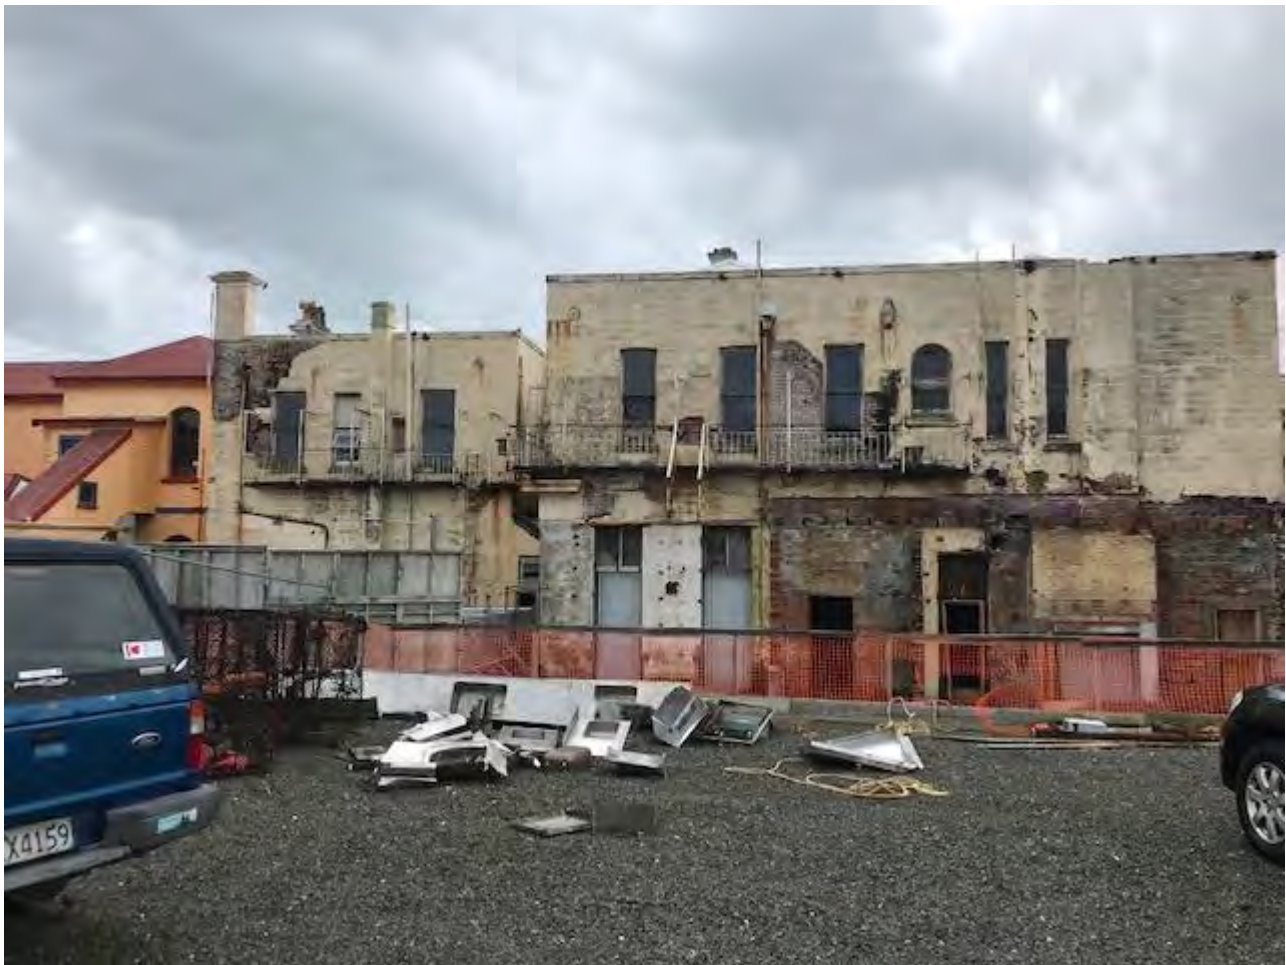
Fig 1 Rear of the Building South View.

These walls (see FIG 1& 2) are past the point where they can be considered to offer any reasonable shear transfer to render themselves collectively as interlinked units outside that of individual bricks which lack structural integrity as is required by walls themselves to transfer such shear loads to adjacent structural mechanisms often in the form of columns.

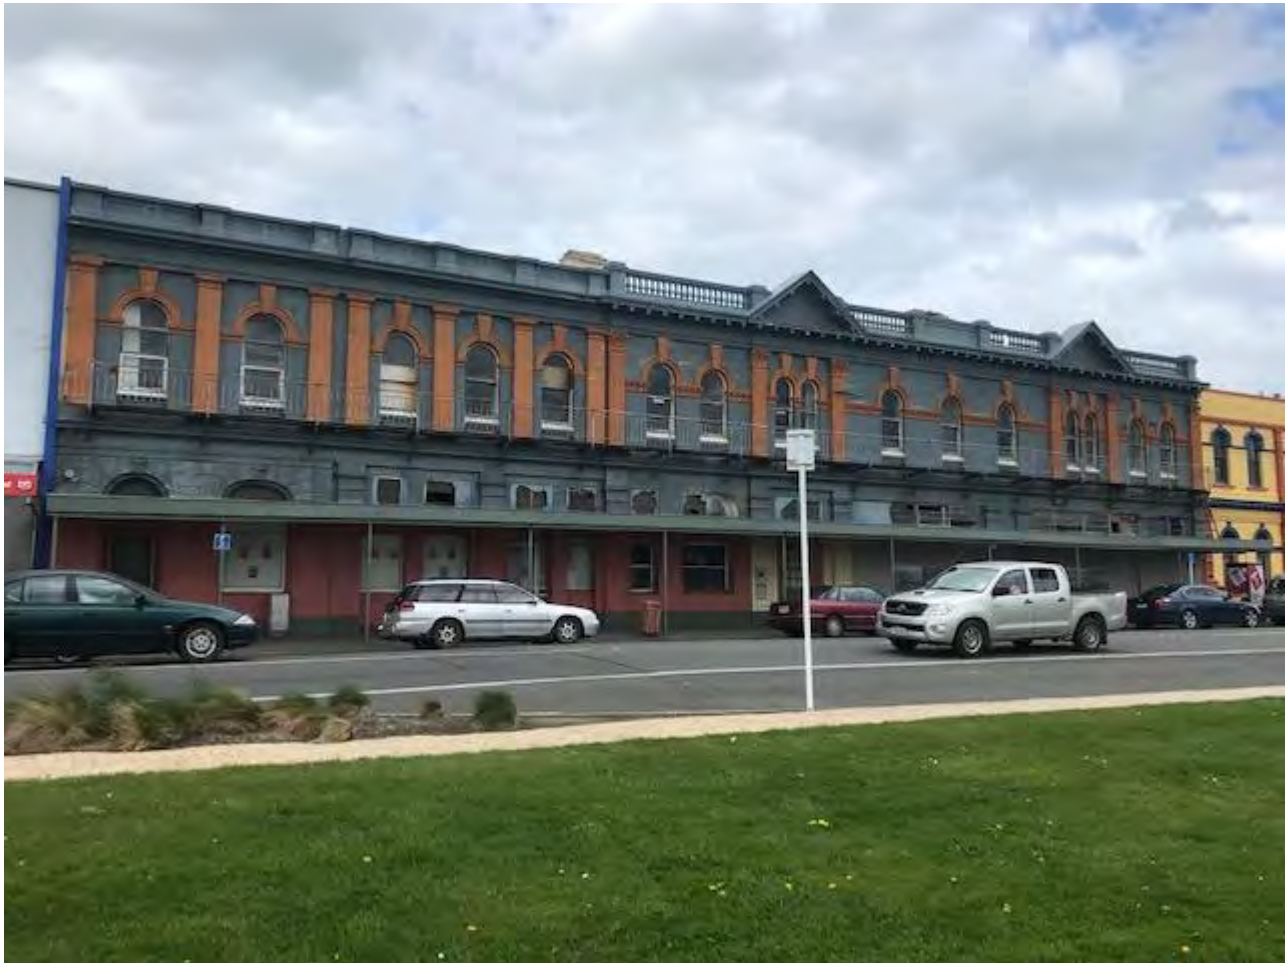
Figure 2: Front Façade discussed facing North. Adjacent yellow building to the West on the RHS.

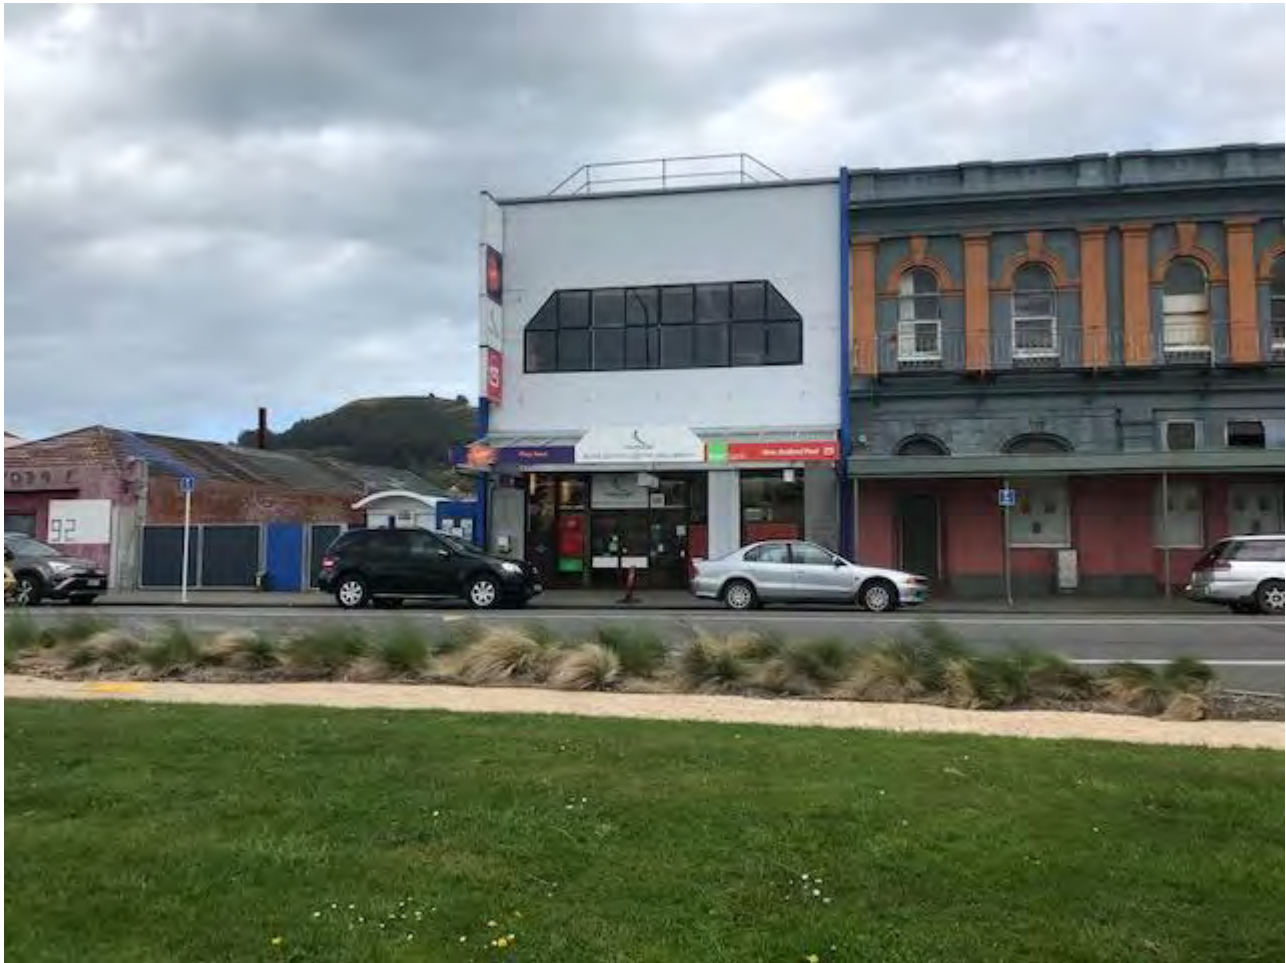
Fig 2A: Showing adjacent building to the East. BNZ Bank on the LHS.

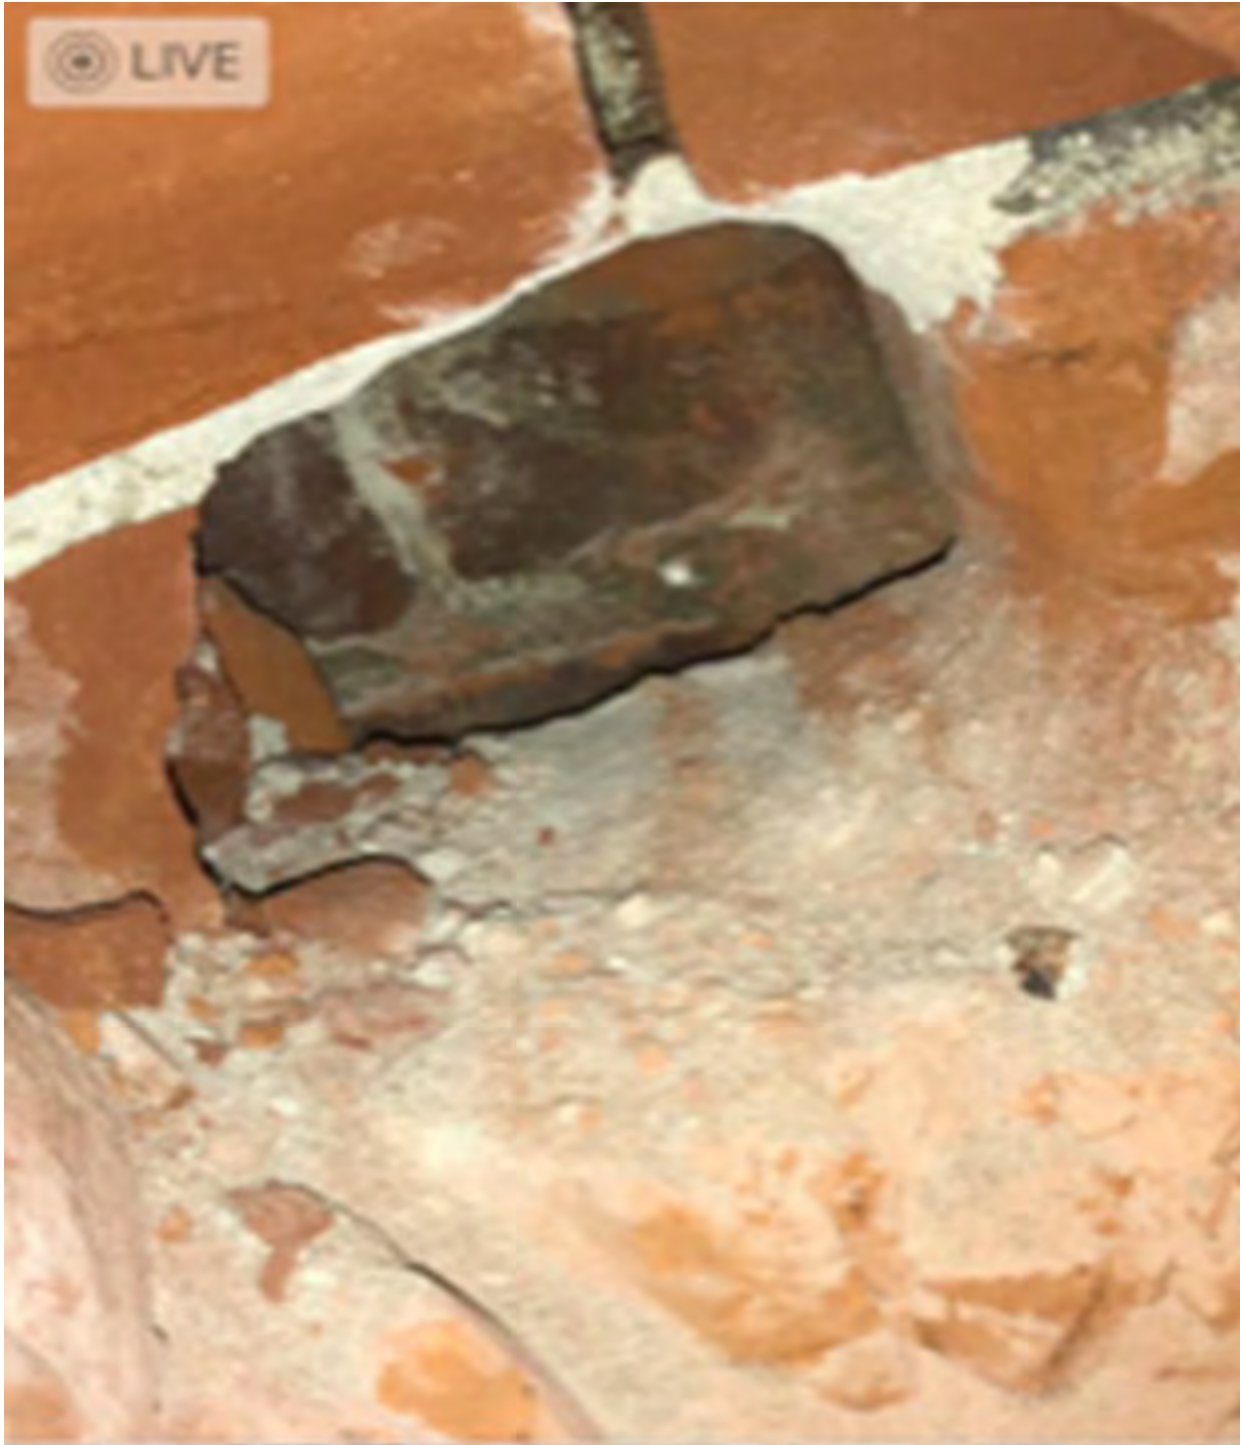
Fig 5 : West Boundary wall with very soft bricks.
